Attachment to Supplemental Form 27  
Remediation #:9744

**Decker Landfarm Site**  
After seed was drilled  
and straw was crimped in soil

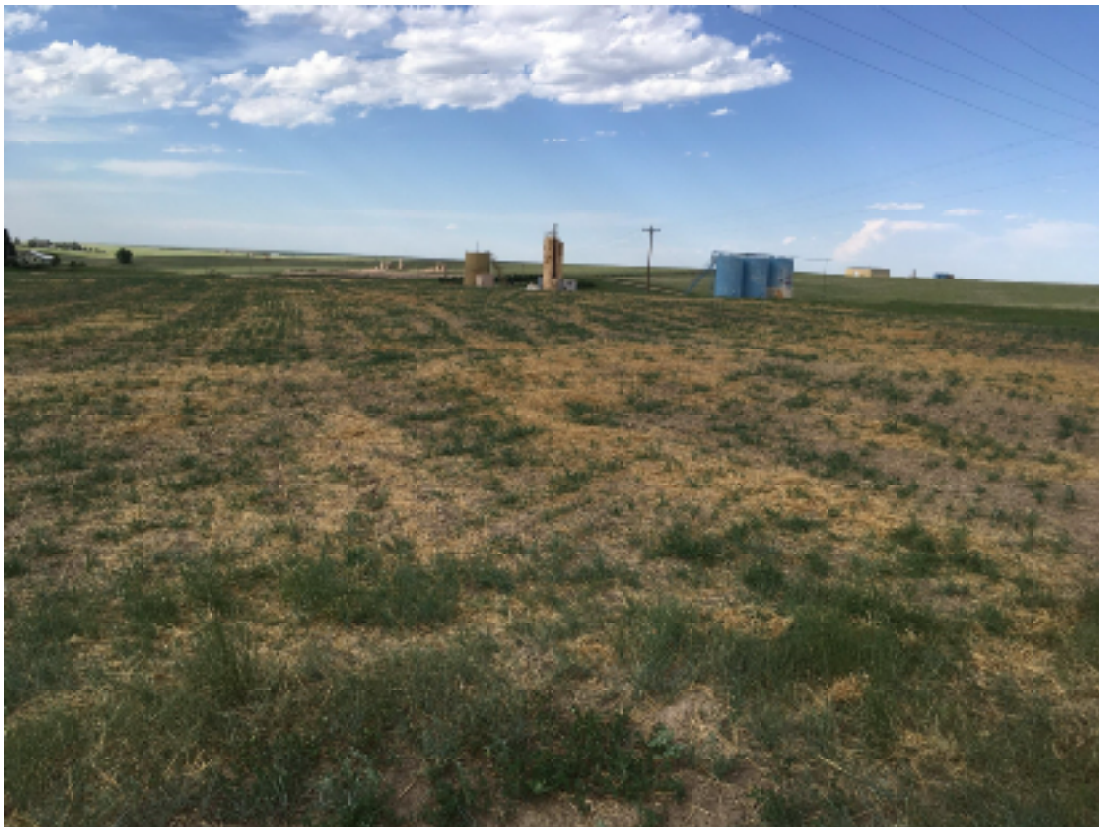
View of site looking North

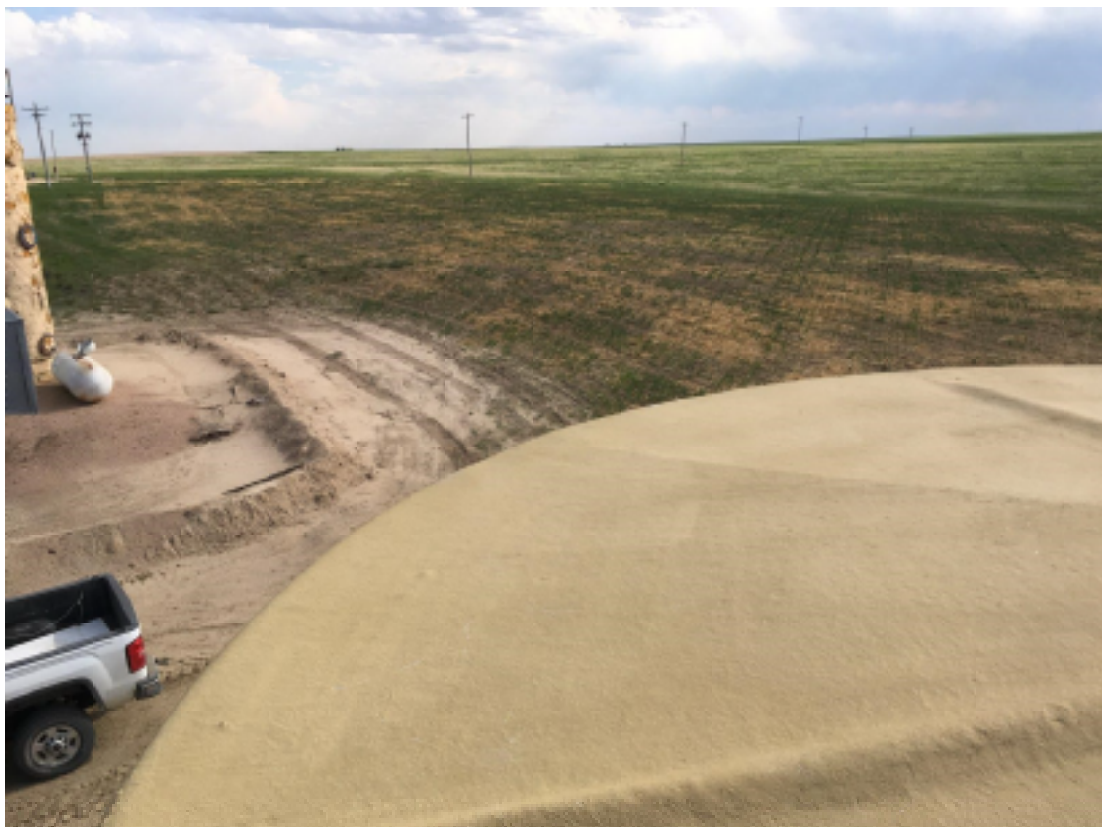
View of site looking South
