Final Reclamation Inspection

Operator: BONANZA CREEK ENERGY OPERATING COMPANY LLC - #8960

API: 05-123-24326

Inspection Photos
Location Name: STATE ANTELOPE #11-12
API: 05-123-24326

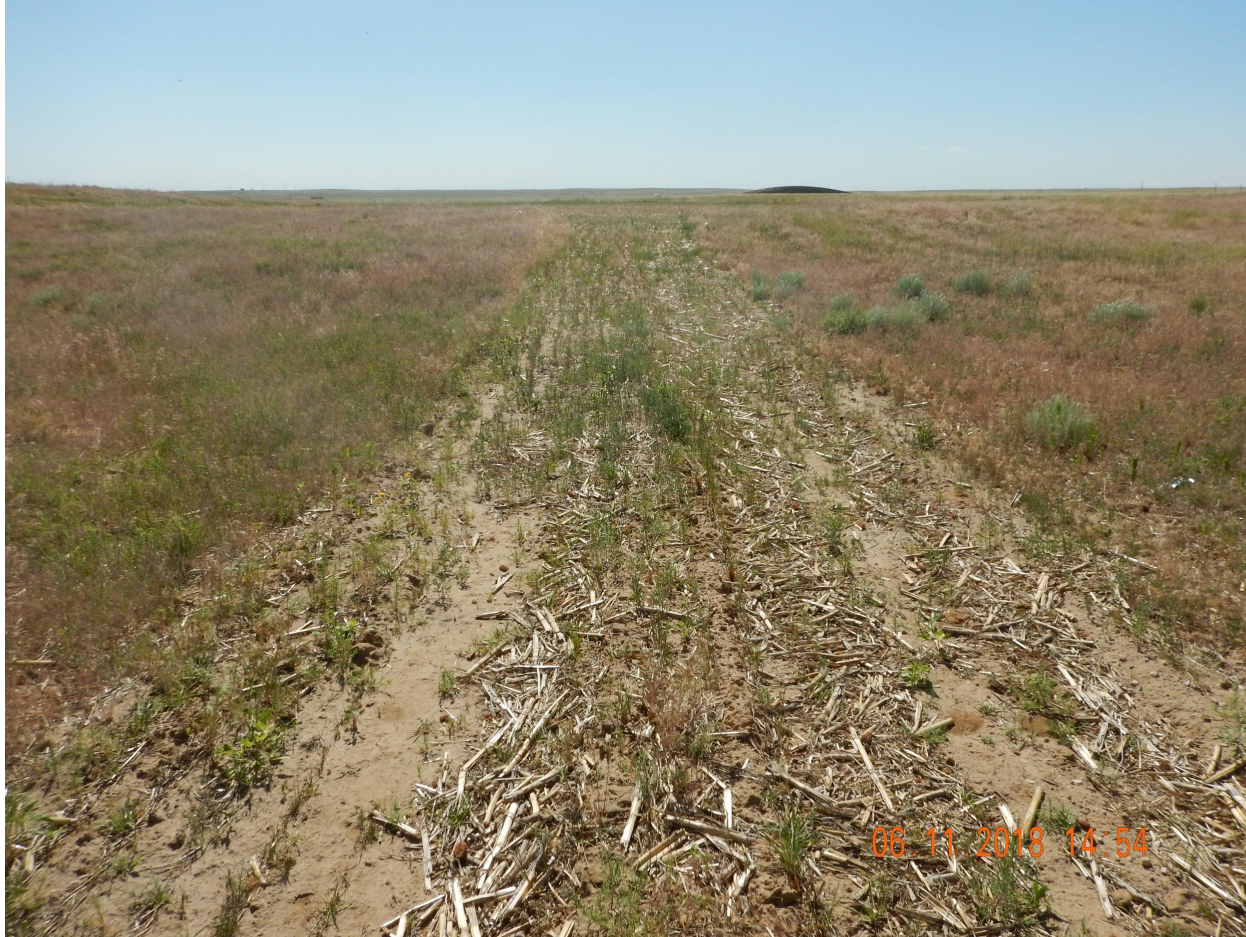
Photo 1. Photo taken from the entrance of the location, facing West. Photo illustrates the evidence of drill rows; however, this location will remain in-process. Large patches of cheatgrass were observed within the location disturbance area. Russian thistle germination was observed throughout the disturbance area that was seeded. Operator shall continue to monitor and manage this site until the location meets Rule 1004 standards.

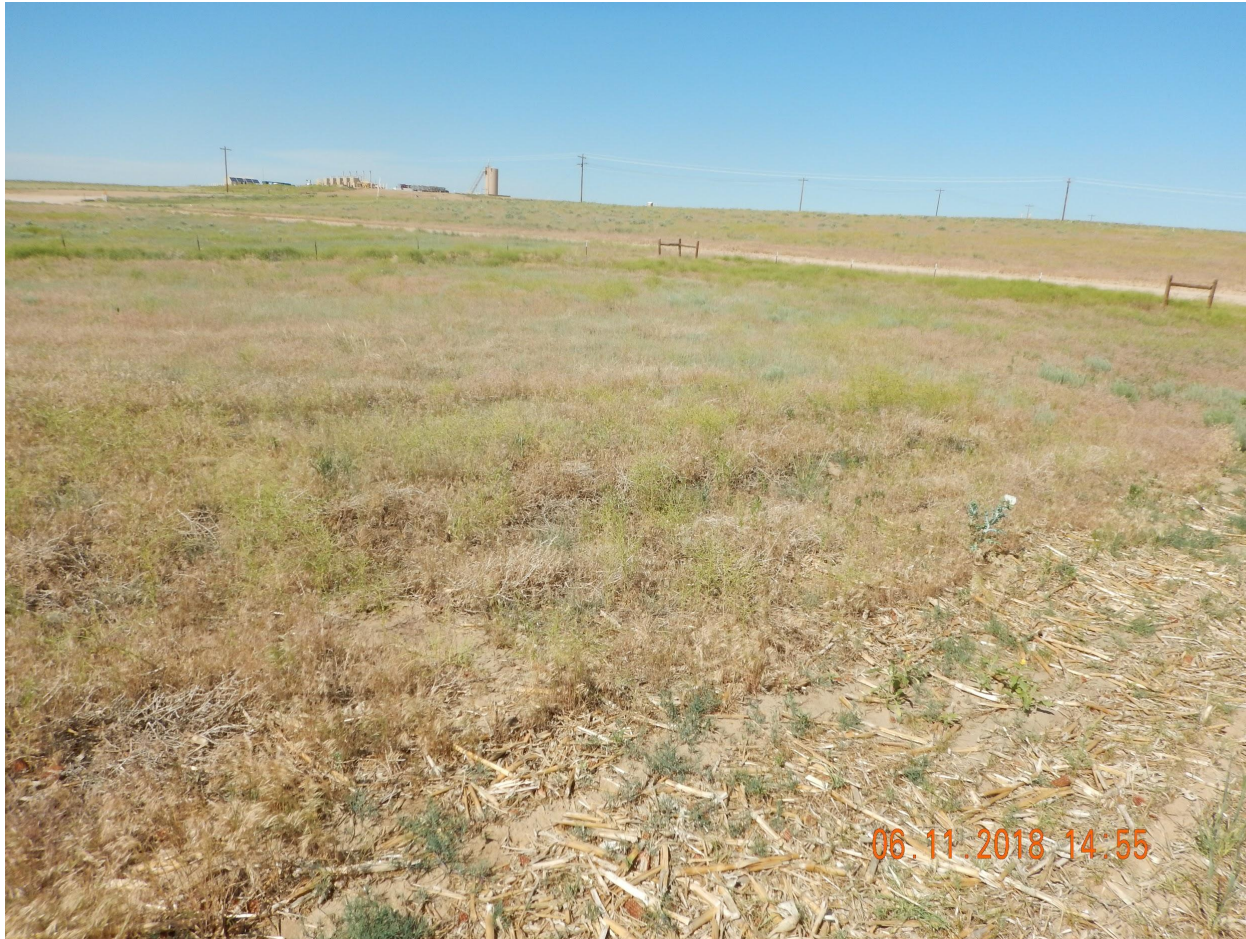
Photo 2. Photo taken from the entrance of the location, facing Northeast. Photo illustrates patches of cheatgrass observed within the location disturbance area.

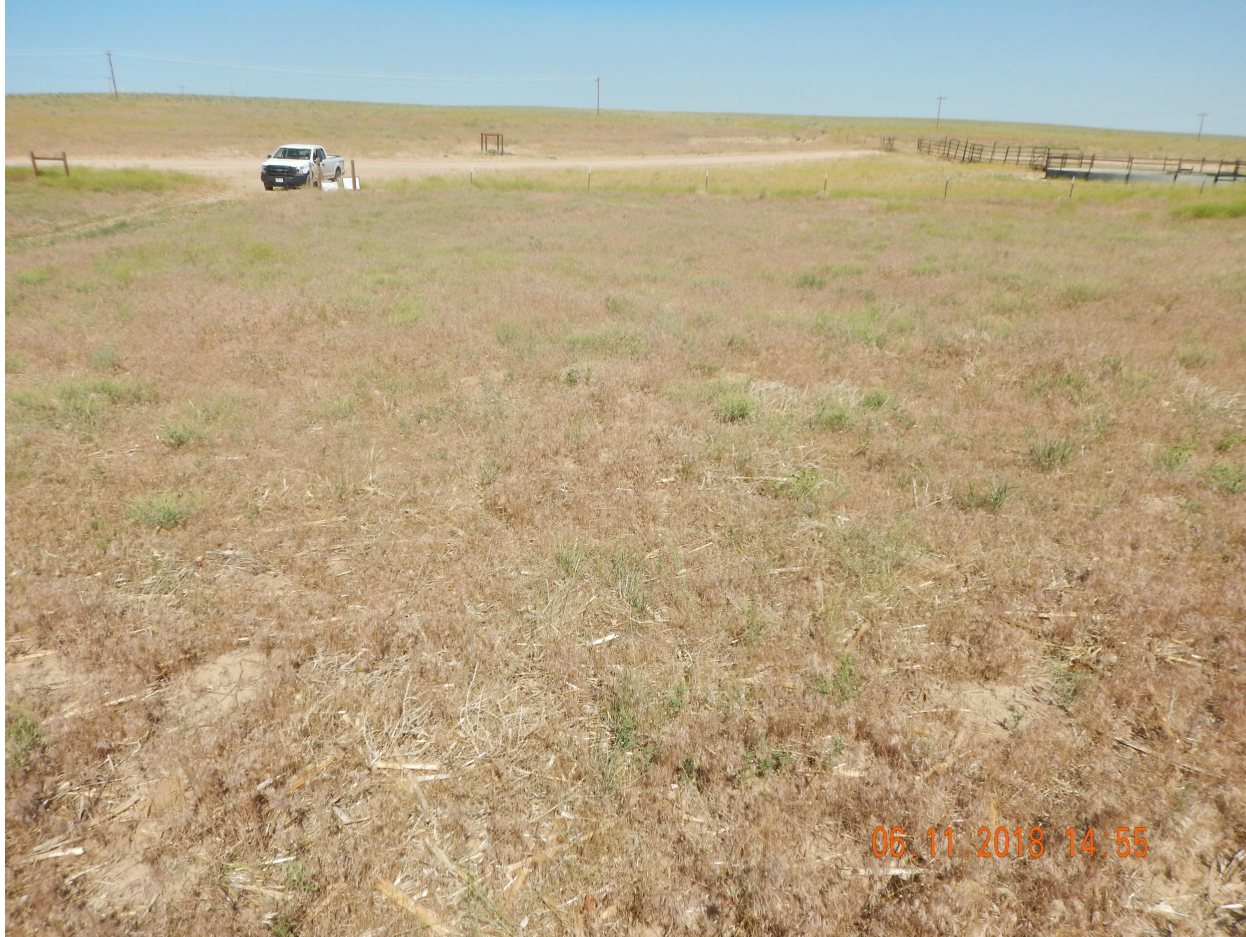
Photo 3. Photo taken from the entrance of the location, facing East. See comments under Photo 2.

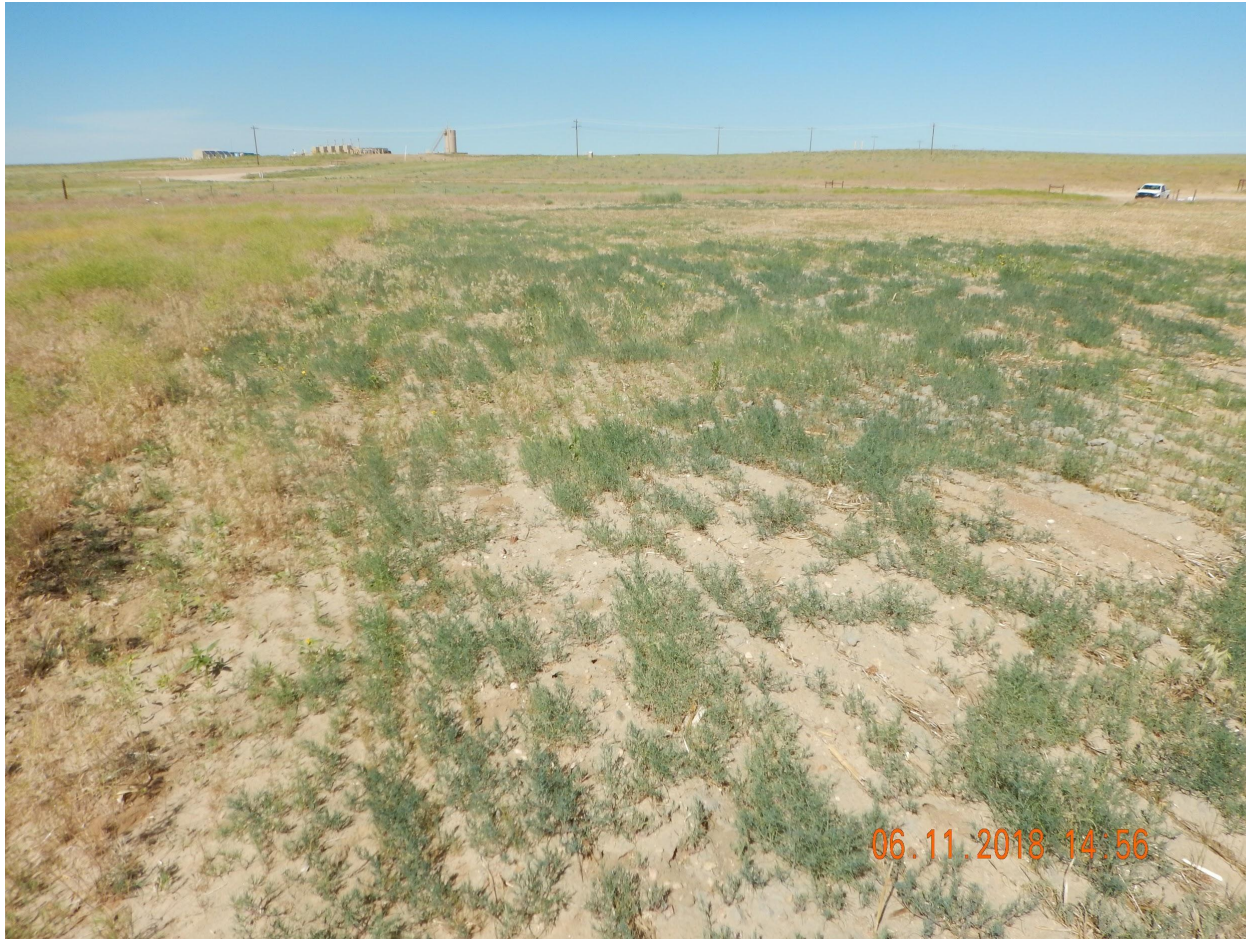
Photo 4. Photo taken from the former western production area, facing Northeast.
Photo illustrates a patch of Russian thistle.
