**Inspection Photo
McLin B20
API # 045-19383
Inspection # 689301297**

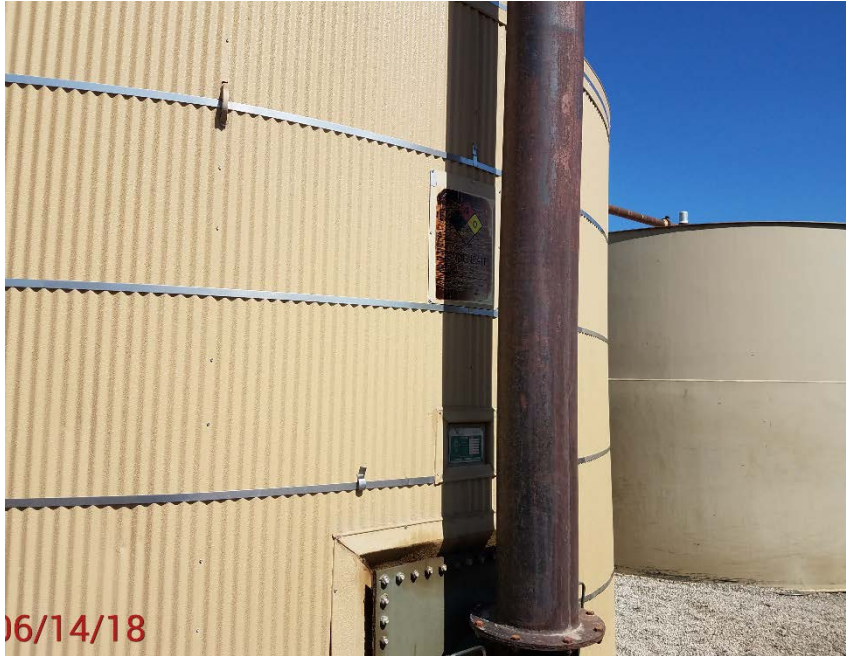
Location Photo #3, sign not legible on tank

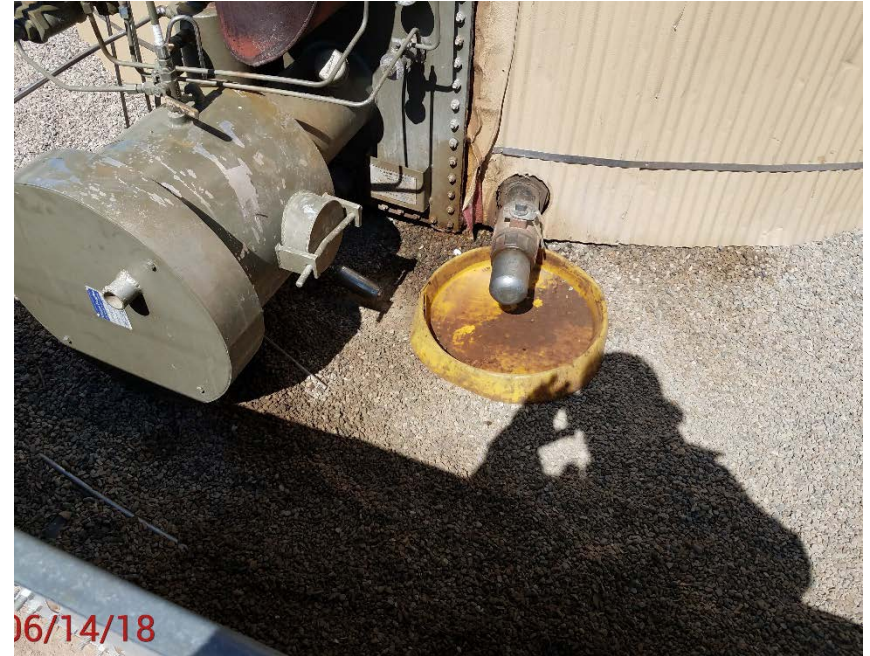
Location Photo #4, Stained rock in containment

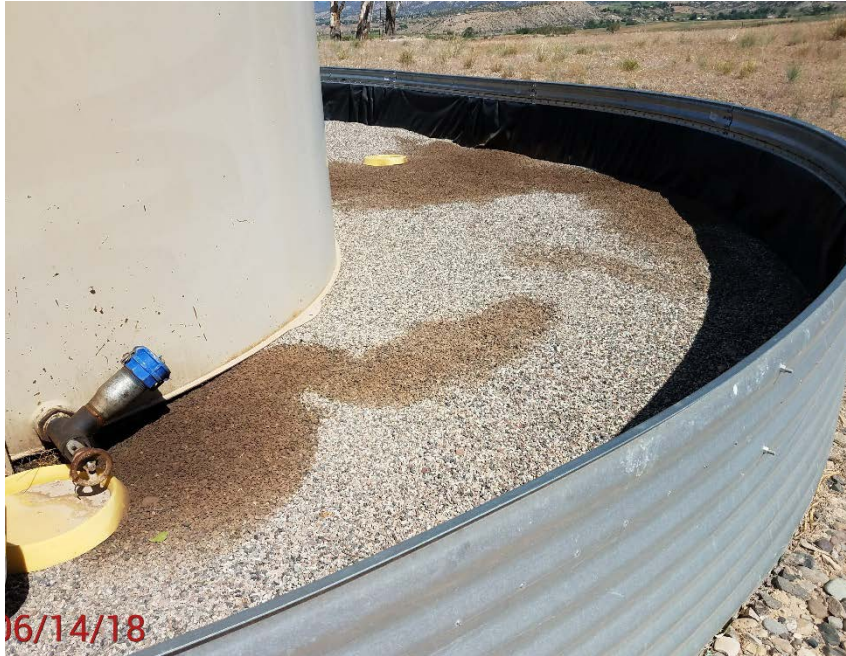
Location Photo #5, Stained rock in containment

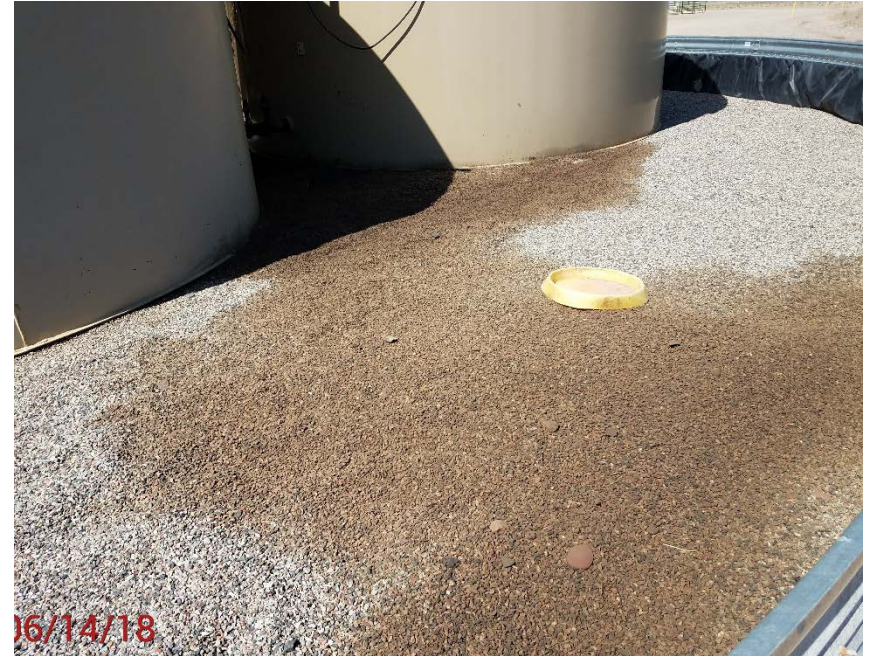
Location Photo #6, Stained rock in containment

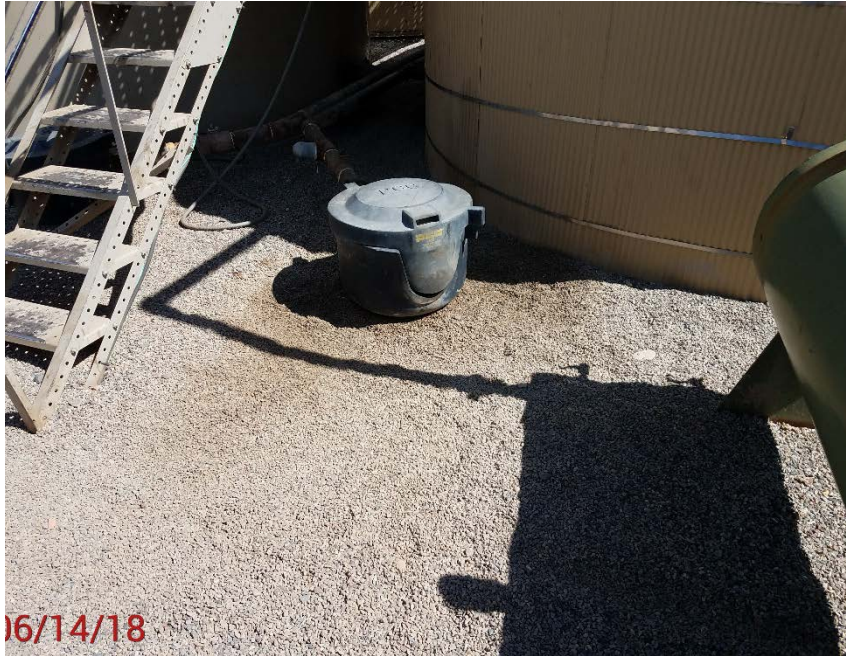
Location Photo #7, Stained rock in containment
