# Inspection Photos

06/15/2018

Operator: FOUNDATION ENERGY  
MANAGEMENT LLC - 10112

Location ID: 447523

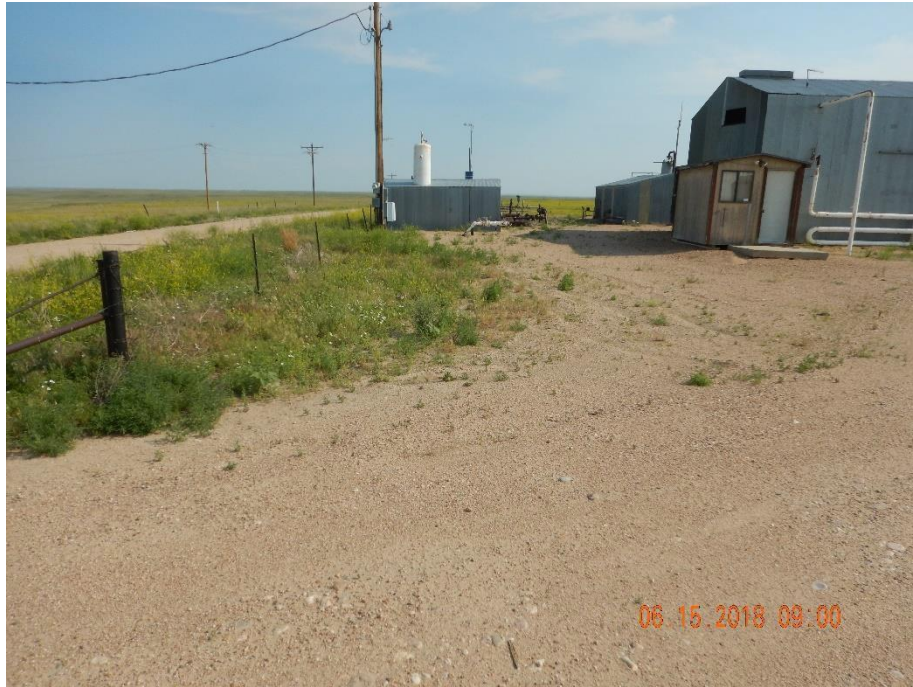
**Photo 1:** Photo taken from the southwest end of the location, facing north. Photos 1-3 show an overview of the location from north, northeast to east.

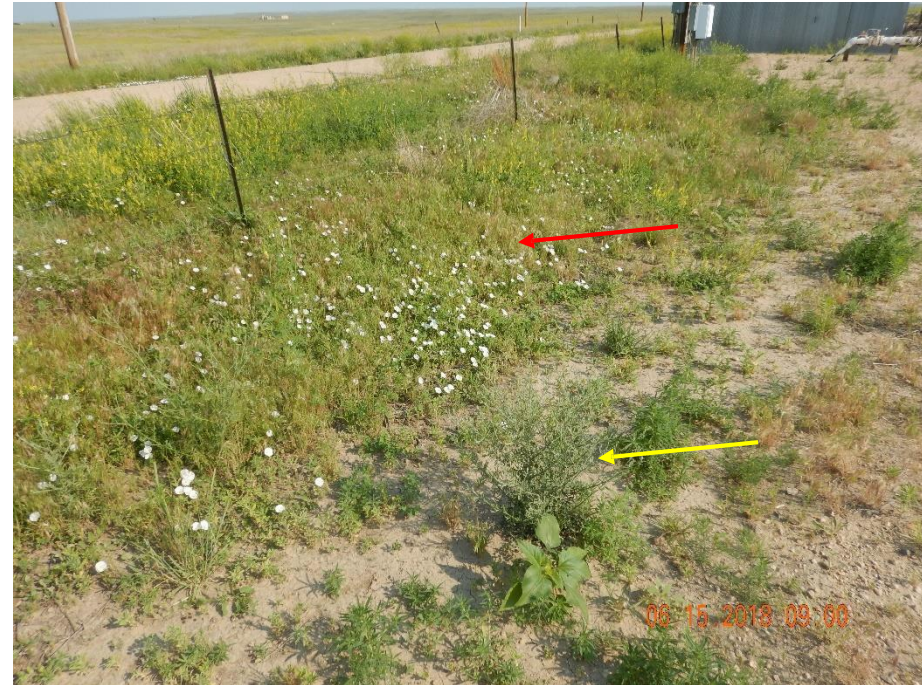
**Photo 4:** Photo taken from the west end of the location, facing north west. Photo shows Field Bindweed (red arrow) and Diffuse Knapweed (yellow arrow) on location.

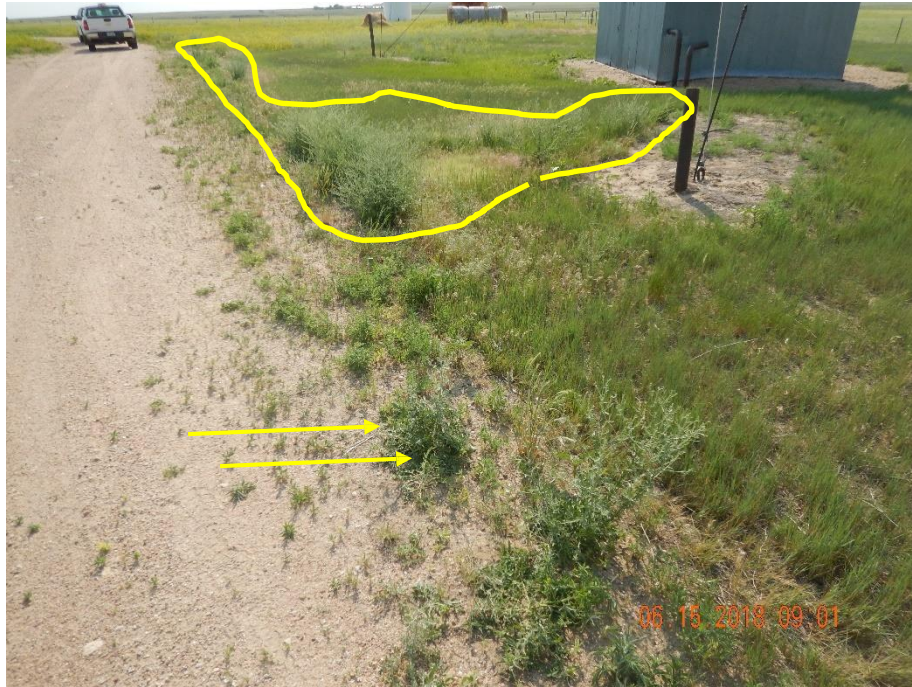
**Photo 5:** Photo taken from the southwest end of the location, facing east. Photo of Diffuse Knapweed on location.

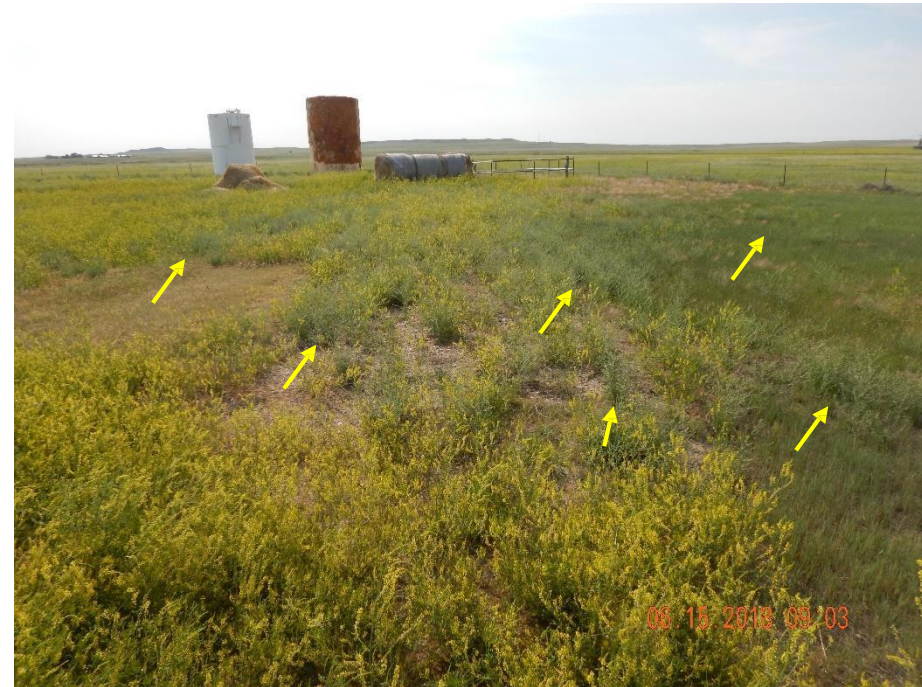
**Photo 6:** Photo taken from the south end of the location, facing west. Photo shows that Diffuse Knapweed (lighter green plant in photo) is prevalent throughout the majority of the location. Yellow plant observed is Yellow Sweetclover.

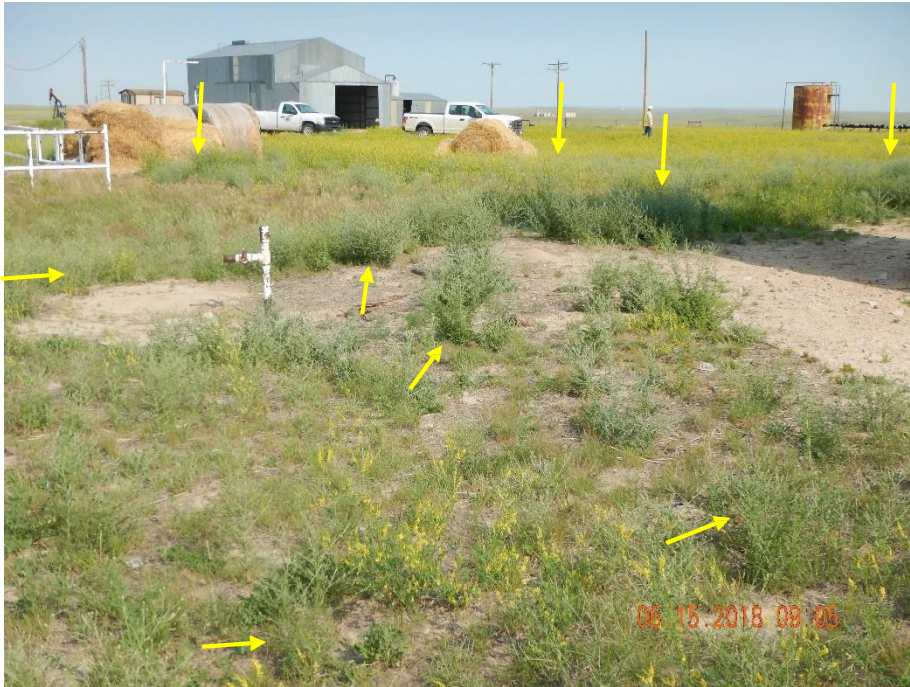
**Photo 7:** Photo taken from the south end of the location, facing north. Photo shows that Diffuse Knapweed (lighter green plant in photo) is prevalent throughout the majority of the location. Yellow plant observed is Yellow Sweetclover.

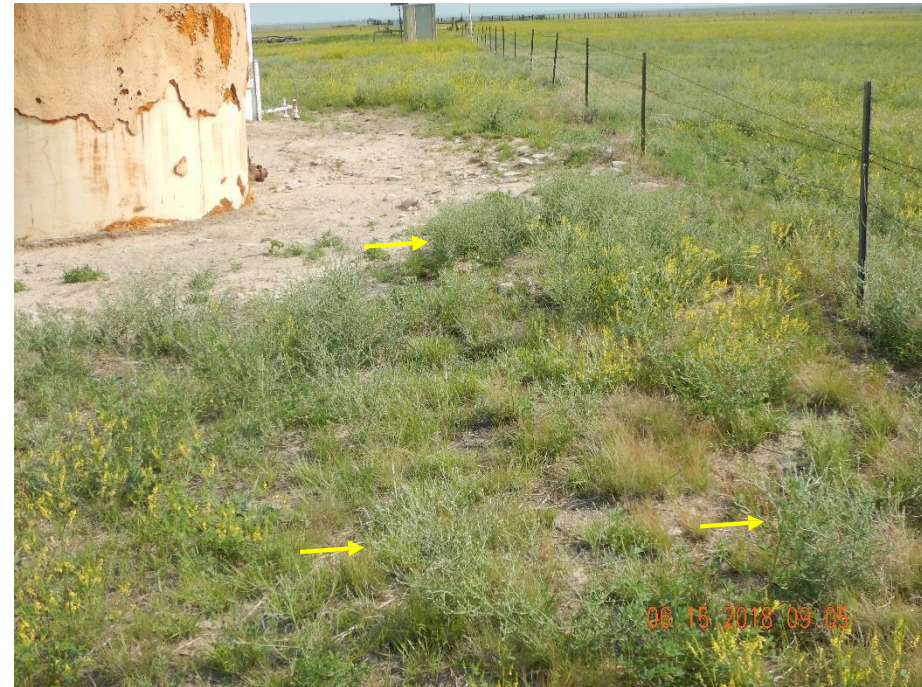
**Photo 8:** Photo taken from the southeast end of the location, facing north. Photo shows that Diffuse Knapweed (lighter green plant in photo) is prevalent throughout the majority of the location.

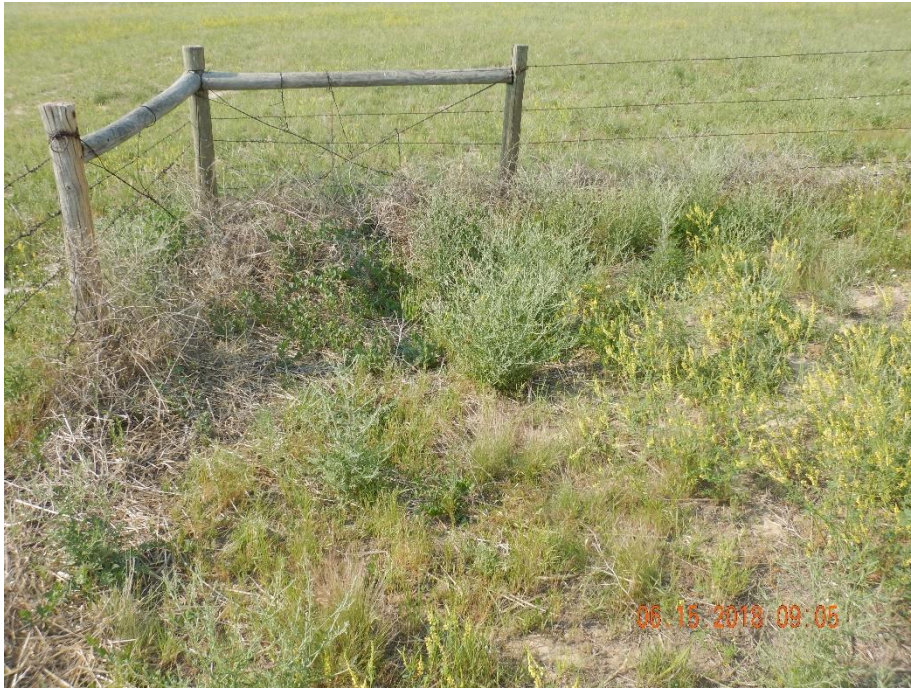
**Photo 9:** Photo taken from the southeast end of the location, facing south. Photo shows that Diffuse Knapweed (lighter green plant in photo) is prevalent throughout the majority of the location.

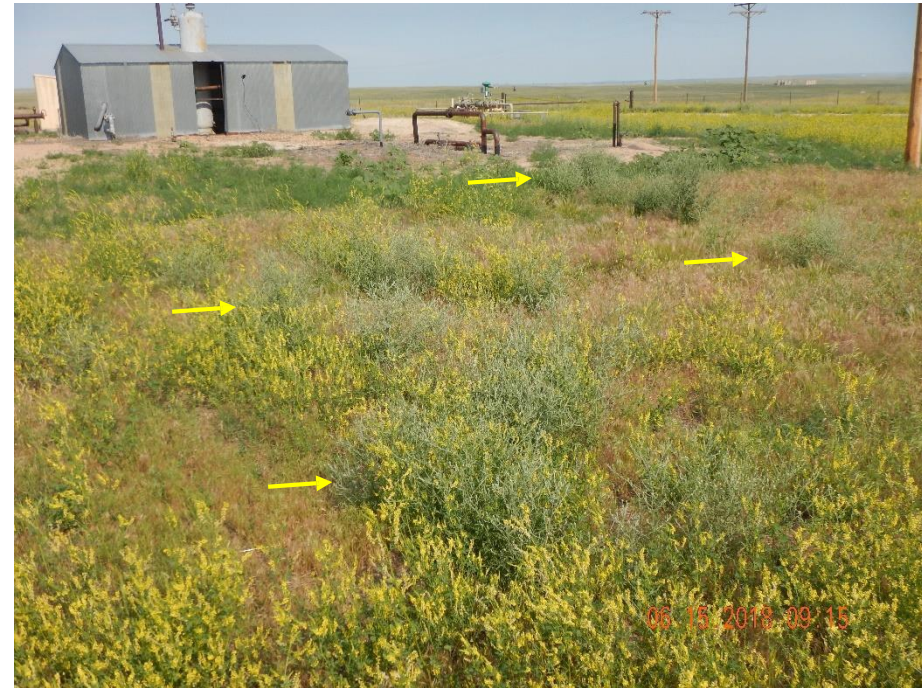
**Photo 10:** Photo taken from the central area of the location, facing west. Photo shows that Diffuse Knapweed (lighter green plant in photo) is prevalent throughout the majority of the location. Yellow plant observed is Yellow Sweetclover.

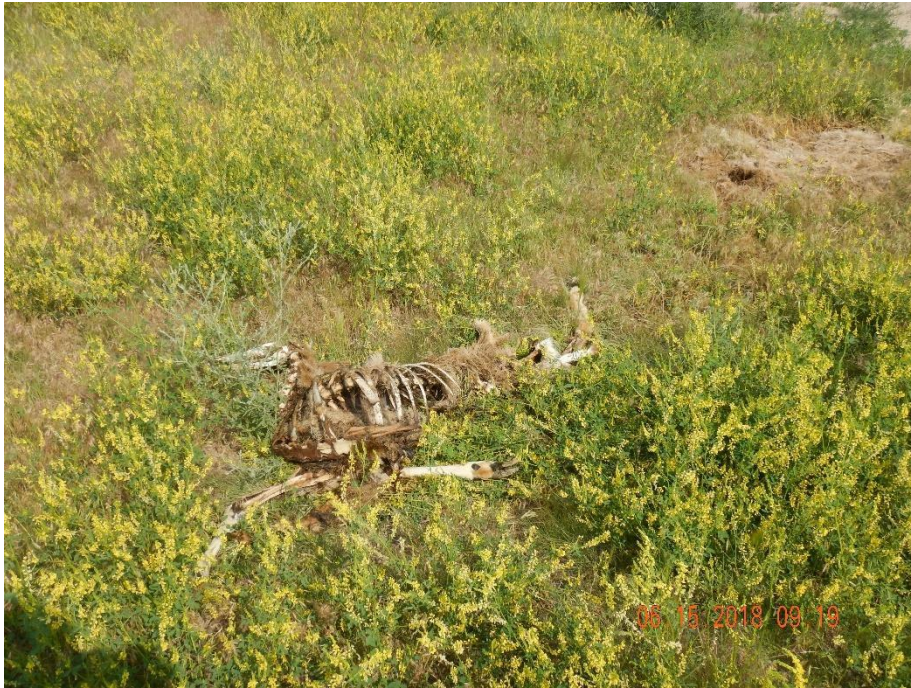
**Photo 11:** Photo taken from the central, north end of the location. Photo of what appears to be a deer carcass found on location. See photo 15.

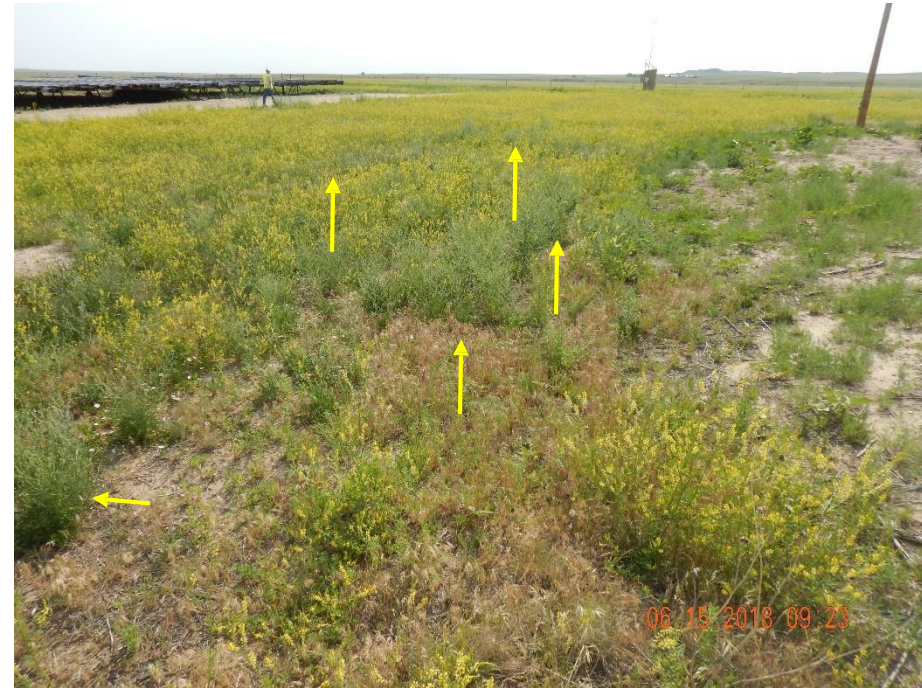
**Photo 12:** Photo taken from the northwest end of the location, facing east. Photo shows that Diffuse Knapweed (lighter green plant in photo) is prevalent throughout the majority of the location. Yellow plant observed is Yellow Sweetclover.

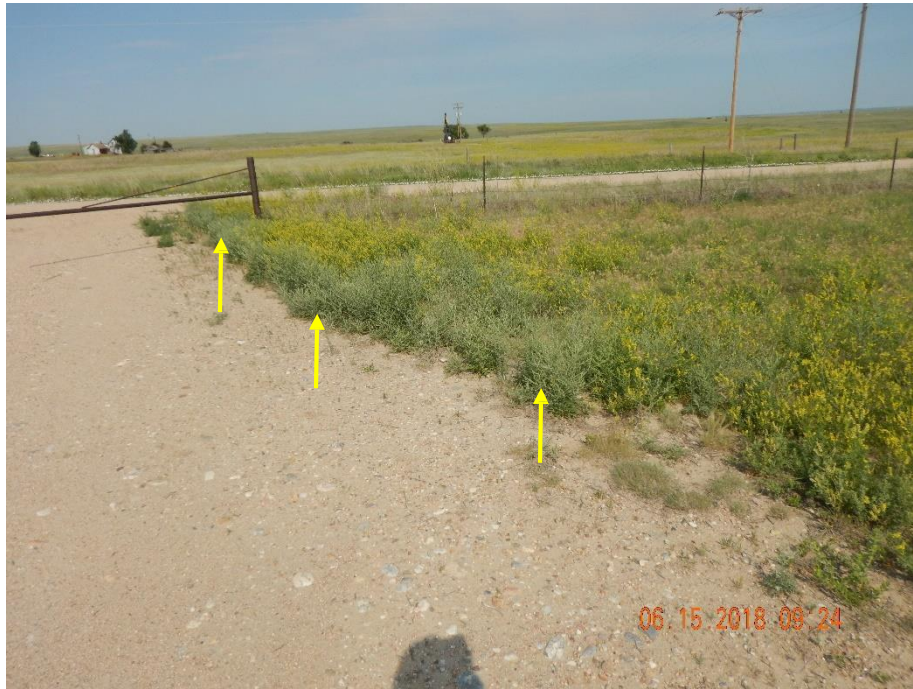
**Photo 13:** Photo taken from the northwest end of the location, facing northwest. Photo shows that Diffuse Knapweed

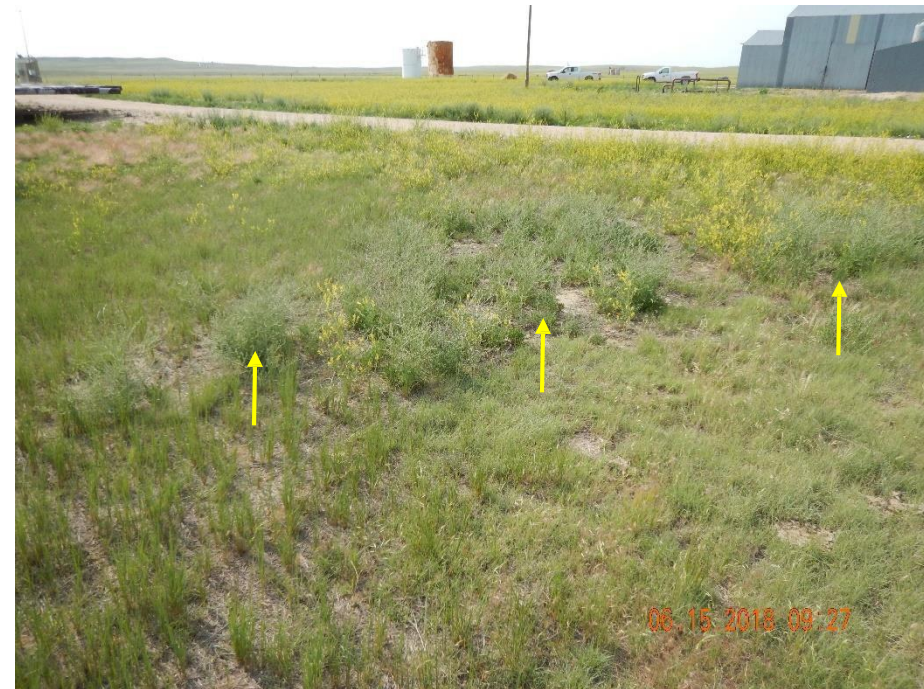
**Photo 14:** Photo taken from the northwest end of the location, facing south. Photo shows that Diffuse Knapweed

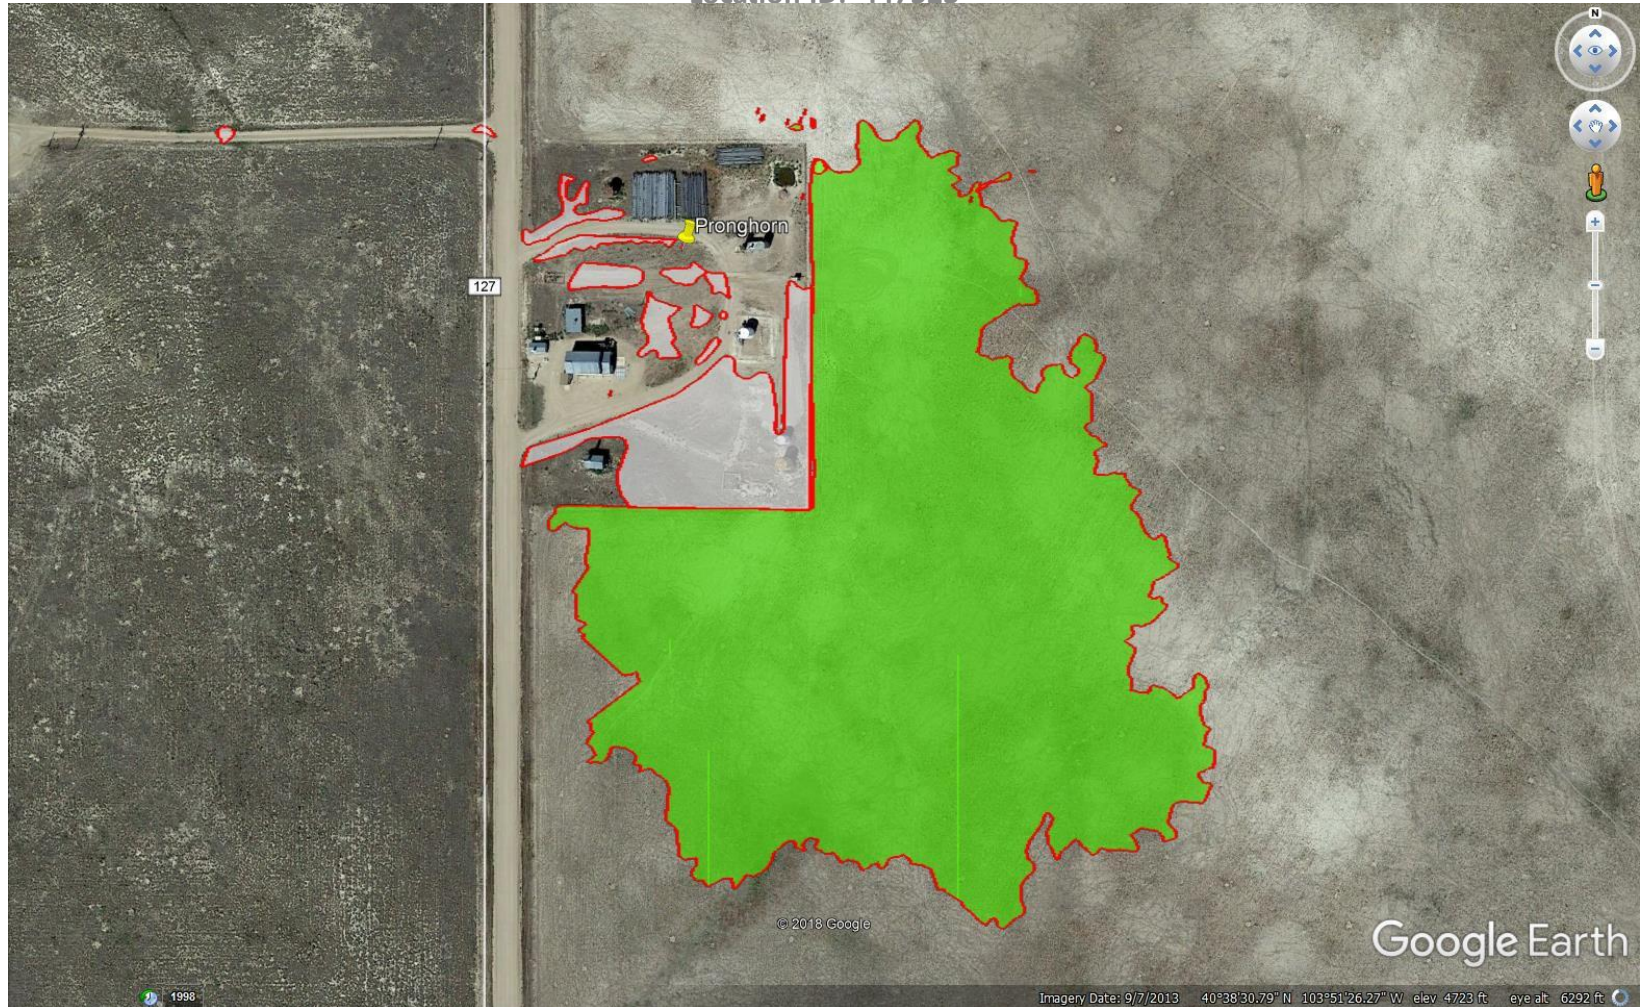
**Photo 15:** 2013 Aerial imagery. Photo shows areas (red polygon) where Noxious Weeds were mapped using a GPS by the Reclamation Specialist. White polygons represent areas of the location where Diffuse Knapweed were observed on the location. Polygon in green are areas where Diffuse Knapweed has spread from the location onto the adjacent lands. It is noted that Knapweed patches observed on reference areas were not as dense as patches observed on location.
