Inspection Photos

06/15/2018

Operator: FOUNDATION ENERGY
MANAGEMENT LLC - 10112

Inspection Doc. Number: 682503496
Weld County, CO

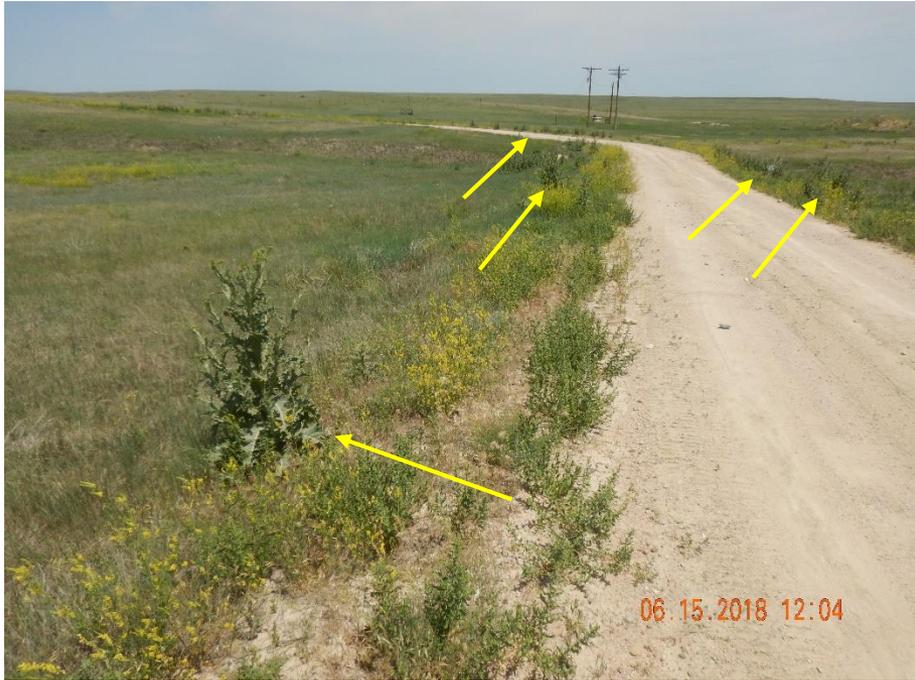
Photo 1: Photo taken from the access road, east of the location, facing north. Photo of Scotch Thistle along road.

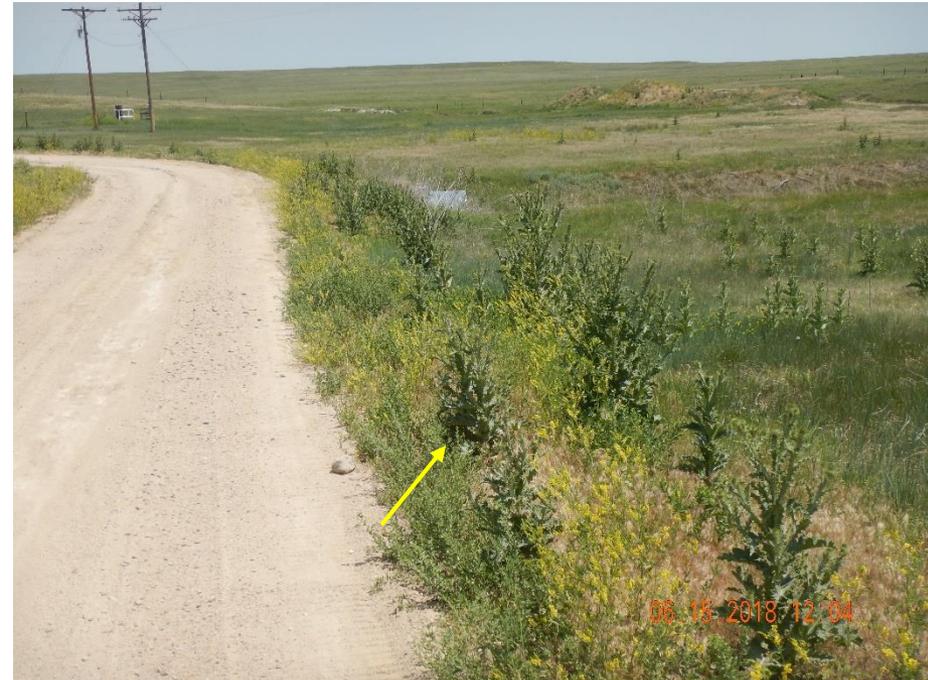
Photo 2: Photo taken from the access road, east of the location, facing north. Photo of Scotch Thistle along road.

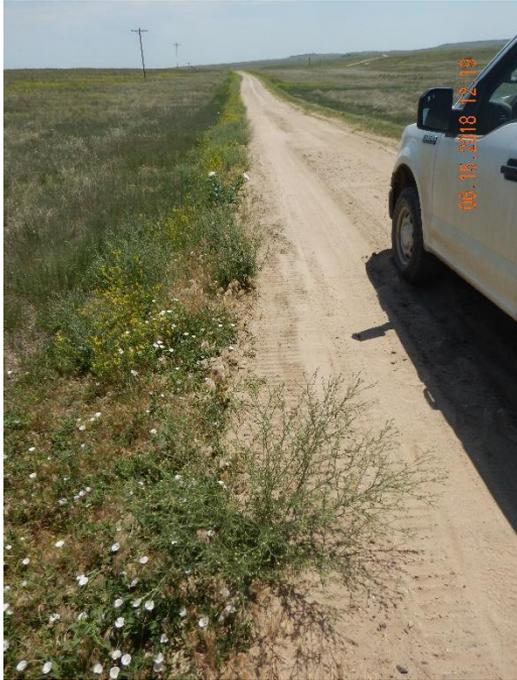
Photo 3: Photo taken from the access road, east of the location, facing west. Photo of Diffuse Knapweed observed along access road.

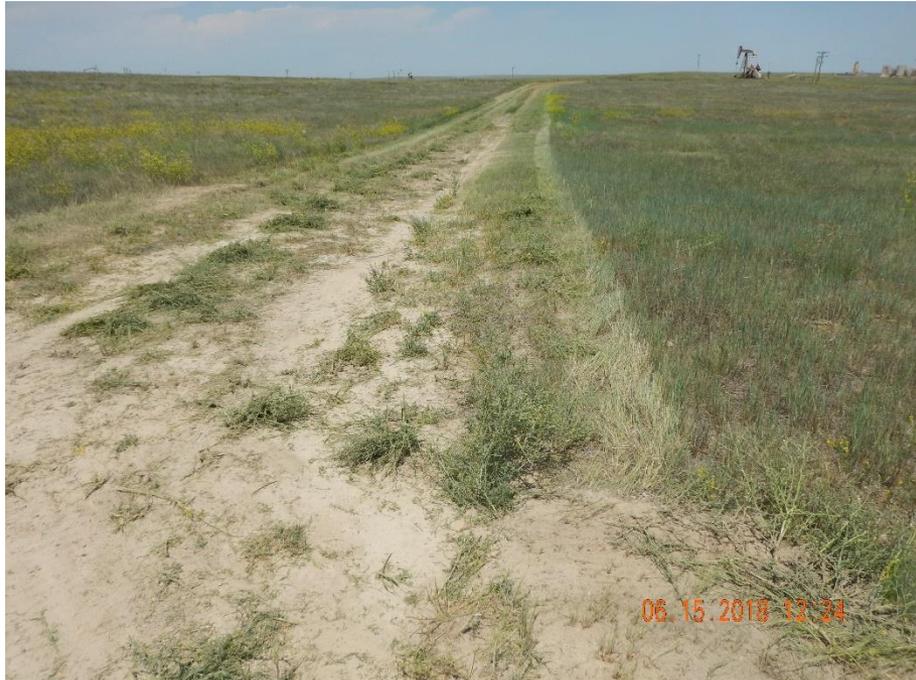
Photo 5: Photo taken from the south end of the location, facing south. Photo shows a narrow strip along the access road where mowing operations appear to have been conducted, however, there are areas where noxious weeds remain intact/uncut. Noxious weeds were also observed beyond areas of the access road and location where mowing operations were conducted.

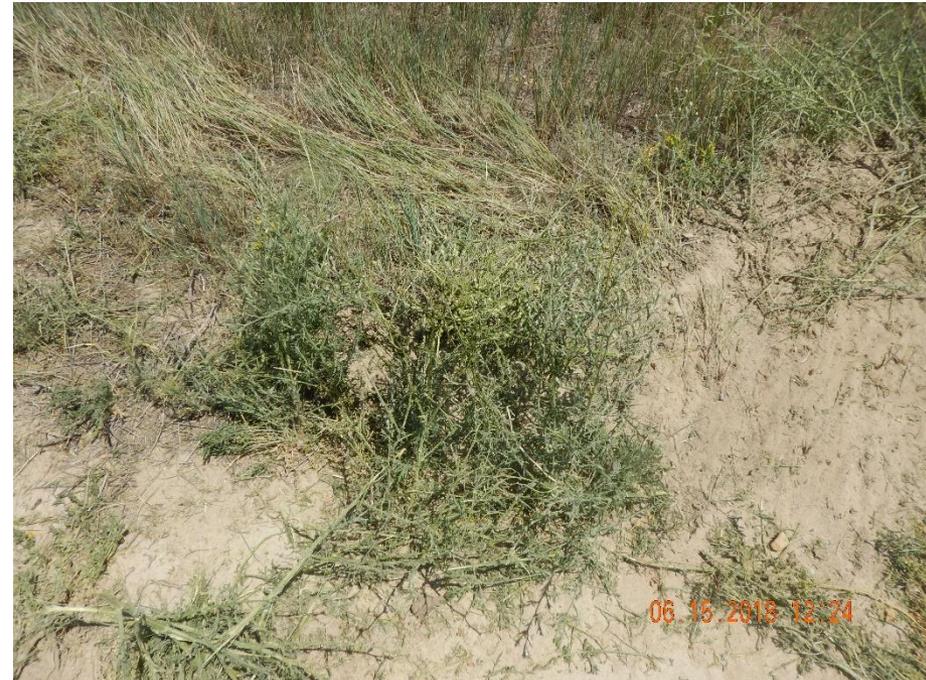
Photo 6: Continued from photo 5. Photo of Diffuse Knapweed that remains intact/uncut after mowing operations.

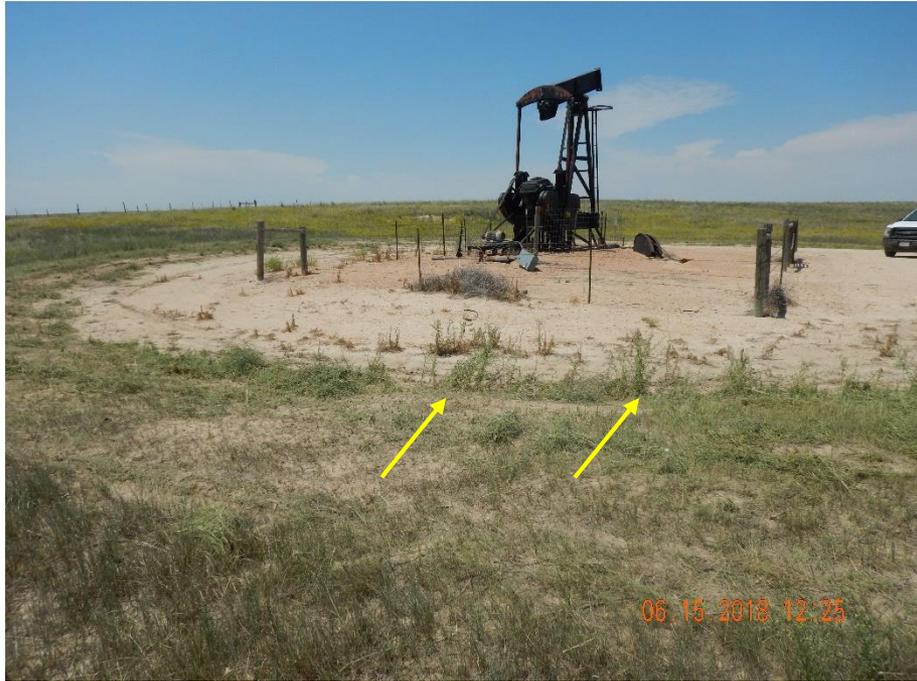
Photo 7: Photo taken from the east end of the well location, facing southwest. Mowing operations appear to have been conducted, however, there area areas where noxious weeds (Diffuse Knapweed) remain intact/uncut. In addition, Knapweed was observed on areas of the access road and location beyond where mowing operations were conducted.

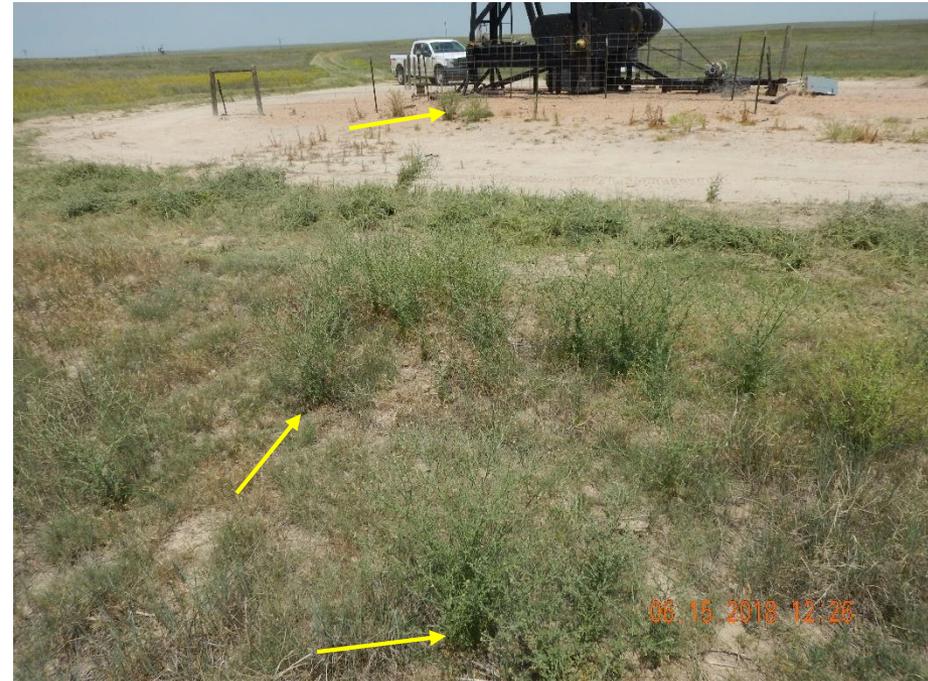
Photo 8: Photo taken from the south end of the well location, facing north. Photo shows a narrow strip along the location where mowing operations appear to have been conducted, however, there area areas where noxious weeds (Diffuse Knapweed) remain intact/uncut. In addition, Knapweed was observed on areas of the access road and location beyond where mowing operations were conducted.

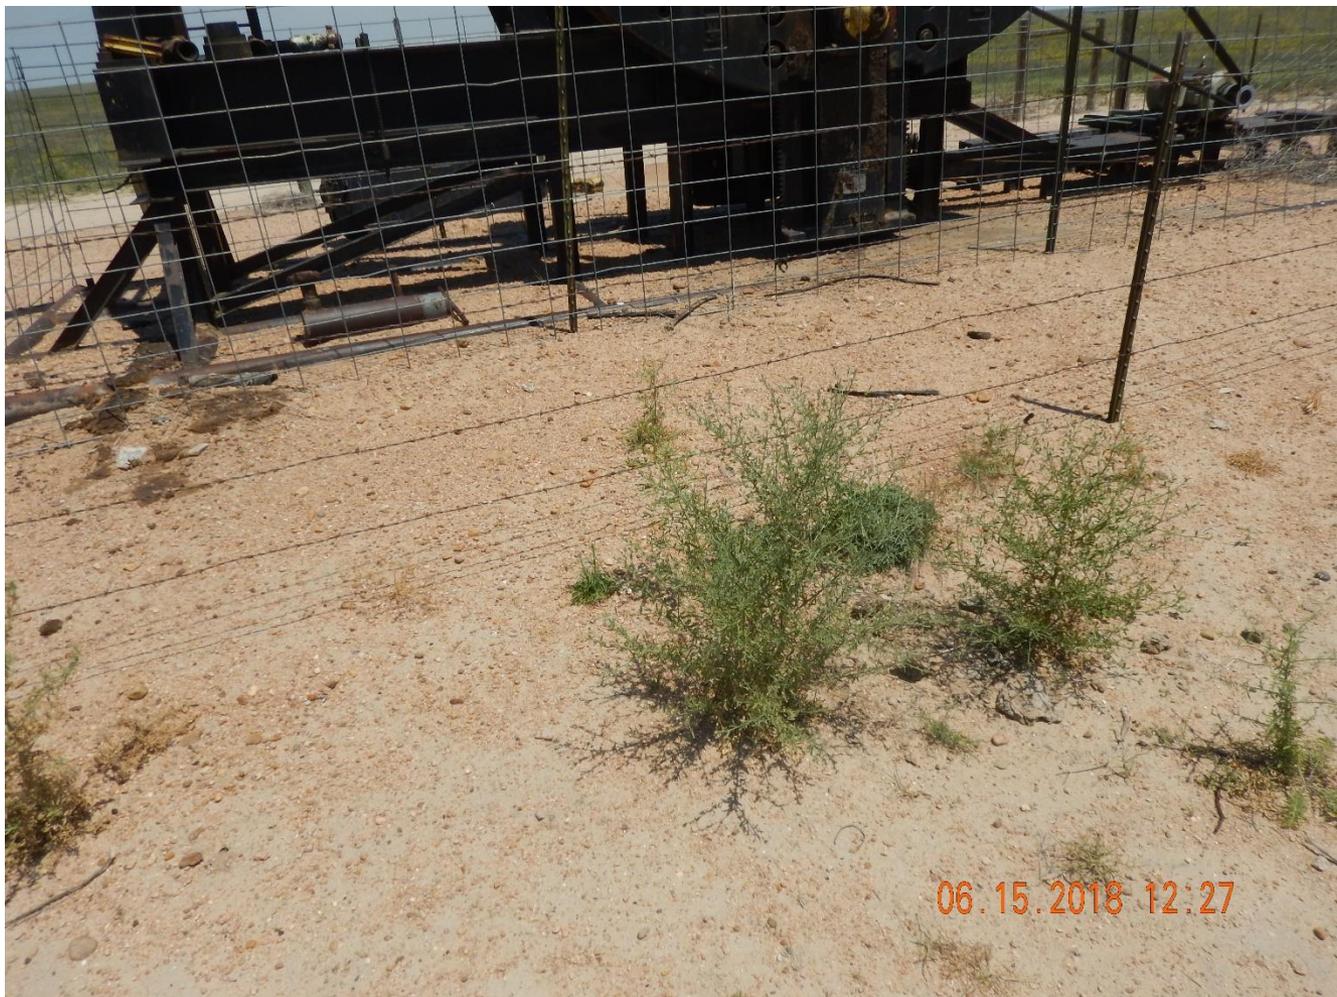
Photo 9: Photo taken from the west end of the well. Photo shows Diffuse Knapweed on location.

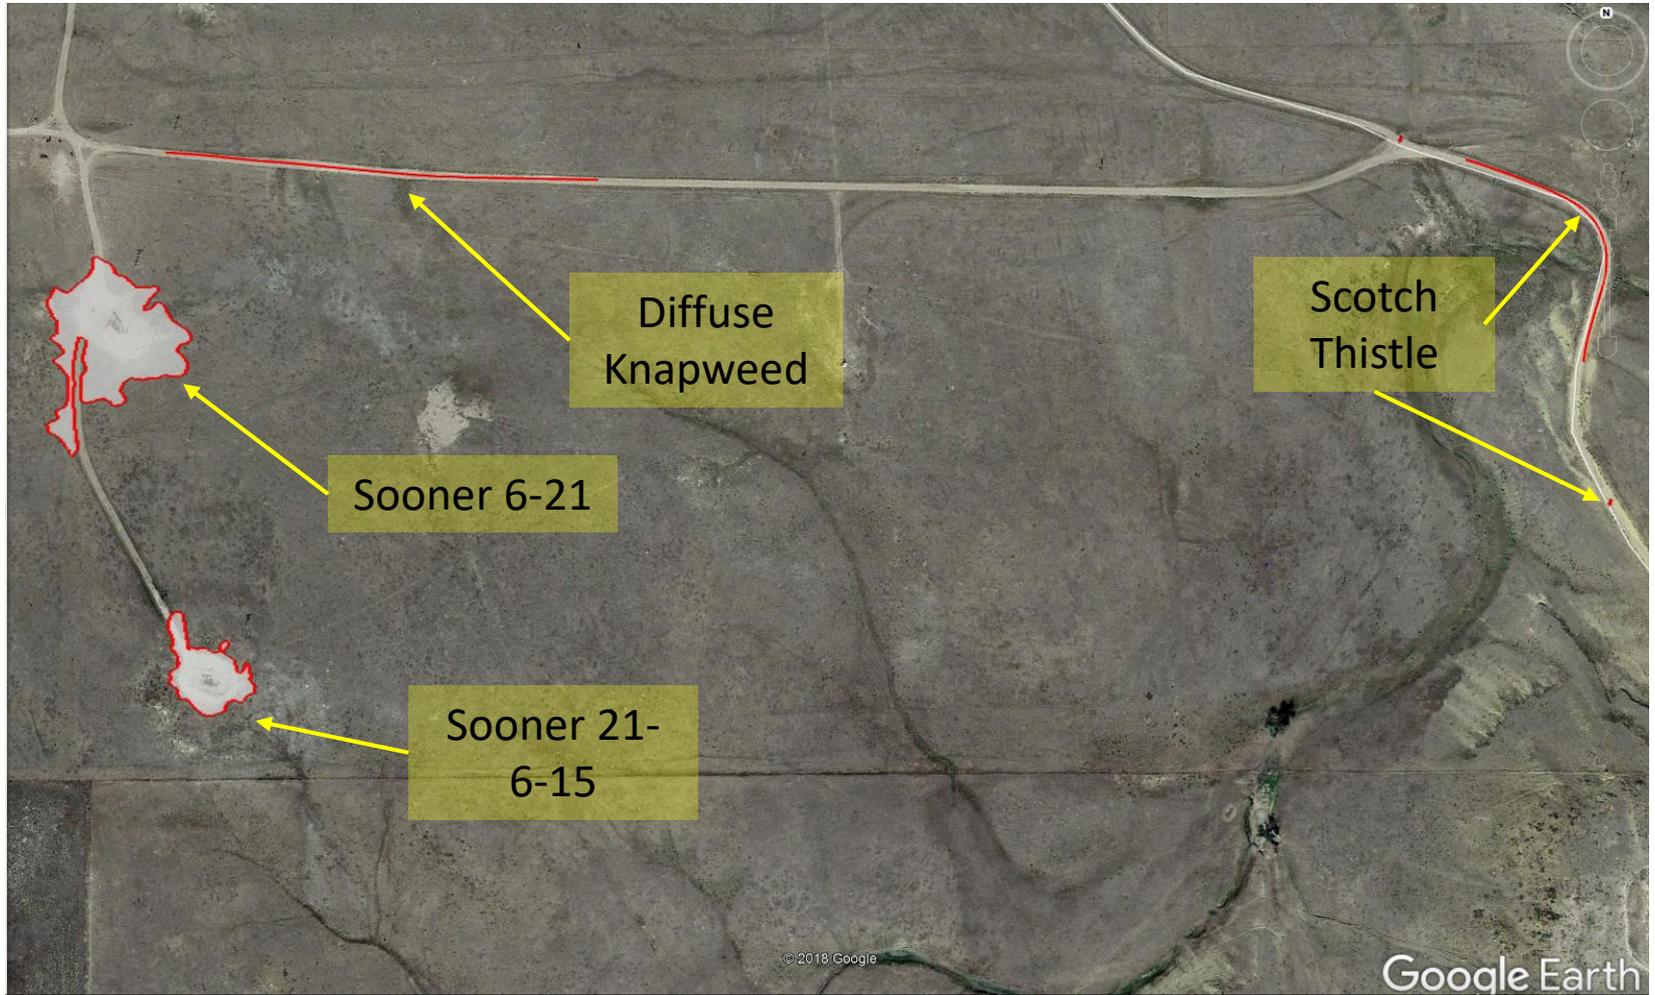
Photo 10: 2013 Aerial imagery. Photo shows areas (red polygon) where Noxious Weeds (Diffuse Knapweed) were observed on location and access road, and mapped using a GPS. Photo also shows areas along the access road where Scotch Thistle (*Onopordum acanthium*) was observed.
