Inspection Photos

04/30/2018

Operator: ABILENE PERFECT ENERGY JV LLC -
10581

Location ID: 433129

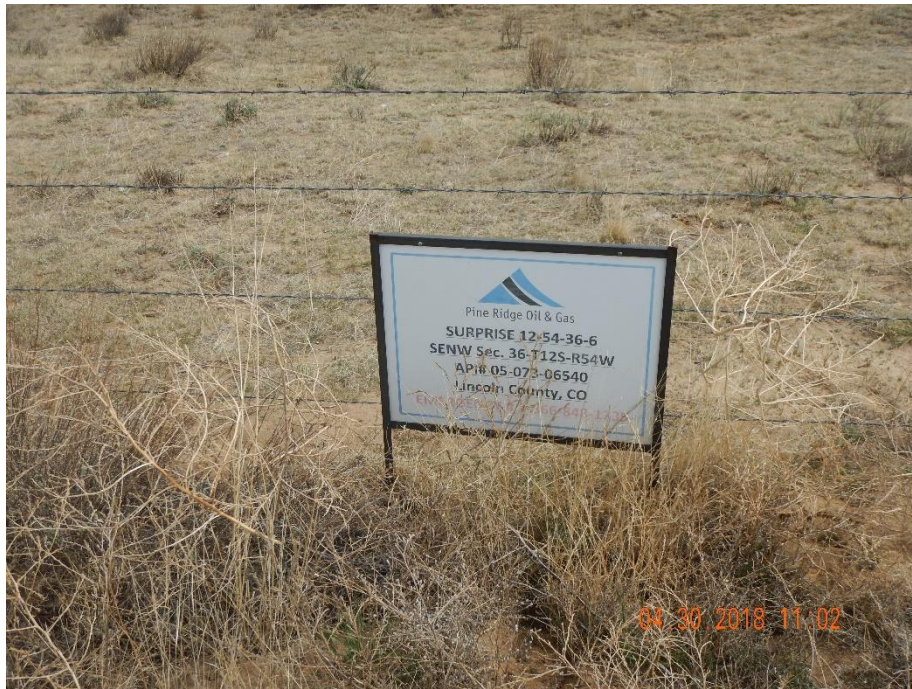
Photo 1: Photo taken at the access road entrance off of CR 26. Photo shows signage has not been updated with the correct operator information.

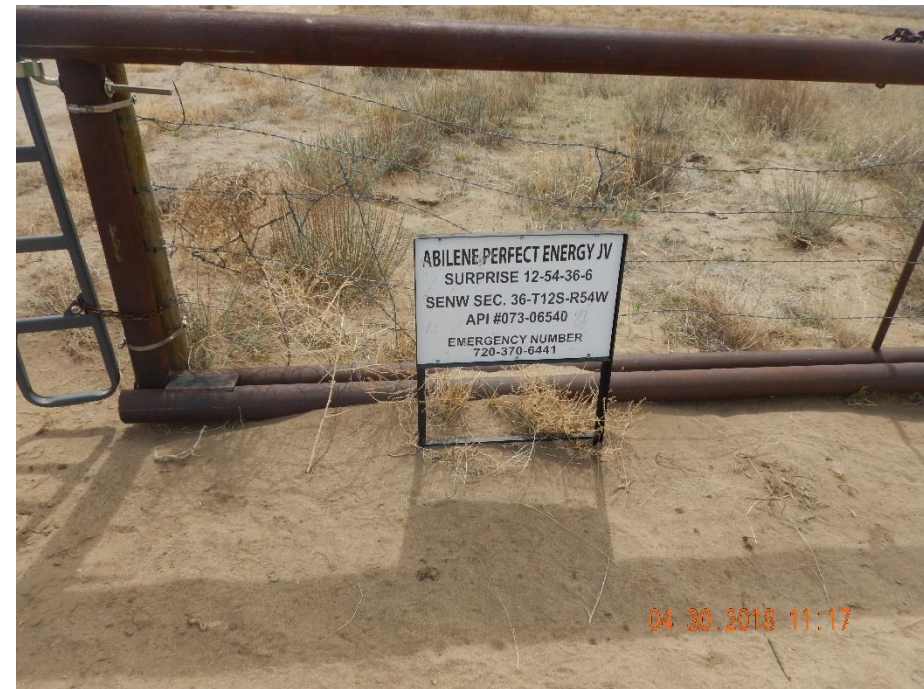
Photo 2: Photo taken from the locked gate at the entrance to the location. Photo shows operator information.

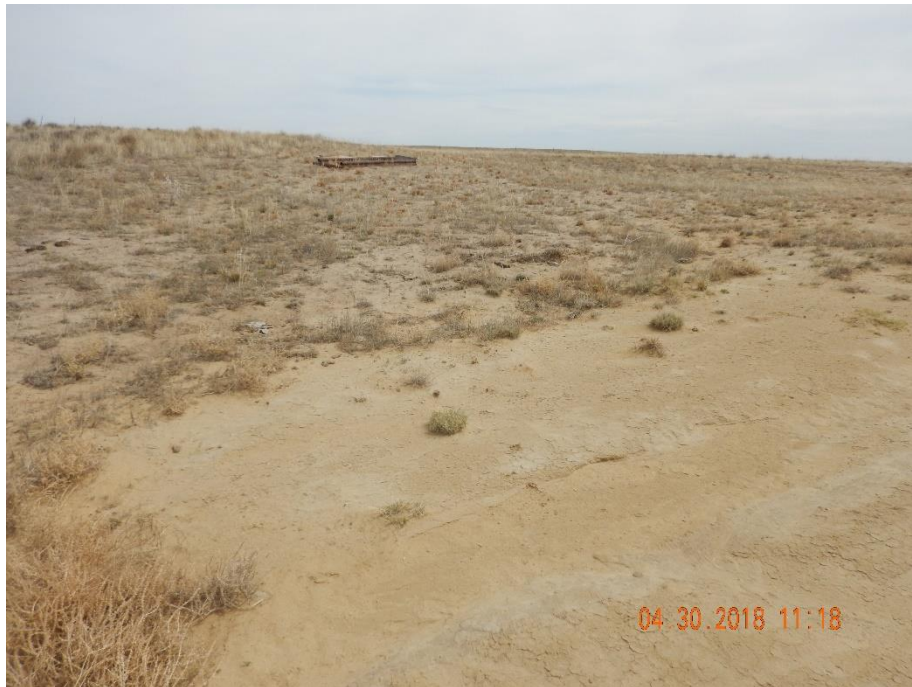
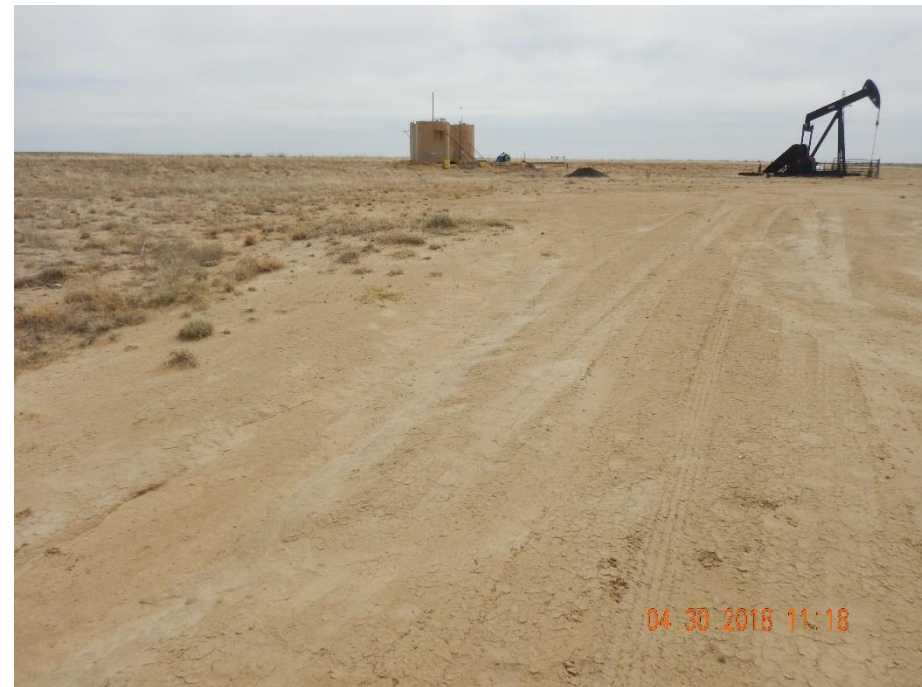
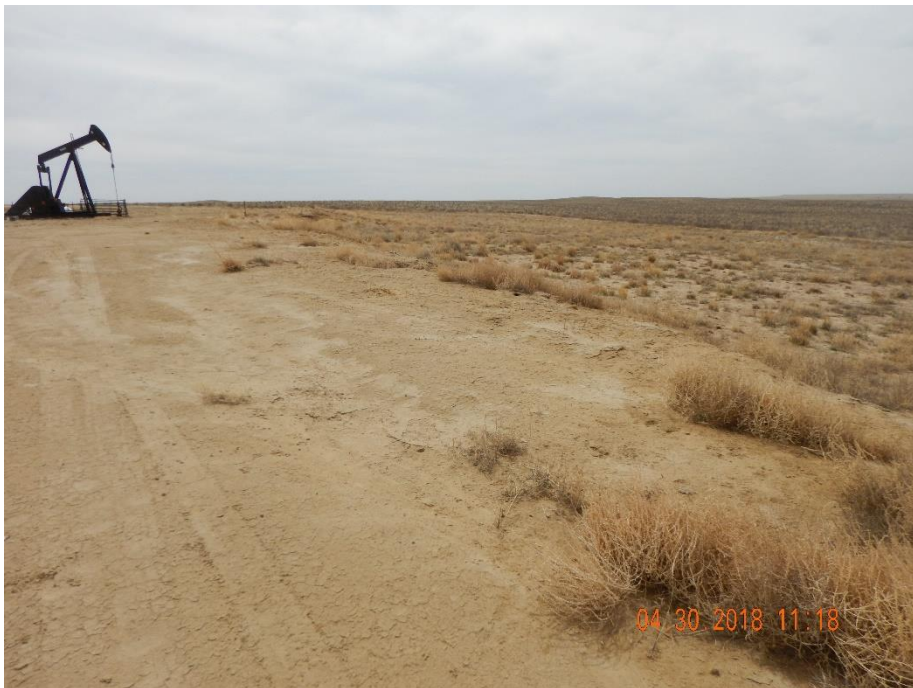
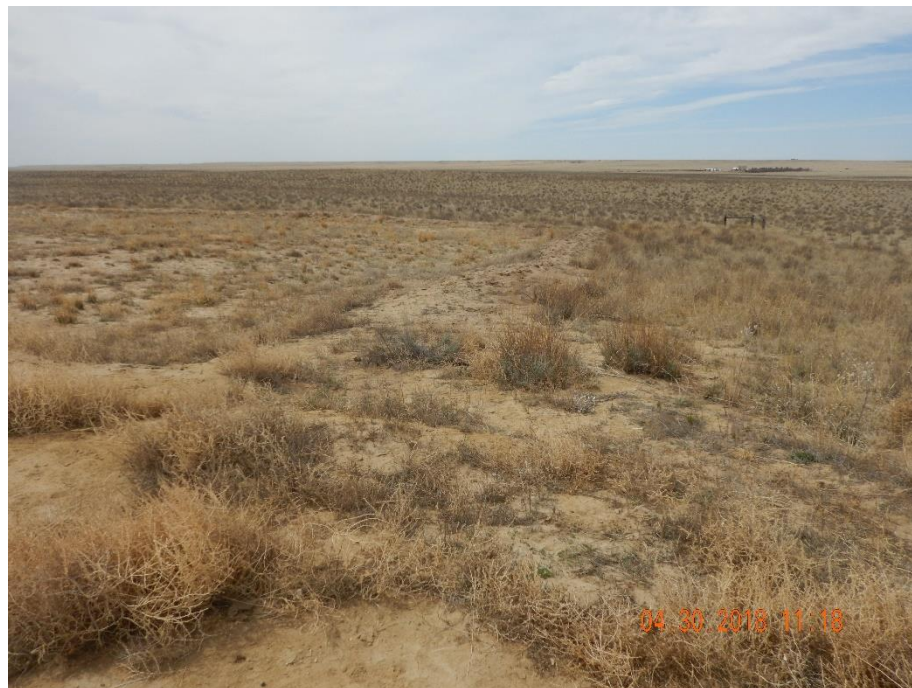
Photo 3: Photo taken from the northwest end (entrance) of the location, facing northeast. Photos 3-6 show an overview of the location and interim areas from the northeast, east, south, and to west.

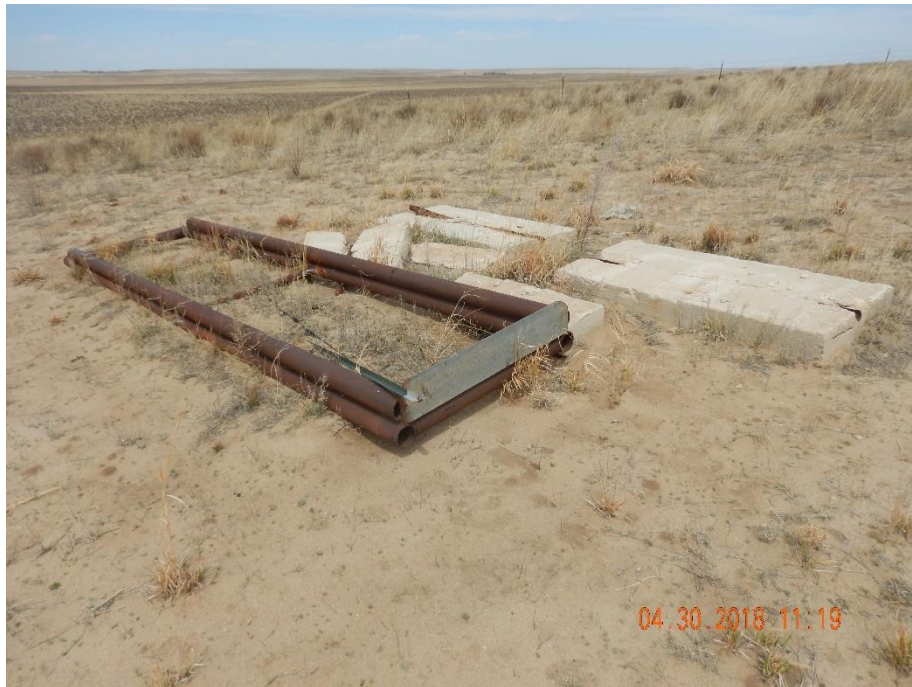
Photo 7: Photo taken from the north end of the location, facing north. Previous inspections documented various debris and unused equipment remaining on the location and required removal. Photo shows equipment/debris has not been removed.

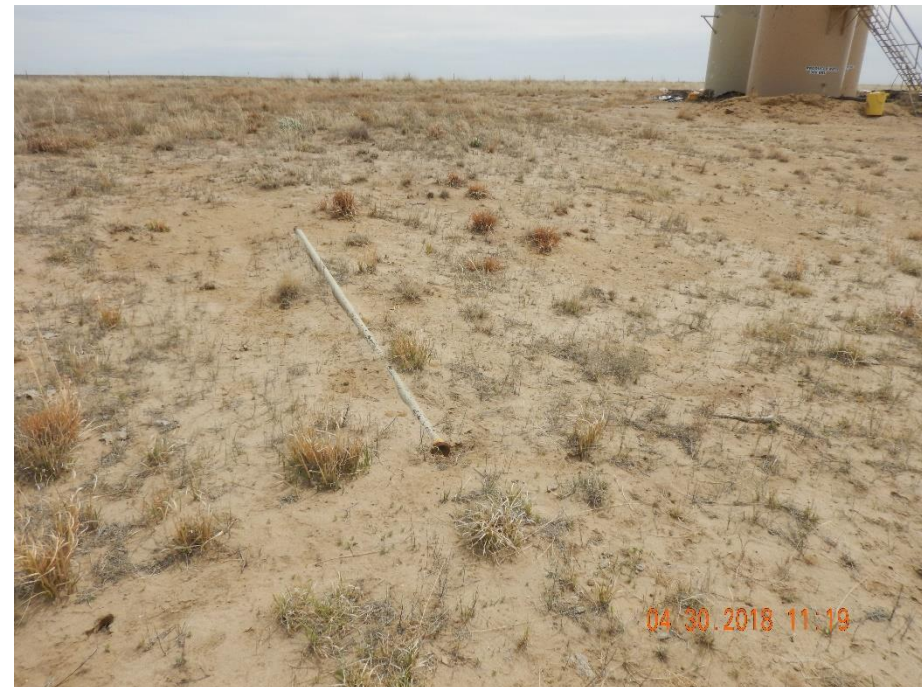
Photo 8: Photo taken from the north end of the location, facing east. Previous inspections documented various debris and unused equipment remaining on the location and required removal. Photo shows equipment/debris has not been removed.

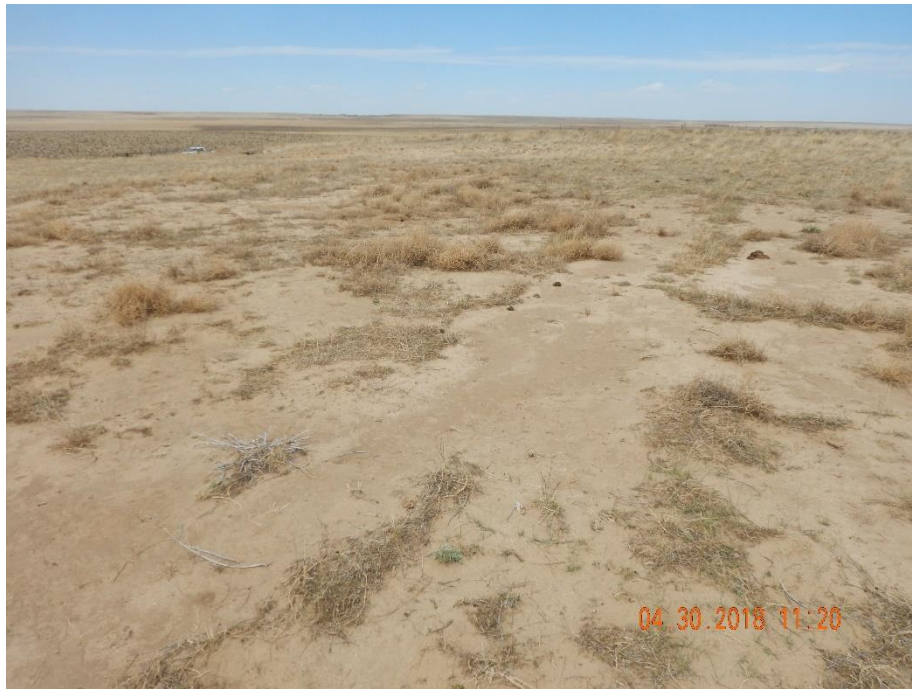
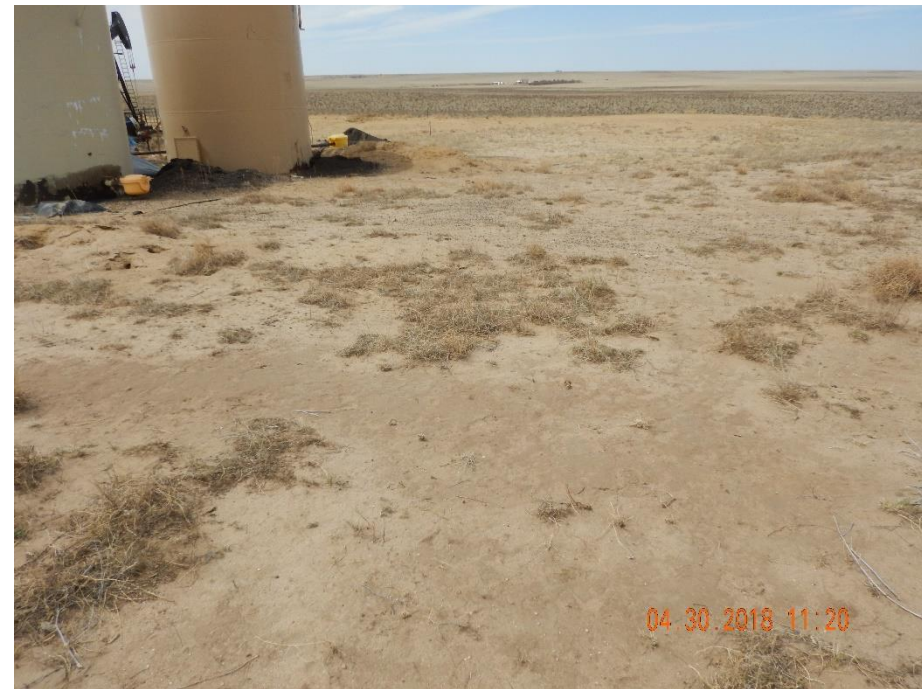
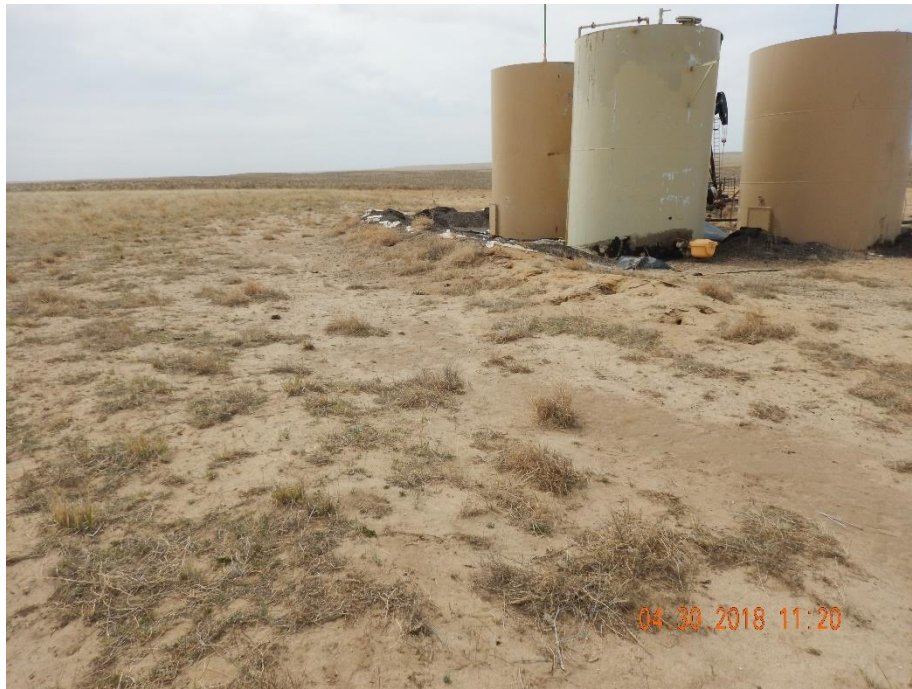
Photo 9: Photo taken from the northeast end of the location, facing west. Photos 9-11 show an overview of the location and interim areas from the west to southeast.

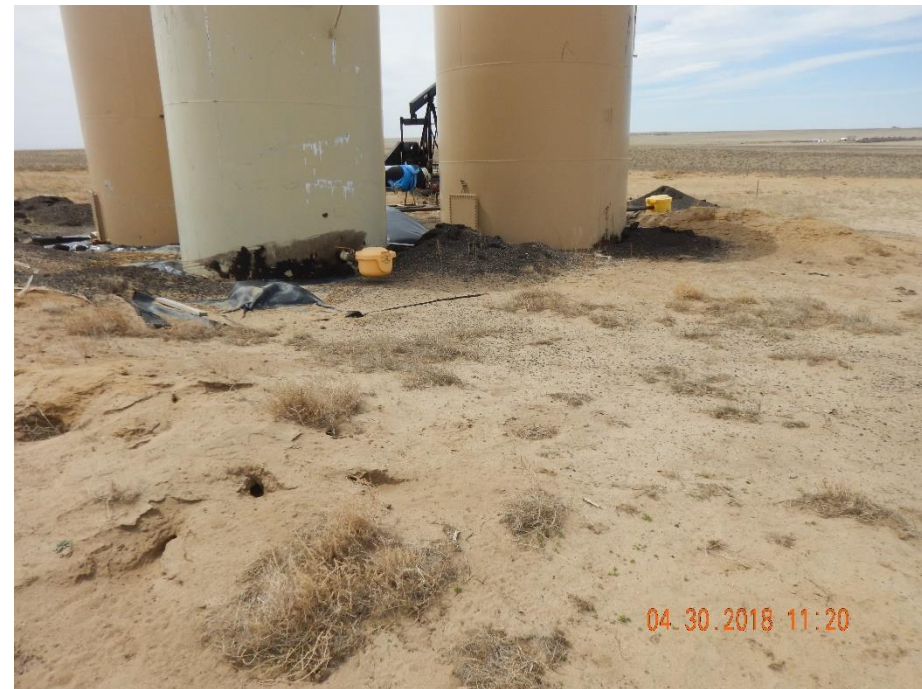
Photo 12: Photo taken from the north end of the tanks on location, facing southwest. Previous inspections documented that the berms around the tanks were inadequate and required operator to repair or install berms, or other secondary containment devices. Photo shows berms, or other secondary containment devices have not been repaired or installed. Photo also shows incomplete signage on the tanks, including NFPA diamond labeling.

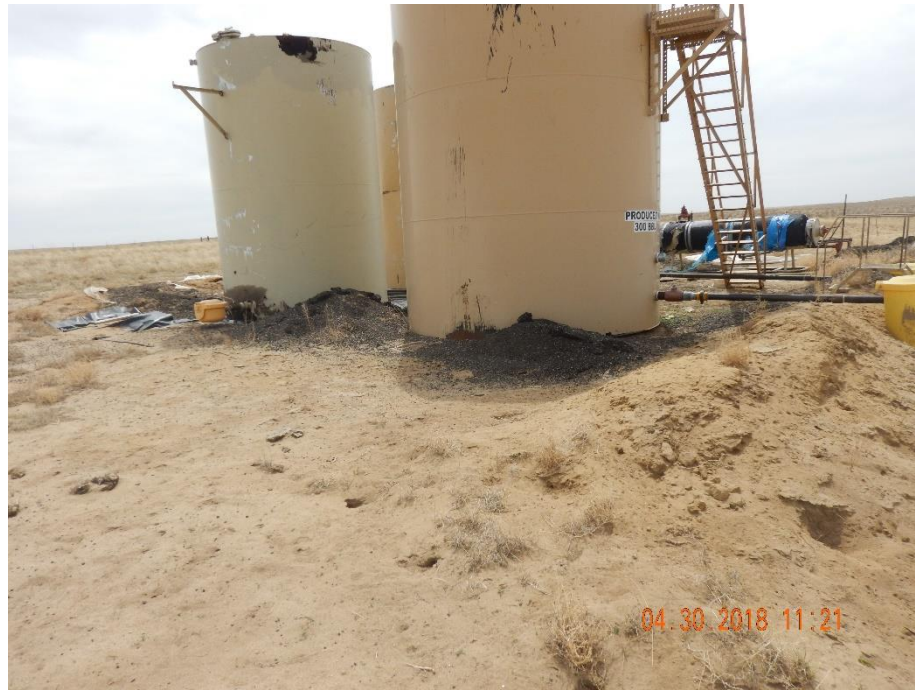
Photo 13: Photo taken from the west end of the tanks facing southeast. See comments under photo 12.

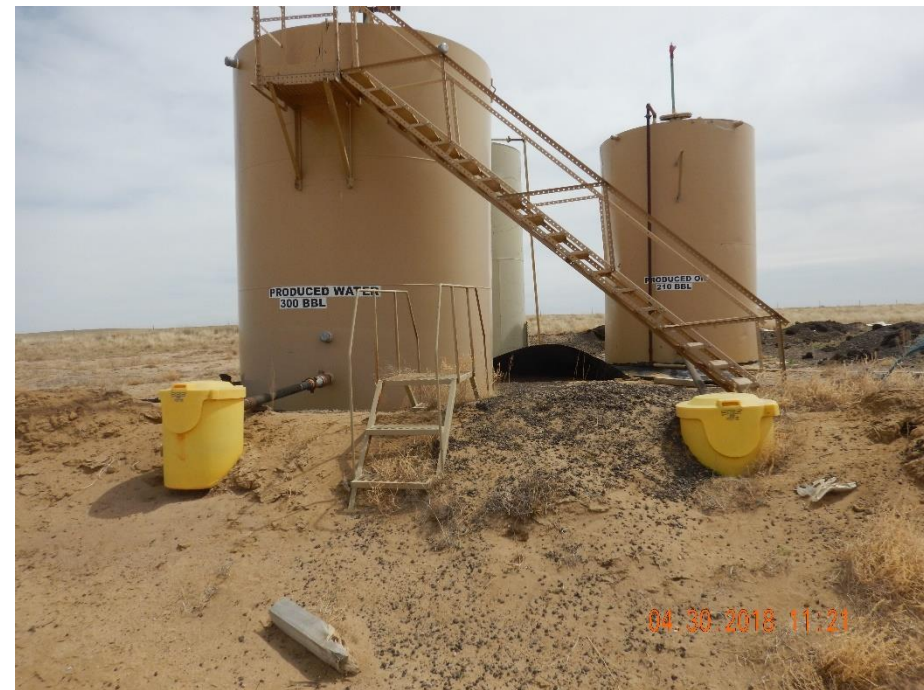
Photo 14: Photo taken from the west end of the tanks facing east. See comments under photo 12.

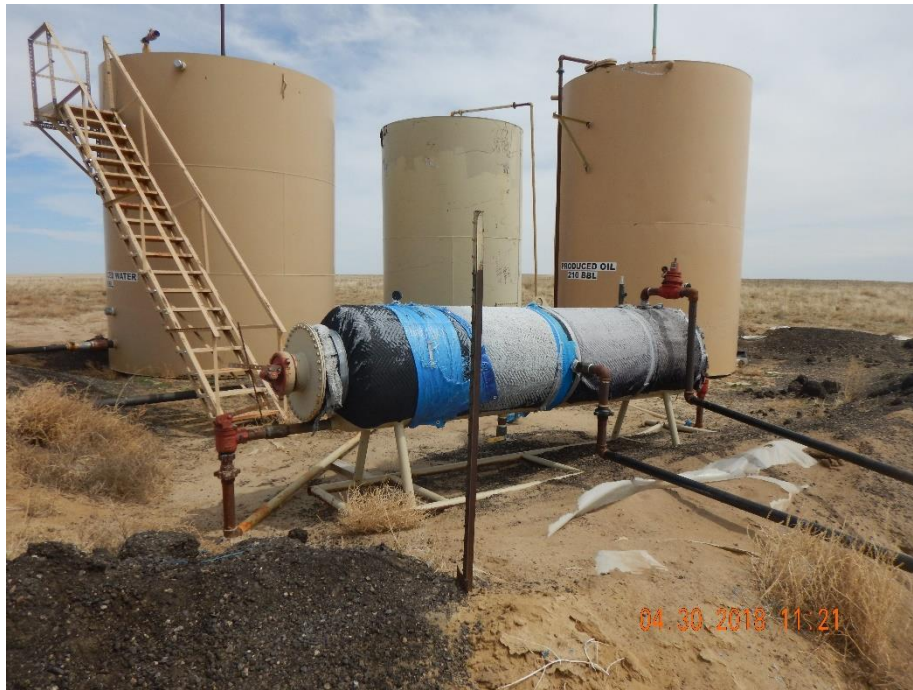
Photo 15: Photo taken from the south end of the tanks facing northeast. See comments under photo 12.

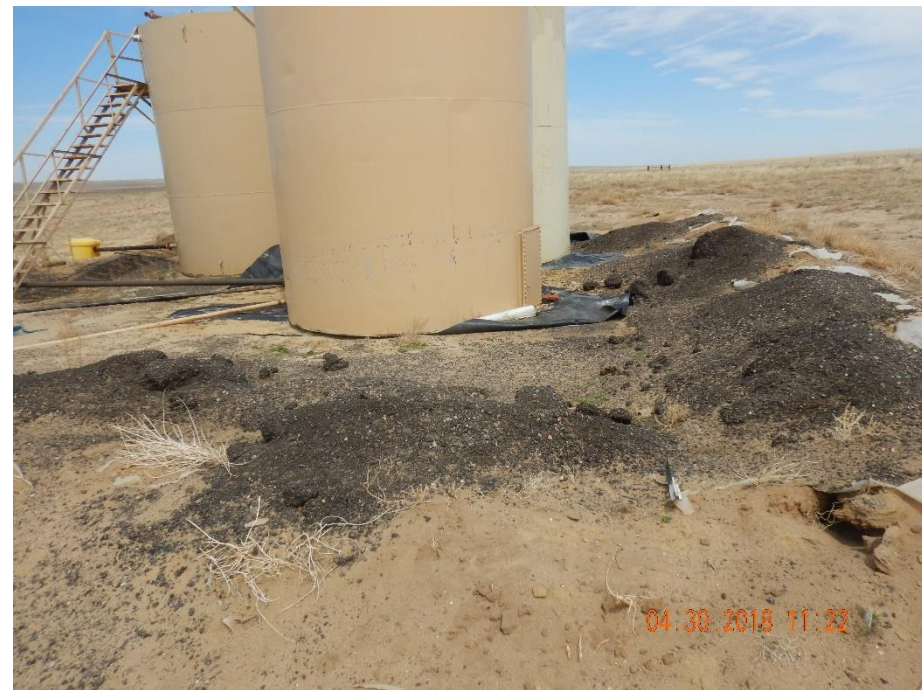
Photo 16: Photo taken from the southeast end of the tanks facing north. See comments under photo 12.

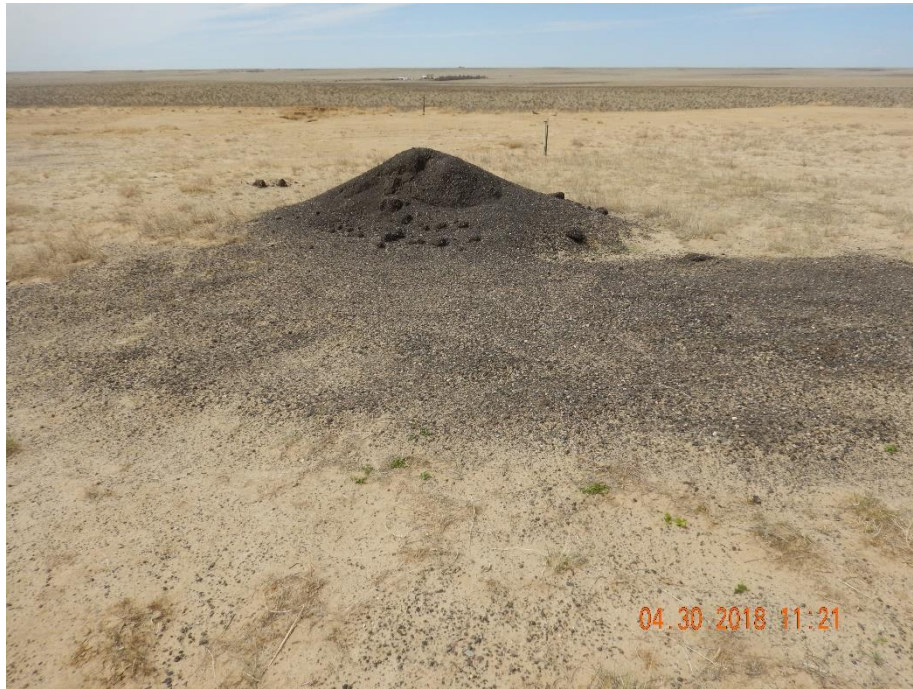
Photo 17: Photo taken from the central area of the pad, facing northwest. Previous inspections required operator to remove gravel pile from the location. Photo shows gravel pile remains.

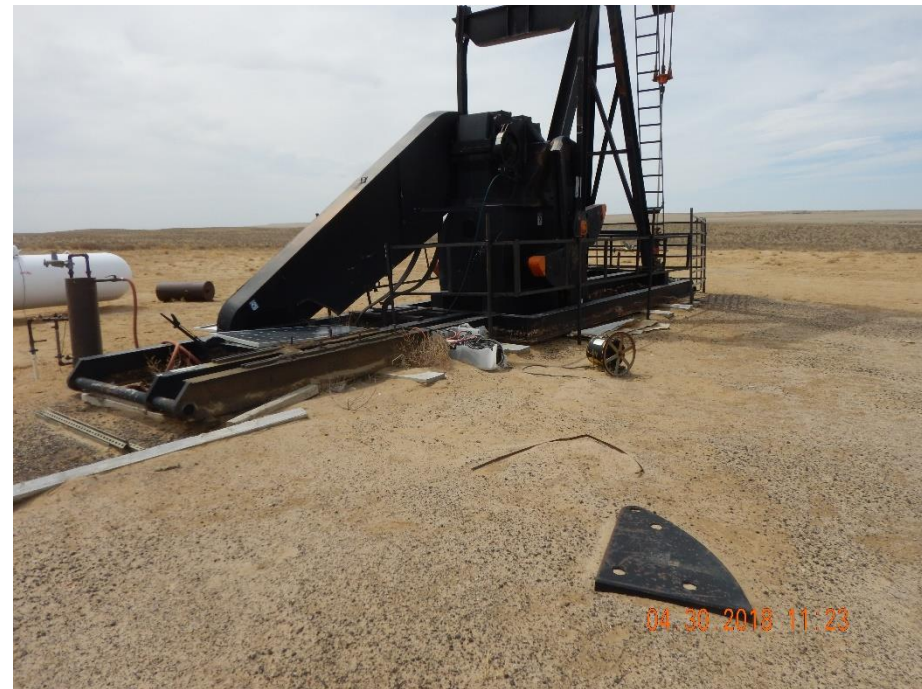
Photo 18: Photo taken from the northeast end of the well, facing southwest. Photo shows various debris and equipment littered around the well.

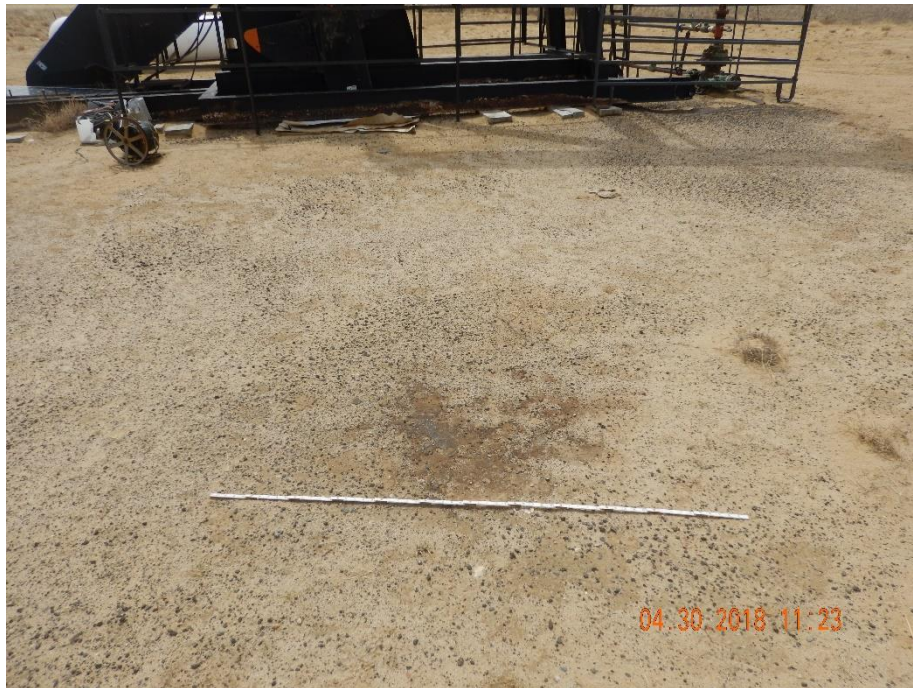
Photo 19: Photo taken from the northwest side of the well. Photo shows stained soil. 6 foot measuring stick for reference.

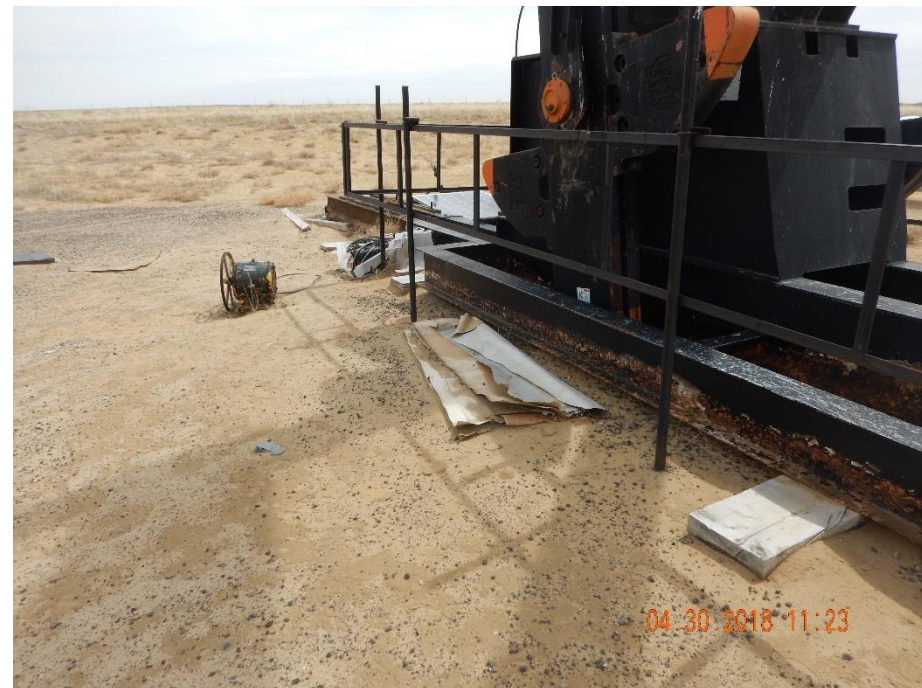
Photo 20: Photo taken from the north end of the well, facing east. Photo shows various debris and equipment littered around the well.

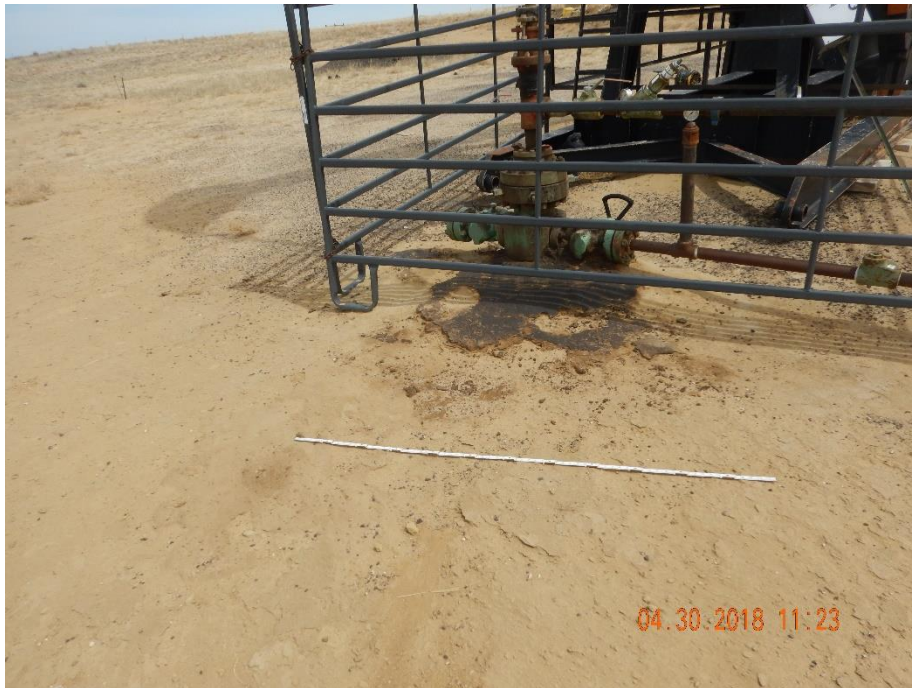
Photo 21: Photo taken from the southwest end of the well, facing north. Previous inspections required operator to remove and/or remediate oil stained soil at well head. Photo shows oil stained soil has not been removed/remediated. .

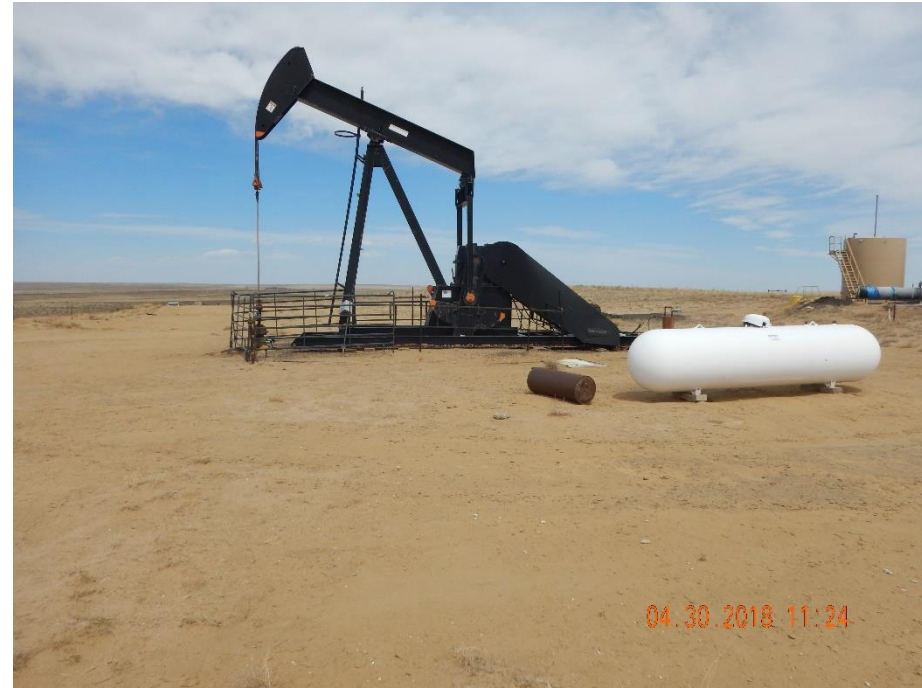
Photo 22: Photo taken from the southeast end of the well, facing north. Photo shows various debris and equipment littered around the well.

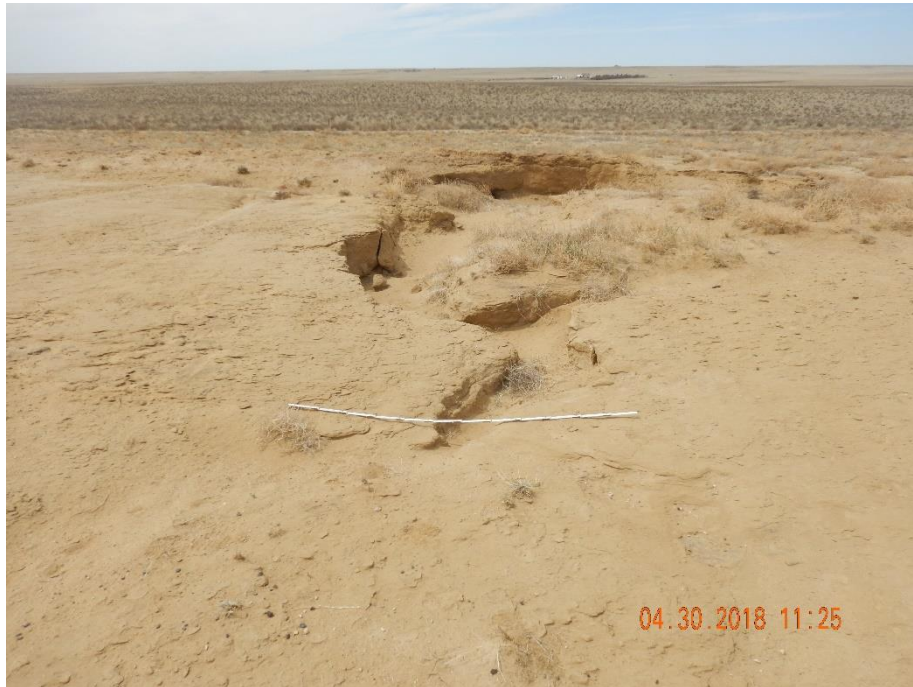
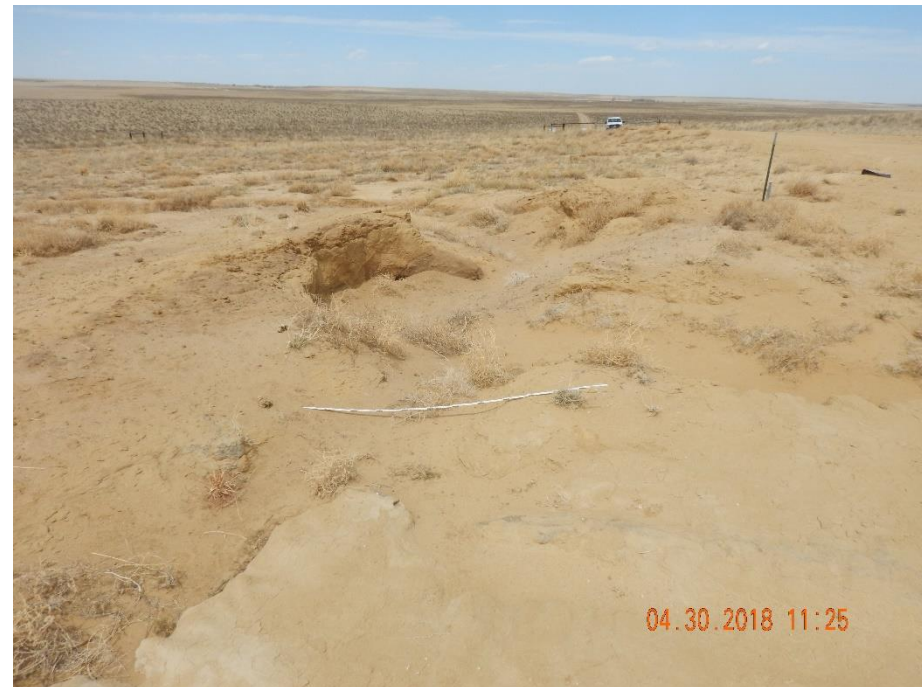
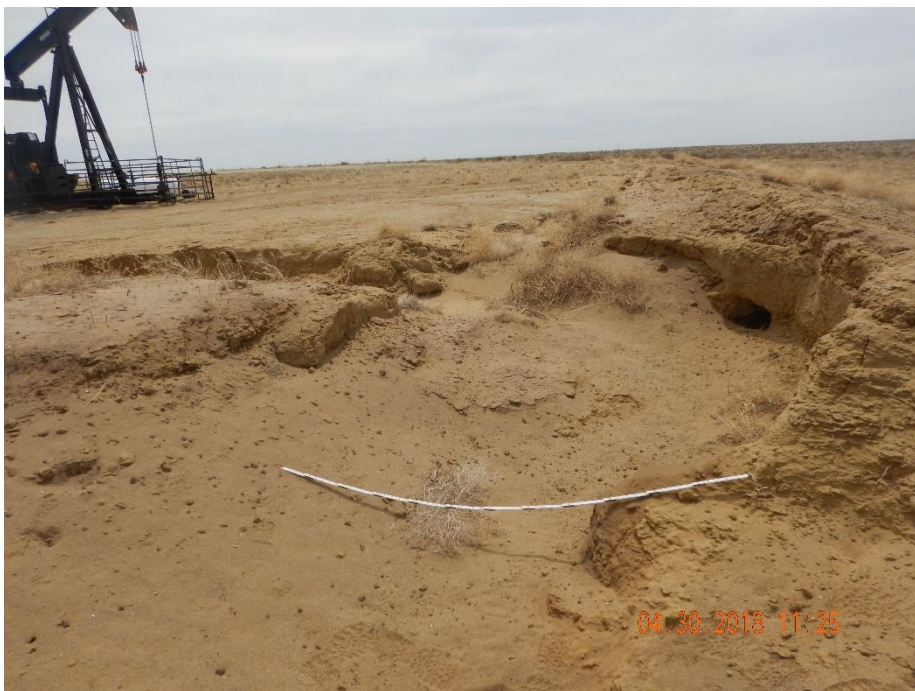
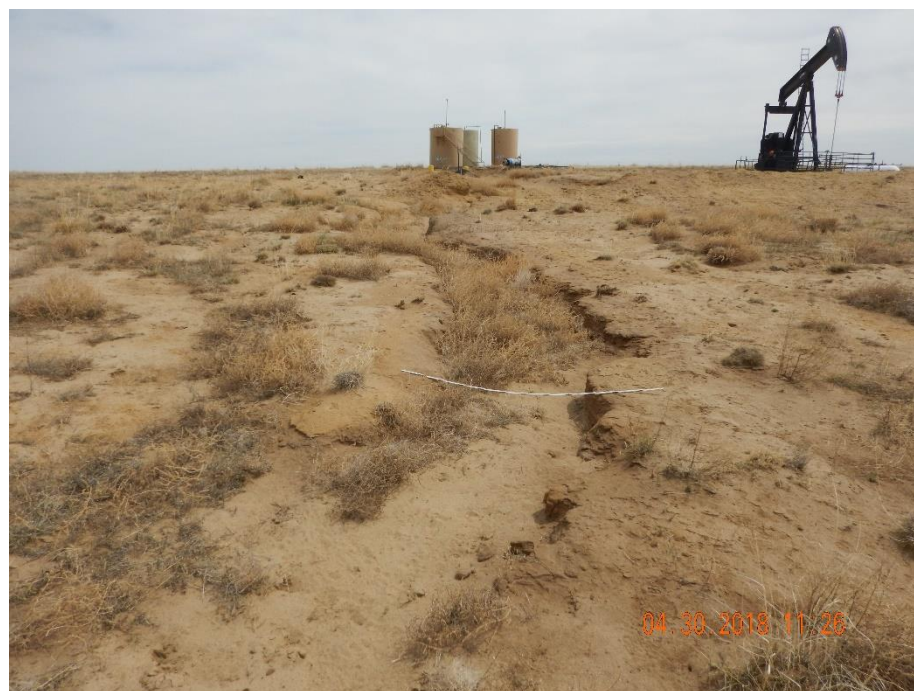
Photo 23: Photo taken to the southwest of the well, facing west. Previous inspection documented stormwater erosion and degradation and required it to be repaired. Photos 23-26 shows stormwater erosion degradation has not been repaired and stabilized, and further degradation into the adjacent interim areas appear to have continued.

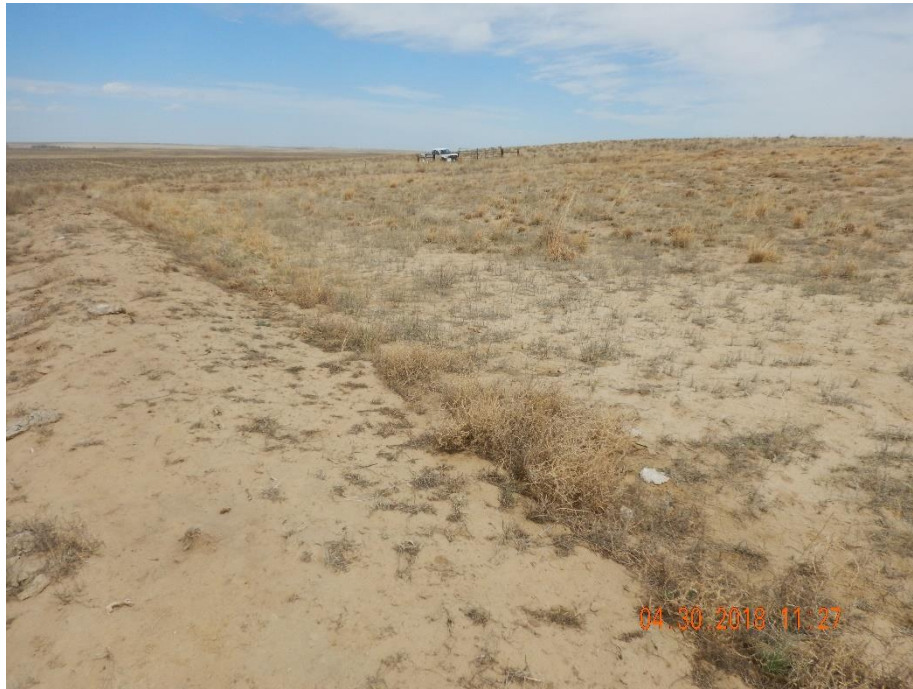
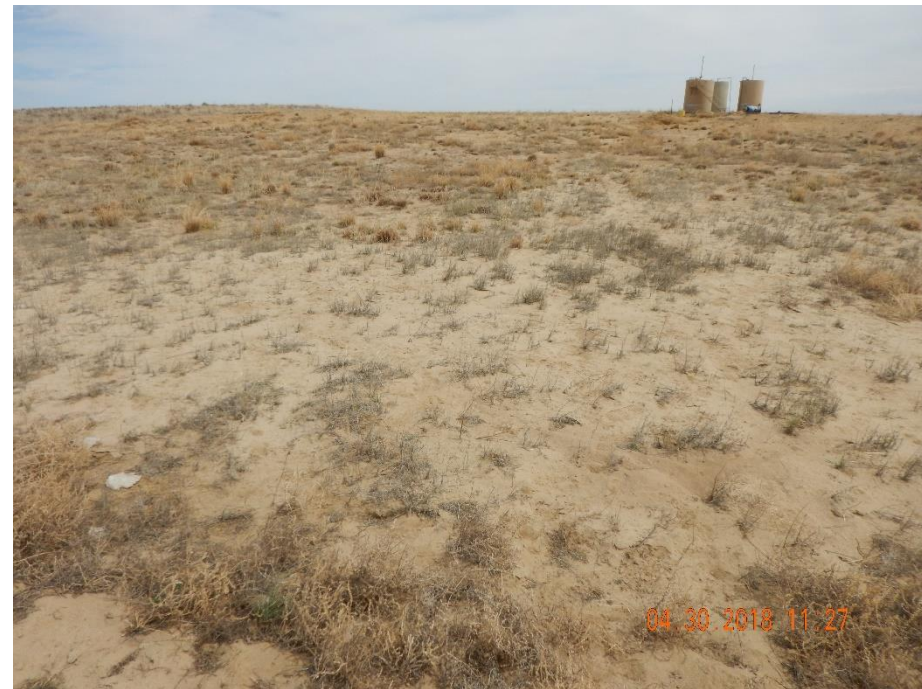
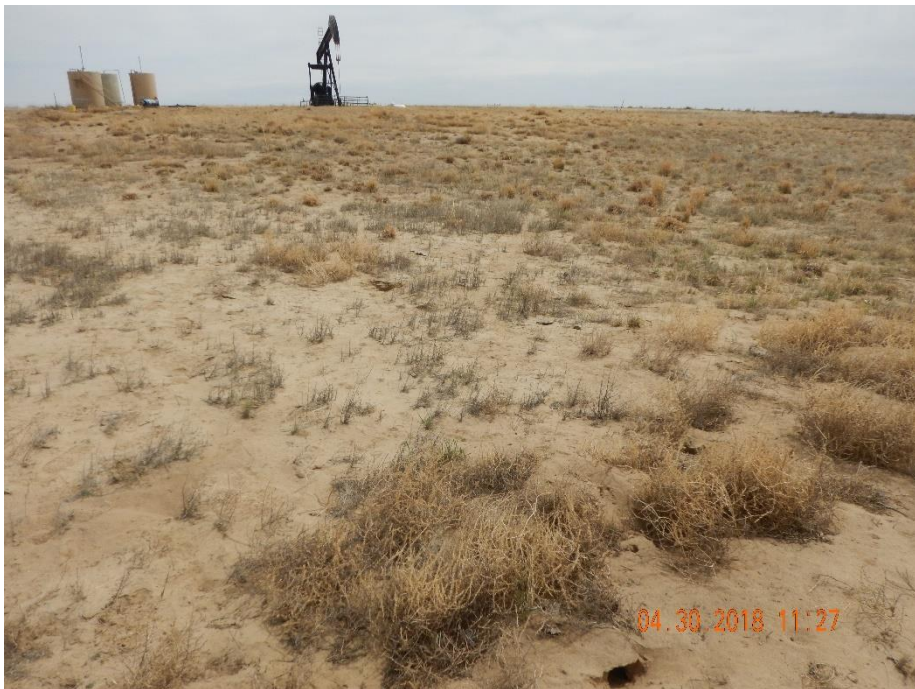
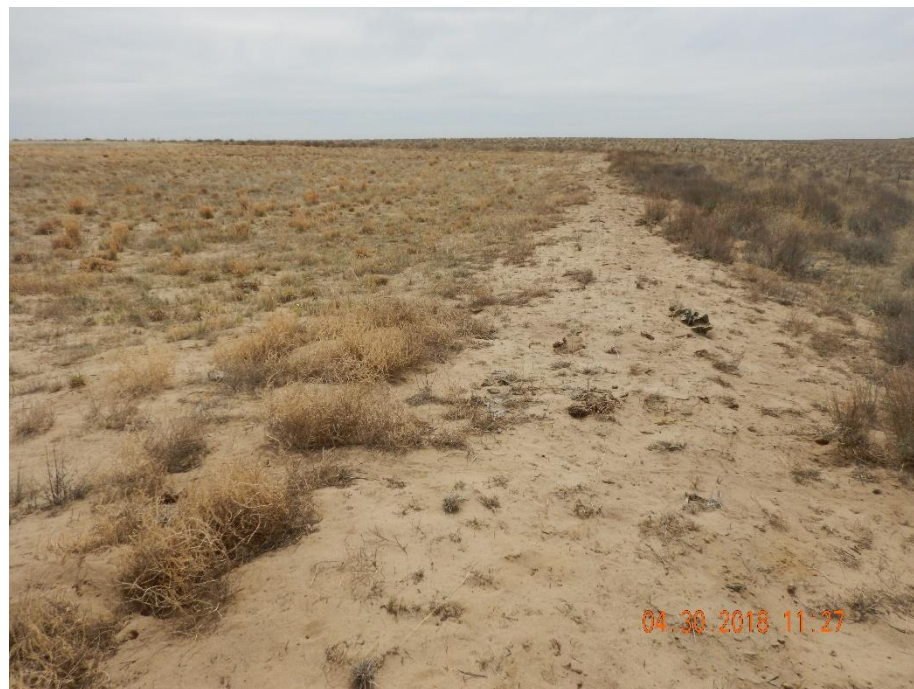
Photo 27: Photo taken from the southwest end (of the location, facing north. Photos 27- 30 show an overview of the location and interim areas from the north, northeast, east, and southeast. Photos 27 and 30 also show the ditch along the perimeter of the location that has not been maintained, is not longer in proper functioning condition, and should have been reclaimed during interim reclamation.

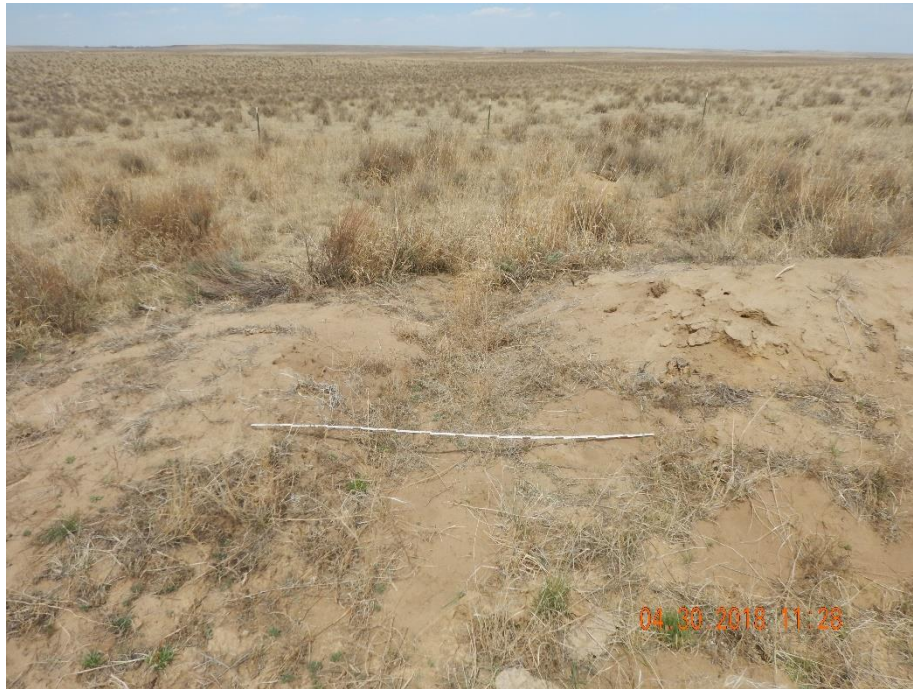
Photo 31: Photo taken from the perimeter stormwater berm on the west end of the location, facing northwest. Photo shows berm is no longer in proper functioning condition, and has “blown out” in this area.

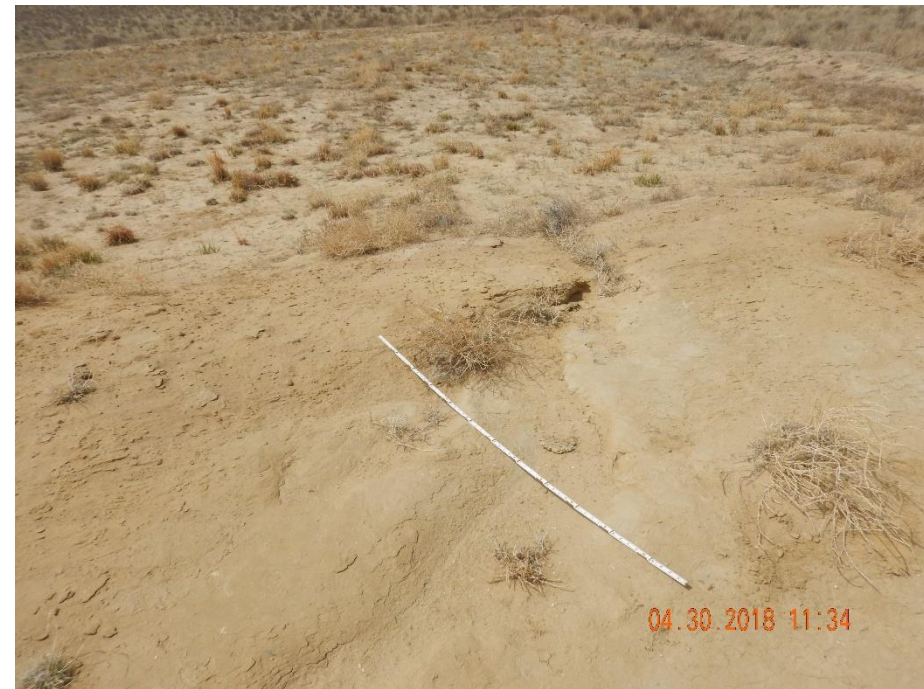
Photo 32: Photo taken from the northwest end of the location, facing west. Photo shows erosion degradation. 6 foot measuring stick for reference.

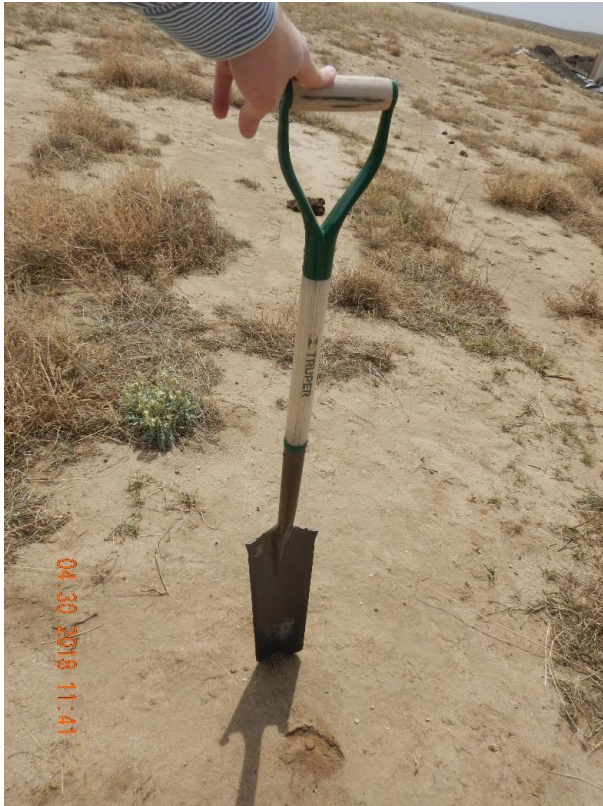
Photo 33: Photo taken from the northern interim area. There are large areas within the interim that remain predominantly bare and exposed soil. Photo shows compaction concerns appear evident within these areas as inspector had difficulty penetrating to top layer of soil with a shovel.

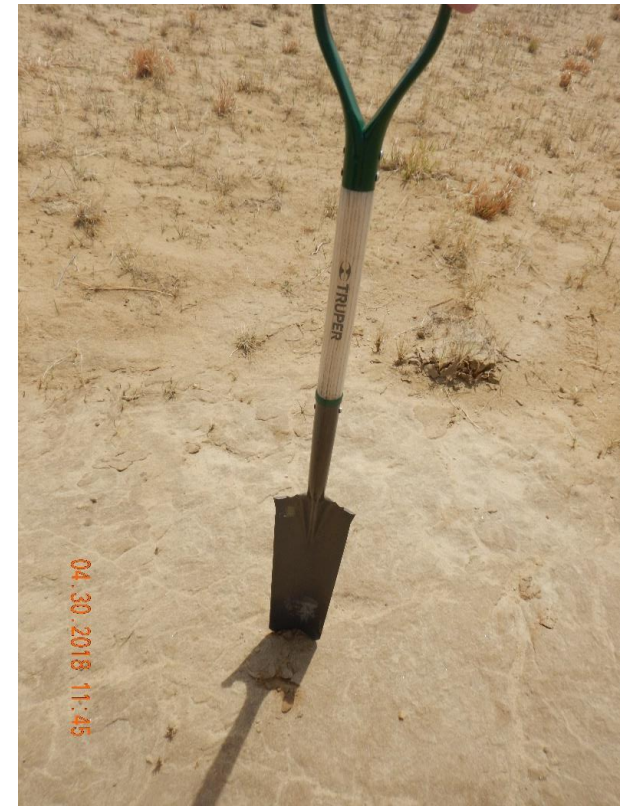
Photo 34: Photo taken from the southern interim area. See comments under photo 33.

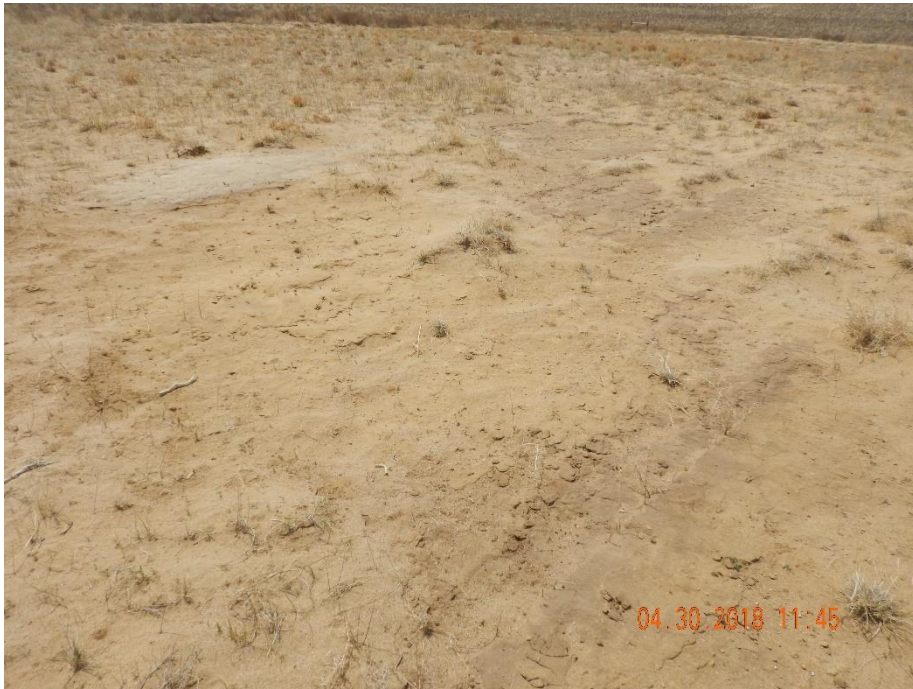
Photo 35: Photo taken from the southern interim area. Photo shows large areas of the interim that remain predominantly bare and exposed soil.
