Inspection Photos

04/30/2018

Operator: ABILENE PERFECT ENERGY JV LLC -
10581

Location ID: 433129

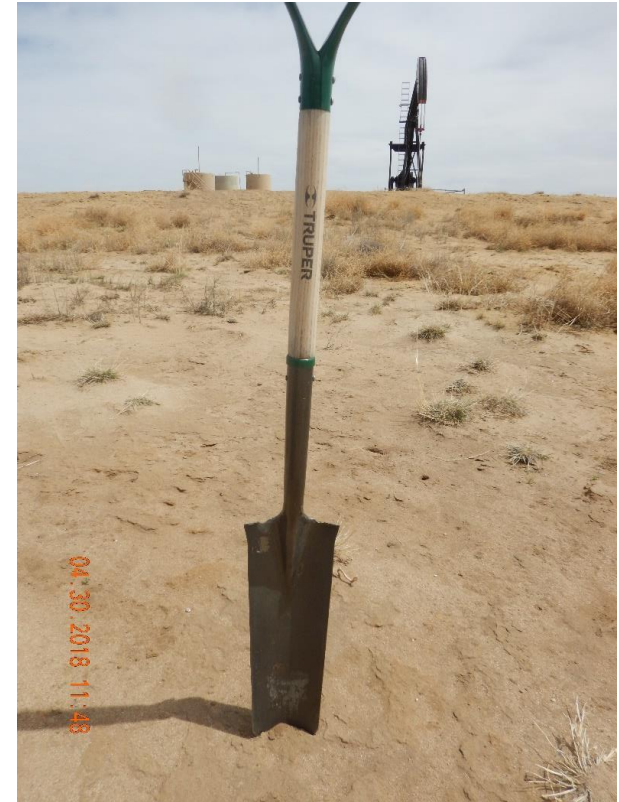
Photo 33: Photo taken from the northern interim area. There are large areas within the interim that remain predominantly bare and exposed soil. Photo shows compaction concerns appear evident within these areas as inspector had difficulty penetrating to top layer of soil with a shovel.

Photo 36: Photo taken from the western interim area. See comments under photo 33.

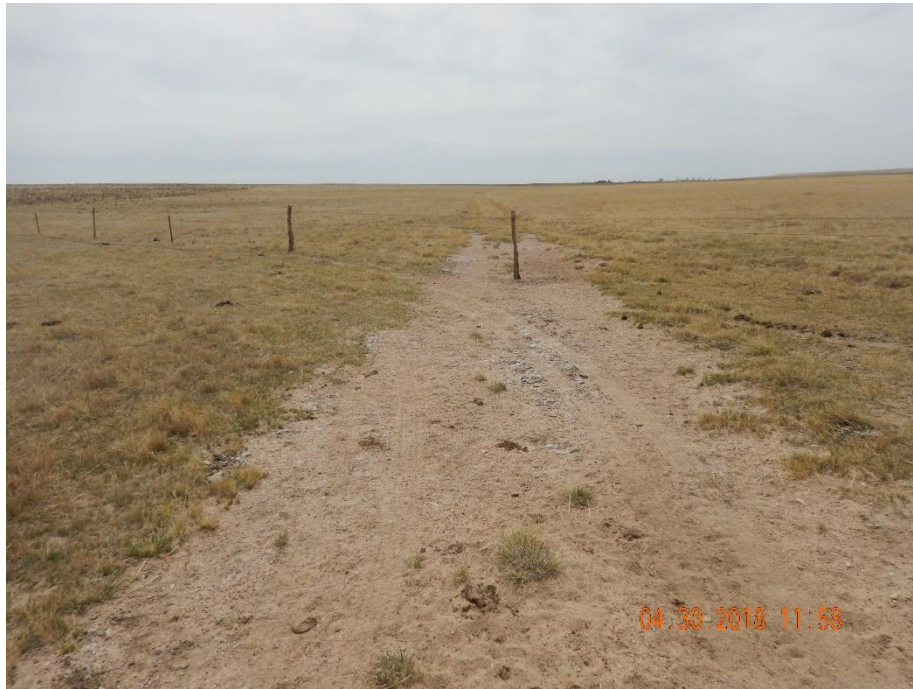
Photo 37: Photo taken from the access road, facing south. Photo shows a fence appears to have been constructed across the road, preventing vehicle travel.

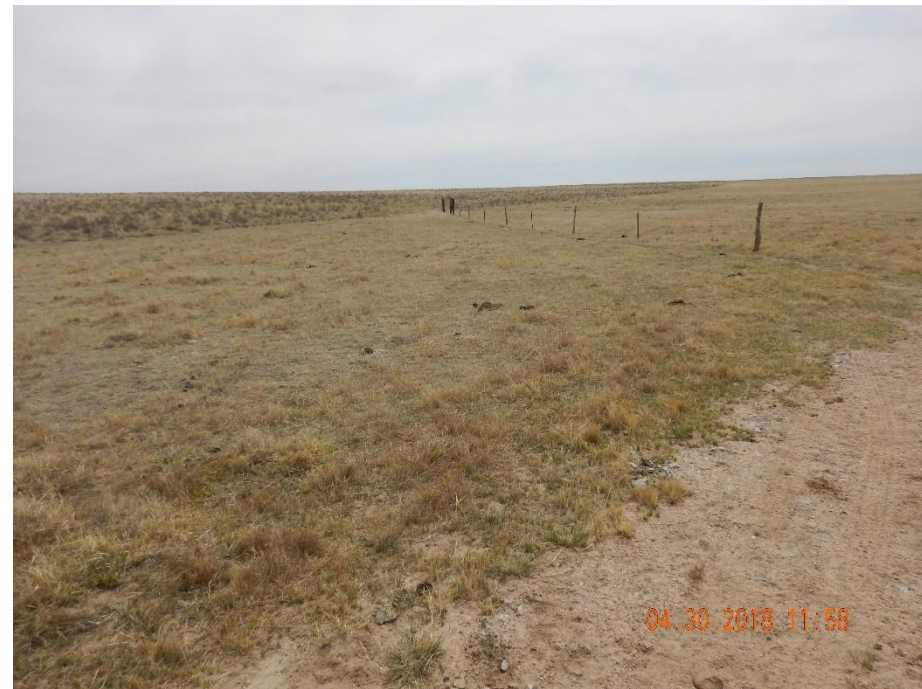
Photo 38: Photo taken from the access road, facing east. Photo shows a fence appears to have been constructed across the road, preventing vehicle travel. Photo shows vehicles have to travel off road to the east in order to access a gate.

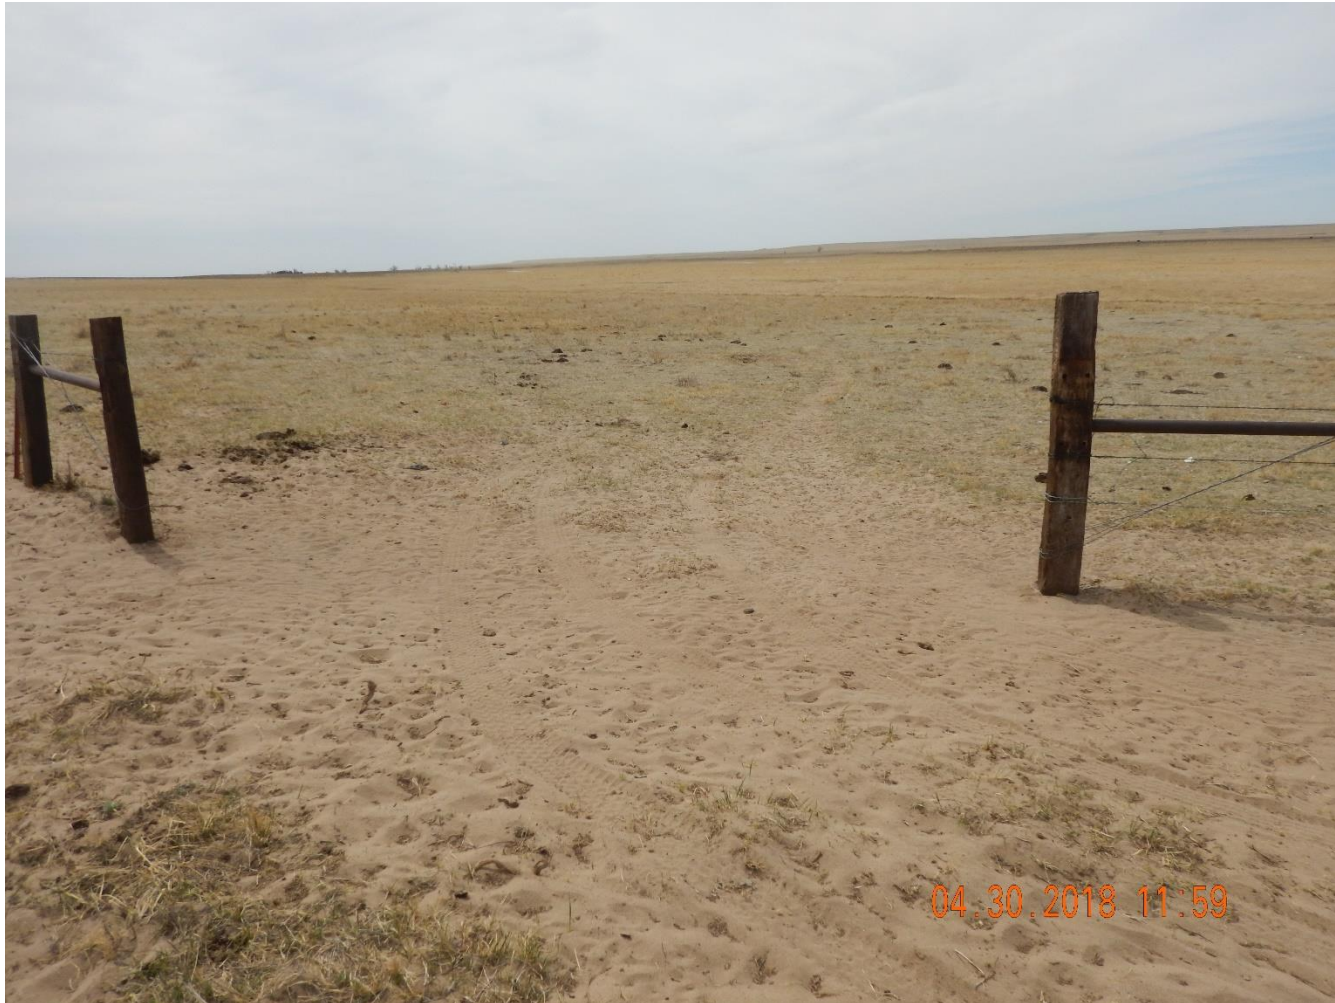
Photo 39: Photo shows gate to the east of the access road. A fence has been constructed across the access road forcing vehicle traffic to drive off road and through this gate in order to access location.
