Inspection Photos

06/19/2018

Operator: ABILENE PERFECT ENERGY JV LLC -
10581

Location ID: 414589

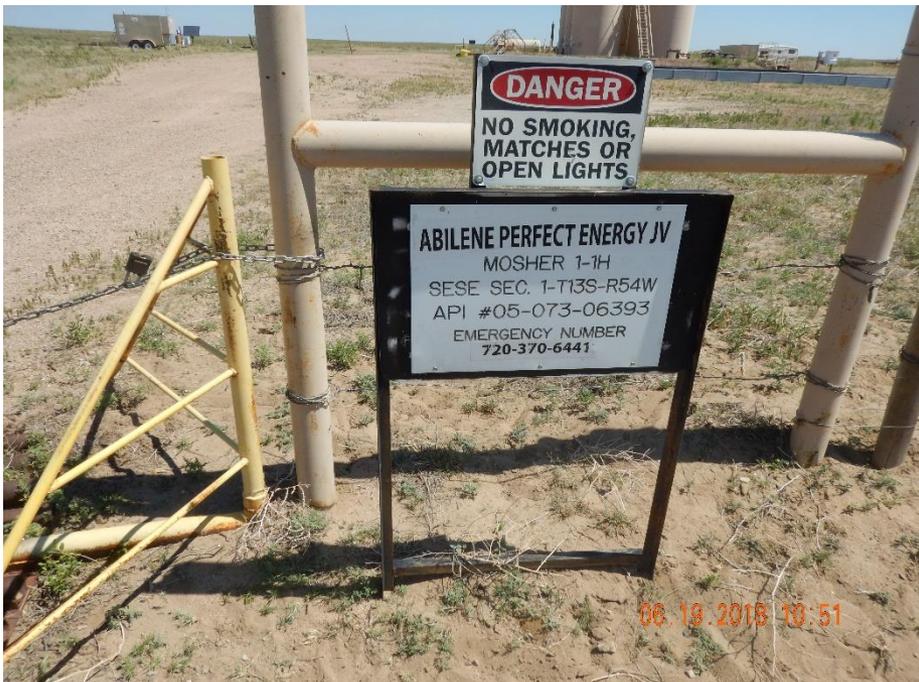
Photo 1: Photo of sign at location gate.

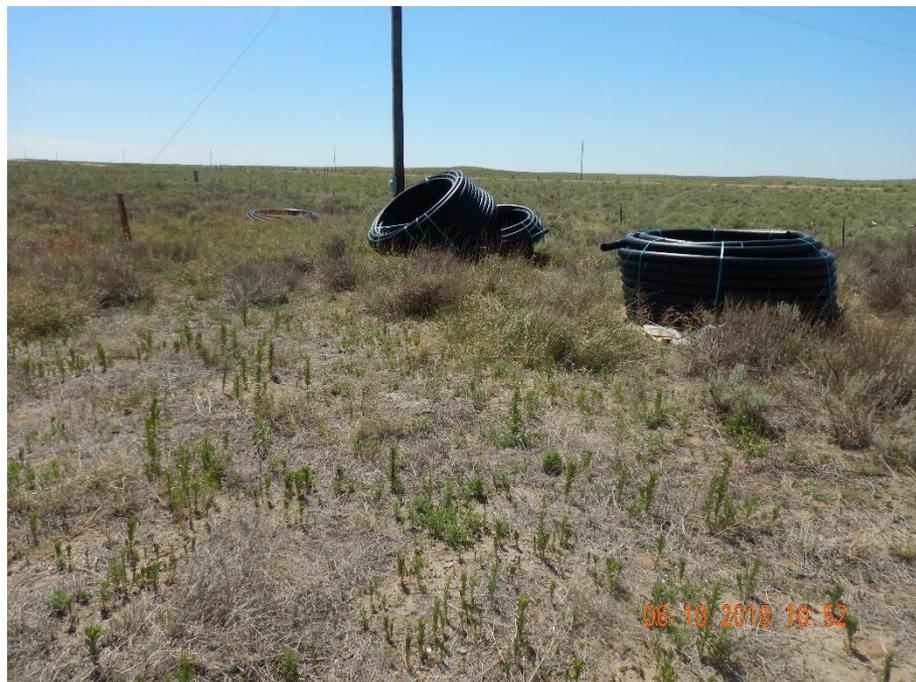
Photo 2: Photo taken from the south end of the location facing east. Photo shows what appears to be four (4) bundles of pipe stored on the southern interim areas. This is considered unused equipment not needed for production and needs to be removed from location.

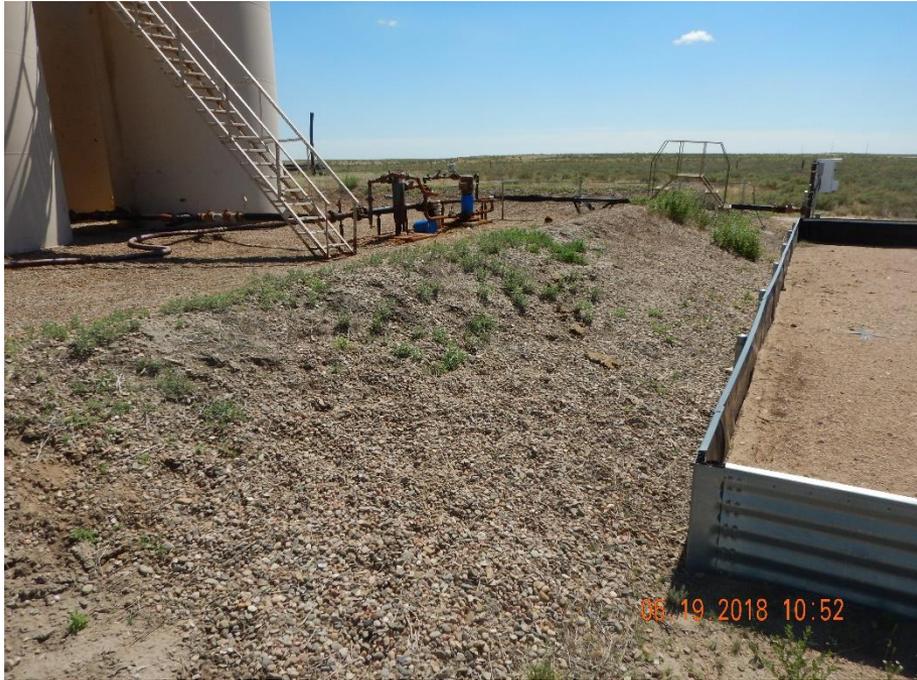
Photo 3: Photo taken from the south end of the tank battery berm, facing east. Photo shows vegetation establishment on the berm. Vegetation compromises the integrity of the containment berms and needs to be removed.

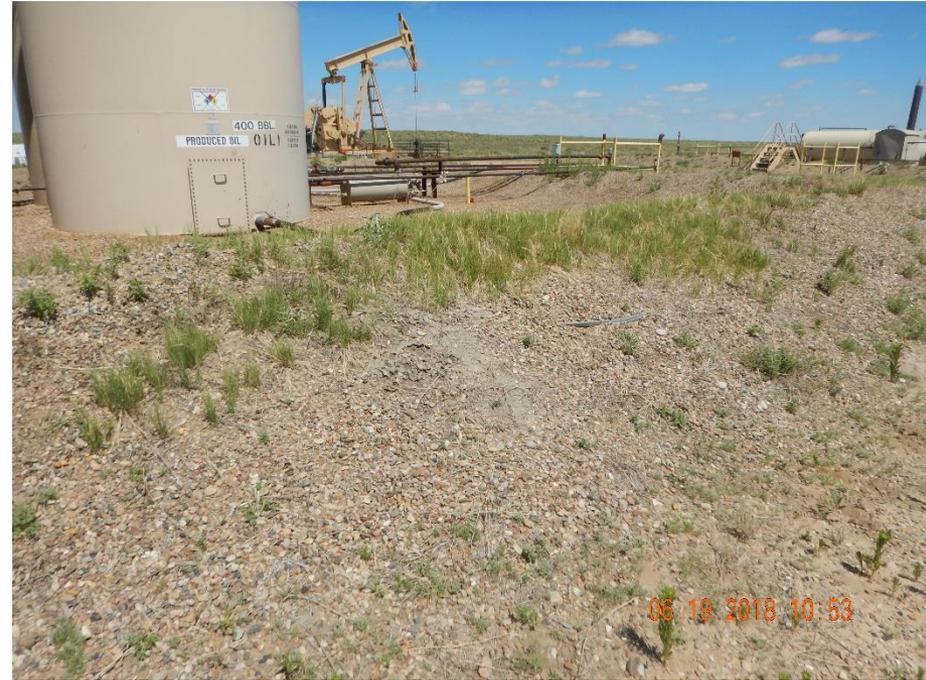
Photo 4: Photo taken from the east end of the tank battery berm, facing northwest. Photo shows vegetation establishment on the berm. Vegetation compromises the integrity of the containment berms and needs to be removed.

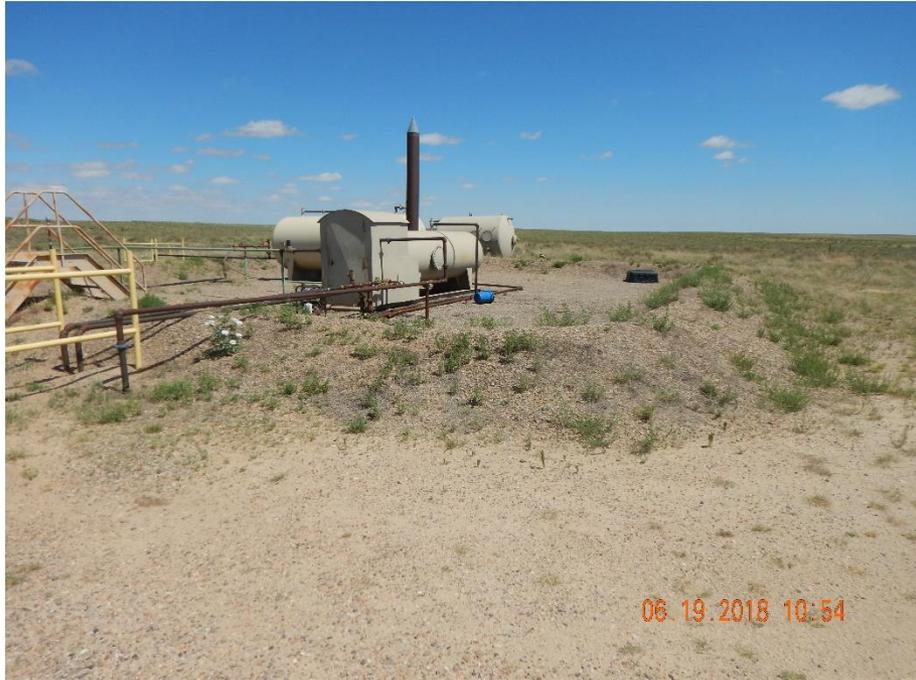
Photo 5: Photo taken from the north end of the location, facing north. Photo shows vegetation establishment on the berm. Vegetation compromises the integrity of the containment berms and needs to be removed.

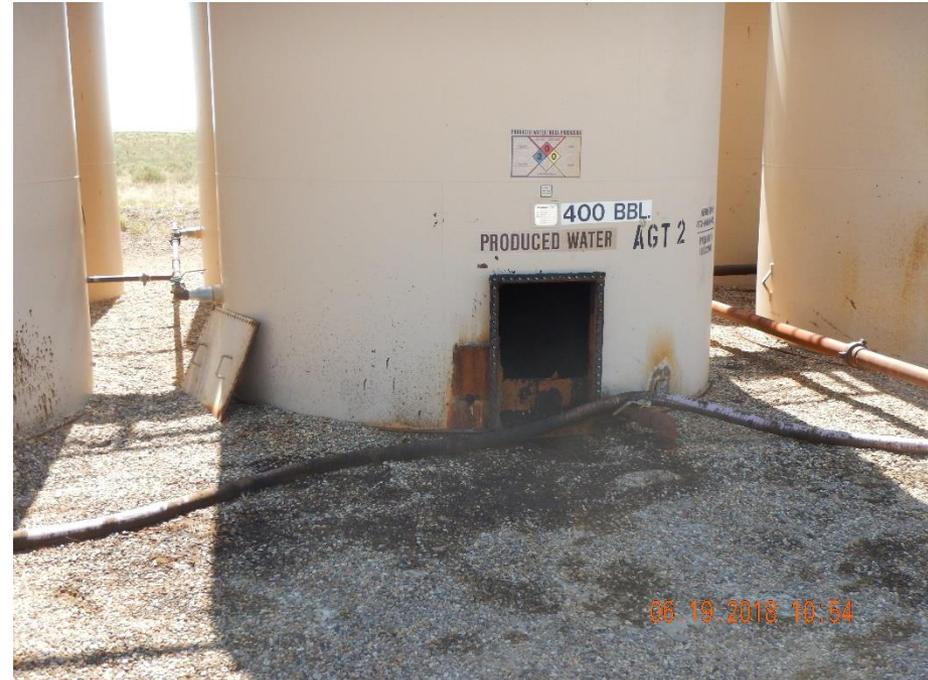
Photo 6: Photo taken from the west end of the tank battery. Photo shows that the manway cover has been removed from the tank. Photo also shows stained soils within berm.

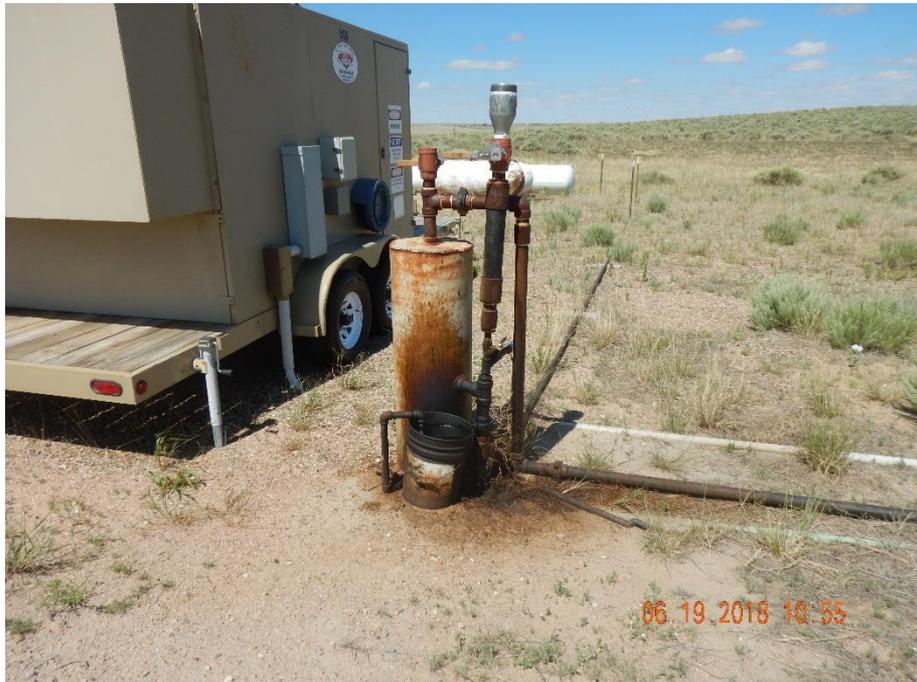
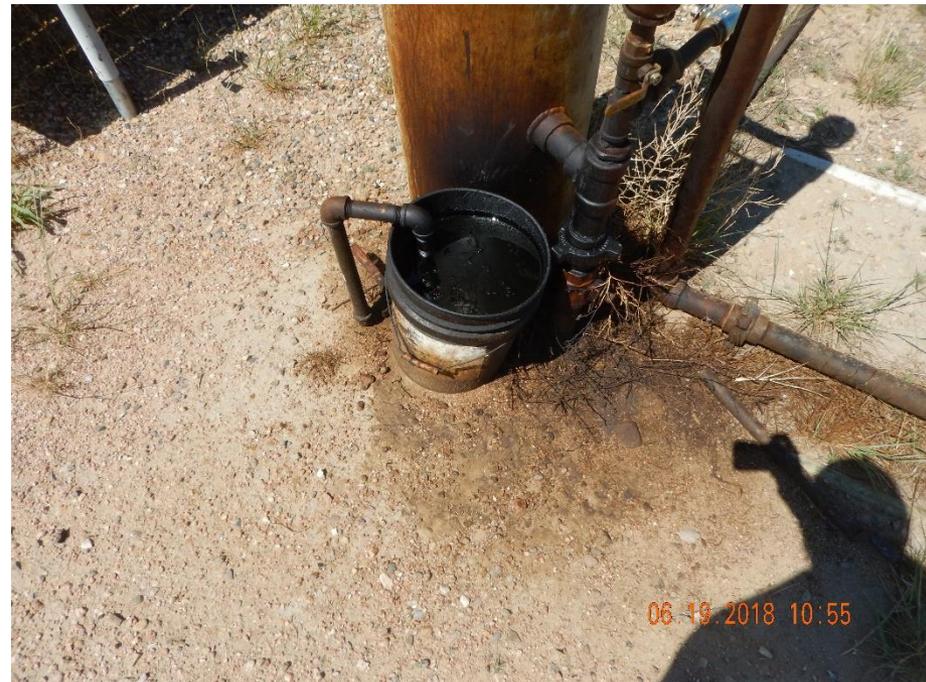
Photo 7: Photo taken from the west end of the location. Photo shows 5 gallon bucket being used to collect chemicals from equipment. Photo also shows stained soils at base. Equipment needs to be repaired to prevent leaks, bucket needs to be removed and properly disposed or placed in containment.

Photo 8: See comments under photo 7.

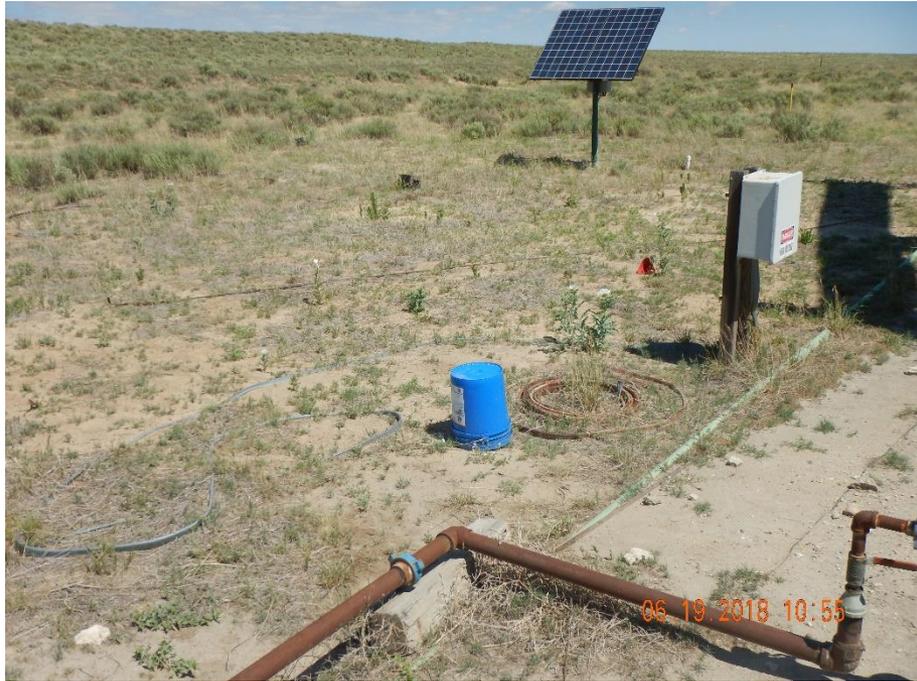
Photo 9: Photo taken from the west end of the location, facing northwest. Photo of bucket and various trash debris that appears to have been blown onto the interim areas.

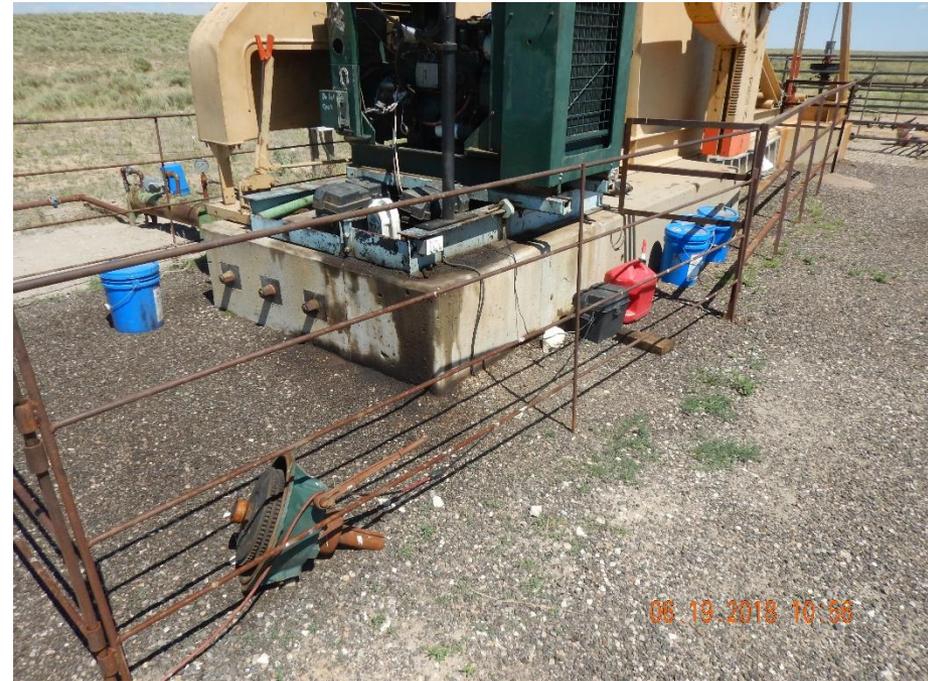
Photo 10: Photo taken from the southeast corner of the pump jack facing northwest. Photo shows numerous 5 gallon buckets with chemical and oil jugs found around the pump jack. Buckets need to be properly removed and disposed, or placed into containment. Photo also shows unused equipment that needs to be removed.

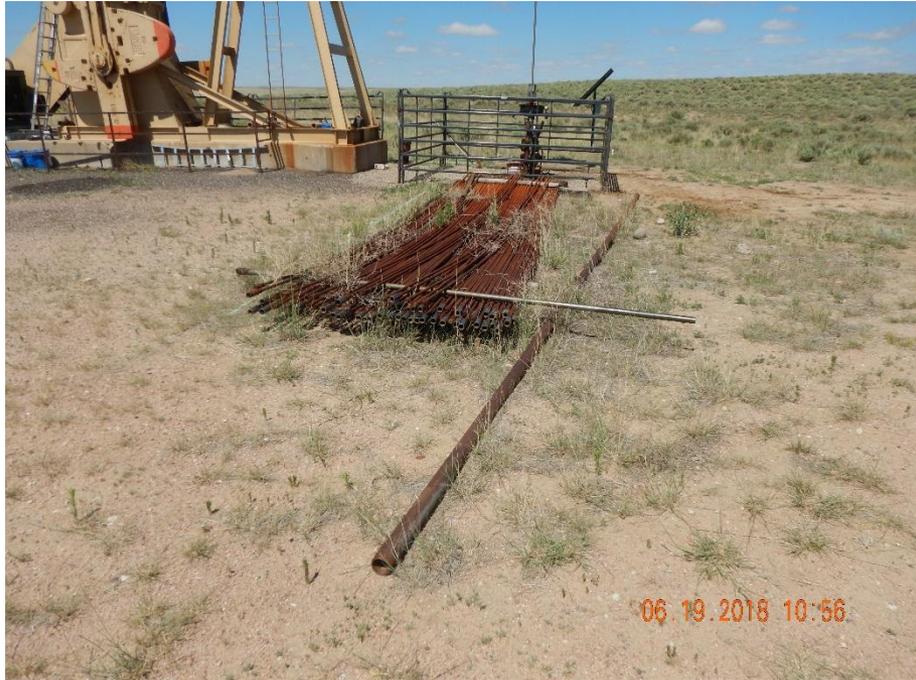
Photo 11: Photo taken from the east end of the pump, facing west. Photo shows unused equipment stored on location. Equipment is not need for production and needs to be removed.

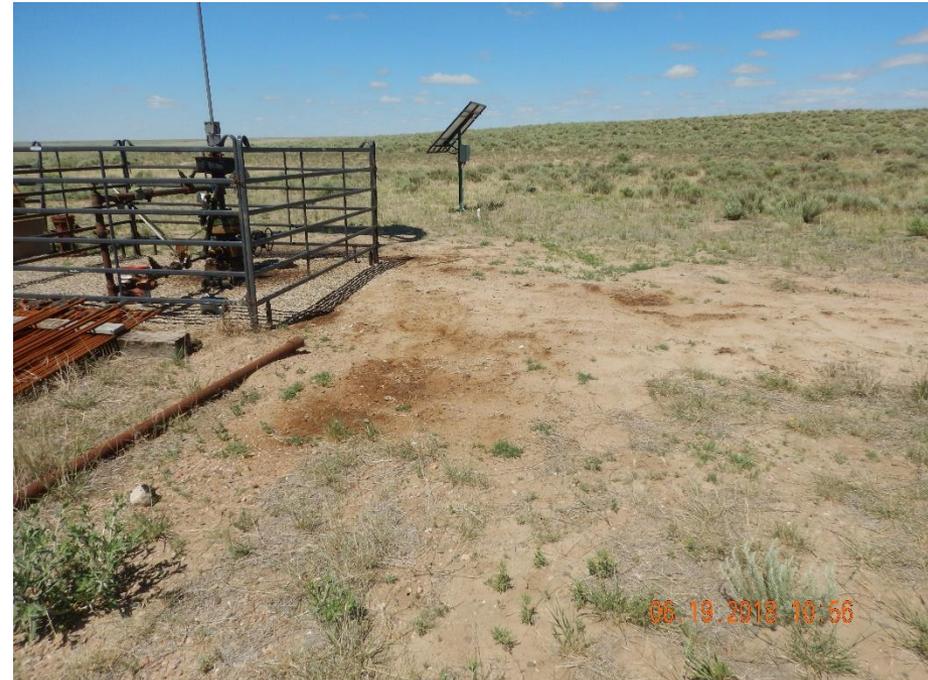
Photo 12: Photo taken from the north end of the well, facing west. Photo shows oil stained soils requiring cleaning.

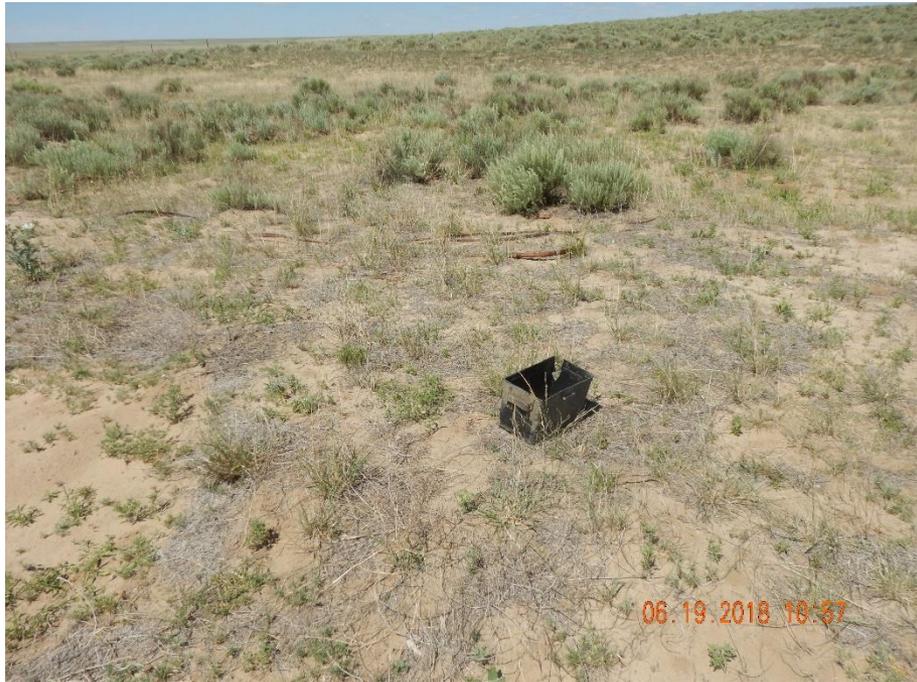
Photo 13: Photo taken from the west end of the location, facing west. Photo of various trash in the interim areas.

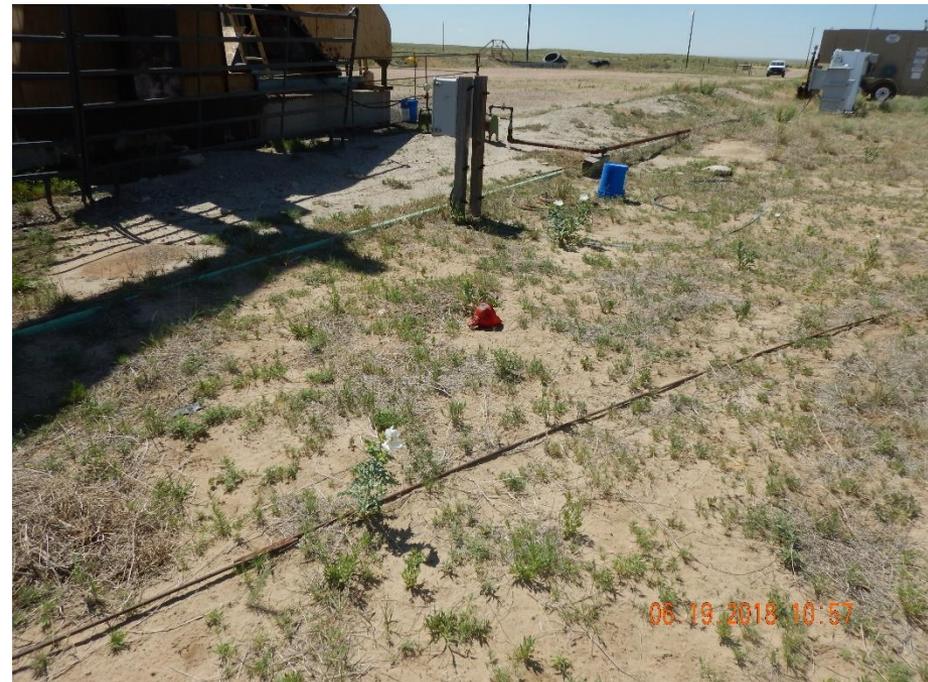
Photo 14: Photo taken from the west end of the location, facing south. Photo of various trash in the interim areas.

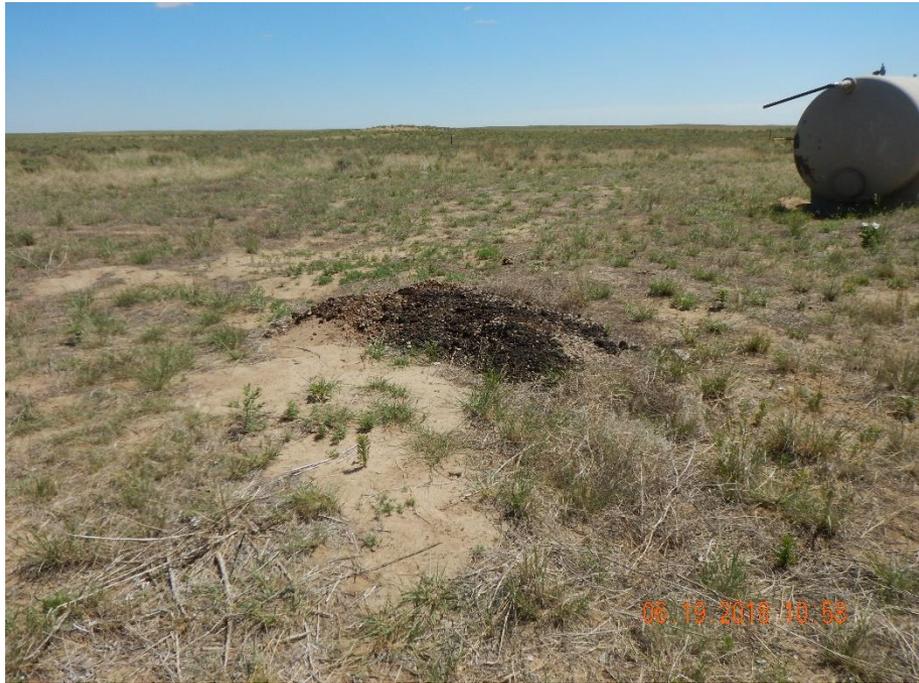
Photo 15: Photo taken from the north end of the location, facing north. Photo shows stained (E&P waste) soil piled on the north end of the location.

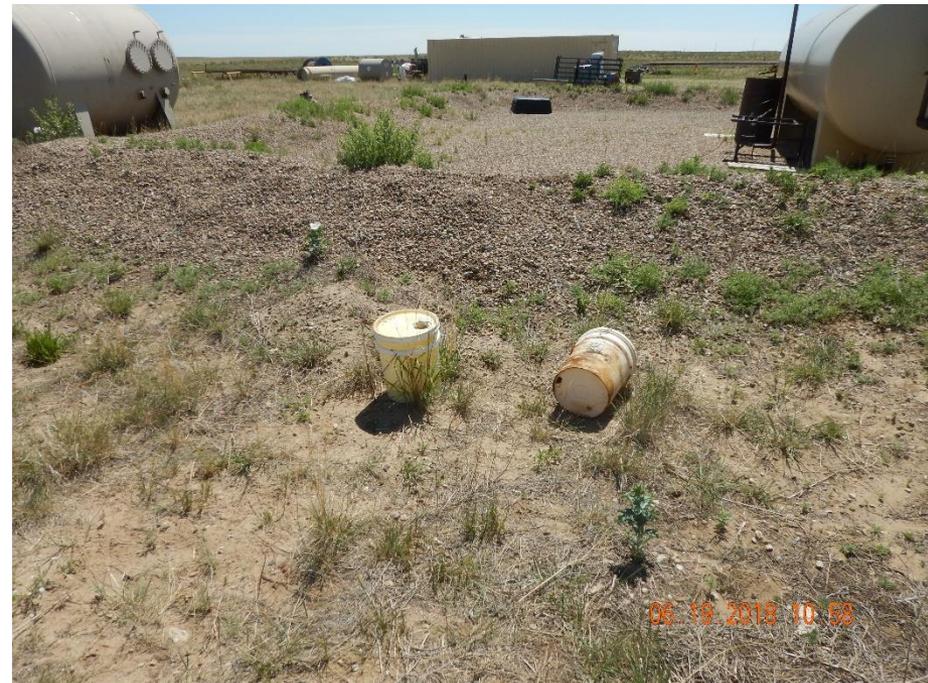
Photo 16: Photo taken from the north end of the location, facing east. Photo shows 5 gallon buckets with chemical outside of containment

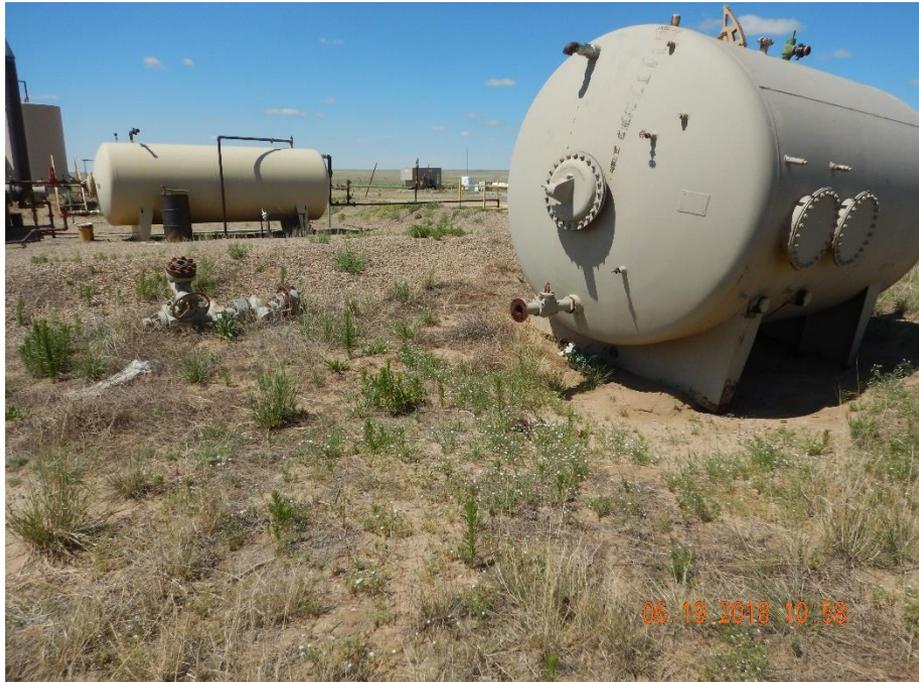
Photo 17: Photo taken from then north end of the location, facing southwest. Photo shows unused equipment not needed for production. This needs to be removed.

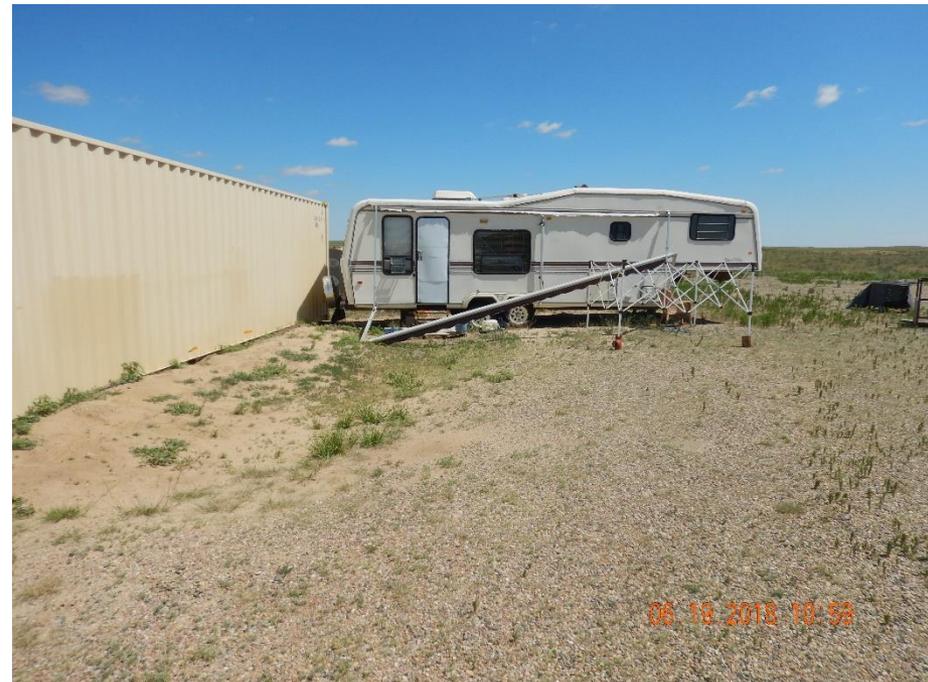
Photo 18: Photo taken from the northeast end of the location, facing north. Photo of camper trailer being stored on the northern end of the location. This is not needed for production and needs to be removed. Additionally, these areas do not appear to be reasonably needed for production and needs to be reclaimed.

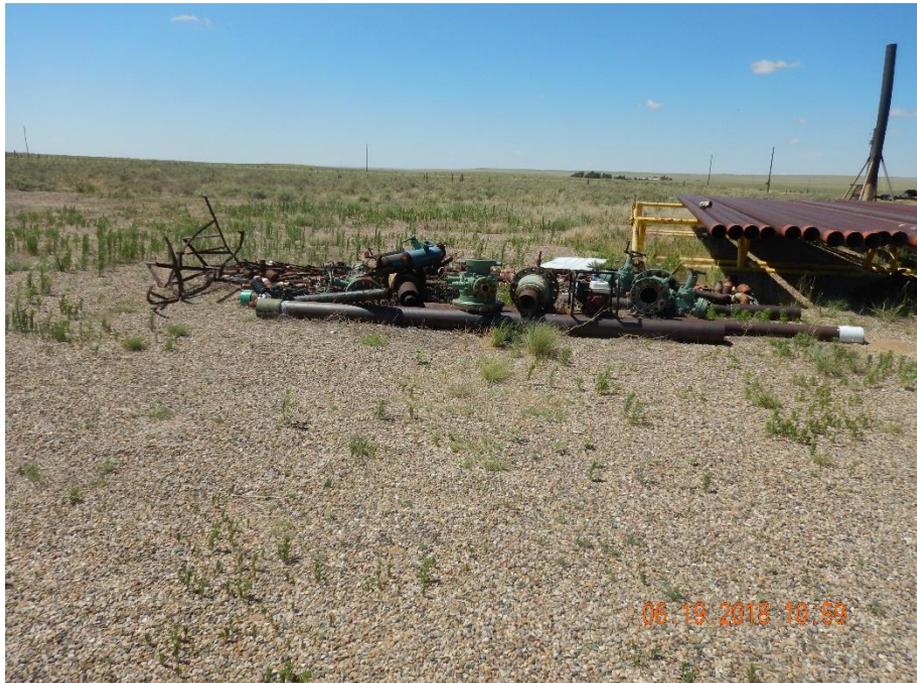
Photo 19: Photo taken from the east end of the location, facing south. Photo shows various unused equipment not needed for production being stored on location. This needs to be removed. Additionally, these areas do not appear to be reasonably needed for production and needs to be reclaimed.

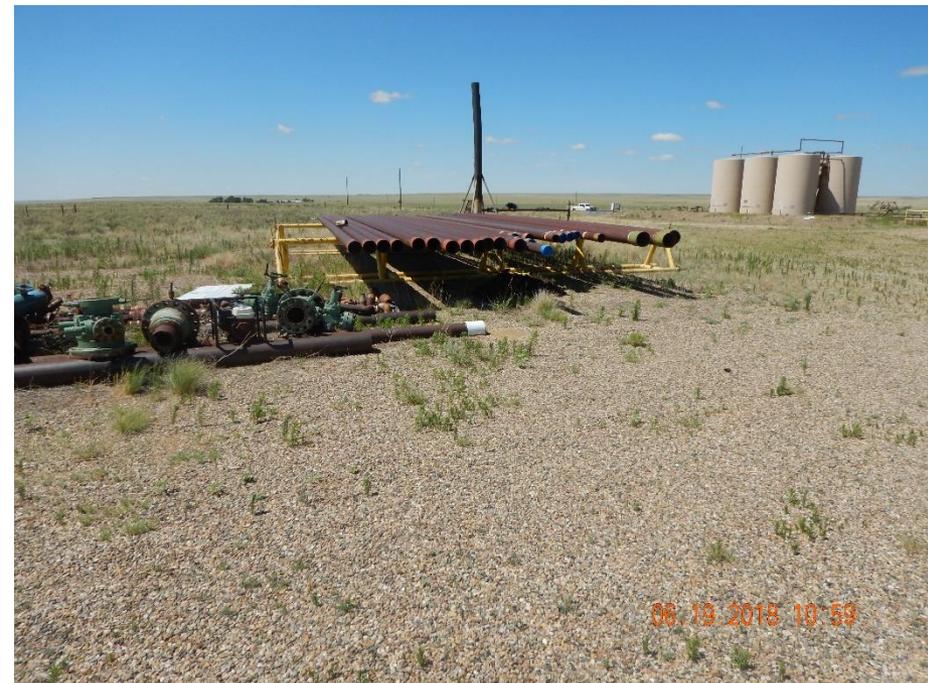
Photo 20: Photo taken from the east end of the location, facing southwest. Photo shows various unused equipment not needed for production being stored on location. This needs to be removed. Additionally, these areas do not appear to be reasonably needed for production and needs to be reclaimed.

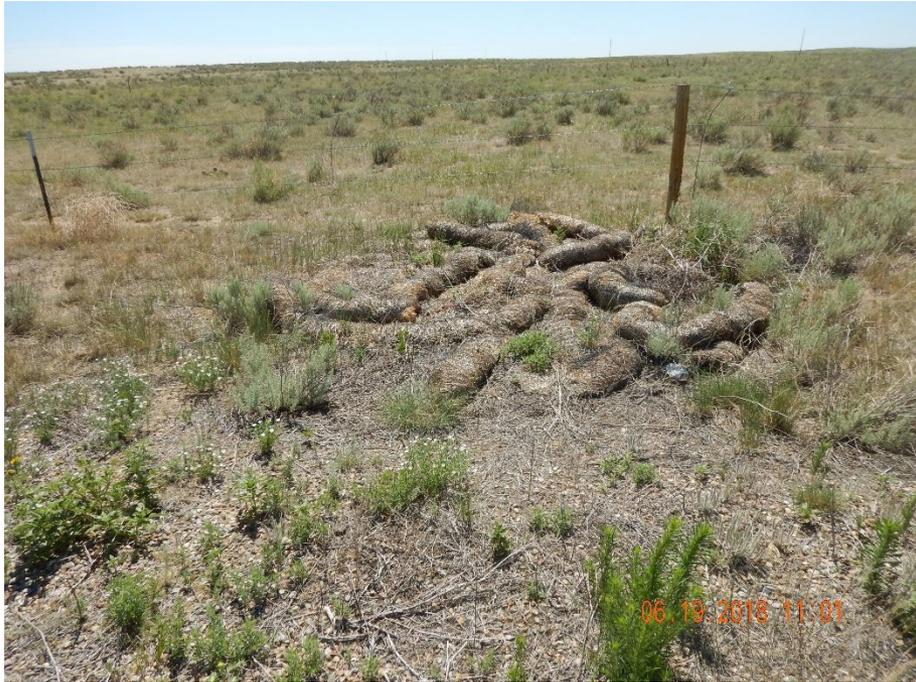
Photo 21: Photo taken from the east end of the location, facing east. Photo of straw wattles. This is considered debris and needs to be removed.

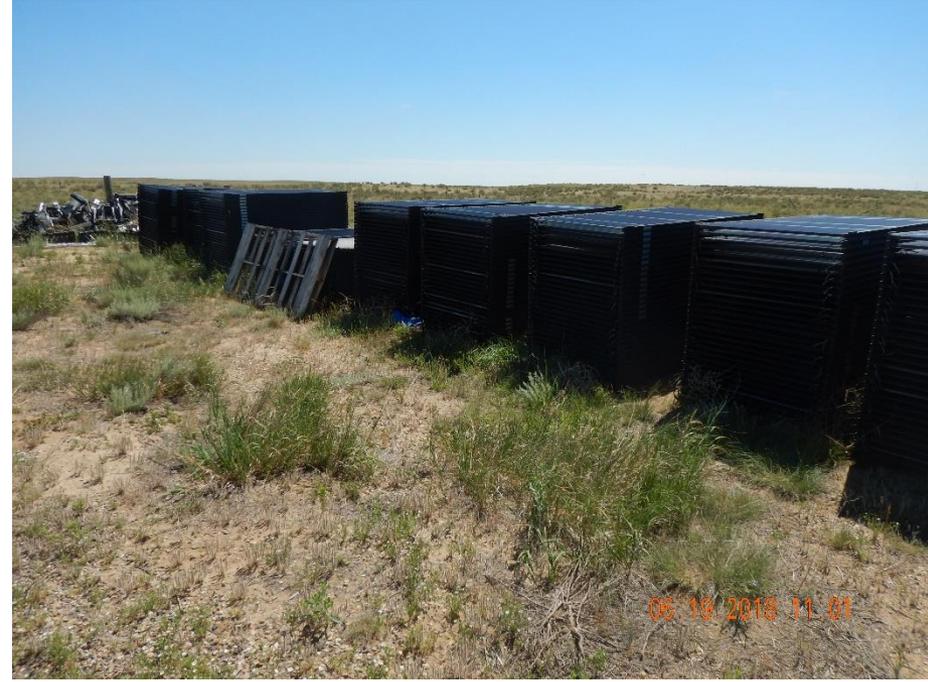
Photo 22: Photo taken from the northeast end of the location, facing north east. Photo shows what appears to be solar panels being stored on location. This is equipment not needed for production and needs to be removed. Additionally, these areas do not appear to be reasonably needed for production and needs to be reclaimed.

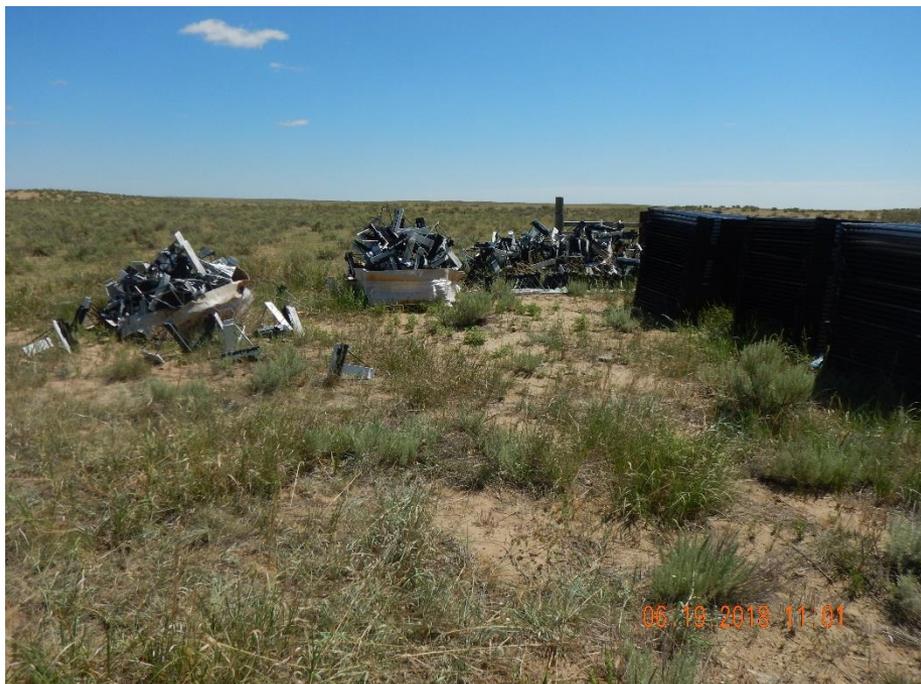
Photo 23: Photo taken from the northeast end of the location, facing north. Photo shows various unused equipment or trash debris not needed for production being stored on location. This needs to be removed. Additionally, these areas do not appear to be reasonably needed for production and needs to be reclaimed.

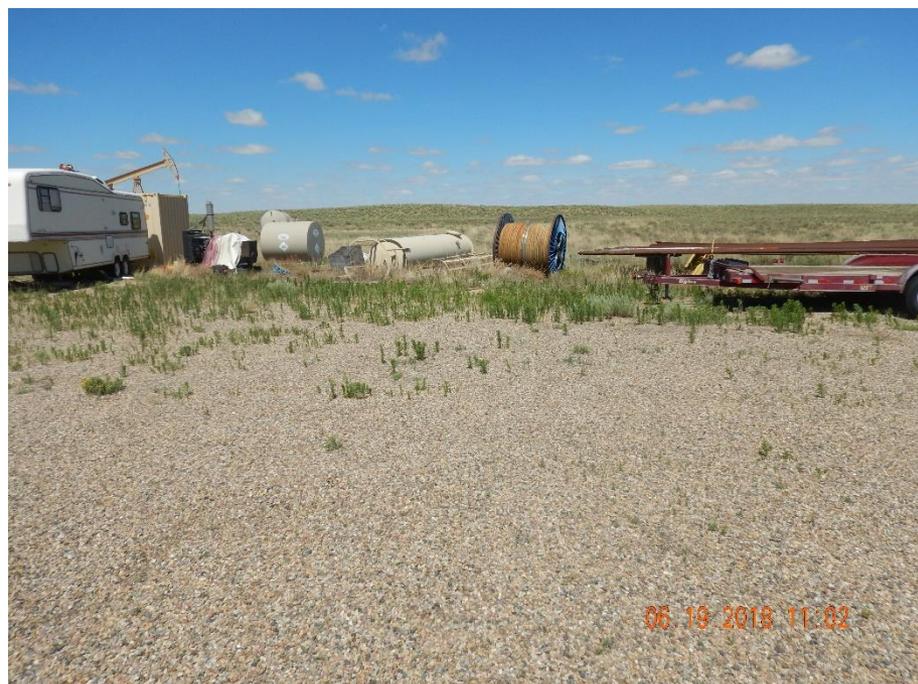
Photo 24: Photo taken from the north end of the location, facing west. Photo shows various unused equipment or trash debris not needed for production being stored on location. This needs to be removed. Additionally, these areas do not appear to be reasonably needed for production and needs to be reclaimed.

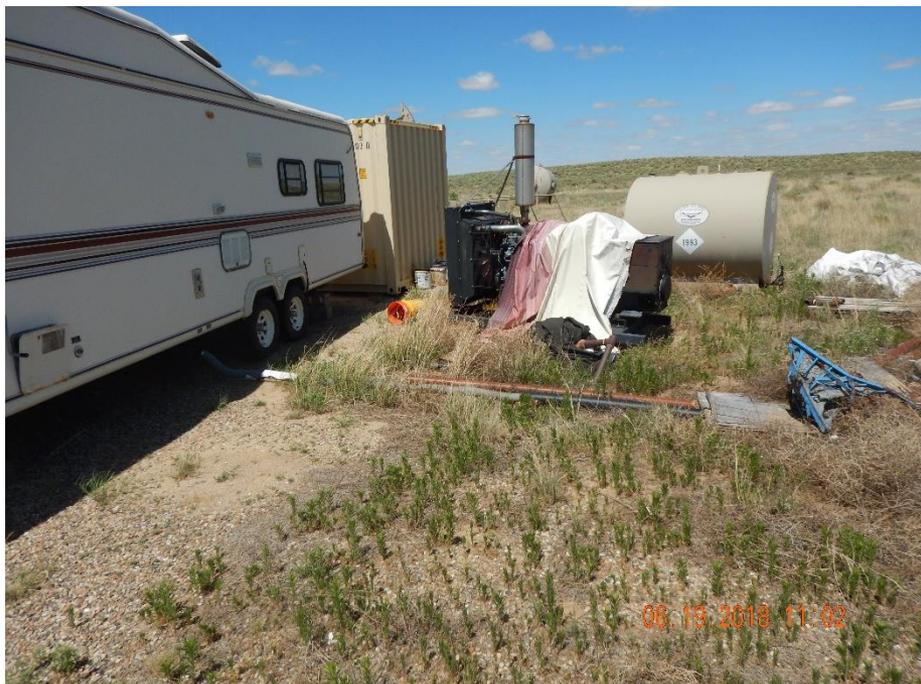
Photo 25: Photo taken from the north end of the location, facing west. Photo shows various unused equipment or trash debris not needed for production being stored on location. This needs to be removed. Additionally, these areas do not appear to be reasonably needed for production and needs to be reclaimed.

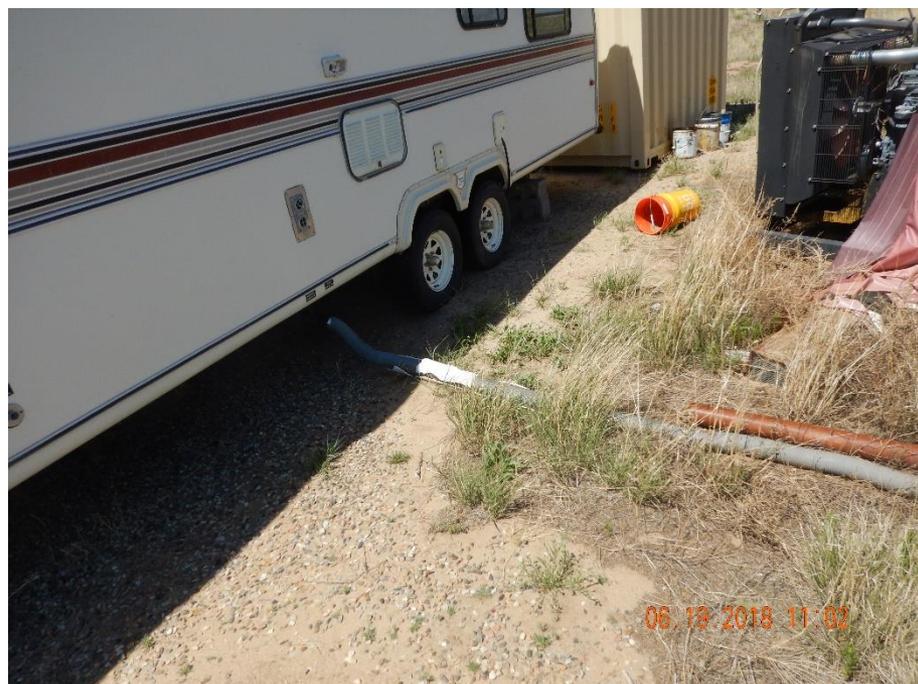
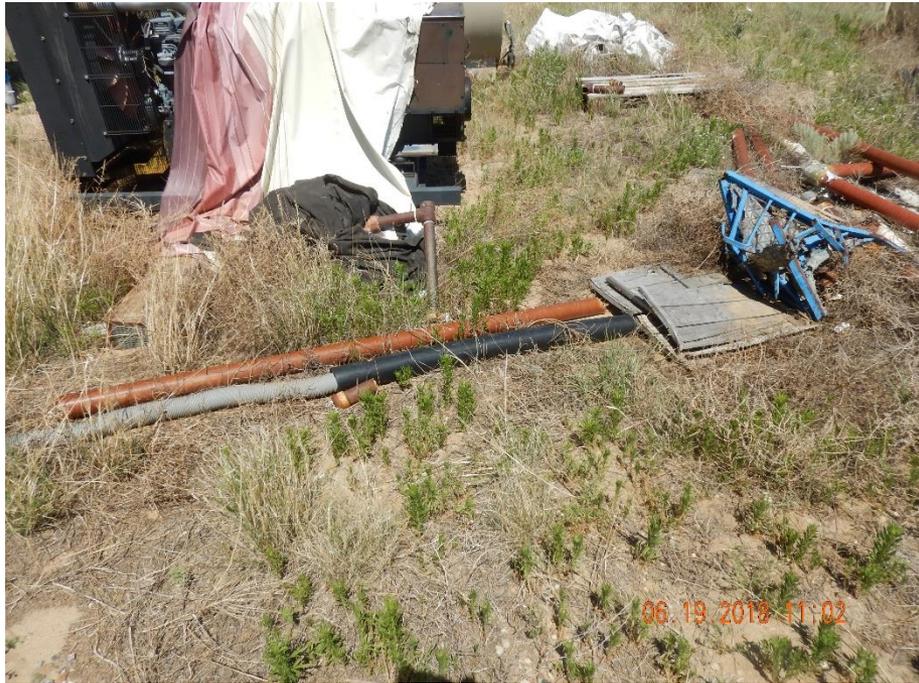
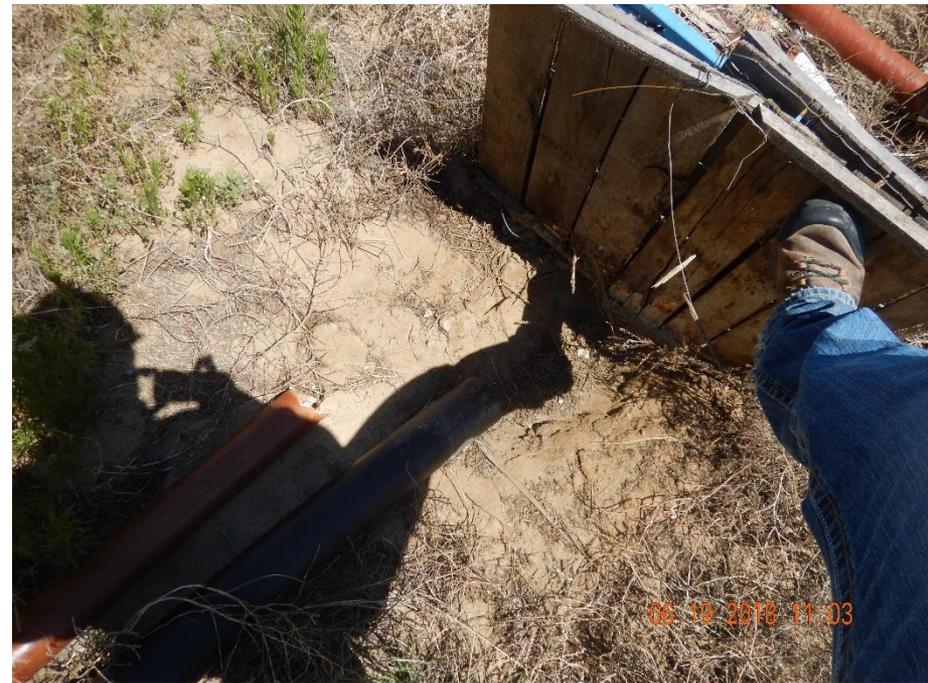
Photo 26: Photo taken from the north end of the camper trailer. Photo shows hose leading from the north end of the camper to a covered hole on the ground; Hose appears to be associated with the grey and/or waste water from the camper.

Photo 27: Continued from photo 26

Photo 28: Continued from photo 26. Photo of hole where hose from camper leads to.

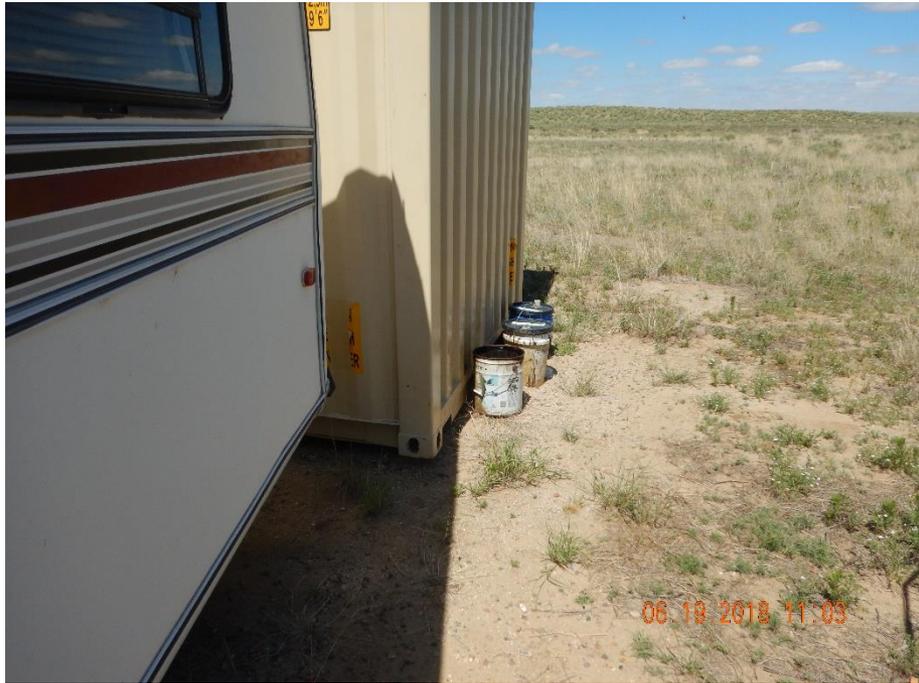
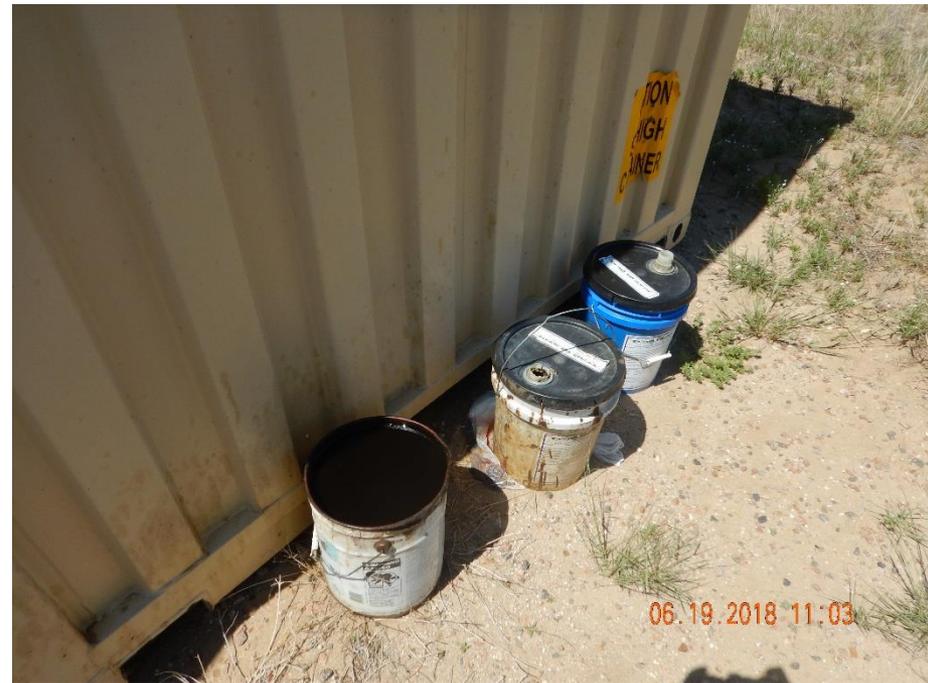
Photo 29: Photo taken from the north end of the camper facing west. Photo shows numerous 5 gallon buckets with chemical. Buckets need to be properly removed and disposed, or placed into containment.

Photo 30: Continued from photo 29
