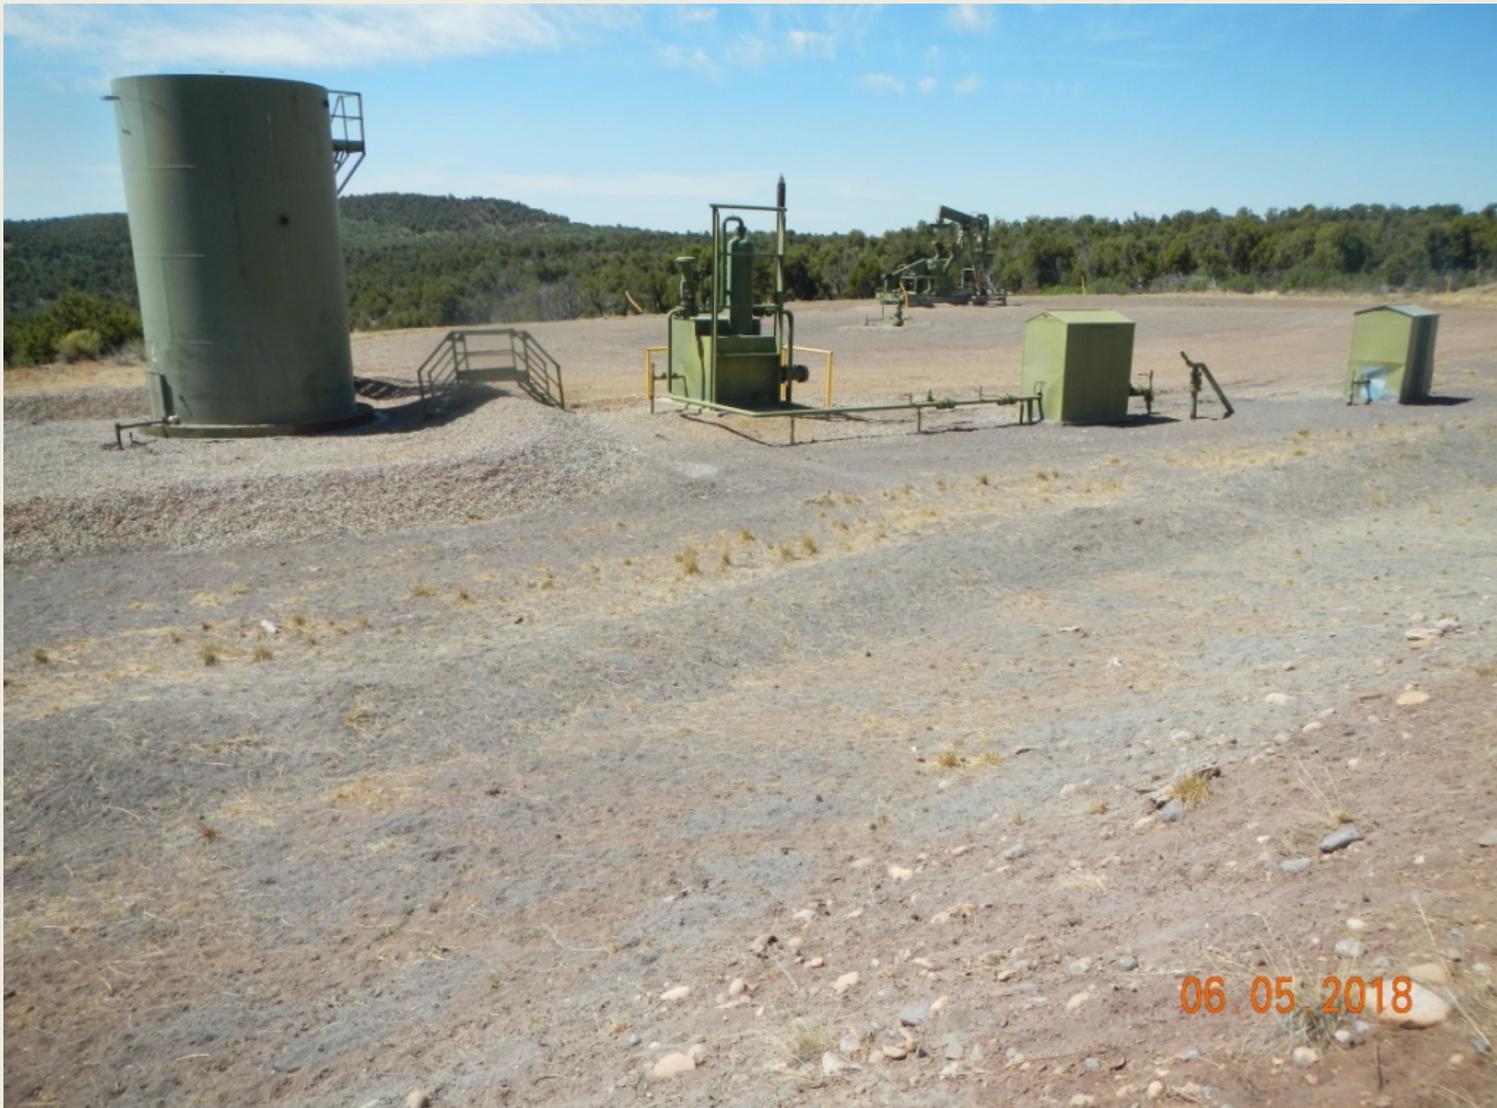
Photo 1. View of the project area from the northeastern corner facing center.

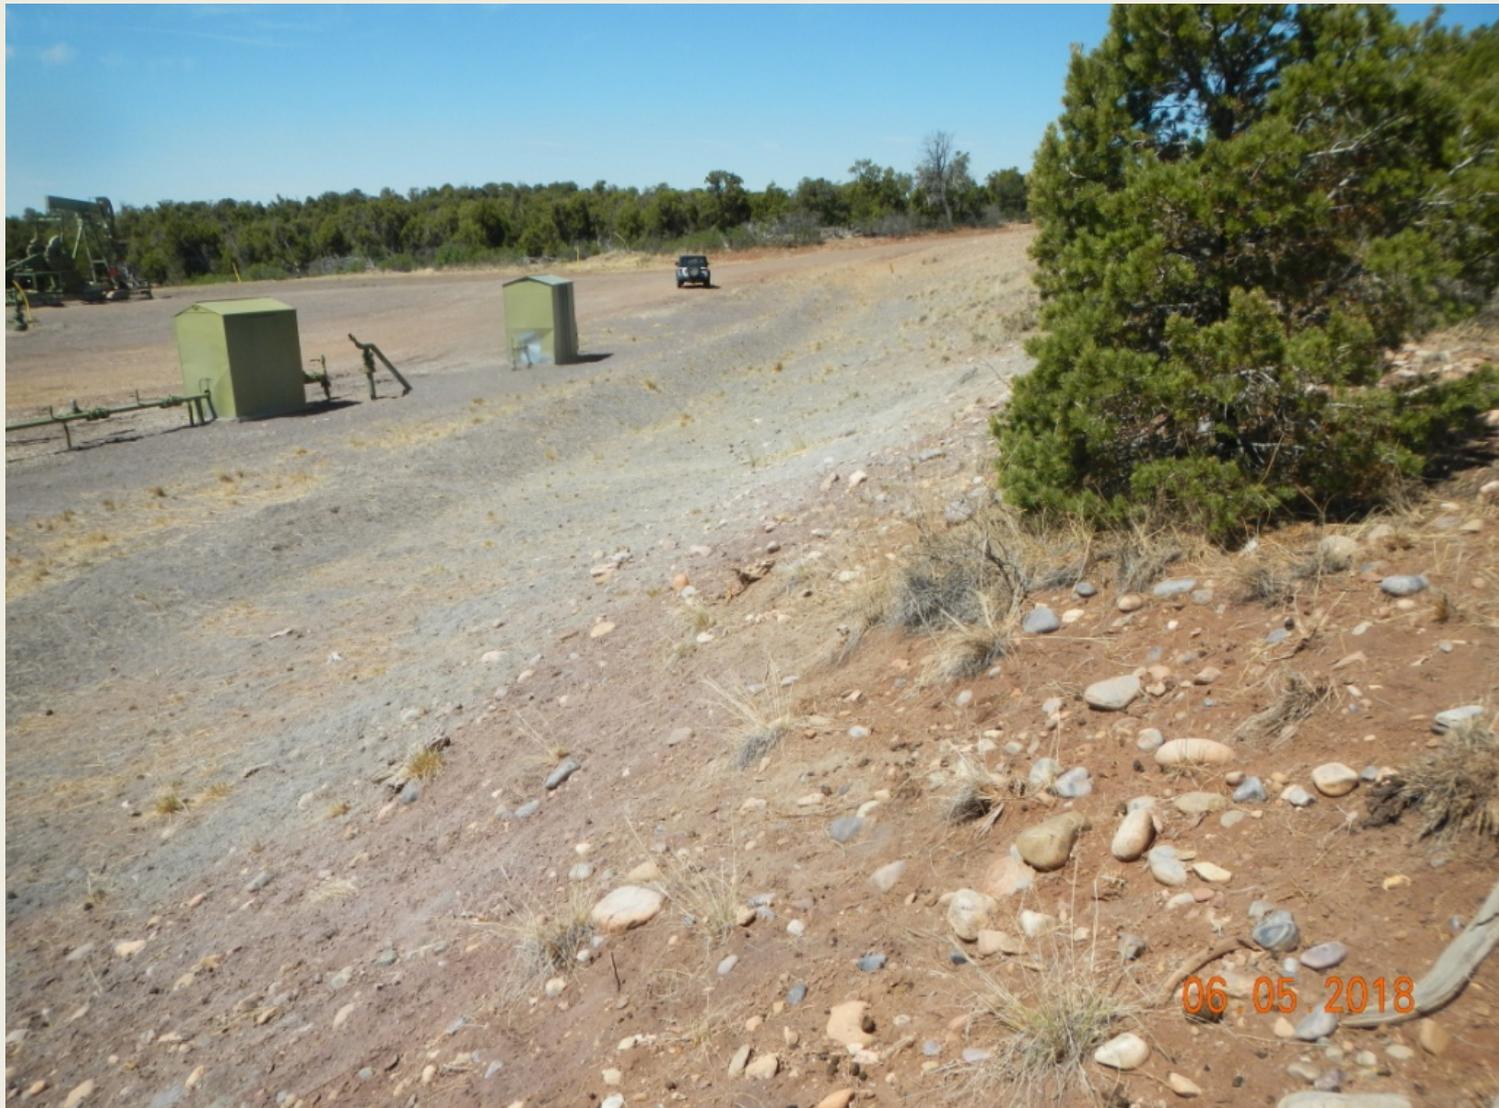
Photo 2. View of the northern portion of the project area from the southwestern corner facing northward. Revegetation is progressing within outer reclamation areas with grasses such as Indian ricegrass (*Achnatherum hymenoides*), smooth brome (*Bromus inermis*), and sand dropseed (*Sporobolus cryptandrus*).

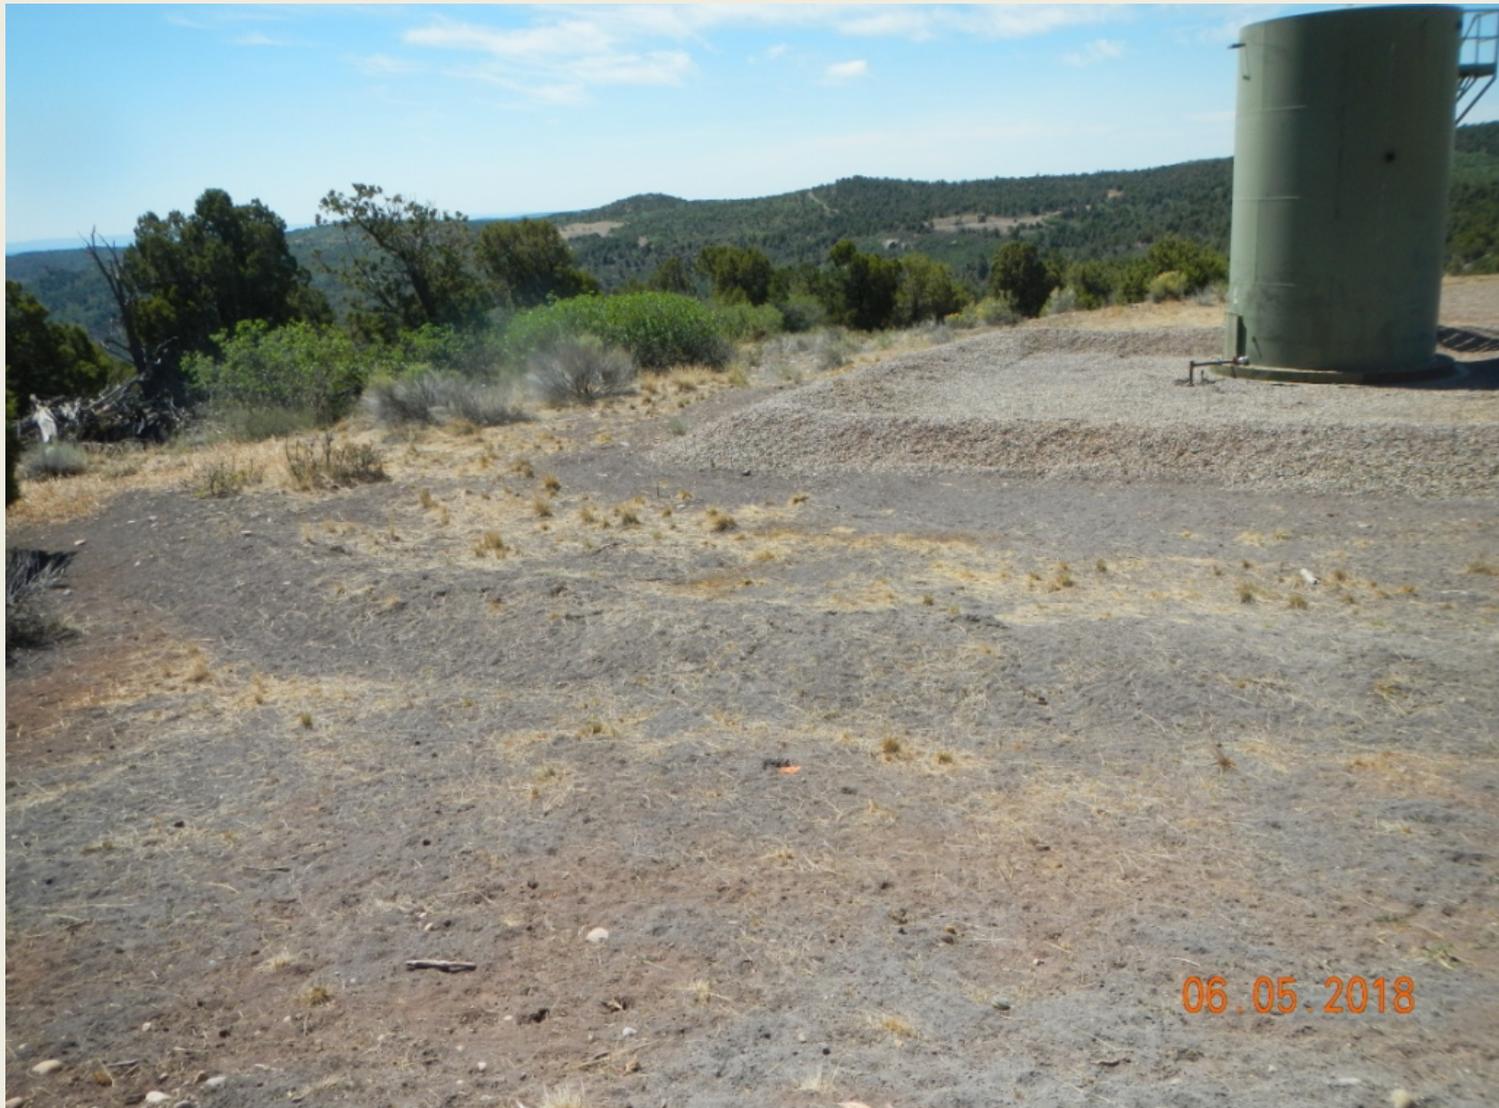
Photo 3. View of the eastern portion of the project area from the northeastern corner facing southward. Vegetation is dry and sparse.

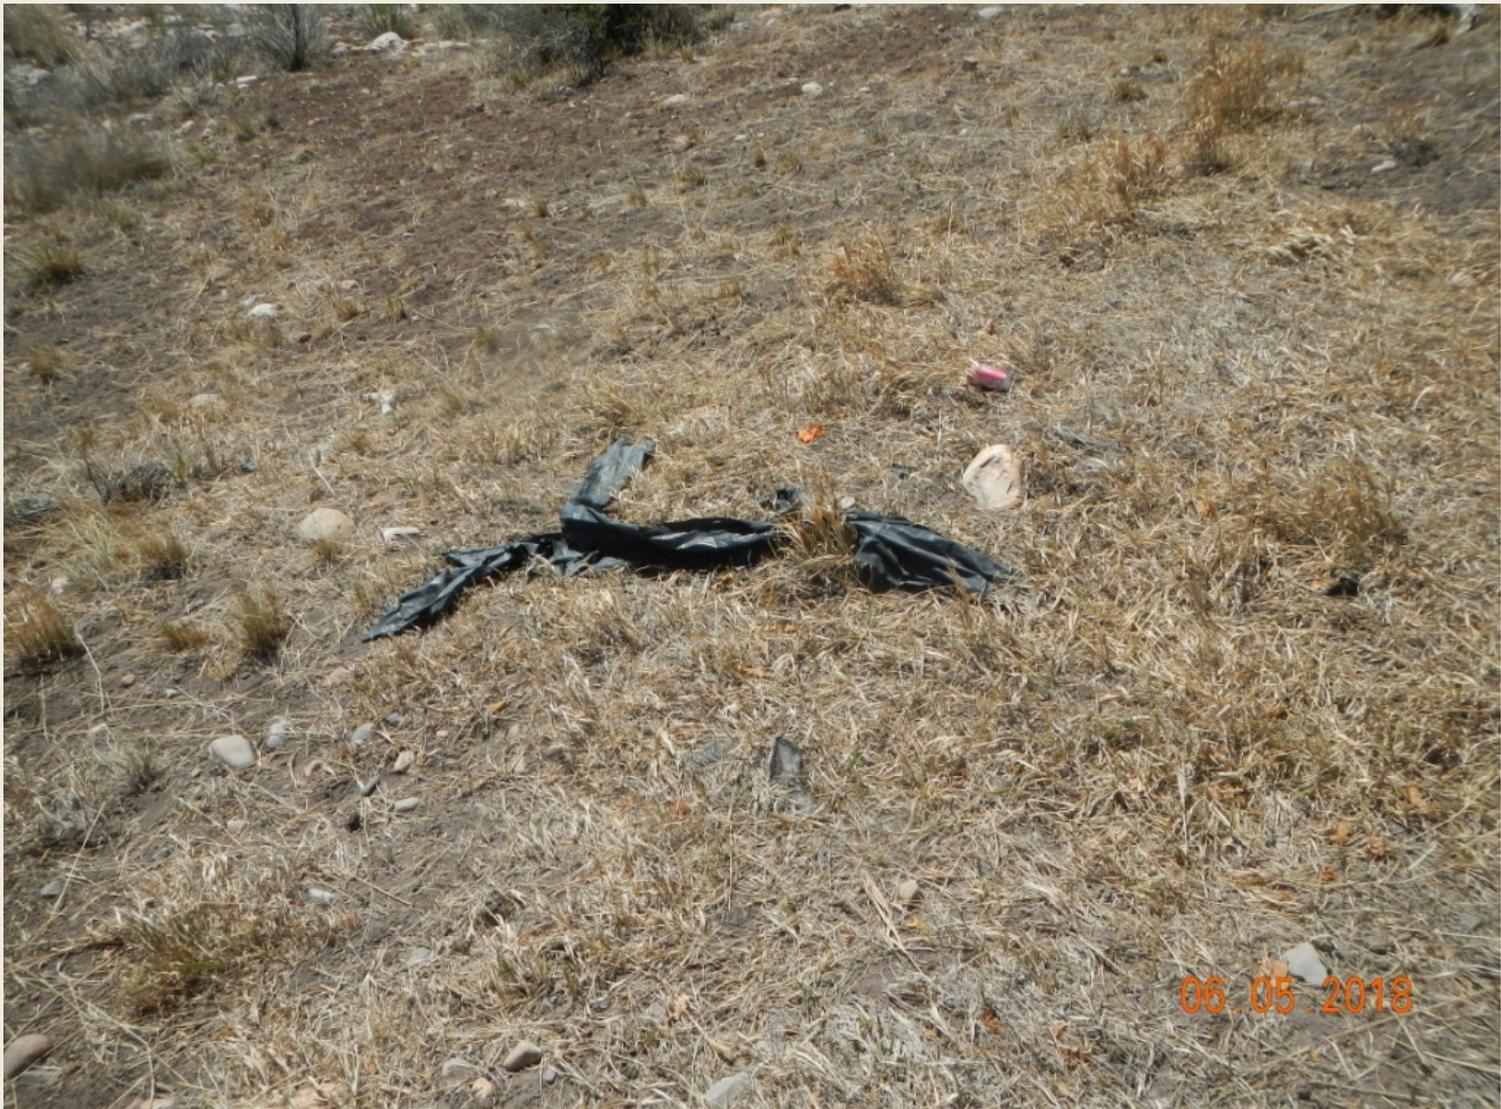
Photo 4. View of liner debris and trash in the southeastern project area.

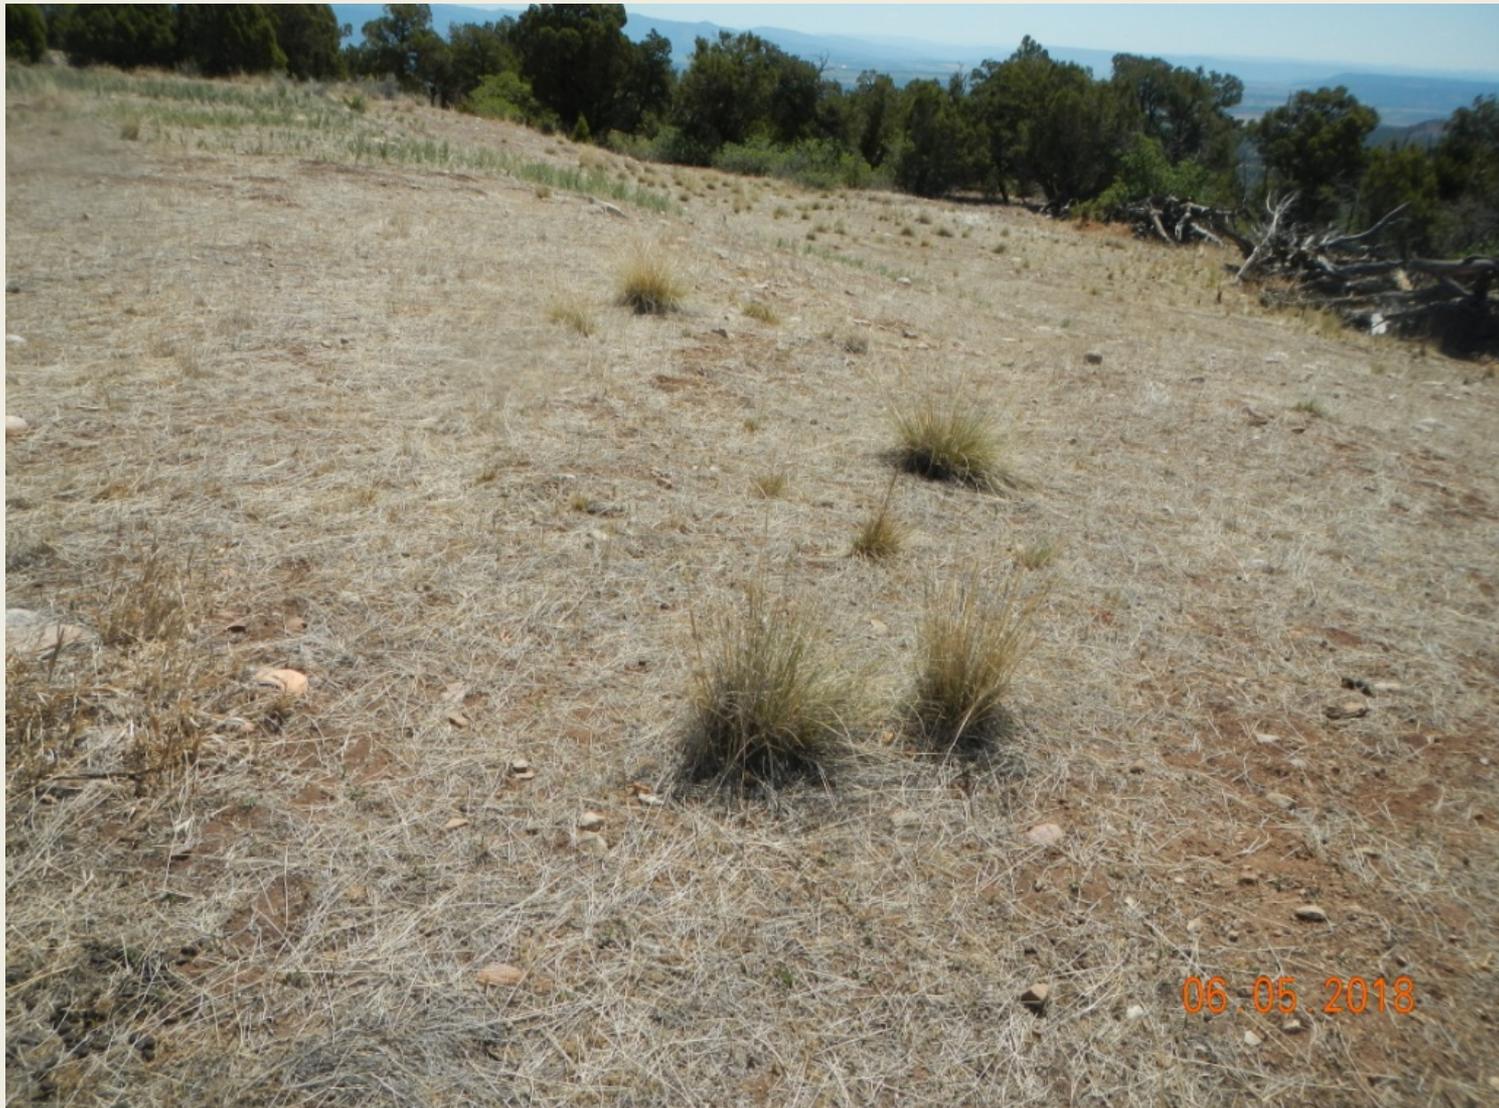
Photo 5. View of the southern portion of the project area from the southwestern edge facing southeastward.

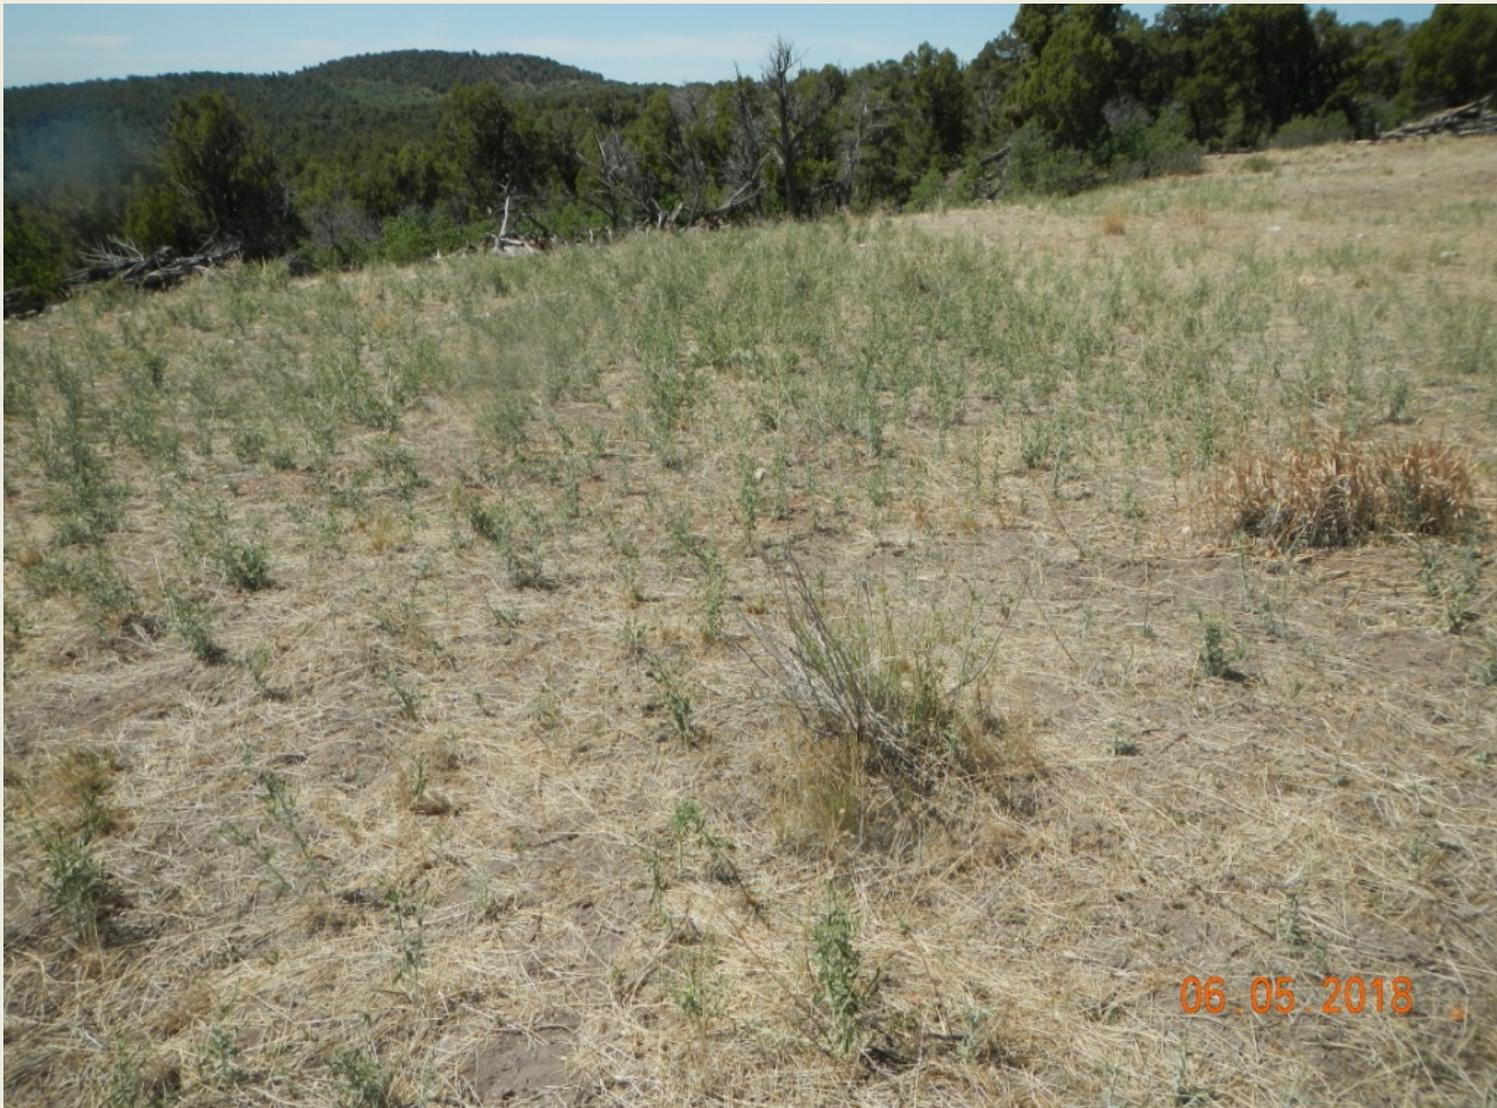
Photo 6. View of Russian knapweed (*Rhaponticum repens*) infestation in the southern portion of the project area.
