Inspection Photos

Operator: WIEPKING-FULLERTON ENERGY LLC -
96340

Location ID: 436744

Inspection Doc. Number: 682503516
Lincoln County, CO

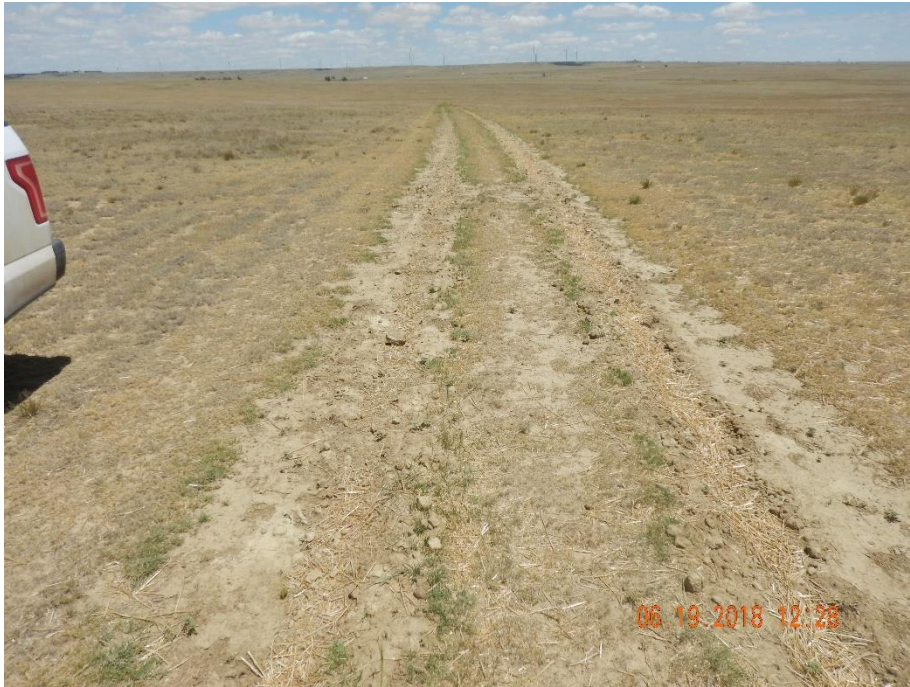
Photo 1: Photo taken from the access road, facing northeast. Photo shows no additional work appears to have been conducted since the previous inspection; it appears a two-pronged ripper only cut through areas of the ruts within the road. Compaction alleviation does not appear to have been conducted in accordance to reclamation requirements. **Compaction concerns remain on access road.**

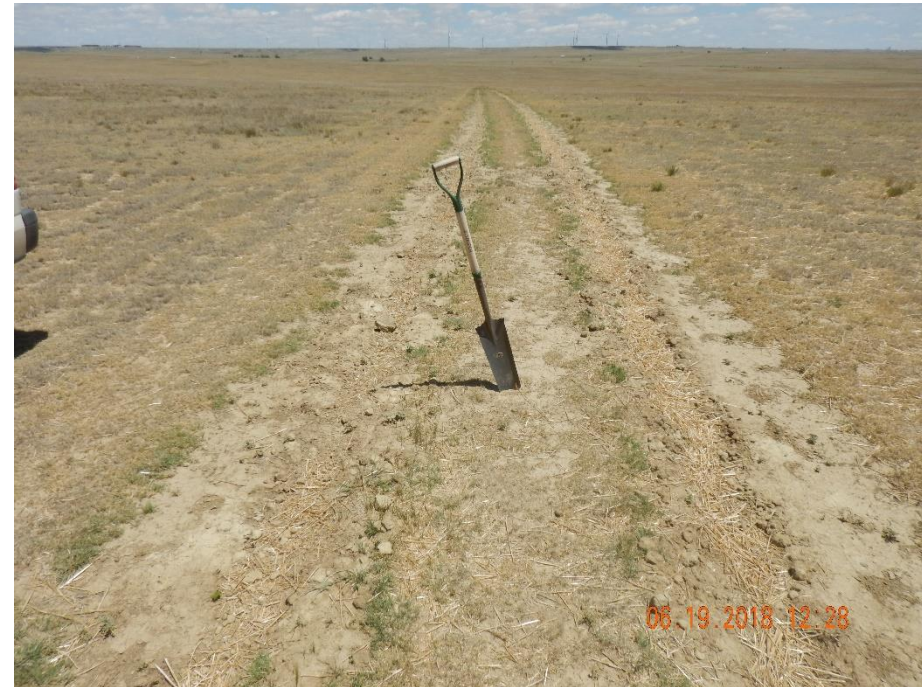
Photo 2: Photo taken from the access road, facing northeast. Photo shows inspector tested the access road for compaction concerns. Photo shows soils **OUTSIDE** the areas of the ruts, where a ripper **DID NOT** pass through, were difficult to penetrate; inspector was only able to easily penetrate the top couple inches of soil. Compaction concerns remain evident.

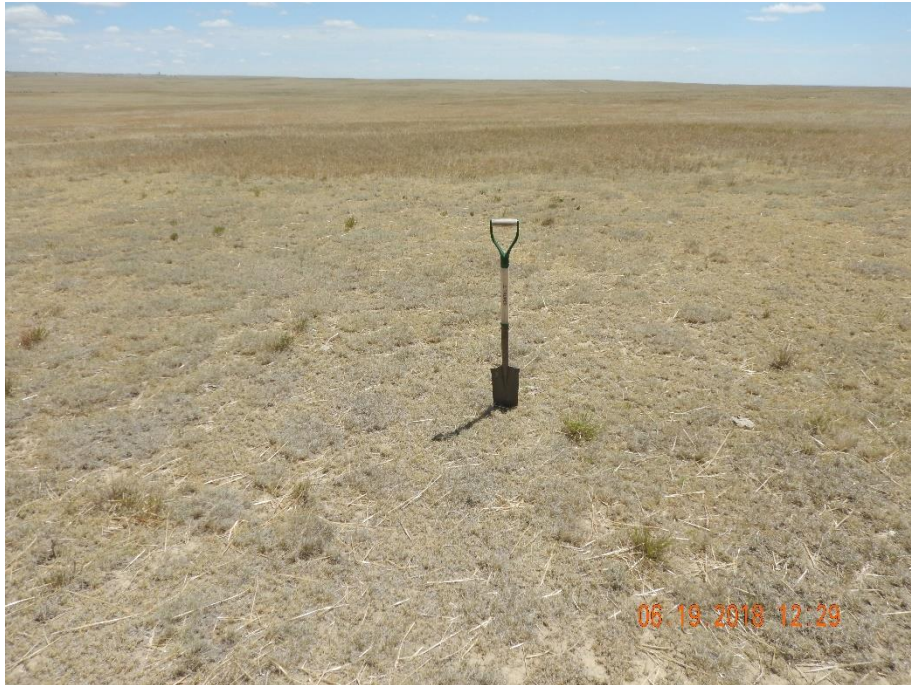
Photo 3: Photo taken from the adjacent reference area. Photo shows inspector was able to easily penetrate the soils in the reference area.

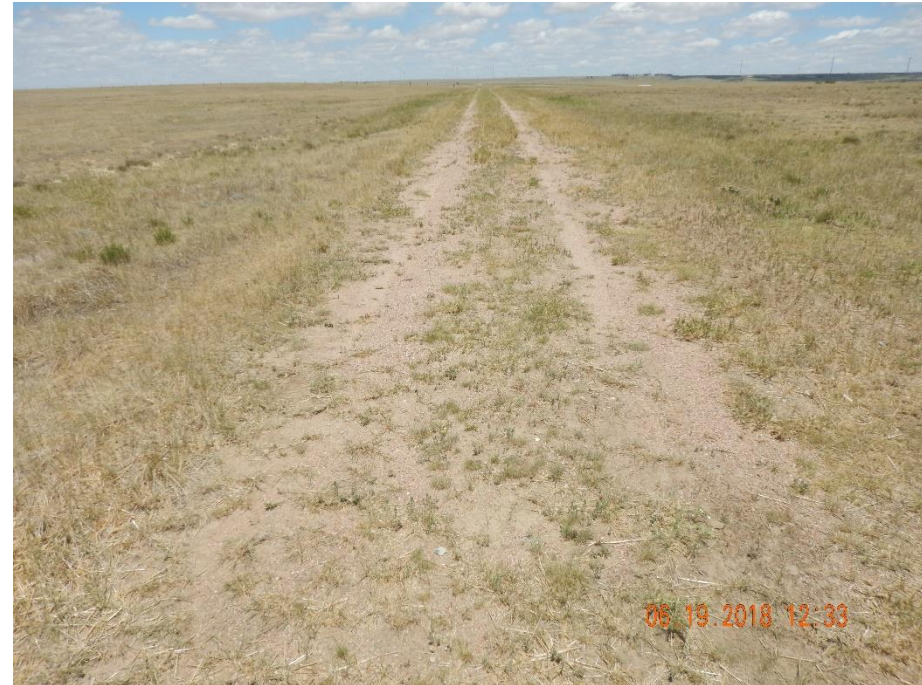
Photo 4: Photo taken from the northern portion of the access road. Photo shows portion of access road where no reclamation activities appear to have been conducted; gravel remains on road, access road has not been re-contoured, re-graded or had compaction alleviation conducted.

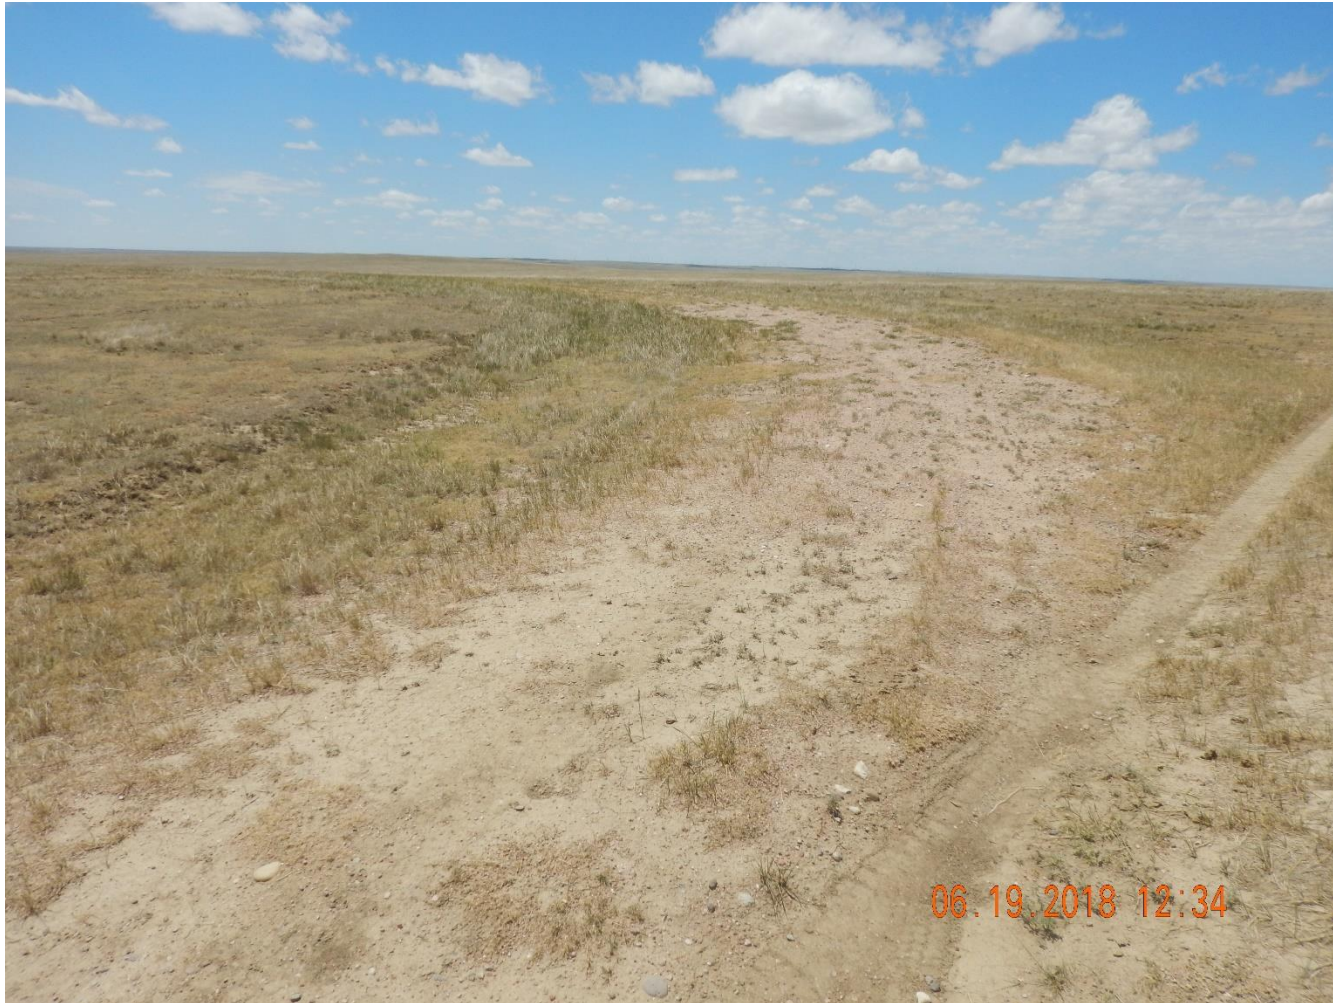
Photo 5: Photo taken from the area where the north section of access road joins the east/west ranch road, facing southwest. Photo shows portion of access road where no reclamation activities appear to have been conducted; gravel remains on road, access road has not been re-contoured, re-graded or had compaction alleviation conducted.
