Inspection Photos

06/19/2018

Operator: CASCADE PETROLEUM LLC - 10414

Location ID: 439341

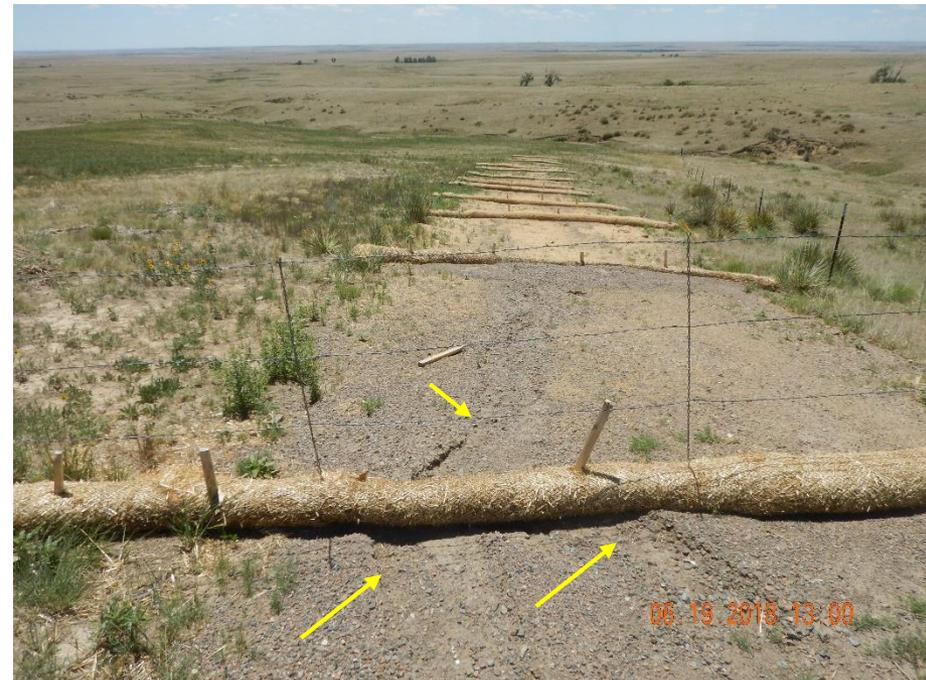
Photo 2: Photo taken from the location entrance, facing south. Photo shows straw wattles have been installed on location. Photo shows wattles do not appear to have been installed in accordance to good engineering practices, and have not been entrenched and backfilled; wattles have been placed directly upon the soil surface. As a result, stormwater erosion and degradation has continued on the location, and is cutting beneath the new wattles (yellow arrow).

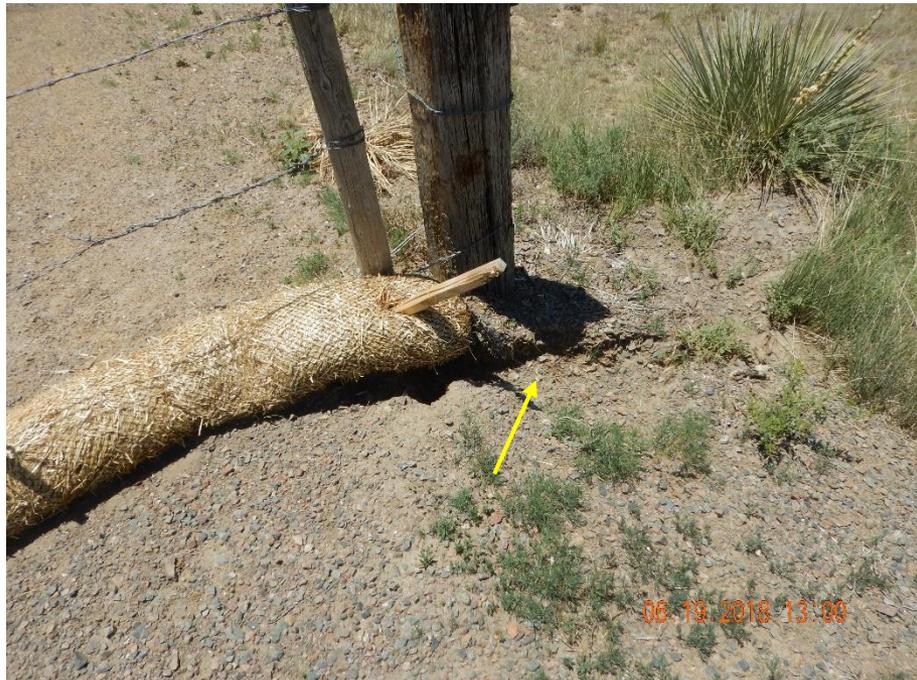
Photo 3: Photo taken from the entrance of the location. Photo shows stormwater erosion is now occurring at entrance.

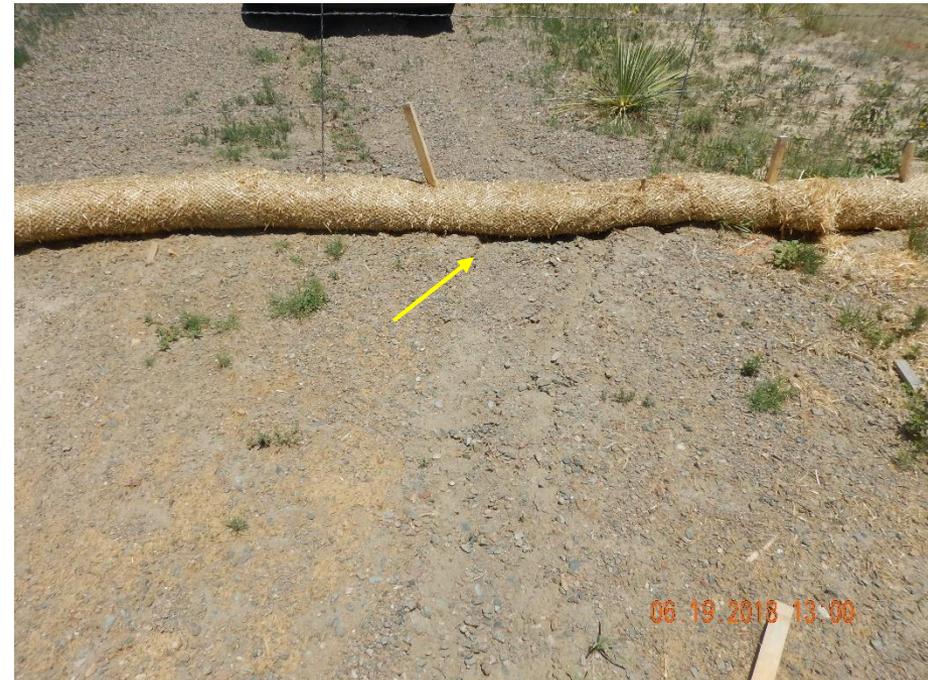
Photo 4: Photo taken from the northwest end of the location, facing north. Photo shows straw wattles have been installed on location. Photo shows wattles do not appear to have been installed in accordance to good engineering practices, and have not been entrenched and backfilled; wattles have been placed directly upon the soil surface. As a result, stormwater erosion and degradation has continued on the location, and is cutting beneath the new wattles (yellow arrow). Photo also shows gravel has not been removed from the western end of the pad as indicated by the FIRR.

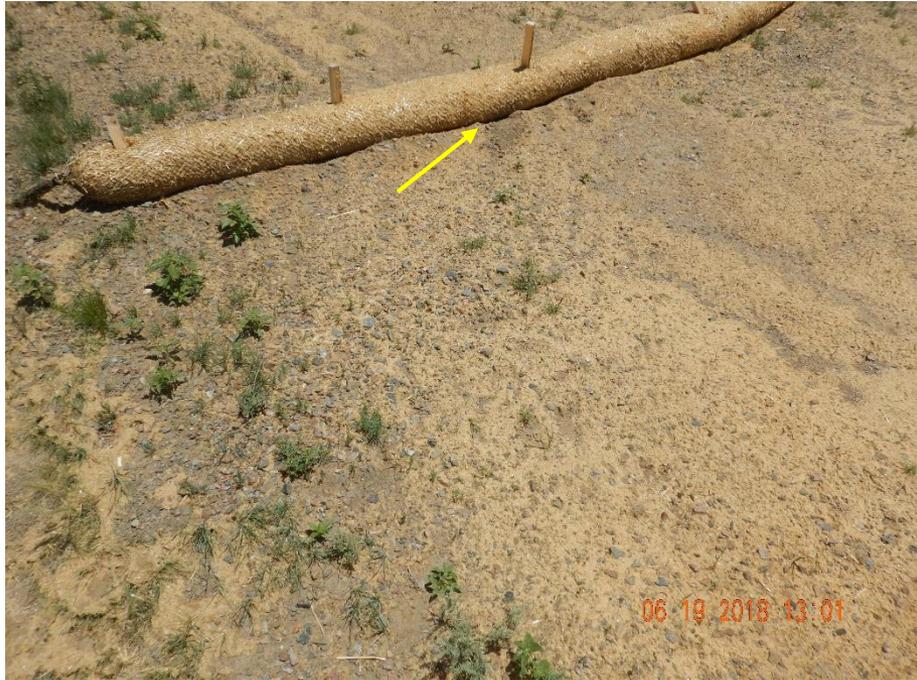
Photo 5: Photo taken from the northwest end of the location. See comments under photo 4.

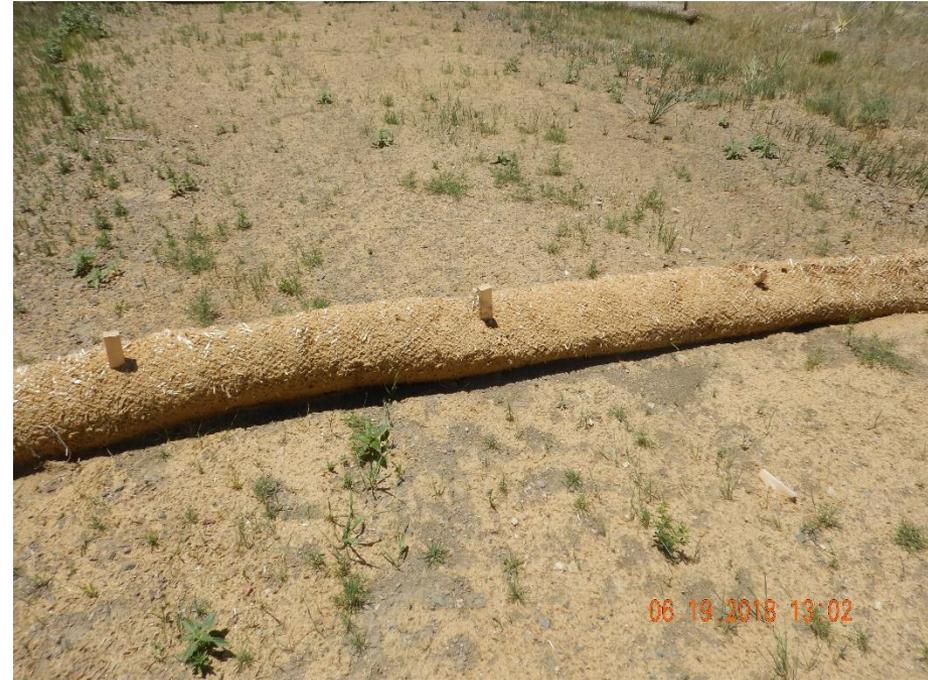
Photo 6: Photo taken from the northwest end of the location. See comments under photo 4.

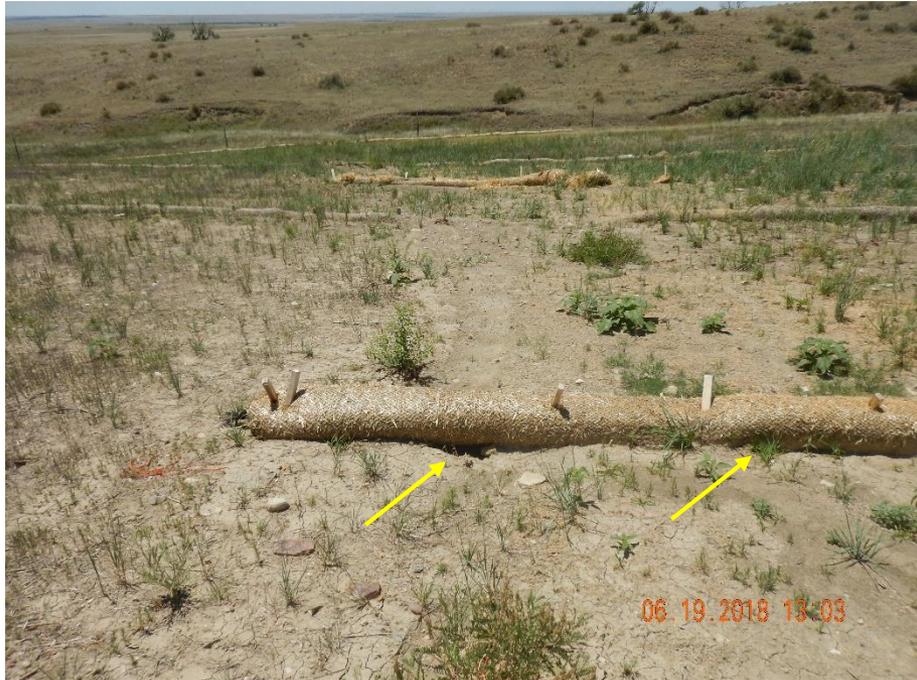
Photo 7: Photo taken from the south end of the location, facing south. See comments under photo 4.

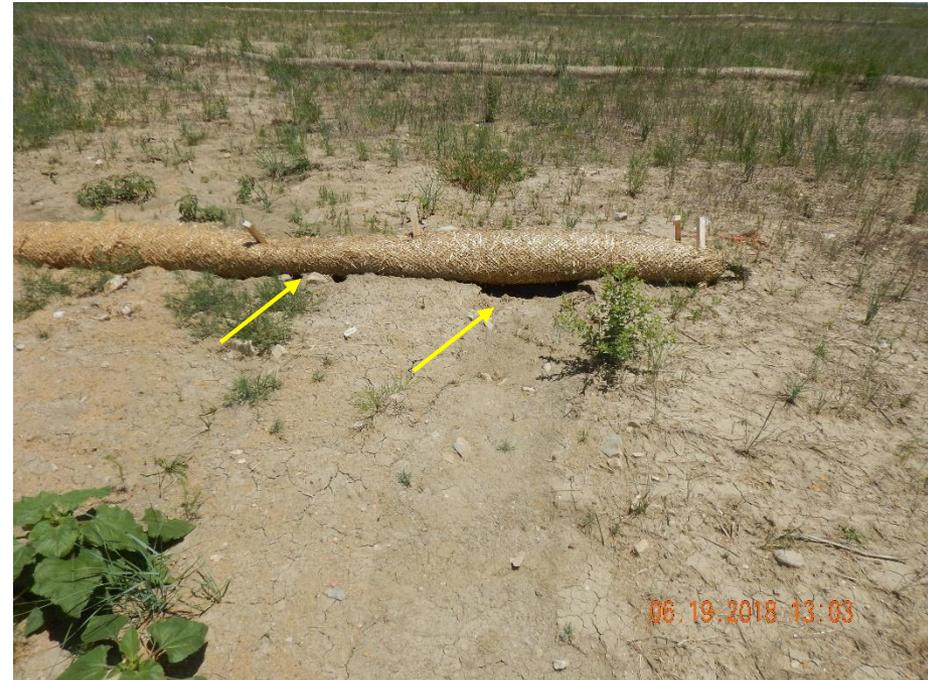
Photo 8: Photo taken from the south end of the location, facing north. See comments under photo 4.

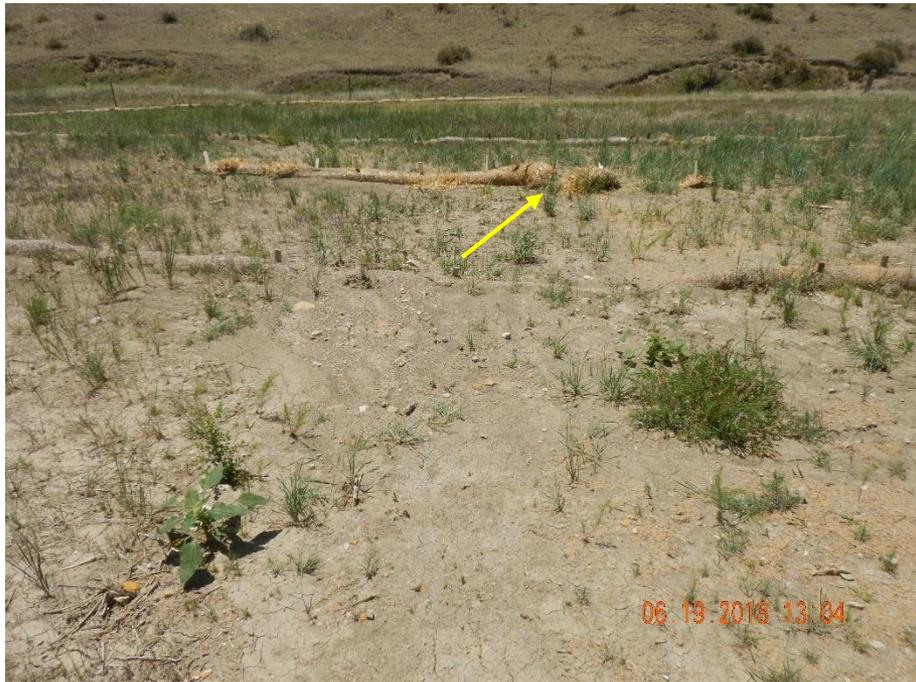
Photo 9: Photo taken from the south end of the location facing south. Photo of stormwater sediment deposition. Photo also shows newer straw wattle in disrepair.

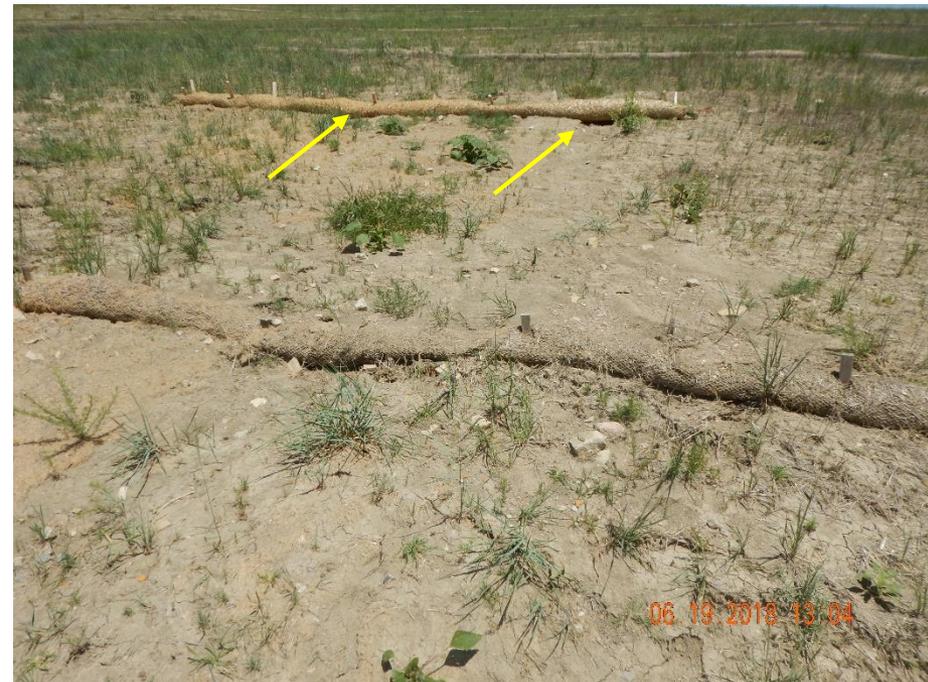
Photo 10: Photo taken from the south end of the location facing south. Photo shows straw wattles have been installed on location. Photo shows wattles do not appear to have been installed in accordance to good engineering practices, and have not been entrenched and backfilled; wattles have been placed directly upon the soil surface. As a result, stormwater erosion and degradation has continued on the location, and is cutting beneath the new wattles (yellow arrow).

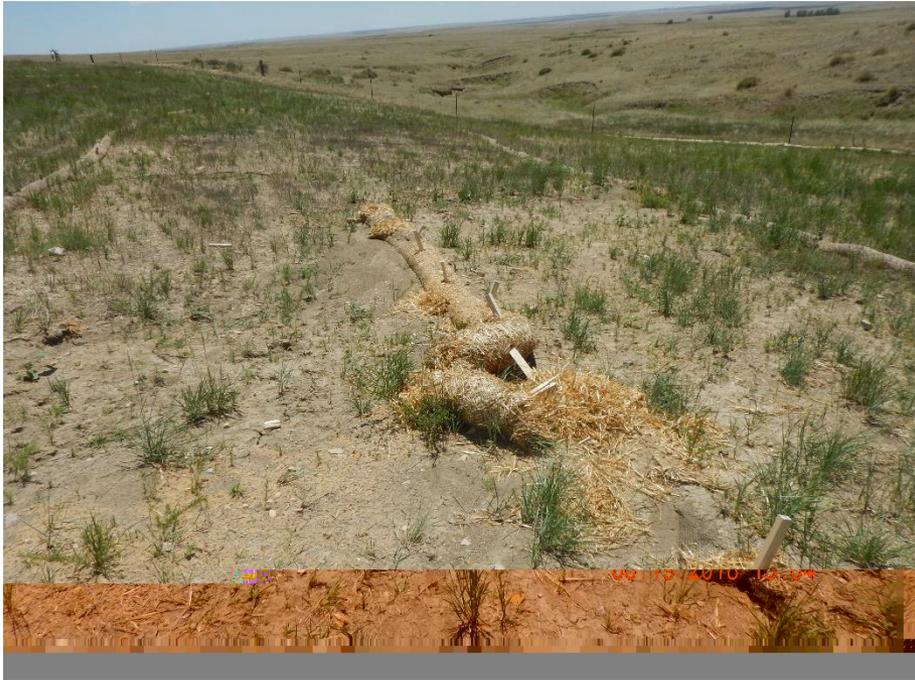
Photo 11: Photo taken from the south end of the location, facing southeast. Photo of straw wattle in disrepair.

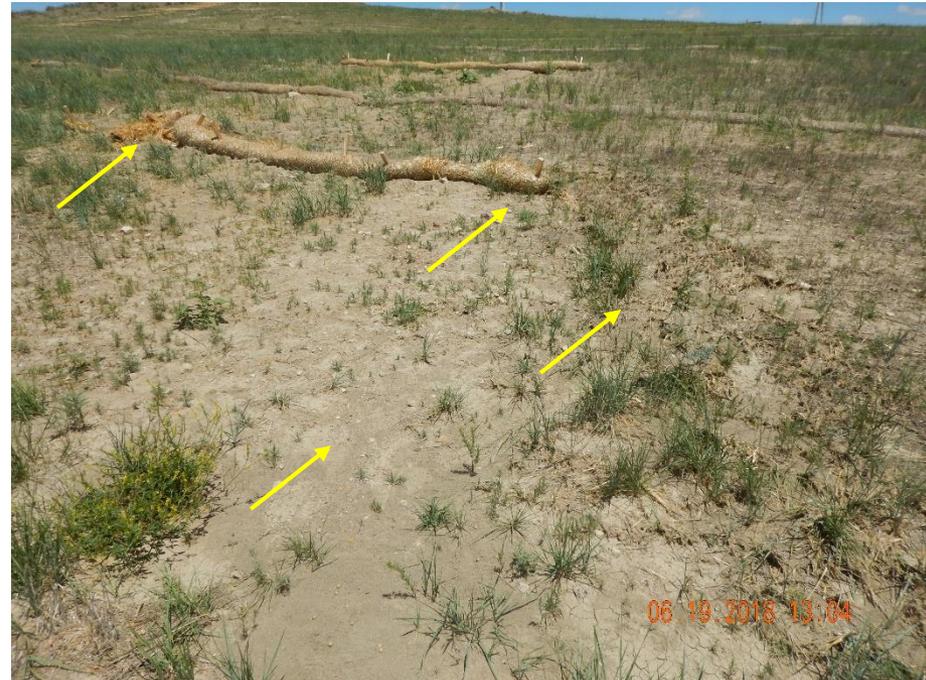
Photo 12: Photo taken from the south end of the location, facing north. Photo shows straw wattle BMP in disrepair, and stormwater erosion degradation.

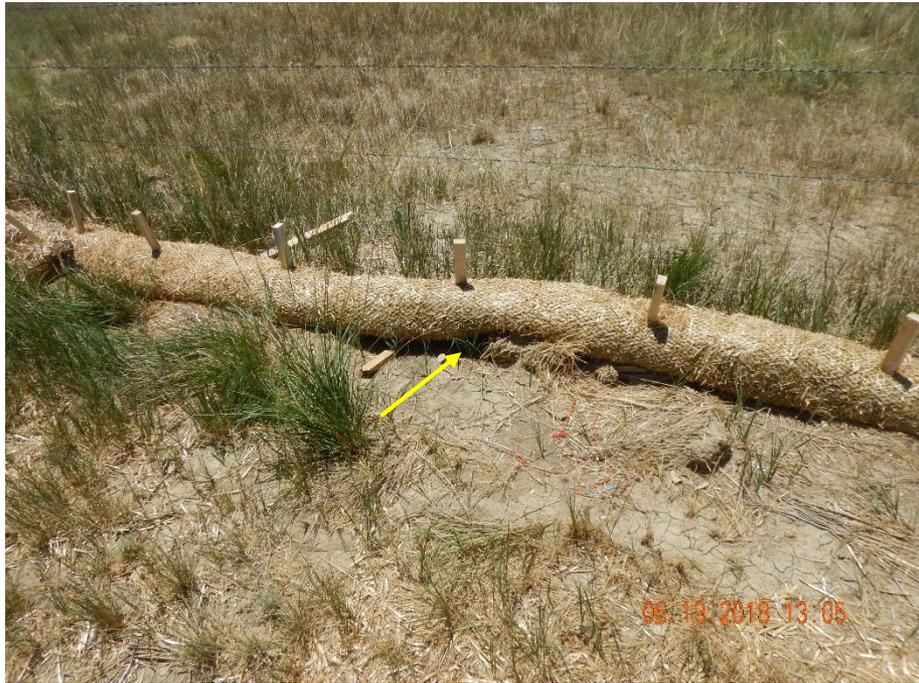
Photo 13: Photo taken from the southern perimeter of the location. See comments under photo 10.

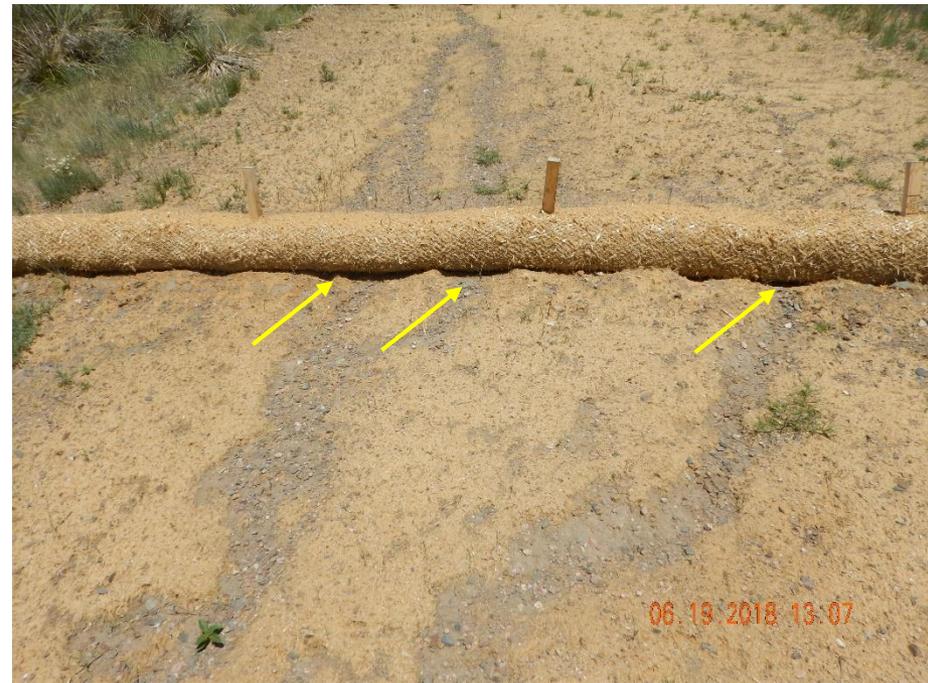
Photo 14: Photo taken from the west end of the location, facing north. See comments under photo 10.

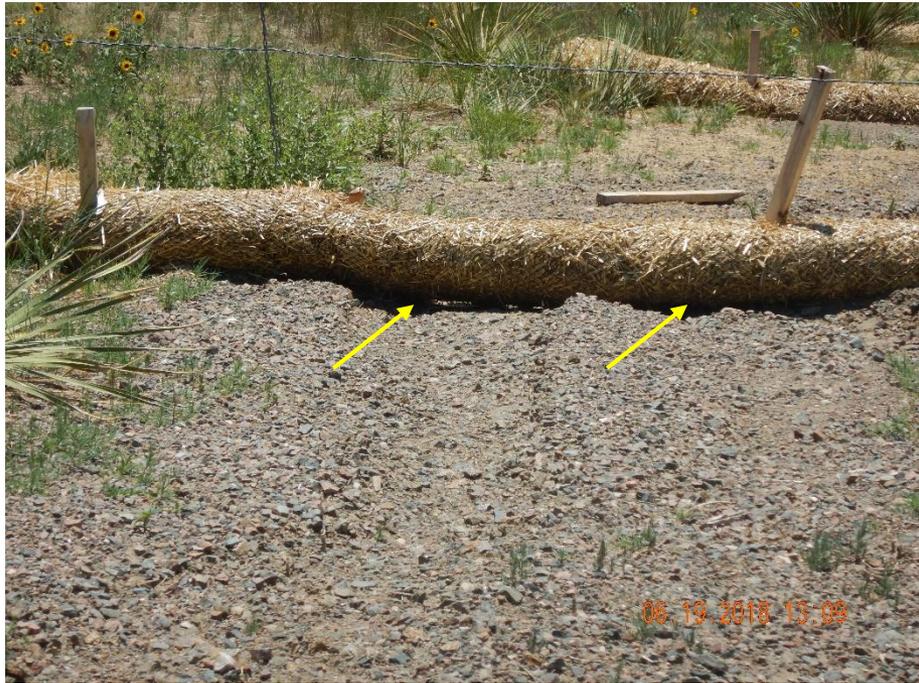
Photo 15: Photo taken from the northwest end of the location, facing south. See comments under photo 10.

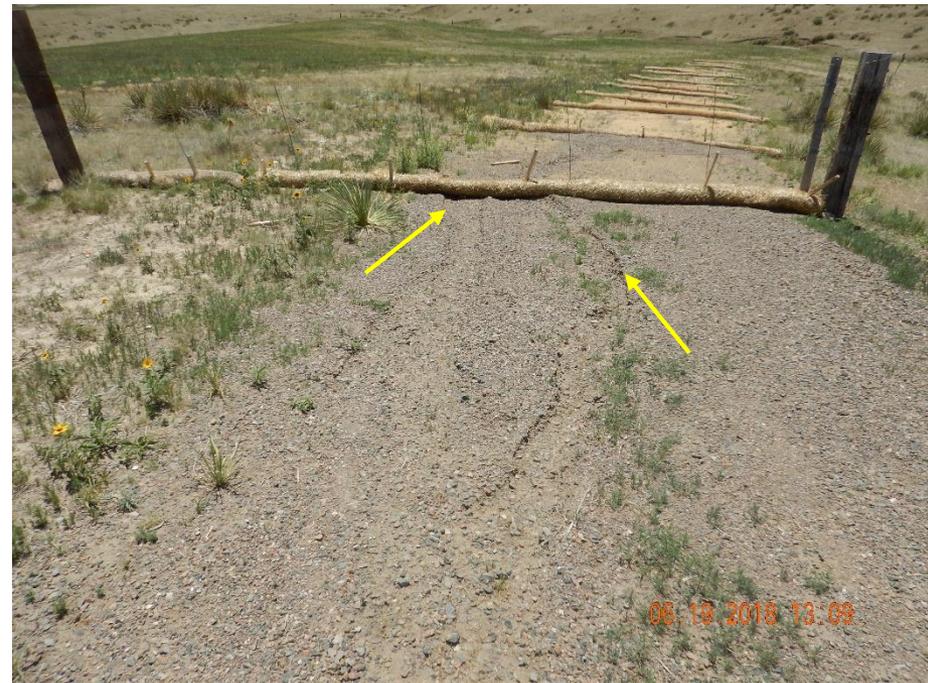
Photo 16: Photo taken from the northwest end of the location, facing south. See comments under photo 10. Photo also shows erosion degradation along access road, and that access road has not been reclaimed.

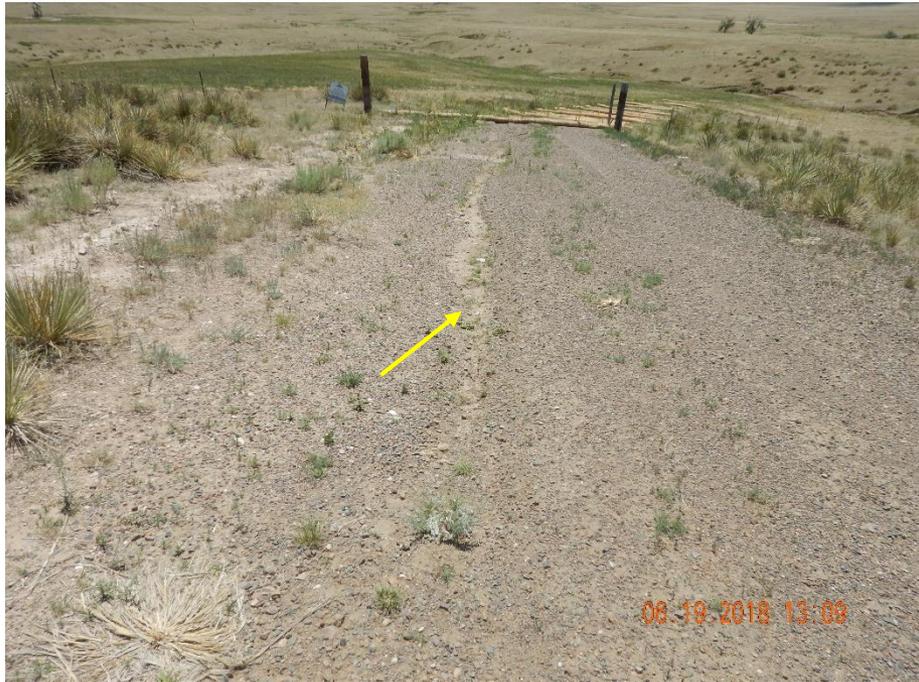
Photo 17: Photo taken from the access road, north of the location, facing south. Photo shows erosion degradation along access road, and that access road has not been reclaimed.

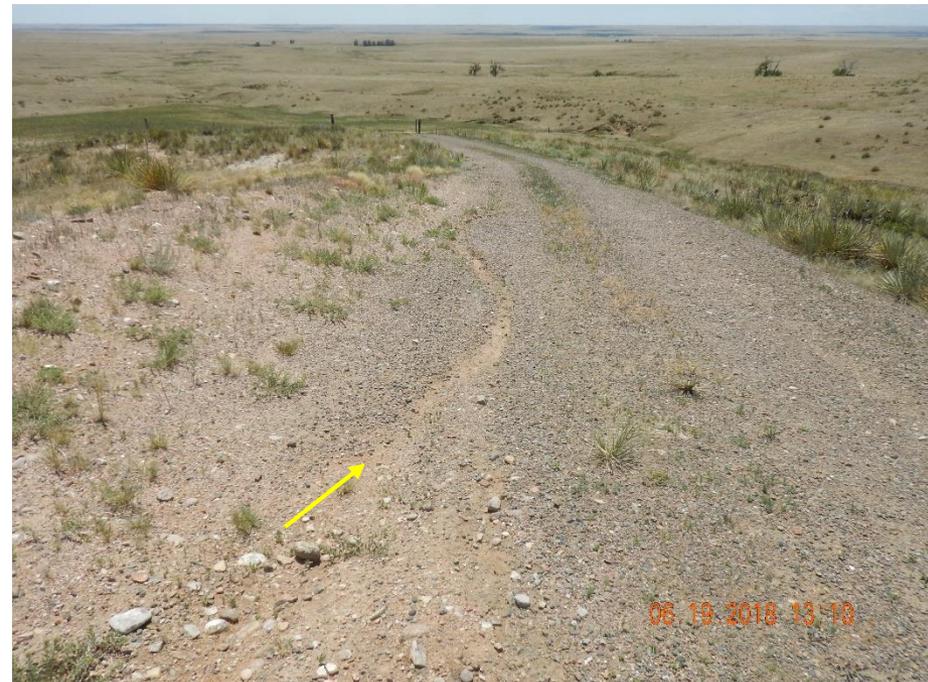
Photo 18: Photo taken from the access road, north of the location, facing south. Photo shows erosion degradation along access road, and that access road has not been reclaimed.

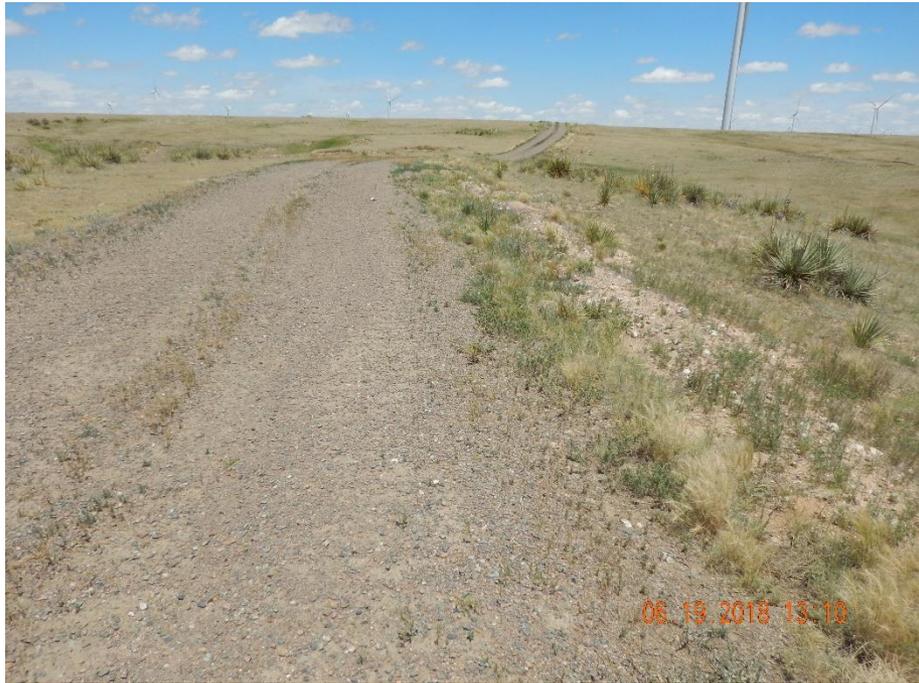
Photo 19: Photo taken from the access road, facing north. Photo shows access road has not been reclaimed.

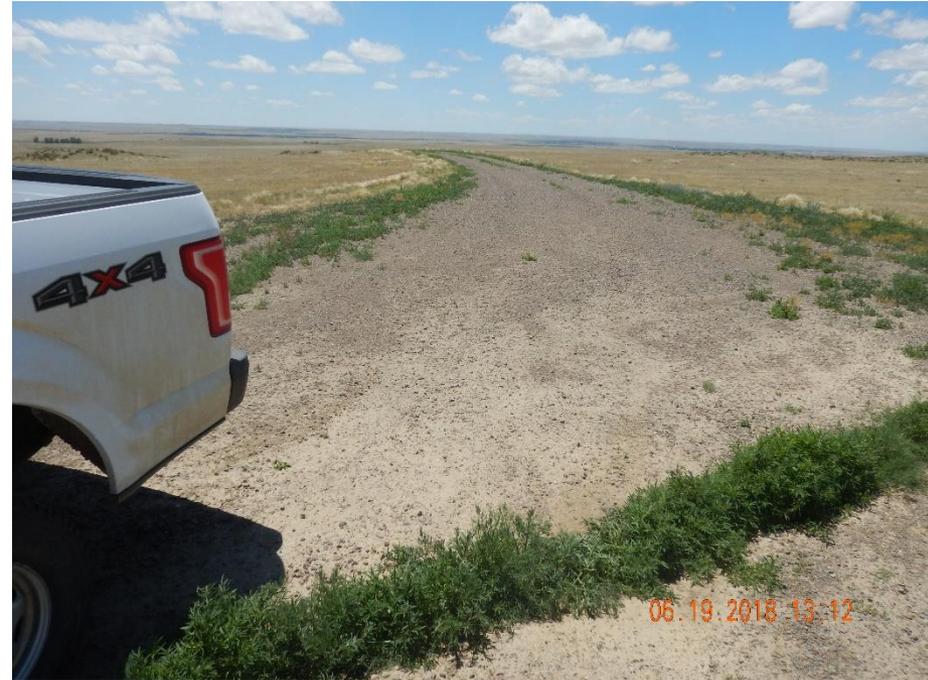
Photo 20: Photo taken from the access road entrance, facing south. Photo shows access road has not been reclaimed.
