Final Reclamation Inspection

Operator: KERR MCGEE OIL & GAS ONSHORE LP #47120

API: 05-123-16156

Inspection Photos
Location Name: SHAW #12-29A
API: 05-123-16156

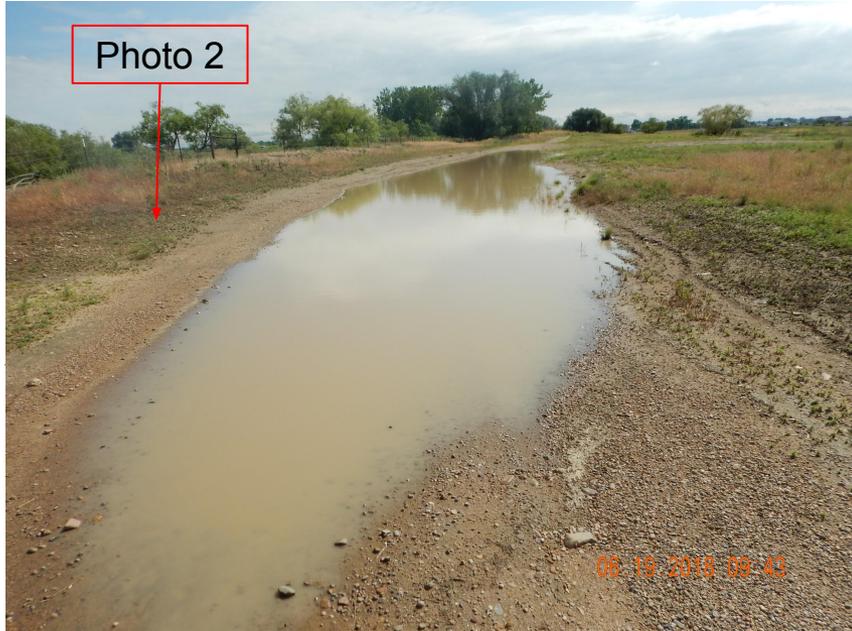
Photo 1. Photo taken from a portion of the access road, facing East. Photo illustrates an area of pooled water just west of the well location. Staff could not inspect this area of the access road for ruts. Staff did not drive past this point during the inspection.

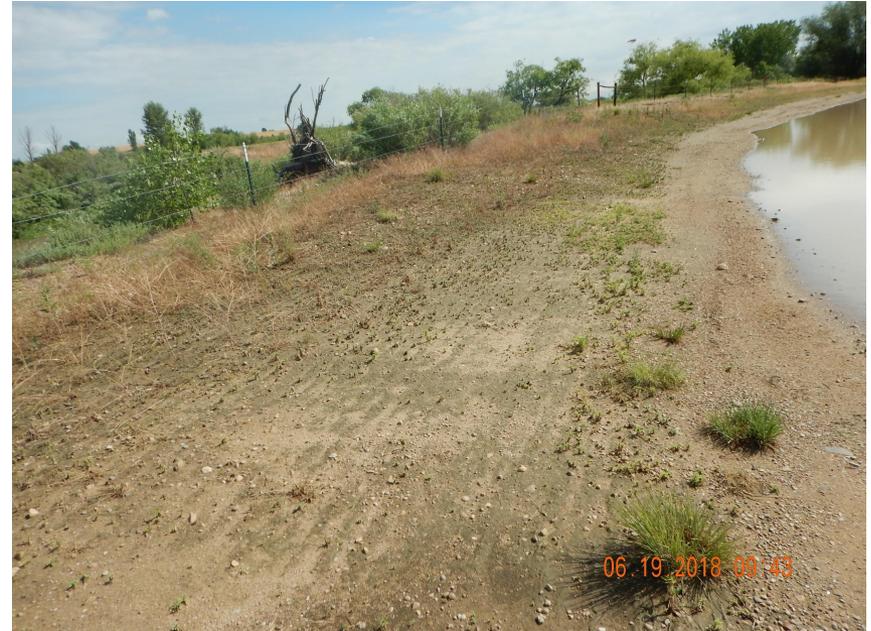
Photo 2. Photo taken from a portion of the northern access road, facing East. Appears a seeding attempt was performed by the evidence of drill rows. Operator may need to perform additional reclamation work as there did not appear to be uniform germination. Operator shall comply with Rule 1004 standards throughout all disturbance areas.

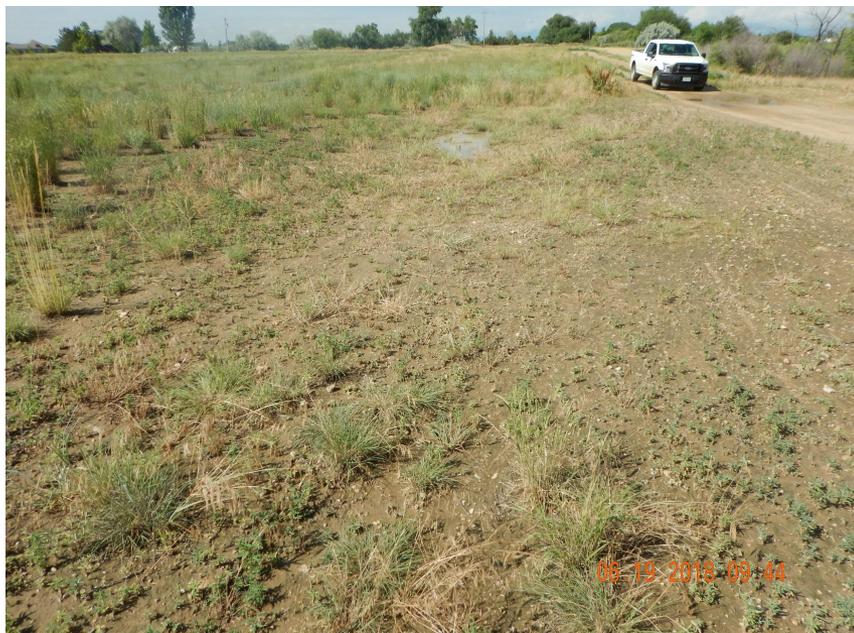
Photo 3. Photo taken from a portion of the southern access road, facing West. See comments under Photo 2. Also, Kochia weeds were observed throughout portions of the disturbance area. Operator shall control and manage Kochia until the location meets Rule 1004 standards.

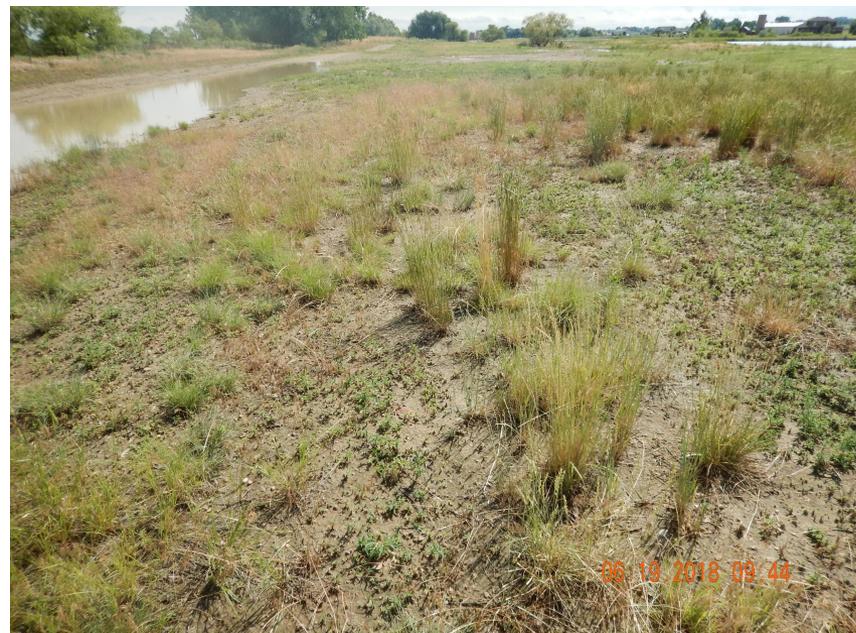
Photo 4. Photo taken from a portion of the southern access road, facing East. See comments under Photo 3.

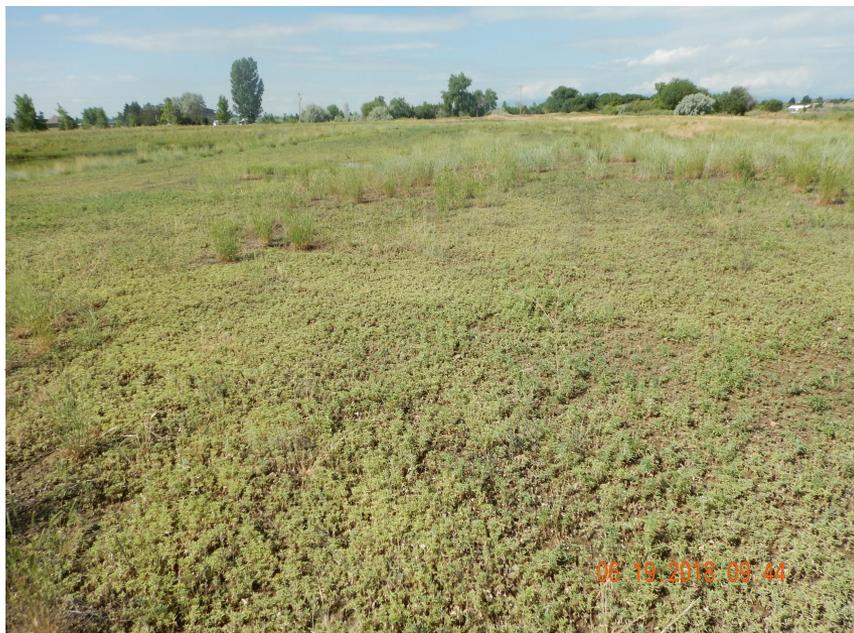
Photo 5. Photo taken just west of the well location, facing West. Photo illustrates Kochia rosette weeds (lower growing vegetation). See comments under Photo 3.

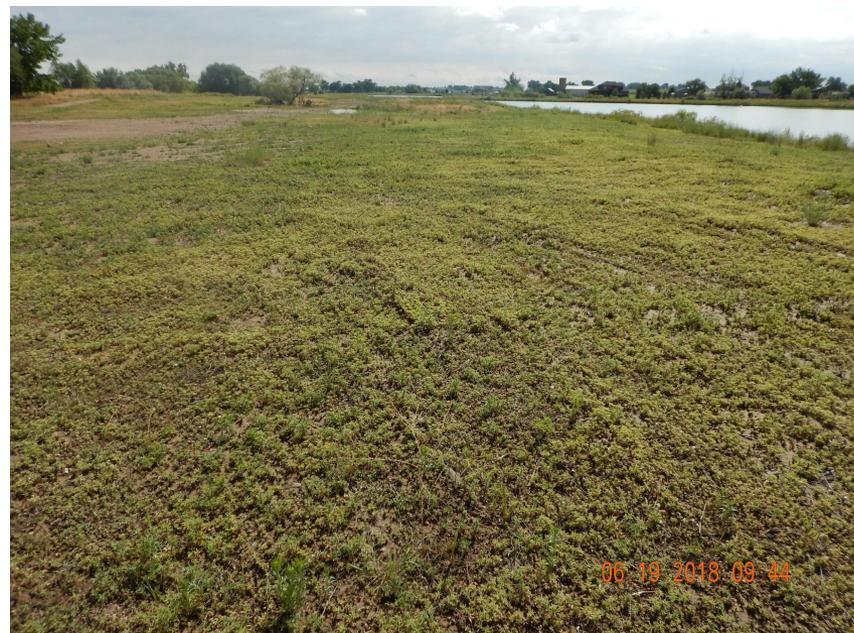
Photo 6. Photo taken just west of the well location, facing East. Photo illustrates Kochia rosette weeds (lower growing vegetation). See comments under Photo 3.

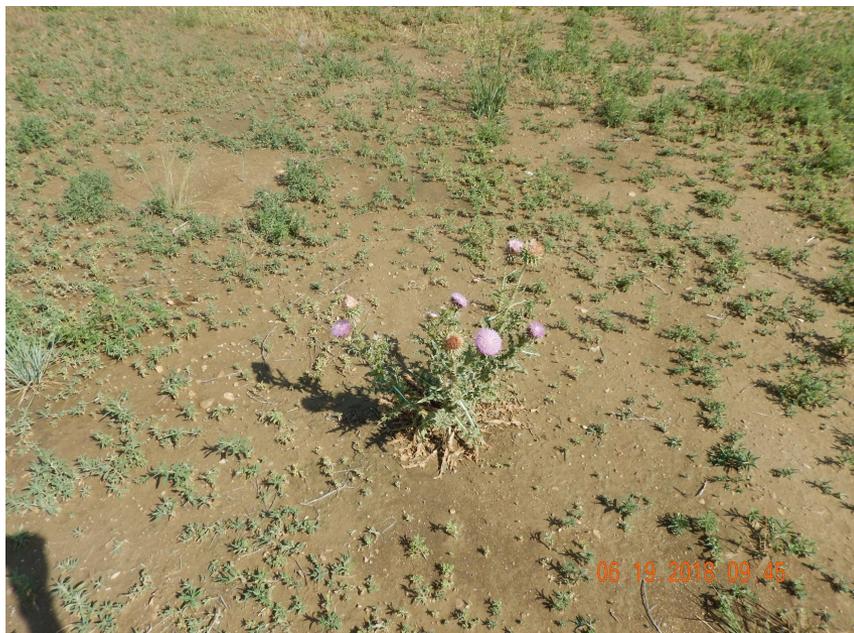
Photo 7. Photo taken near the well location. Photo illustrates Musk thistle, a List B Colorado noxious weed. Operator shall control and manage all List B Colorado noxious weeds. Staff only observed a few Musk and Scotch thistle plants. Scotch thistle is also a List B Colorado noxious weed.

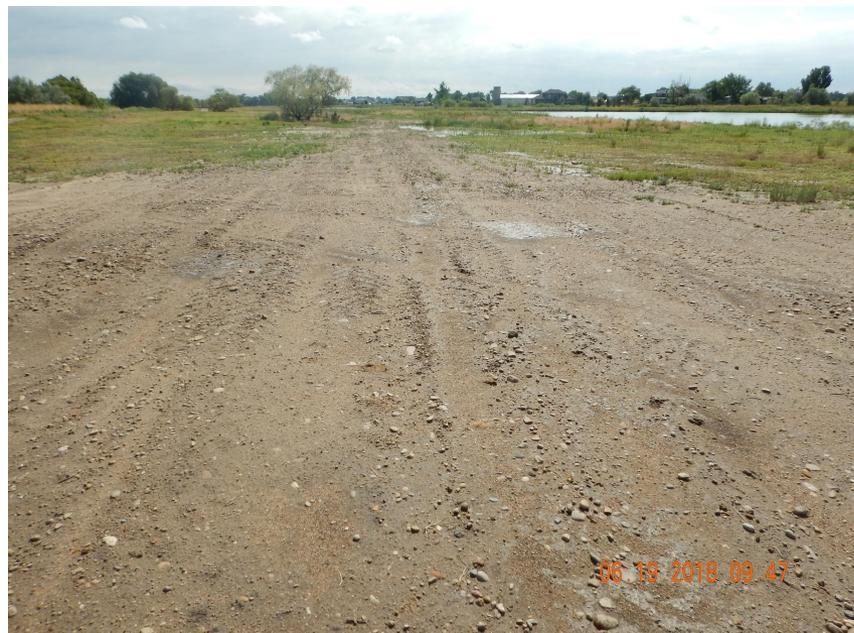
Photo 8. Photo taken from the well location, facing East. Photo illustrate a disturbance area from the well location and the removal of a flowline. Operator shall comply with Rule 1004 standards throughout all disturbance areas. No surface equipment was observed at the well location.

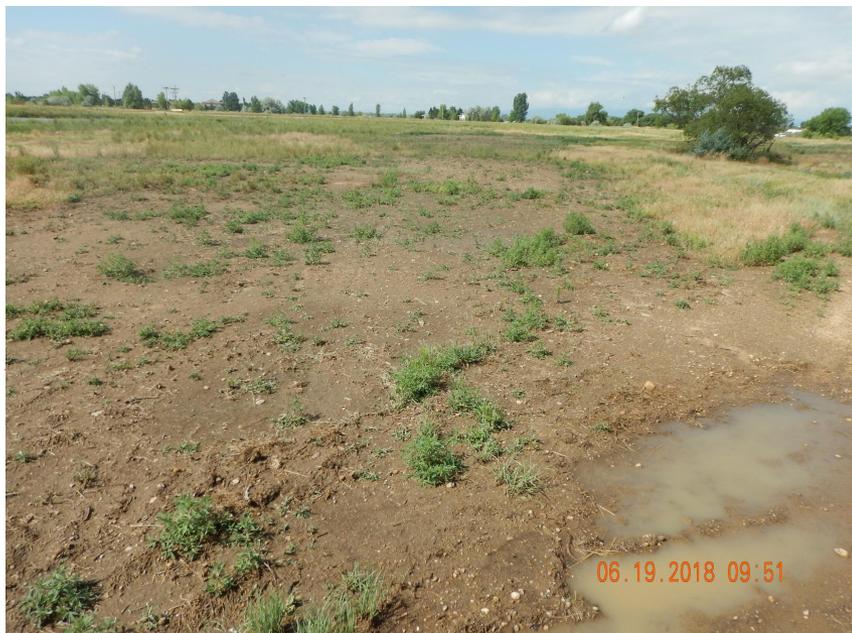
Photo 9. Photo taken from a portion of the flowline disturbance area at the interaction of the access road, facing West. See comments under Photos 3 & 8.

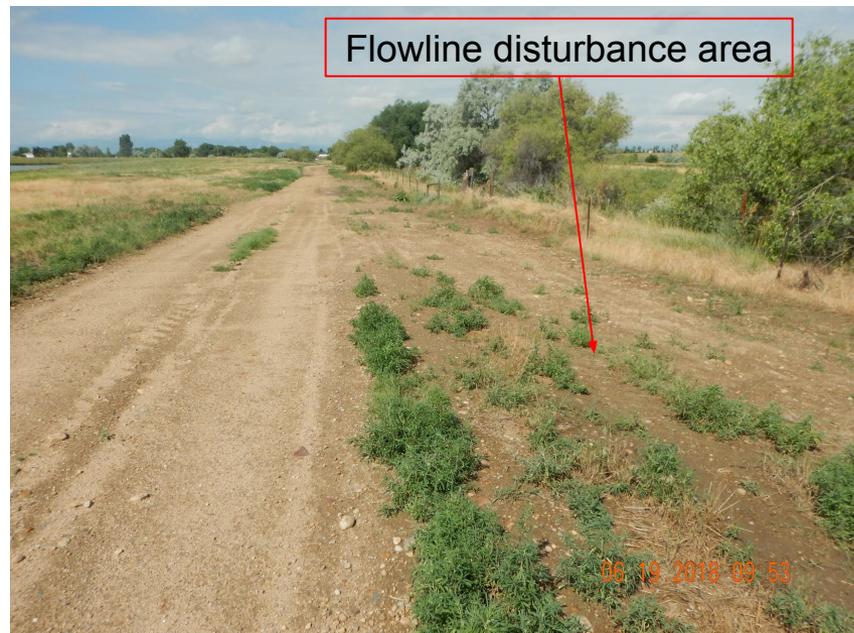
Photo 10. Photo taken from a portion of the northern access road, facing West. See comments under Photos 3 & 8.

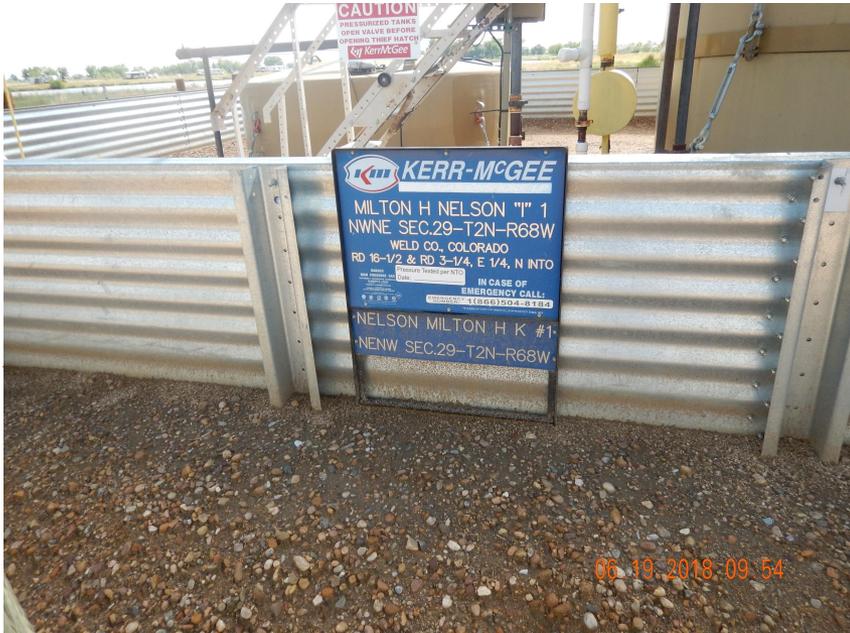
Photo 11. Photo taken from the battery location. Battery location is still active a services another nearby well.

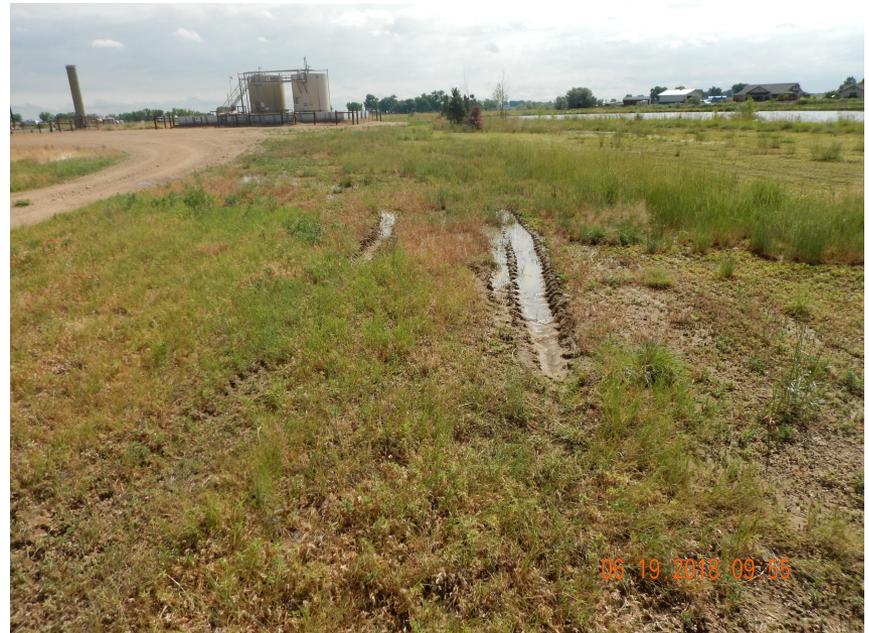
Photo 12. Photo taken from a portion of the southern access road, facing East. Per Rule 1002.e.(4), Operator shall minimize disturbances and shall not travel outside of the original access road boundary. Appears ruts were recently created. Operator shall repair ruts and shall comply with Rule 1004 standards.
