Construction and Stormwater Inspection

June 20, 2018

Operator: BURLINGTON RESOURCES OIL & GAS LP- #26580

Location Name: Arkansas 4-64 3-2

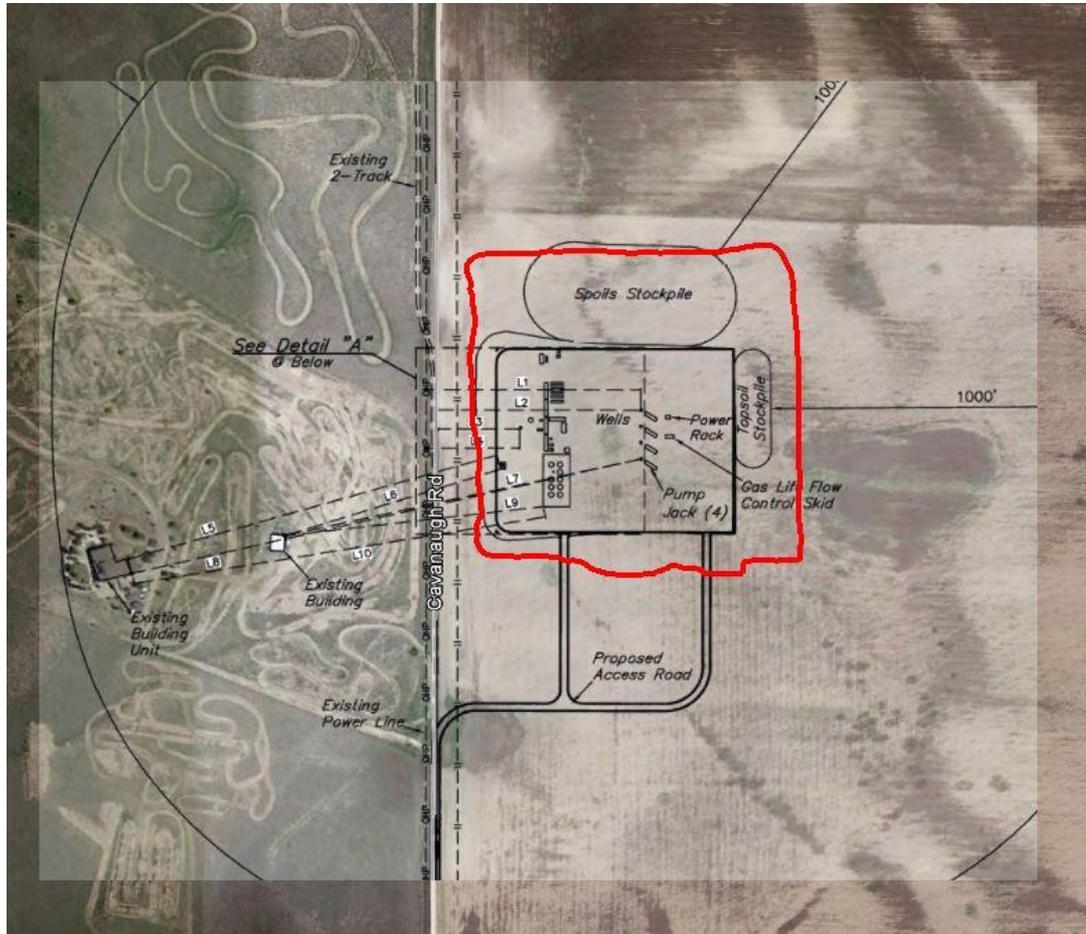
Google Earth aerial imagery taken on 6/9/2017, prior to construction operations. Facility Layout Drawing (Doc. #1010399) has been overlaid with field collected data from 6/20/2018, illustrating the approximate areas that have exceeded the permitted boundary. Field collected data on 6/20/2018, using a Trimble handheld GPS (red line), would indicate total disturbance after construction operations is approximately 13.78 acres. This does not appear to be the approved total permitted disturbance. Appears the Operator may not have accounted for soil stockpile storage areas and stormwater BMP areas for the total disturbance area.

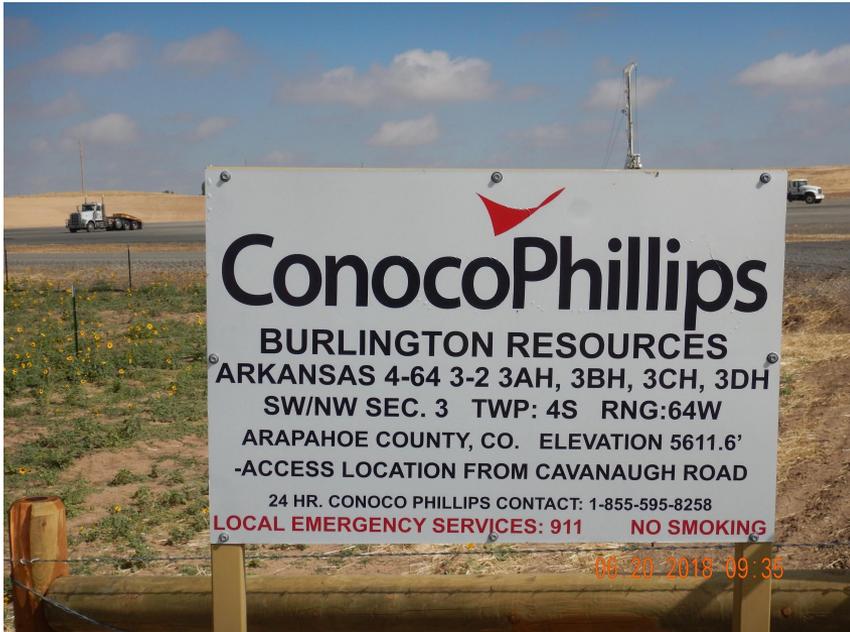
Photo 1. Photo taken from the entrance of location, illustrating the Operator sign.

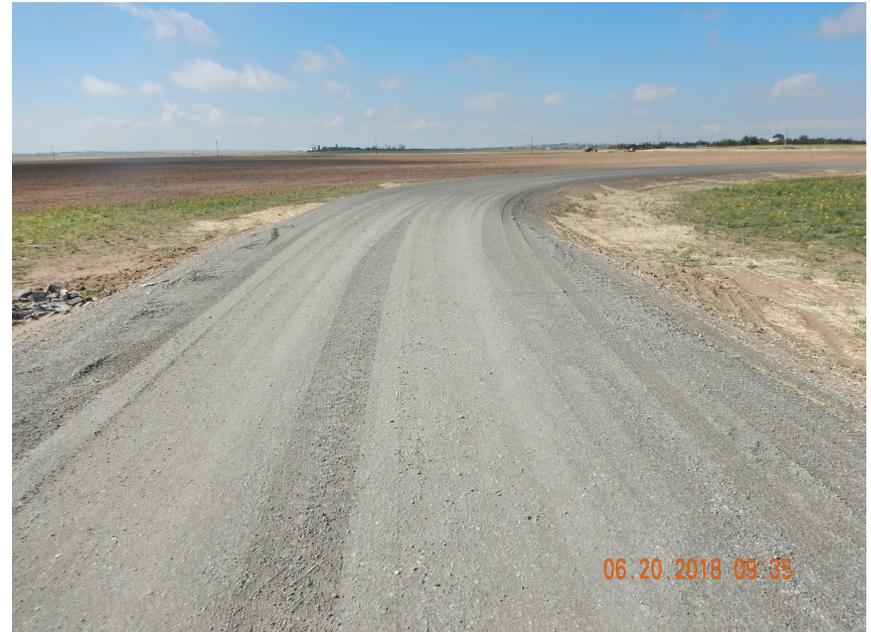
Photo 2. Photo taken from the entrance of location, facing South. Photo illustrates a portion of the access road which has been gravelled.

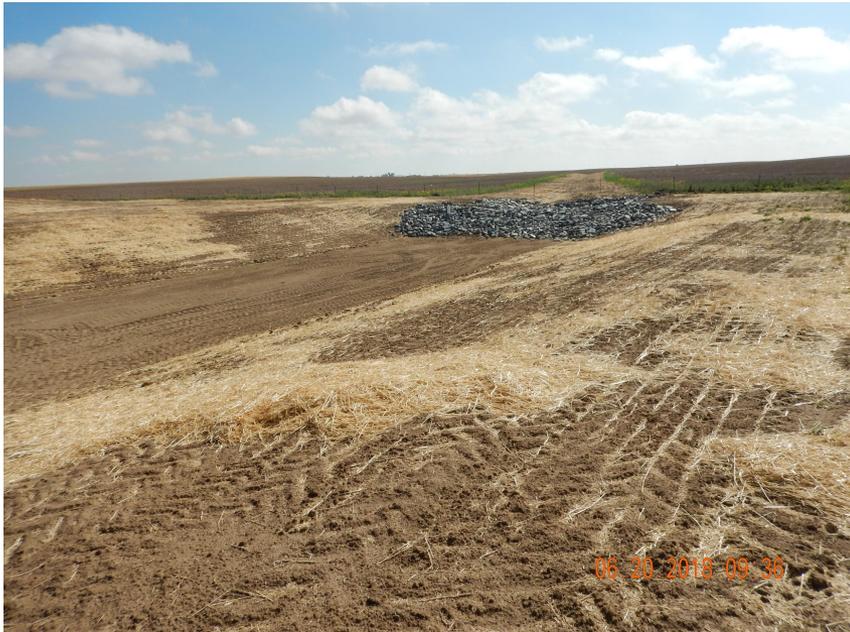
Photo 3. Photo taken from the southeastern perimeter of the location, facing East. Photo illustrates the sediment trap BMP. A ditch BMP has been installed along portion of the perimeter of the location which is directed to this sediment trap. Disturbance areas have been mulched and crimped, and appear to be seeded. Crimped mulch does not appear to be crimped along portions.

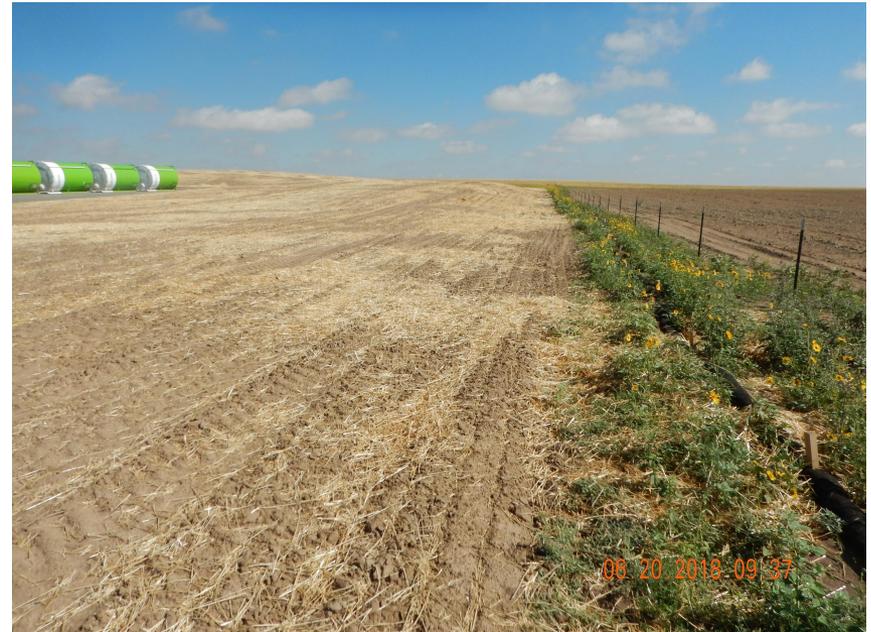
Photo 4. Photo taken from the southeastern perimeter of the location, facing North. Filtrex wattle has been installed along portions of the perimeter of the location. Topsoil appears to be stored along the eastern perimeter of the location.

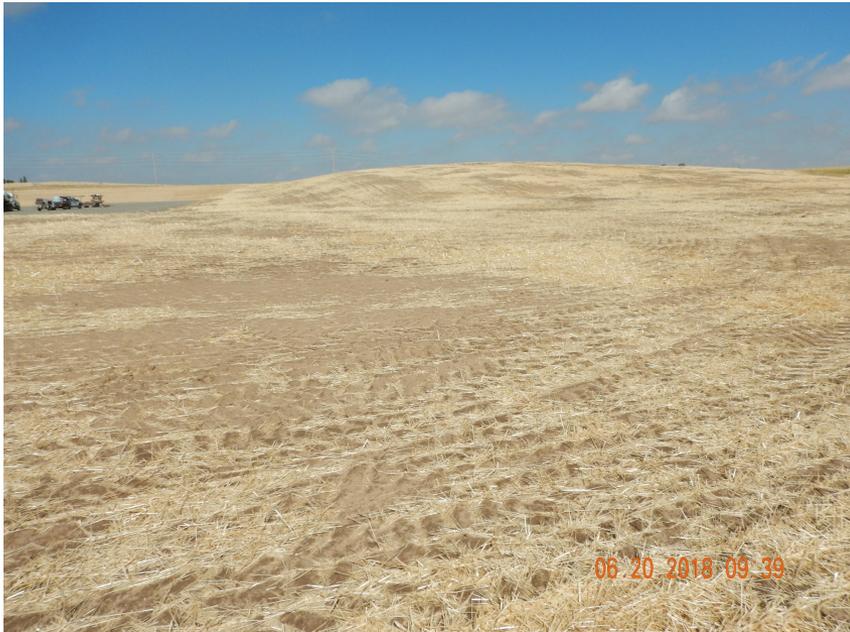
Photo 5. Photo taken from the northeastern perimeter of the location, facing West. Photo illustrates the northern spoils stockpile.

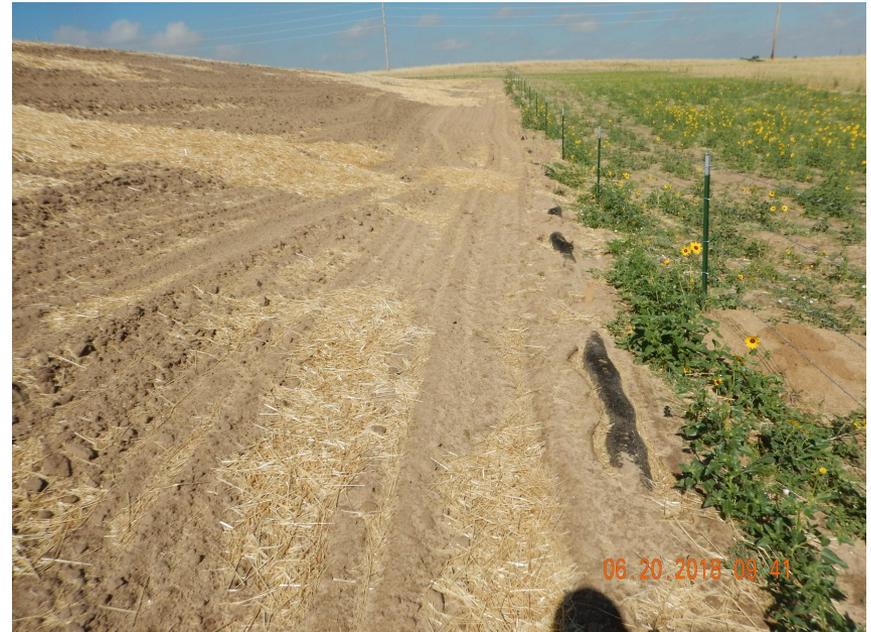
Photo 6. Photo taken from the northern perimeter of the location, facing West. Appears soil material was pushed over the top of the wattle BMP from equipment traffic which is no long in proper functioning condition.

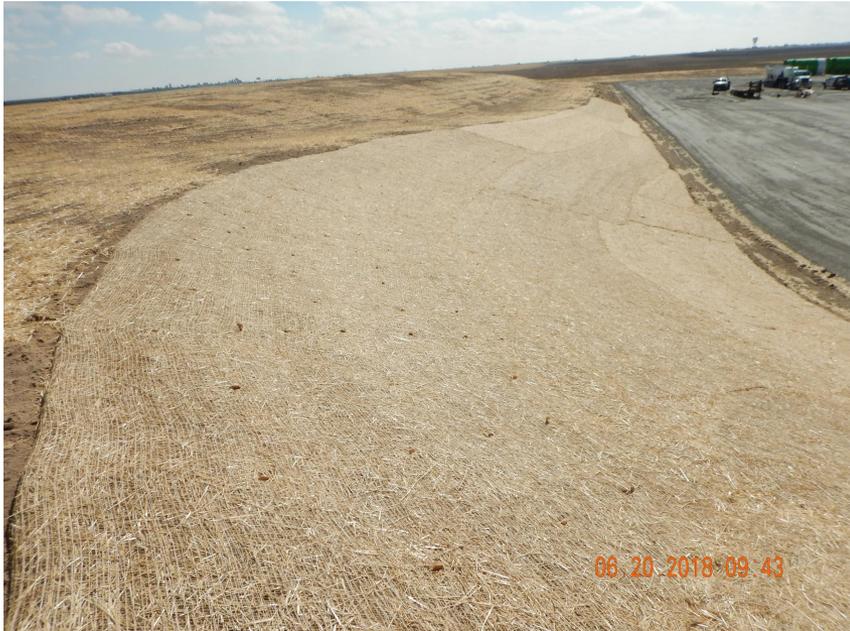
Photo 7. Photo taken from the northwestern perimeter of the location, facing East. Cut slope has been stabilized with erosion control blankets.

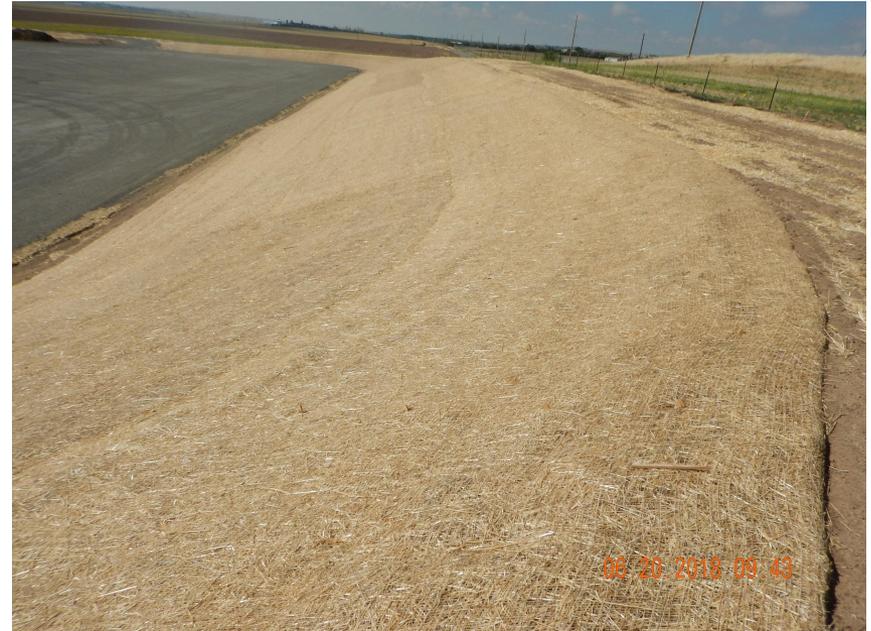
Photo 8. Photo taken from the northwestern perimeter of the location, facing South. See comments under Photo 7.

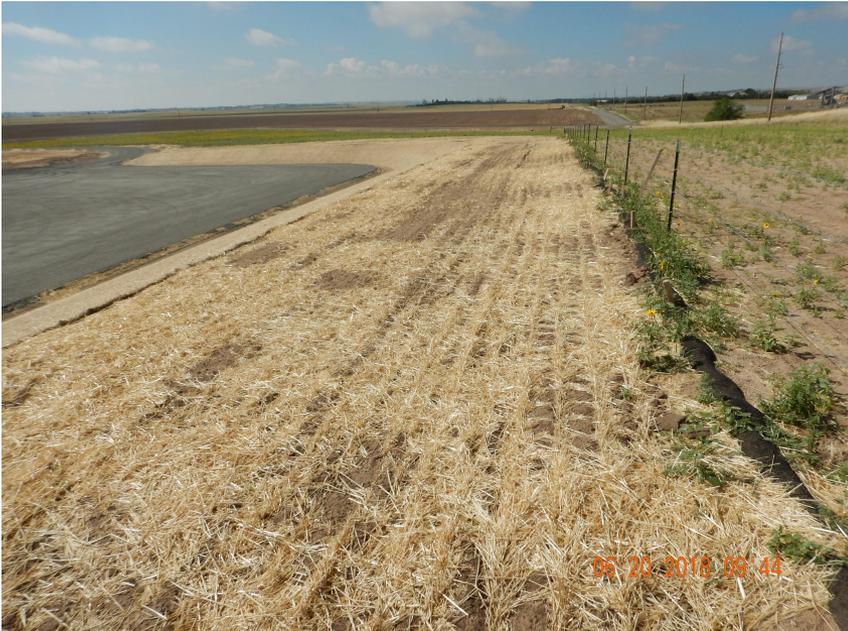
Photo 9. Photo taken from the western perimeter of the location, facing South. See comments under Photo 3.

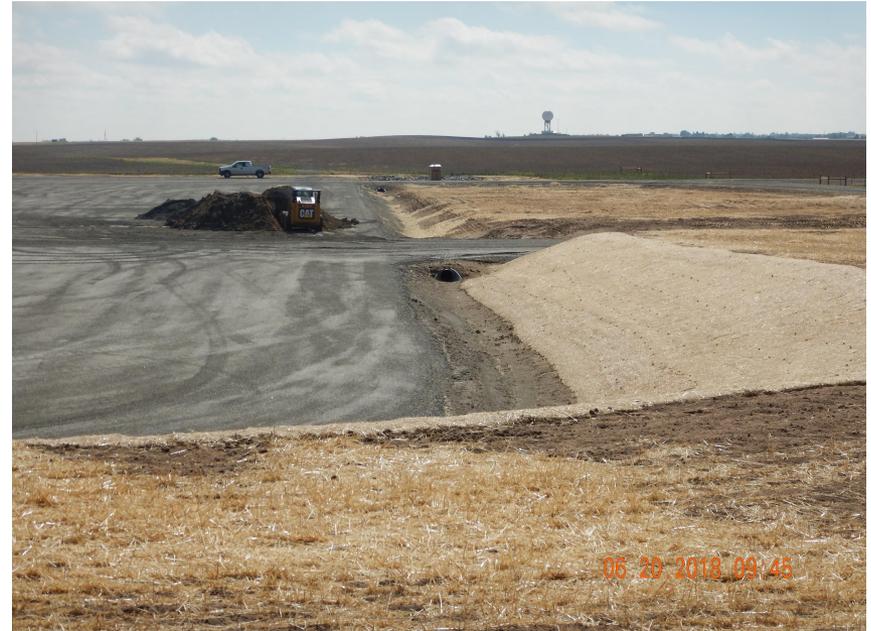
Photo 10. Photo taken from the southwestern perimeter of the location, facing East. Photo illustrates well pad operational areas have been stabilized with gravel, as well as cut slopes with erosion control blankets.

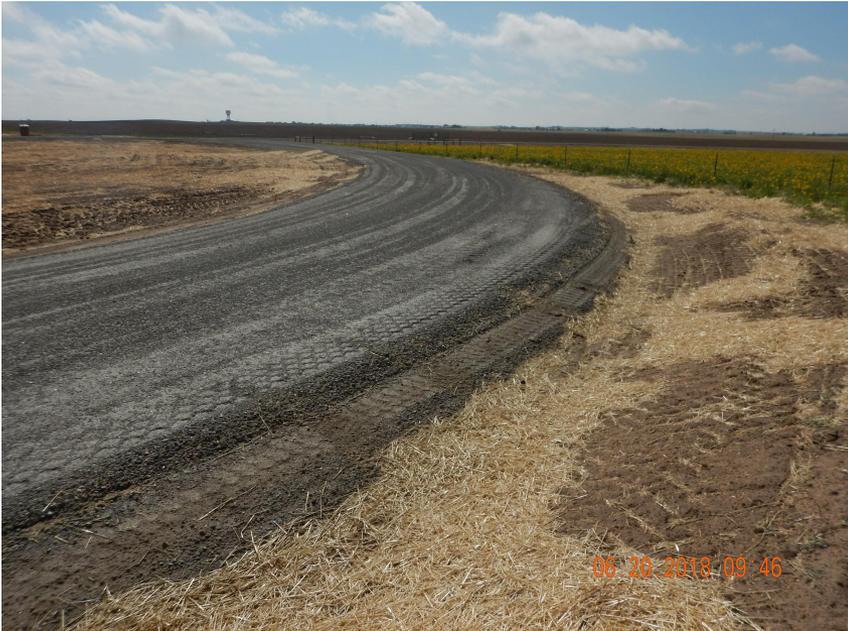
Photo 11. Photo taken from the southwest perimeter of the location, facing East. See comments under Photo 3.

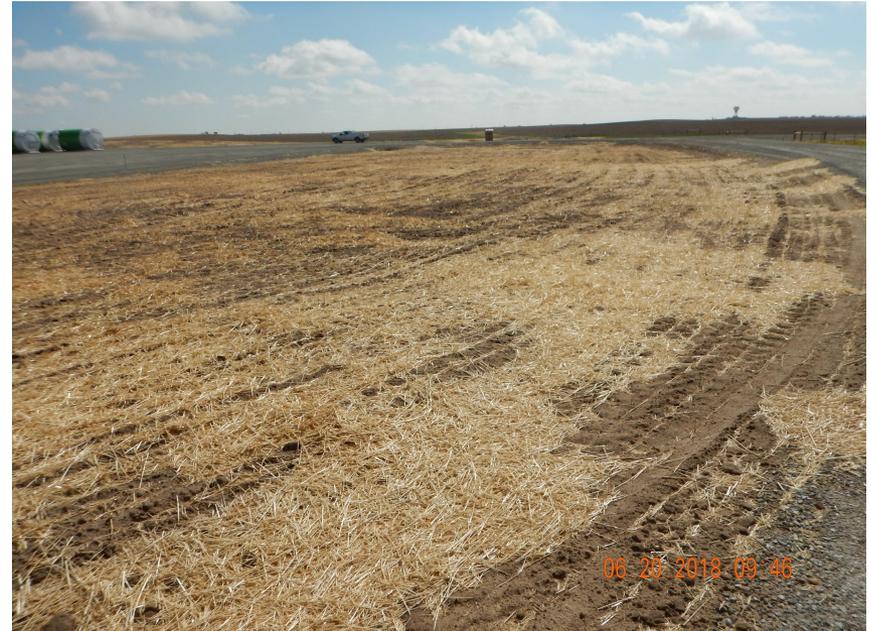
Photo 12. Photo taken from the southwestern perimeter of the location, facing East. See comments under Photo 3.
