Inspection Photo
Clough RWF 27-11-6S-94W
API # 045-06573
Inspection # 689301390

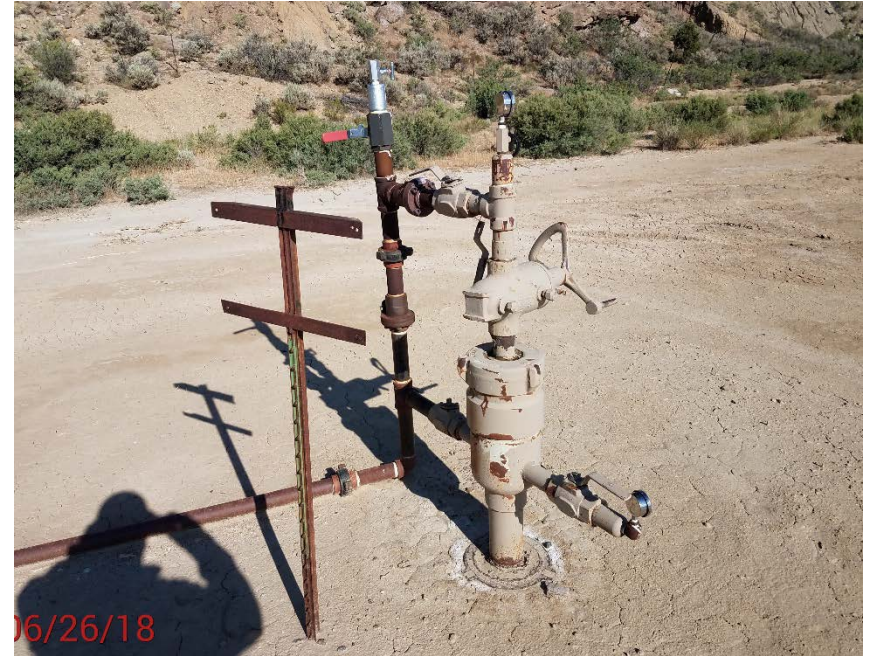
Location Photo #2, missing wellhead sign
