Inspection Photos

Operator: ST CROIX OPERATING INC # 81490

Location ID: 455594

Inspection Doc. Number: 682503521

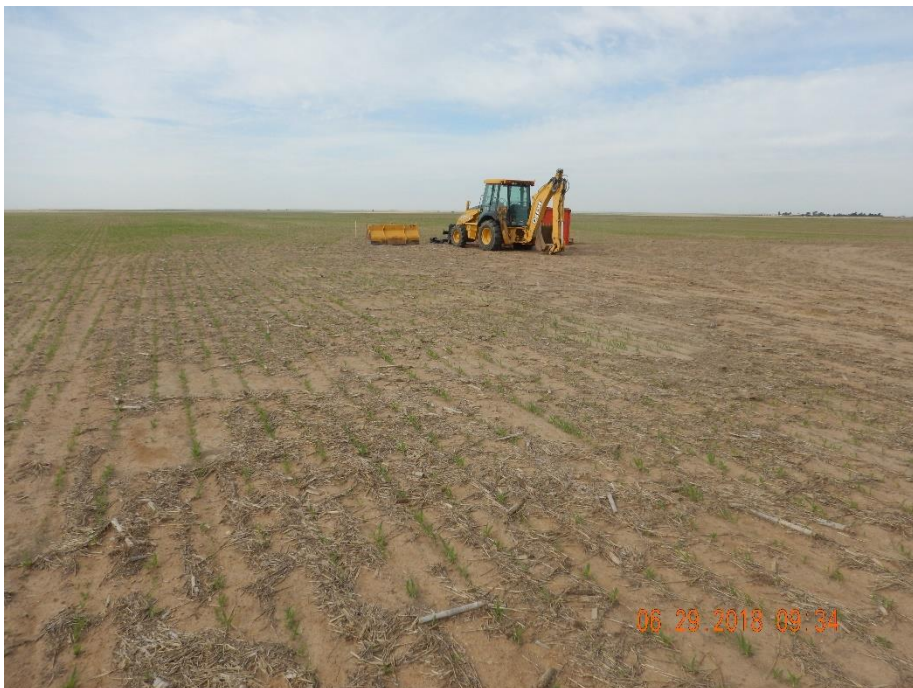
Photo 1: Photo taken from the east end of the location, facing south. Photo shows equipment has been brought on location in preparation for drilling activities. Photo shows no soil salvage has been conducted on location. Photo also show no perimeter stormwater and sediment controls have been implemented.

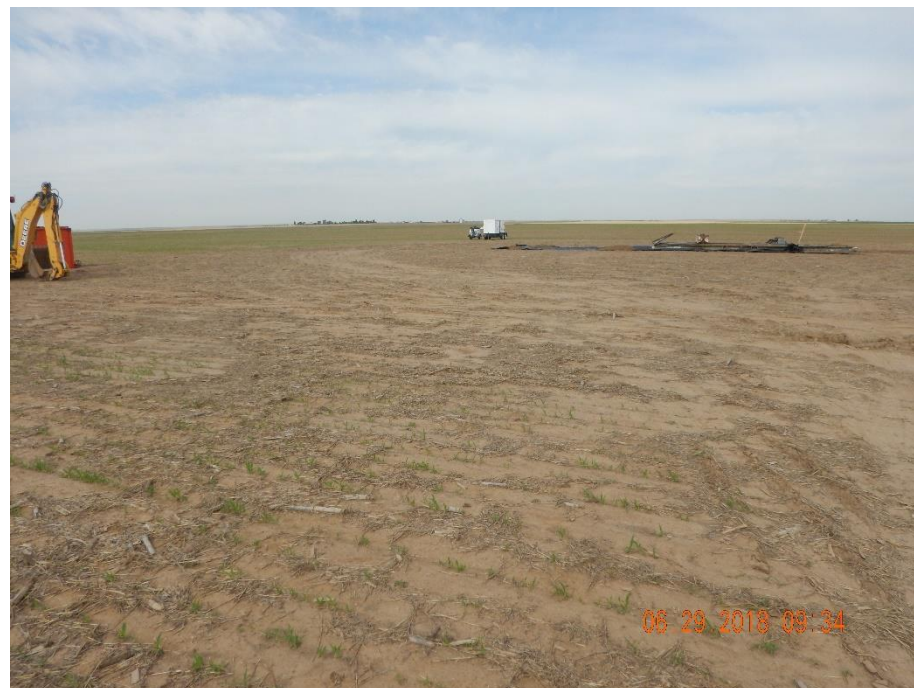
Photo 2: Photo taken from the east end of the location, facing southwest. Photo shows equipment has been brought on location in preparation for drilling activities. Photo shows no soil salvage has been conducted on location. Photo also show no perimeter stormwater and sediment controls have been implemented.

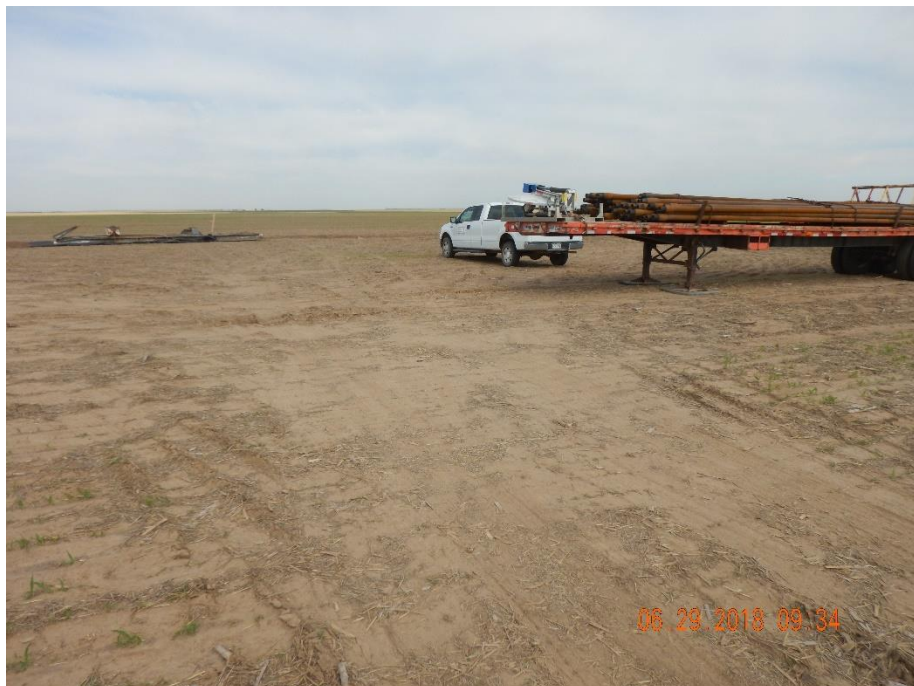
Photo 3: Photo taken from the east end of the location, facing northwest. Photo shows equipment has been brought on location in preparation for drilling activities. Photo shows no soil salvage has been conducted on location. Photo also show no perimeter stormwater and sediment controls have been implemented.

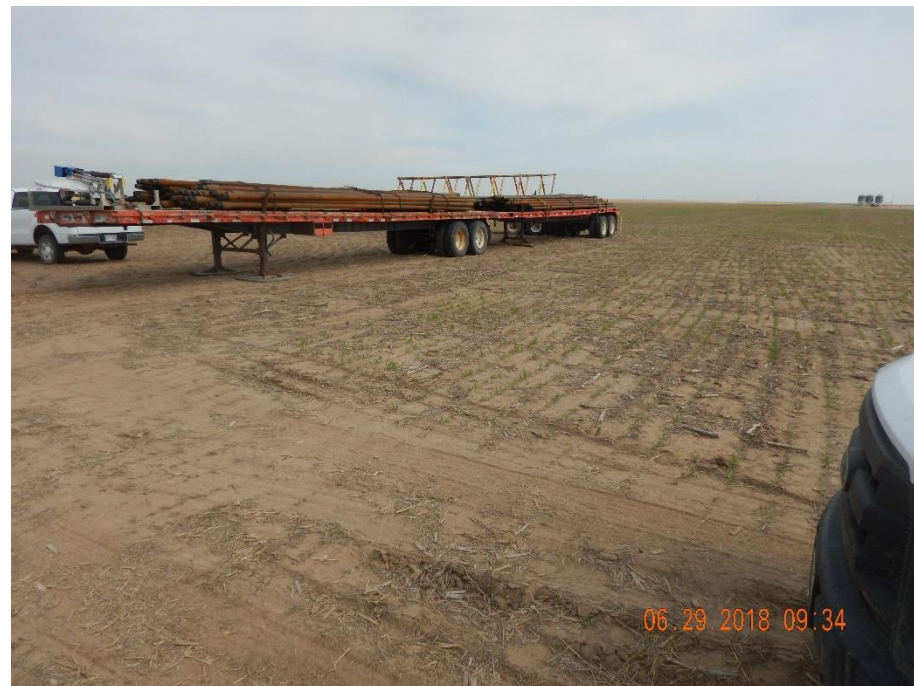
Photo 4: Photo taken from the east end of the location, facing north. Photo shows equipment has been brought on location in preparation for drilling activities. Photo shows no soil salvage has been conducted on location. Photo also show no perimeter stormwater and sediment controls have been implemented.

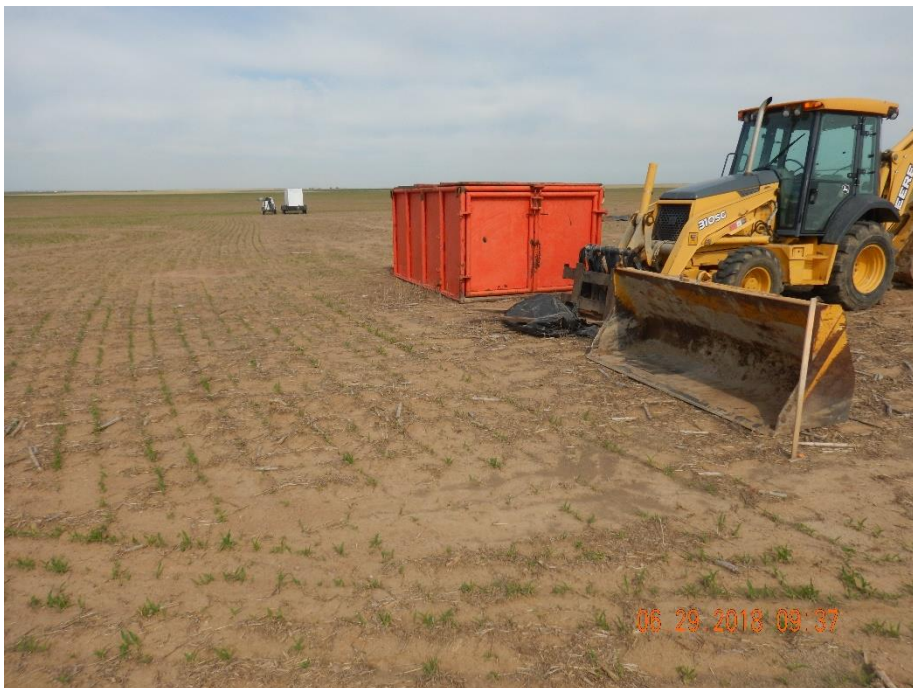
Photo 5: Photo taken from the southeast end of the location, facing west. Photo shows equipment has been brought on location in preparation for drilling activities. Photo shows no soil salvage has been conducted on location. Photo also show no perimeter stormwater and sediment controls have been implemented.

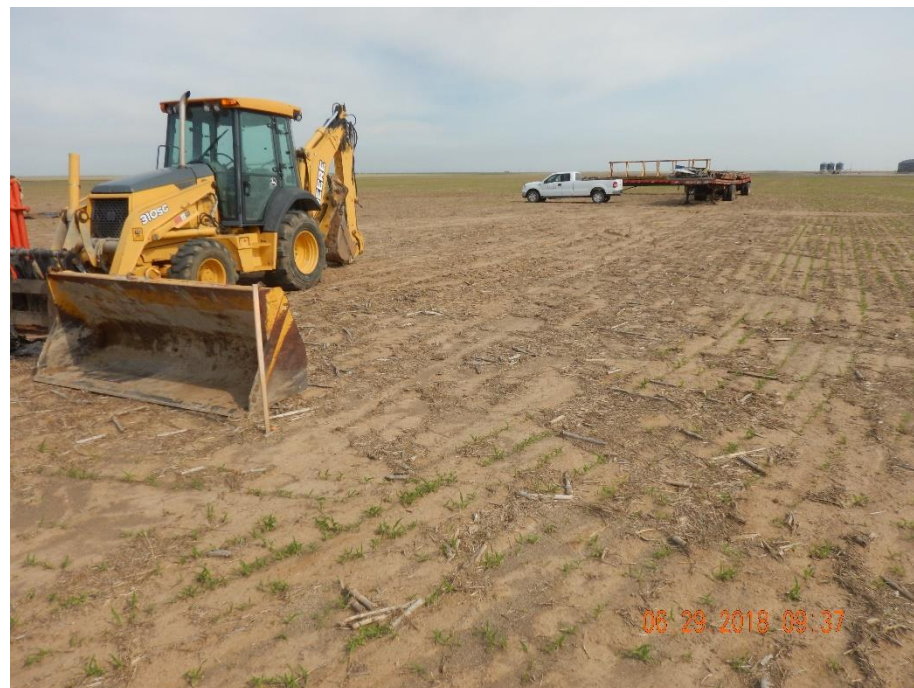
Photo 6: Photo taken from the southeast end of the location, facing north. Photo shows equipment has been brought on location in preparation for drilling activities. Photo shows no soil salvage has been conducted on location. Photo also show no perimeter stormwater and sediment controls have been implemented.

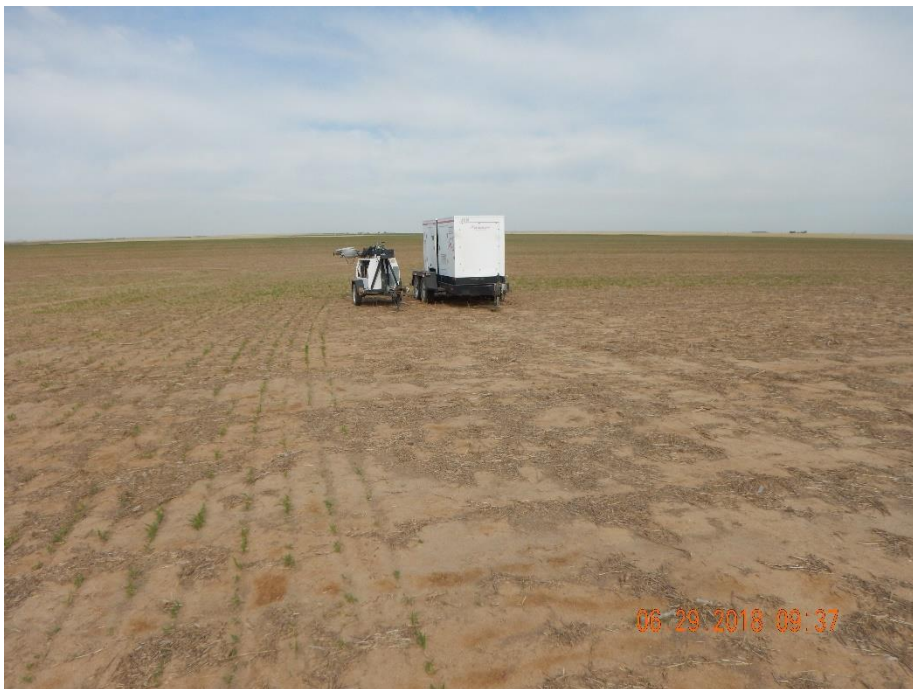
Photo 7: Photo taken from the south end of the location, facing west. Photo shows equipment has been brought on location in preparation for drilling activities. Photo shows no soil salvage has been conducted on location. Photo also show no perimeter stormwater and sediment controls have been implemented.

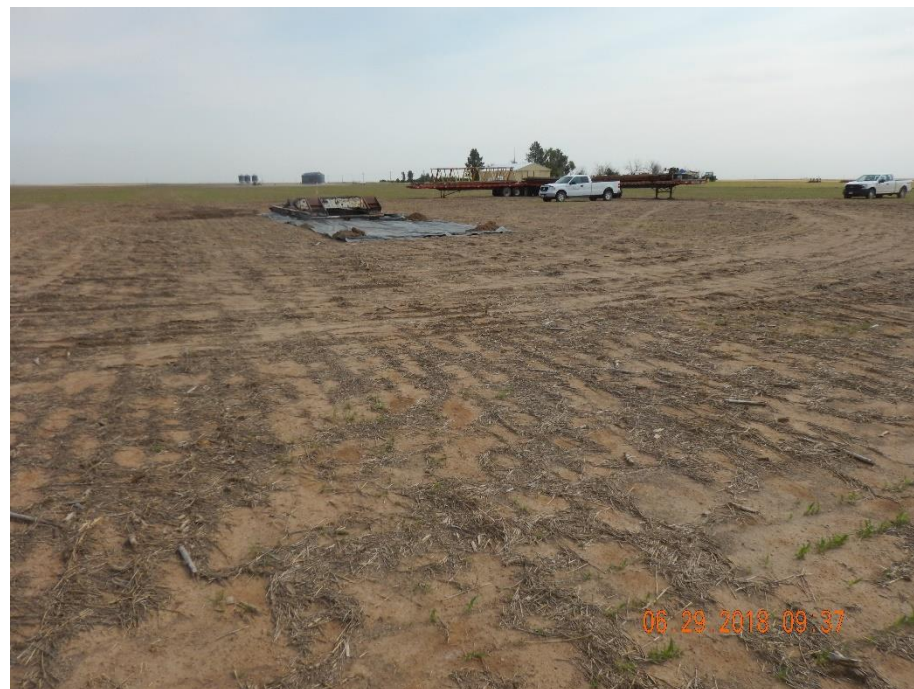
Photo 8: Photo taken from the south end of the location, facing north. Photo shows equipment has been brought on location in preparation for drilling activities. Photo shows no soil salvage has been conducted on location. Photo also show no perimeter stormwater and sediment controls have been implemented.

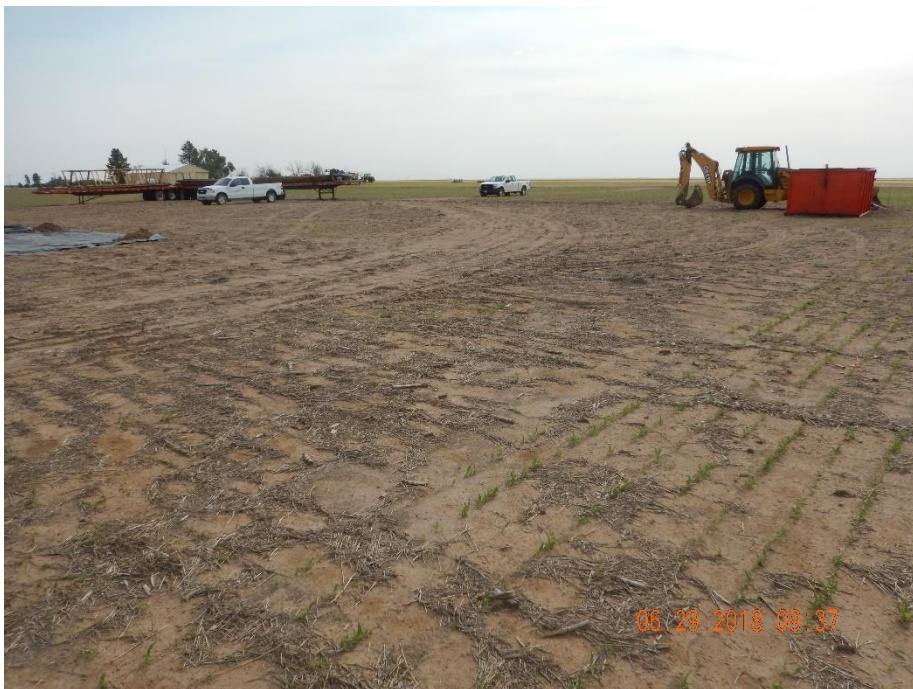
Photo 9: Photo taken from the south end of the location, facing east. Photo shows equipment has been brought on location in preparation for drilling activities. Photo shows no soil salvage has been conducted on location. Photo also show no perimeter stormwater and sediment controls have been implemented.

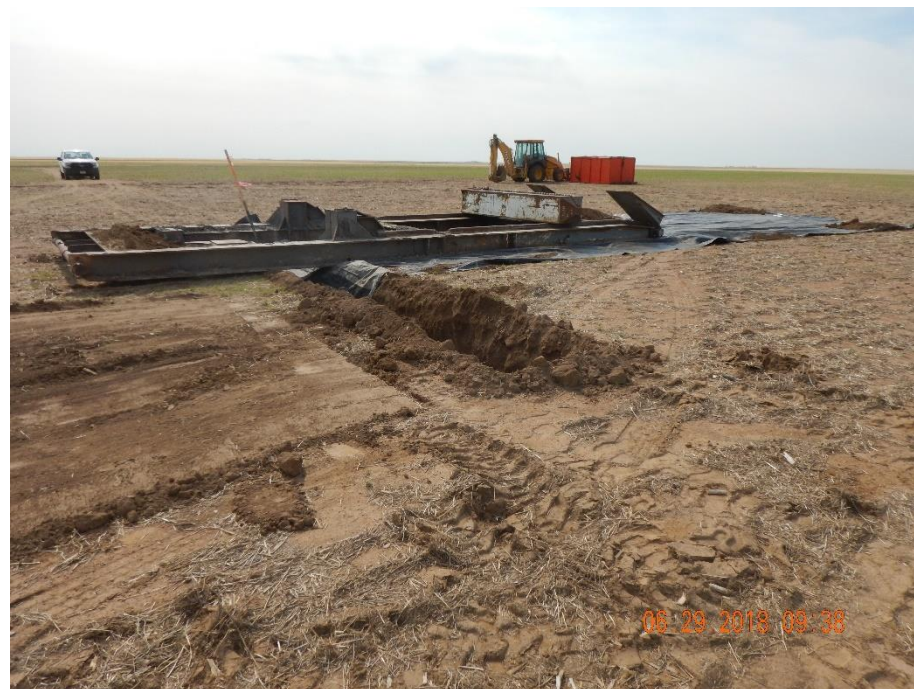
Photo 10: Photo taken from the center of the location, facing east. Photo shows equipment has been brought on location in preparation for drilling activities. Photo shows no soil salvage has been conducted on location.

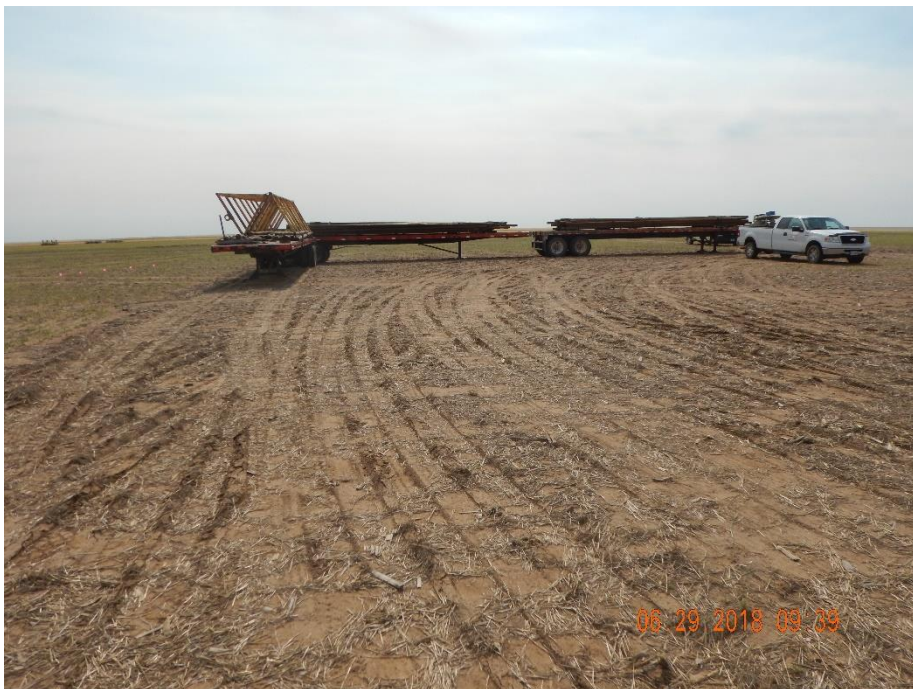
Photo 11: Photo taken from the north end of the location, facing east. Photo shows equipment has been brought on location in preparations for drilling activities. Photo shows no soil salvage has been conducted on location. Photo also show no perimeter stormwater and sediment controls have been implemented.

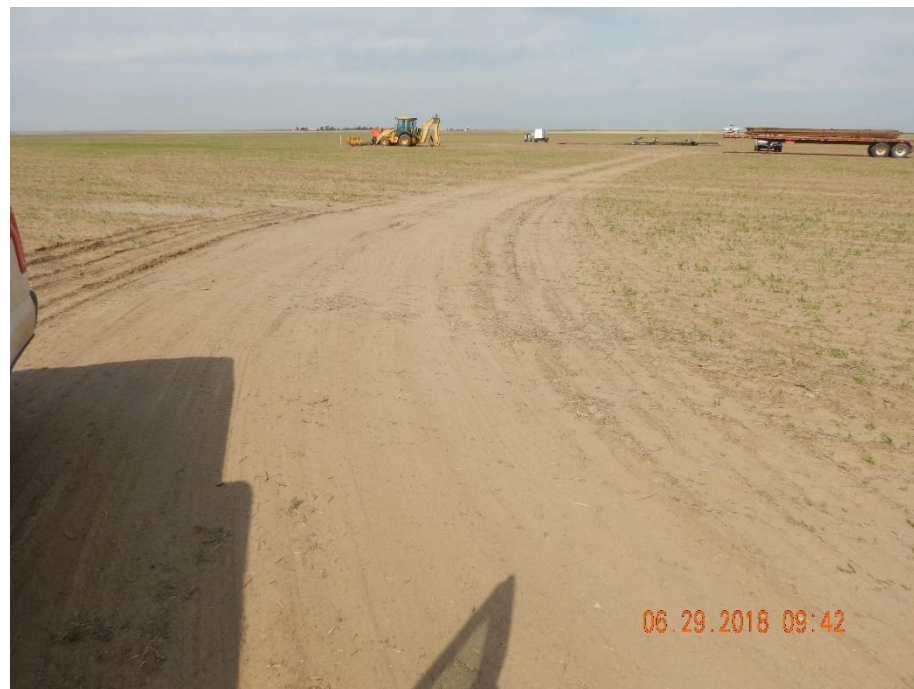
Photo 12: Photo taken from the east of the location, facing west. Photo of access road.

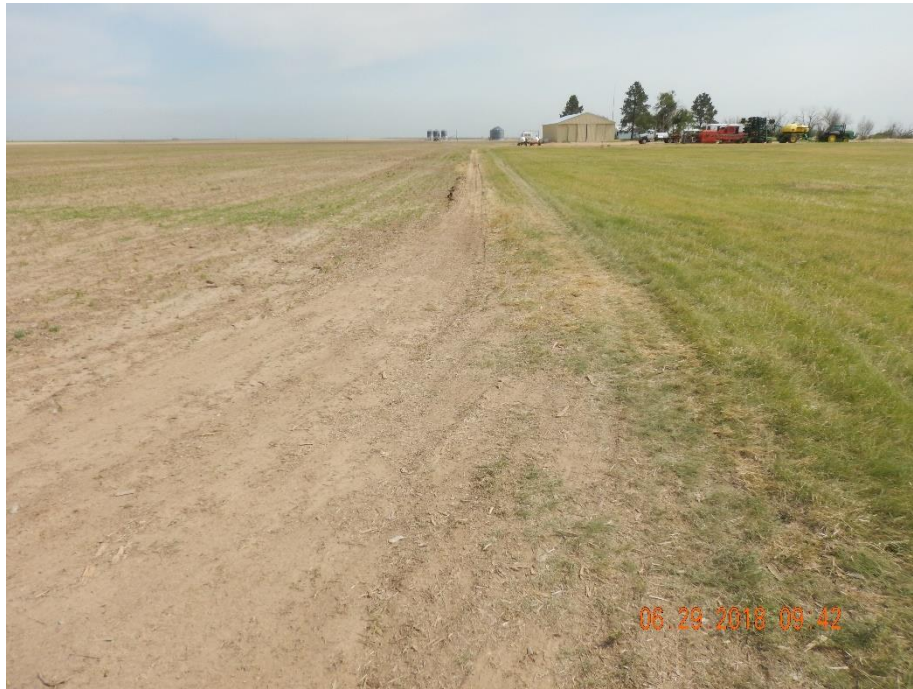
Photo 13: Photo taken from the east of the location, facing north. Photo of access road. Though location resides in cropland, access road travels across non-cropland.

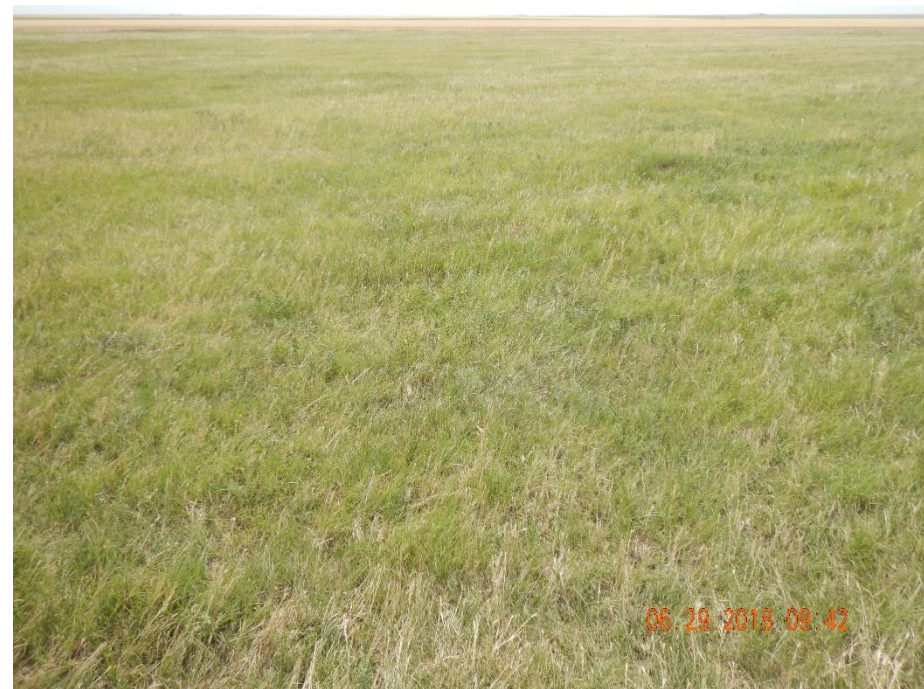
Photo 14: Photo of the vegetation adjacent to the North/South traveling section of the access road. Photo of shows road travels through non-crop grassland.

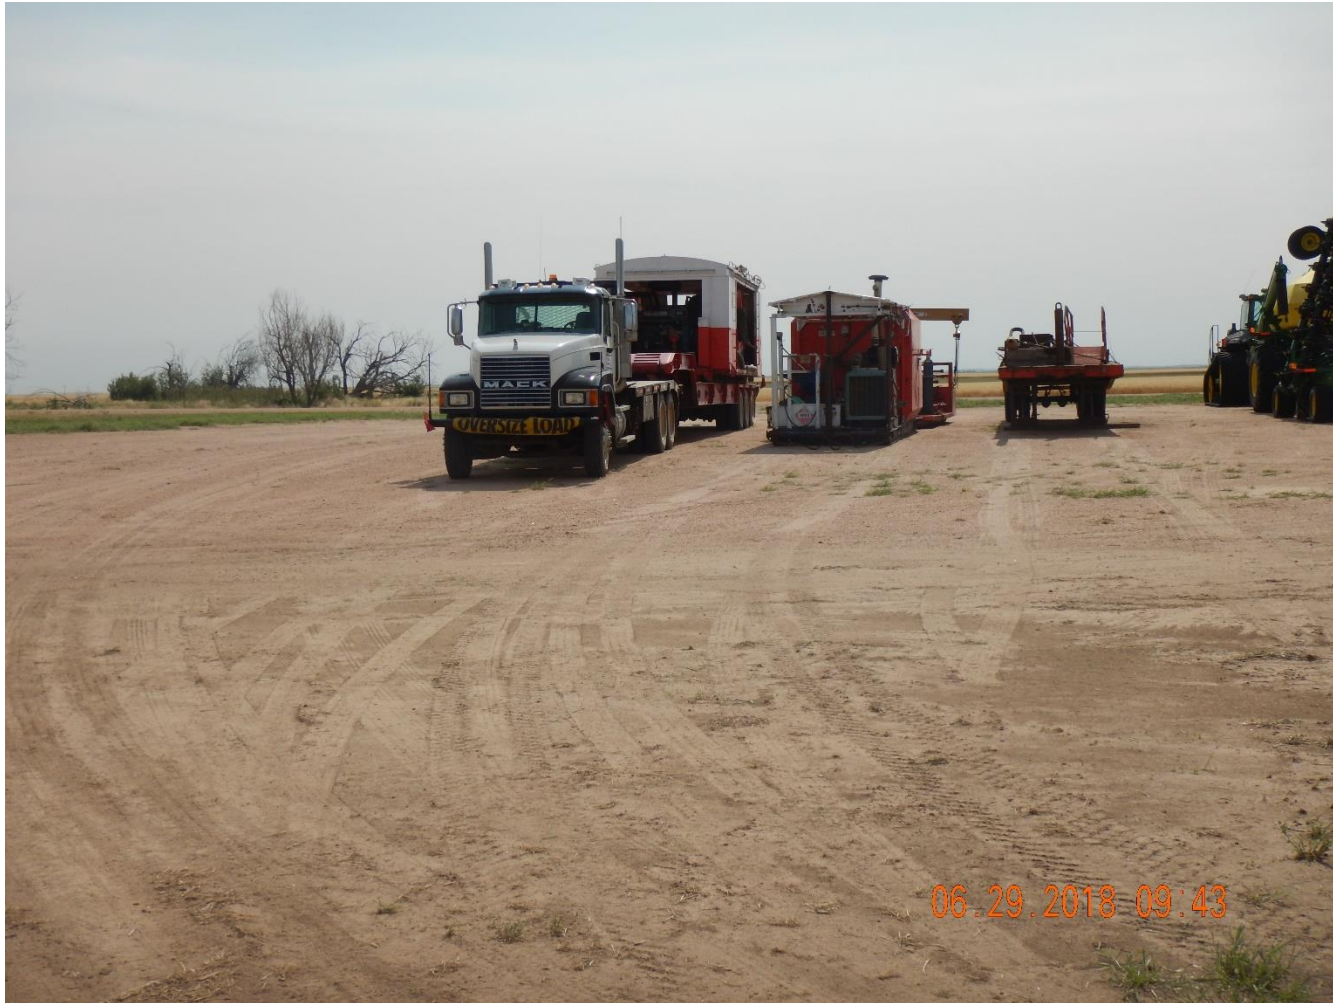
Photo 15: Photo taken from a the farmstead to the northeast of the location. Photo shows operator appears to be storing equipment on the property.
