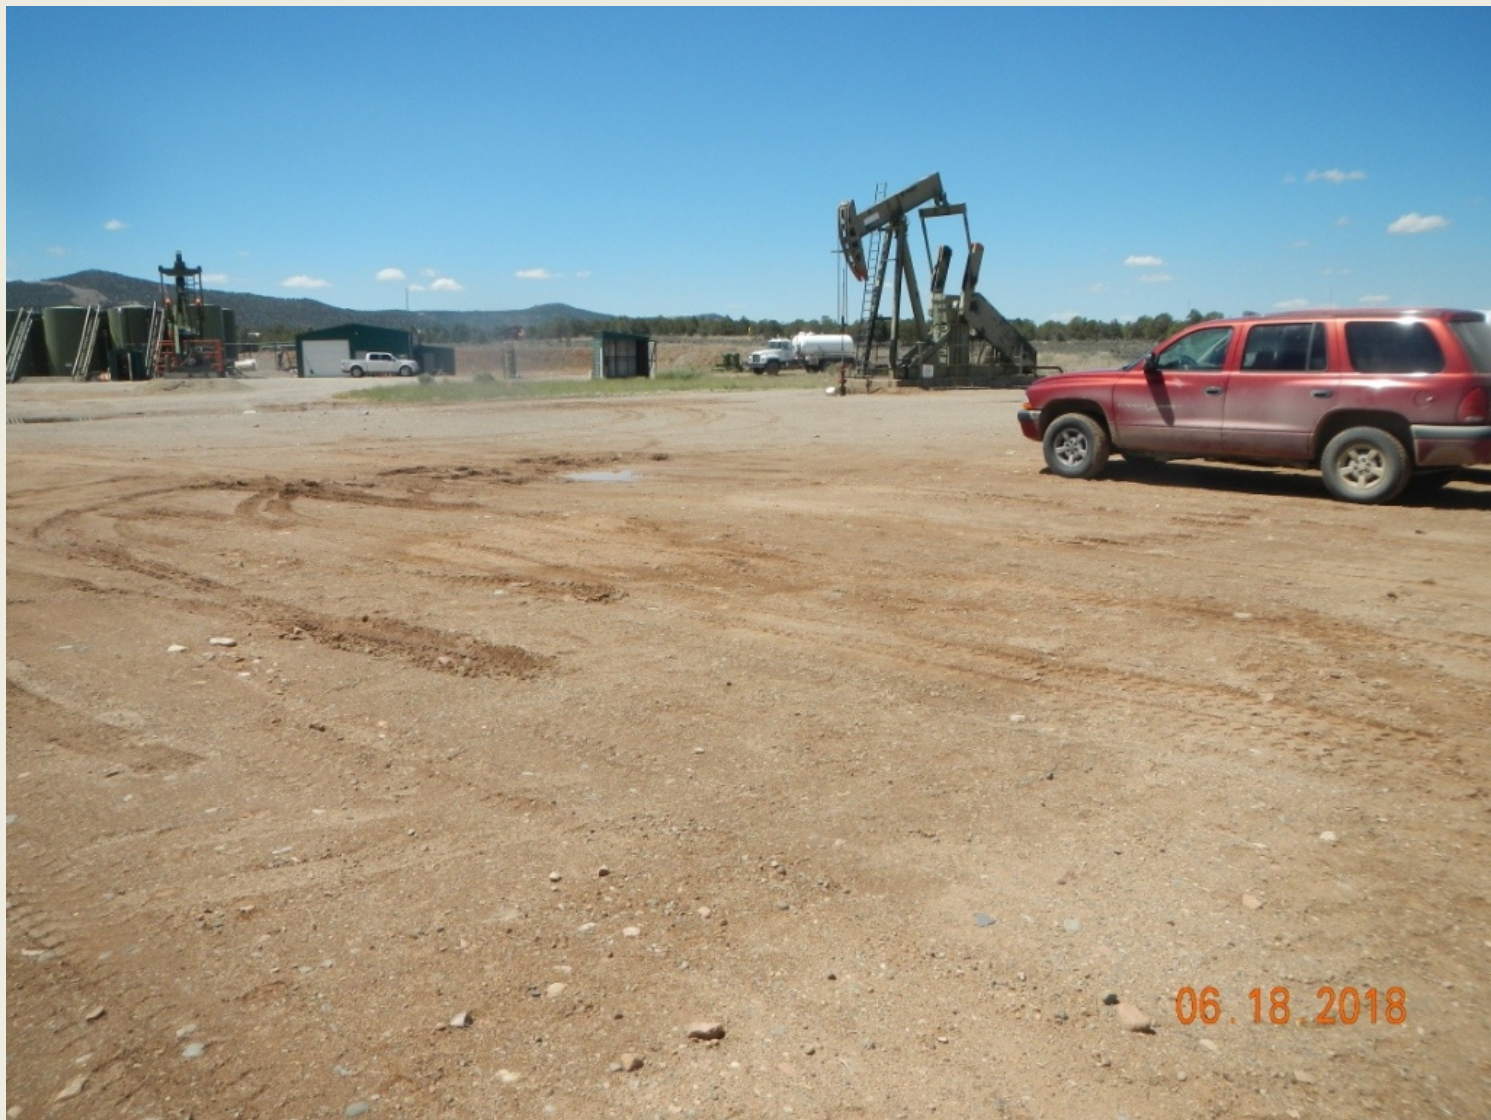
Photo 1. View of the project area from the northeastern corner facing center.

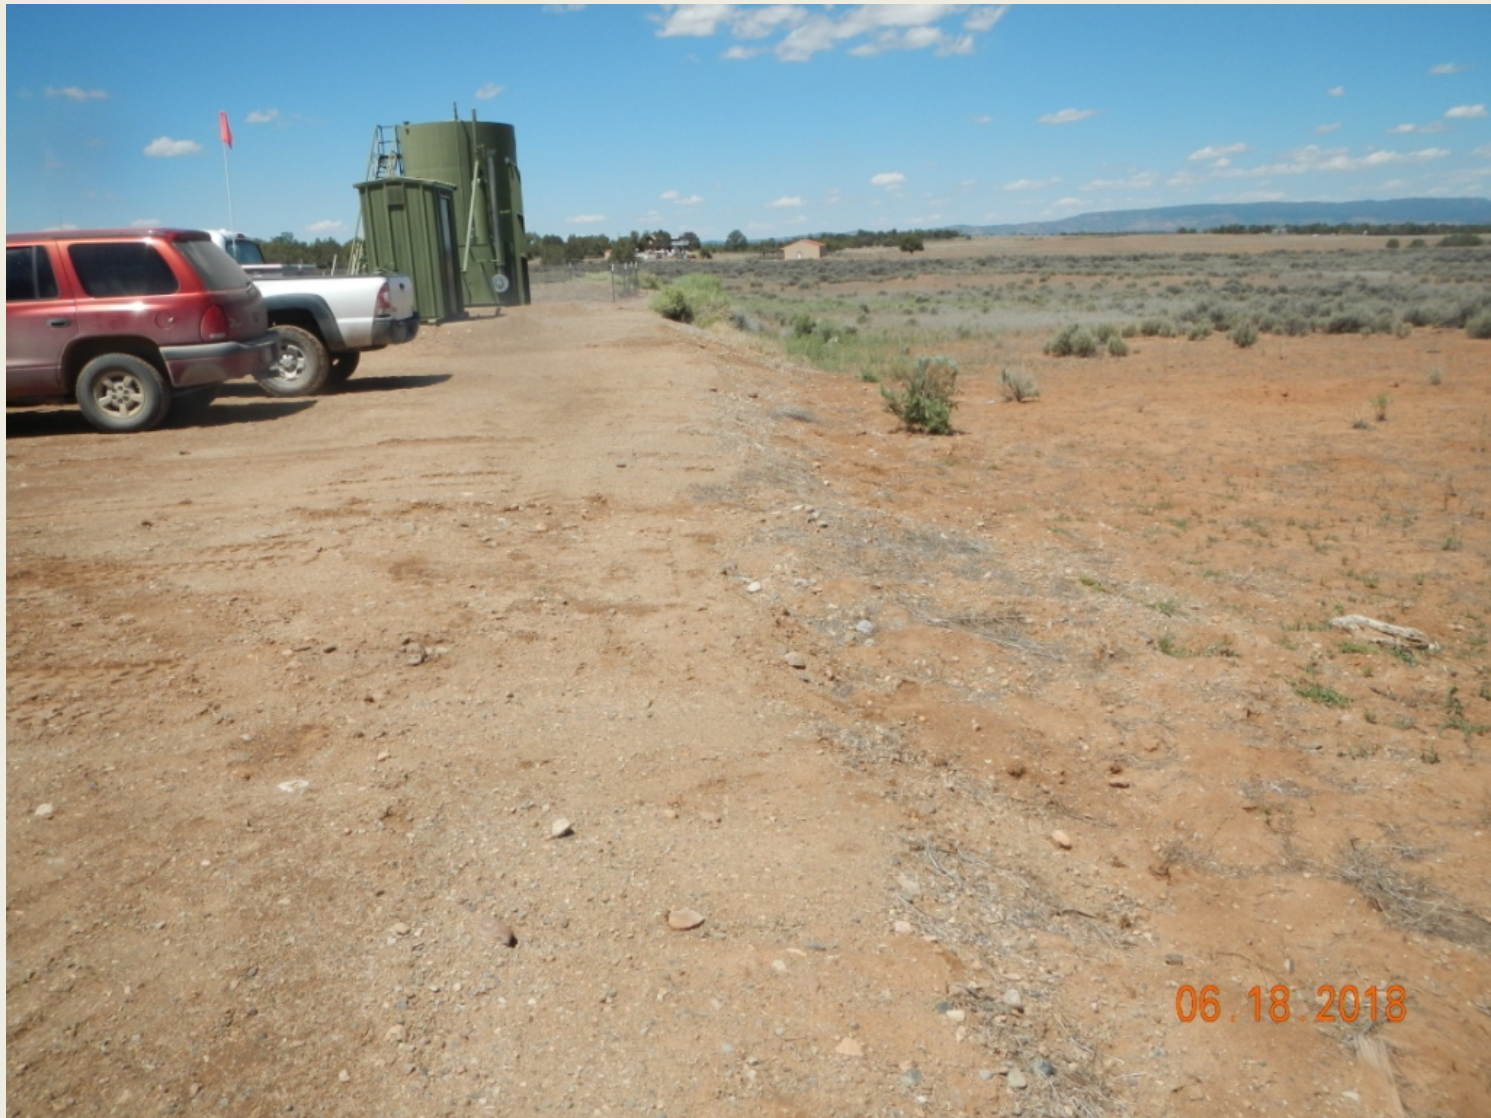
Photo 2. View of the northern portion of the project area from the northeastern corner facing westward. Revegetation is sparse in portions, and progressing in other areas with grasses such as western wheatgrass (*Pascoopyrum smithii*) and smooth brome (*Bromus inermis*).

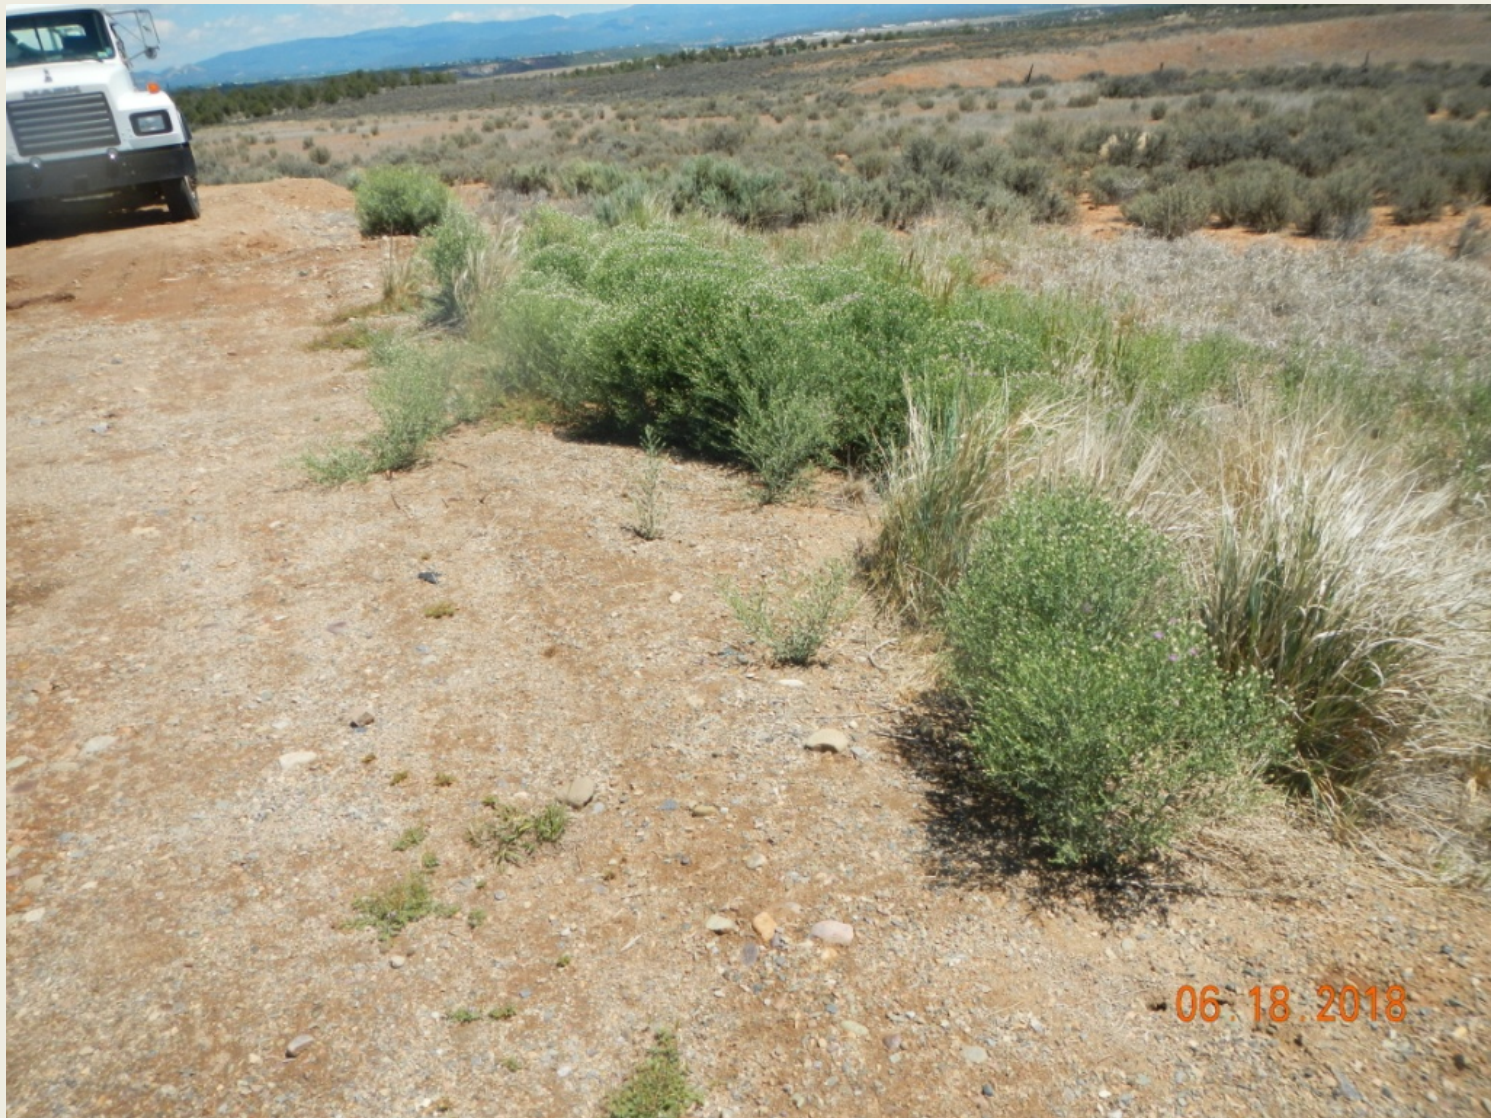
Photo 3. View of Russian knapweed (*Rhaponticum repens*) infestation along the eastern edge of the project area.

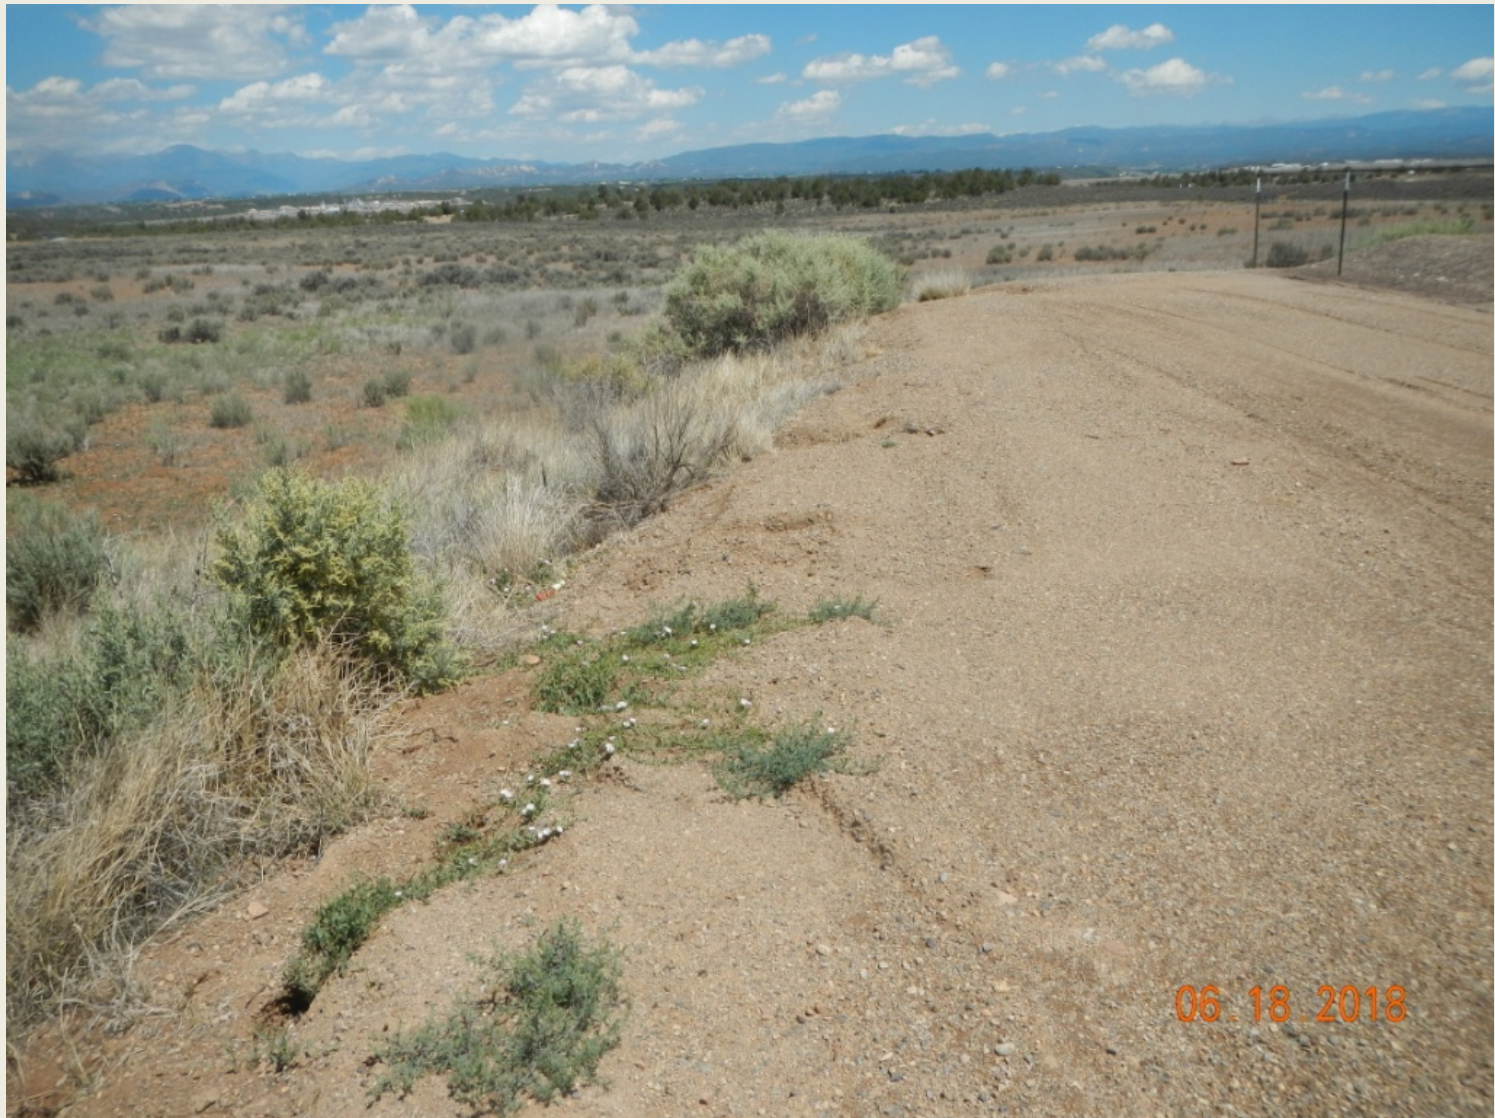
Photo 4. View of area where rilling is occurring from stormwater runoff from the well pad, along the northwestern edge of the project area.

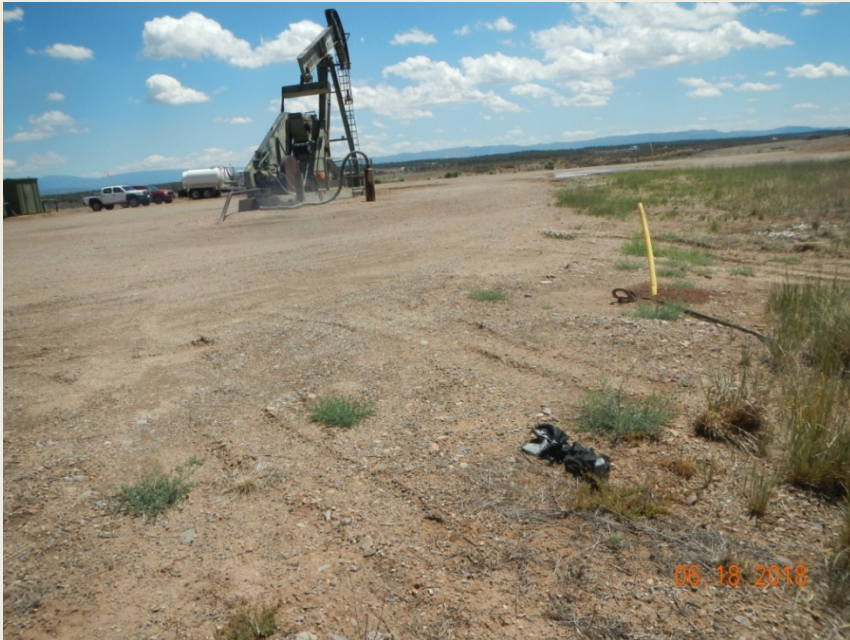
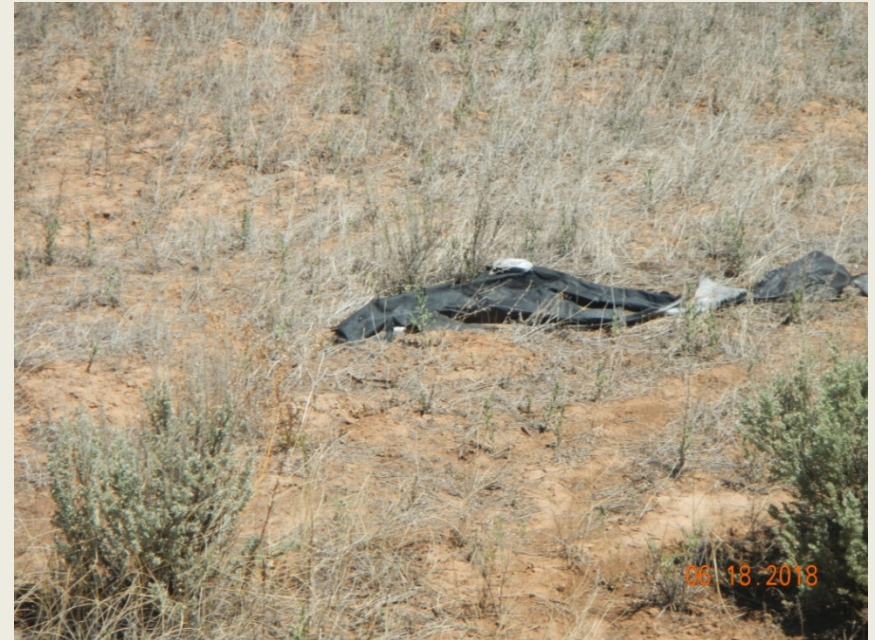
Photos 5 and 6. View of black plastic debris within the interim reclamation areas.
