Interim Reclamation and Stormwater Inspection

June 27, 2018

Operator: EXTRACTION OIL & GAS INC #10459

Location ID: 436824

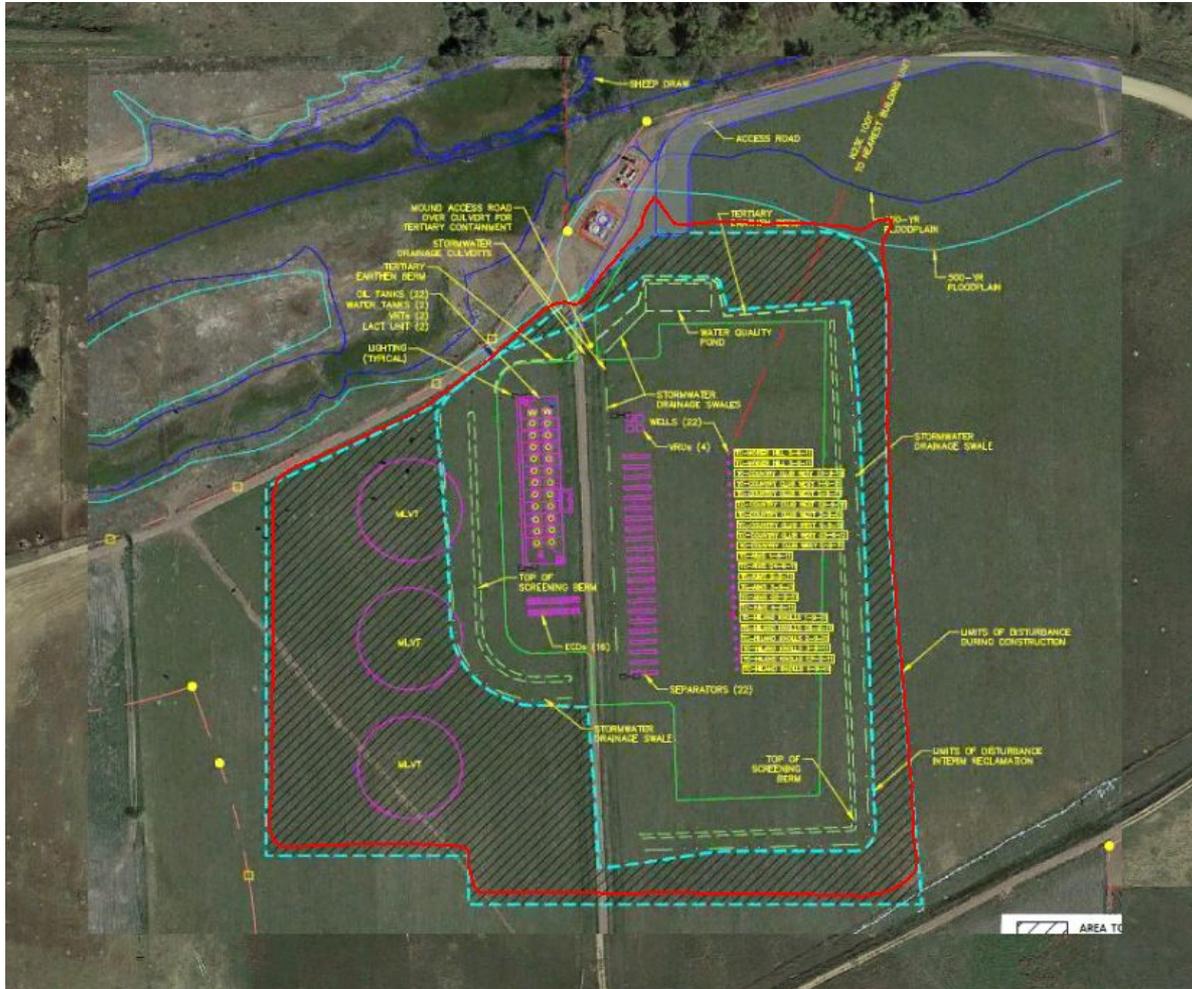
Google Earth aerial imagery taken on 10/14/2017. Facility Layout Drawing (Doc. #24778002) has been overlaid with field collected data. Field collected data on 6/27/2018, using a Trimble handheld GPS (red line), would indicate total disturbance after construction operations is ~19.2 acres. Note: This location is not in compliance with Rule 1002 and 1003.

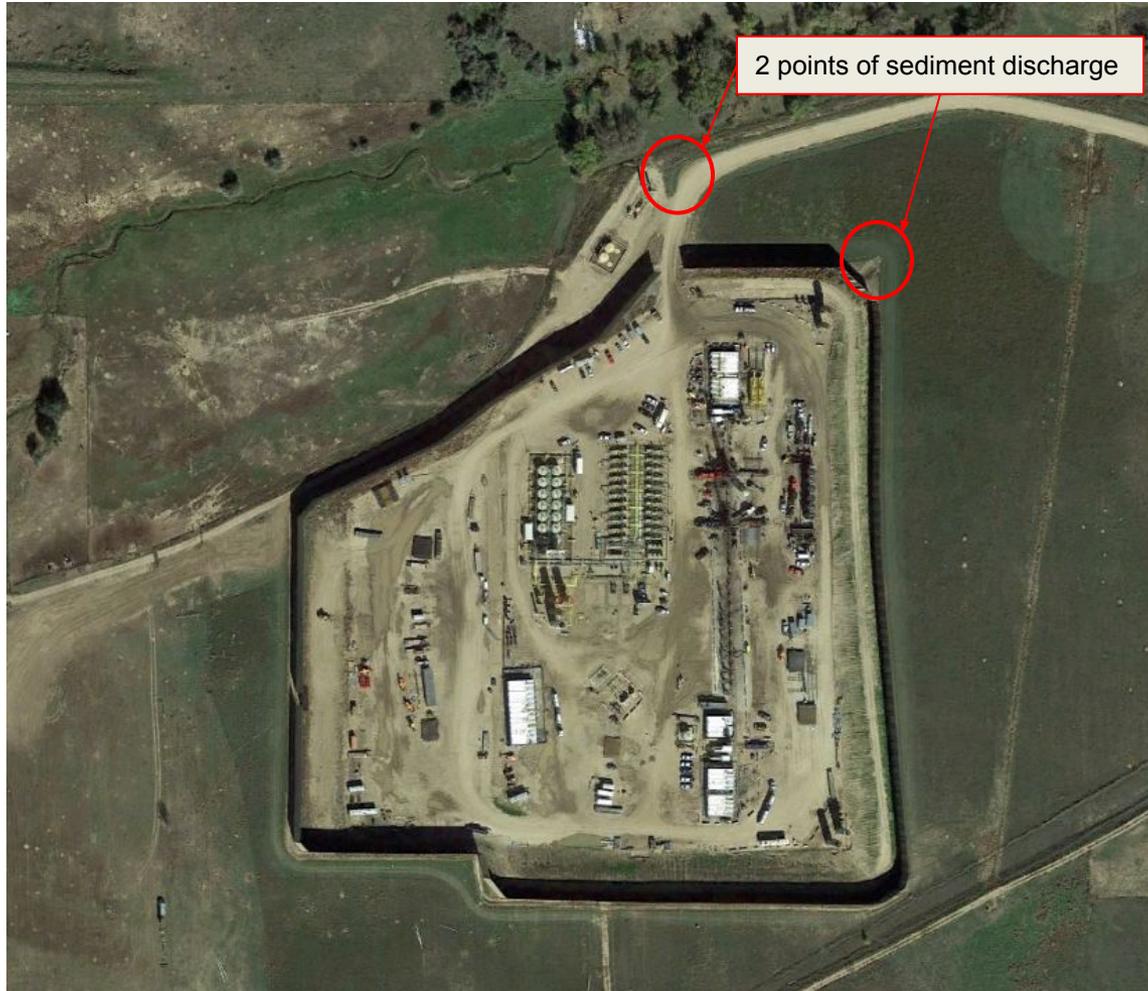
Google Earth aerial imagery taken on 10/14/2017. Sediment discharge was observed at 2 discharge points along the northern location. Stormwater BMP maintenance is required immediately, as BMPs were not in compliance at the time of the inspection. Rill and gully erosion were observed throughout the northern fill slopes, eastern earthen berm, and topsoil stockpile.

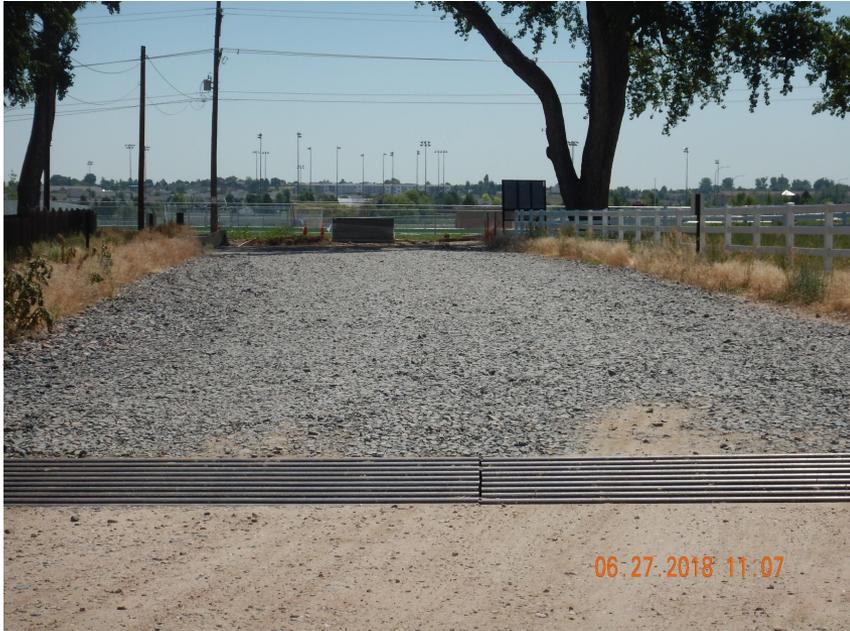
Photo 1. Photo taken from the entrance of location off 71st Ave., facing East. Vehicle tracking device installed and appears to be in proper functioning condition.

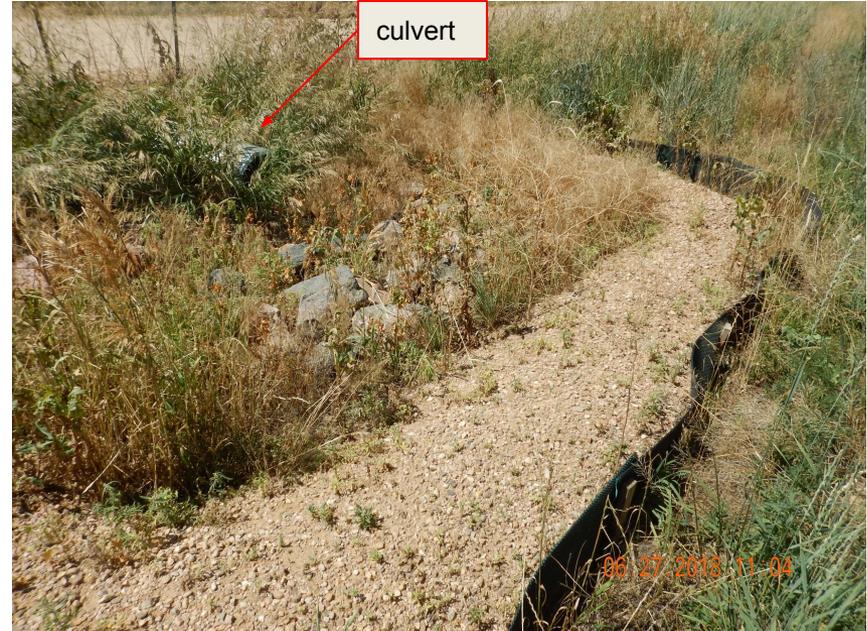
Photo 2. Photo taken along a portion of the access road. Photo illustrates a stabilized outlet area installed in conjunction with a culvert. No sediment discharge was observed beyond the stabilized outlet area. Note: Straw wattles along the access road are in need of maintenance.

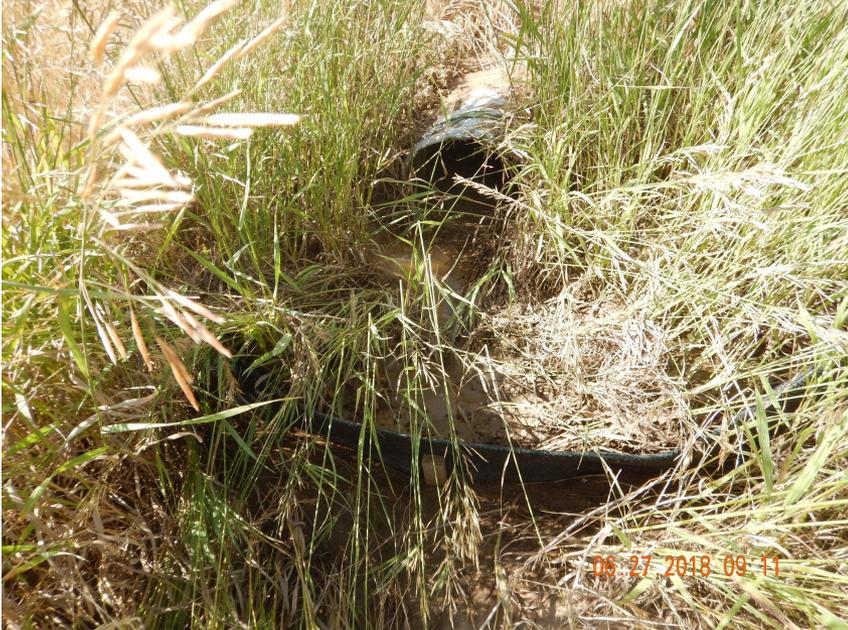
Photo 3. Photo taken from the northwestern discharge point. S-fence was installed to outlet protection in conjunction with the culvert. Sediment discharge was observed beyond the S-fence.

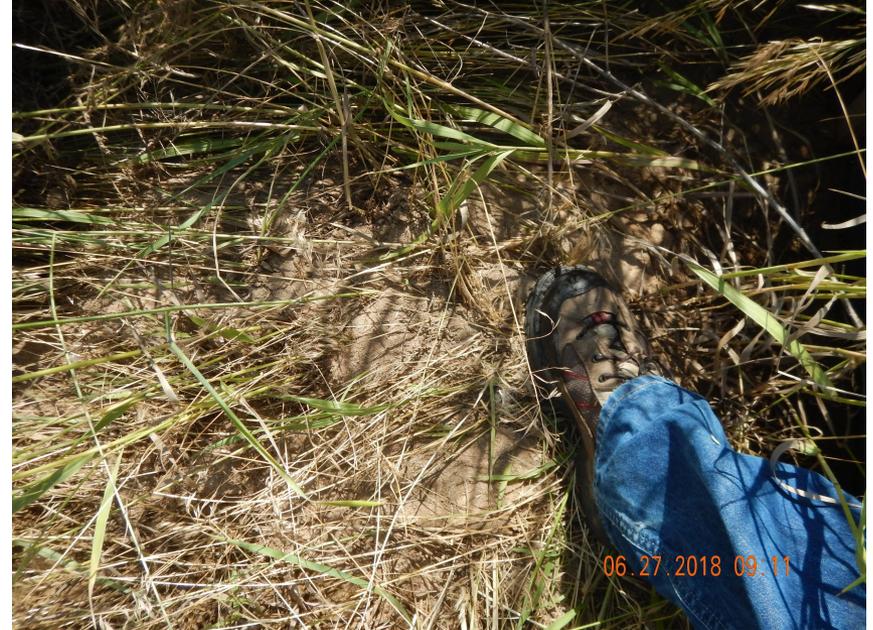
Photo 4. Photo illustrating sediment discharge beyond the S-fence.

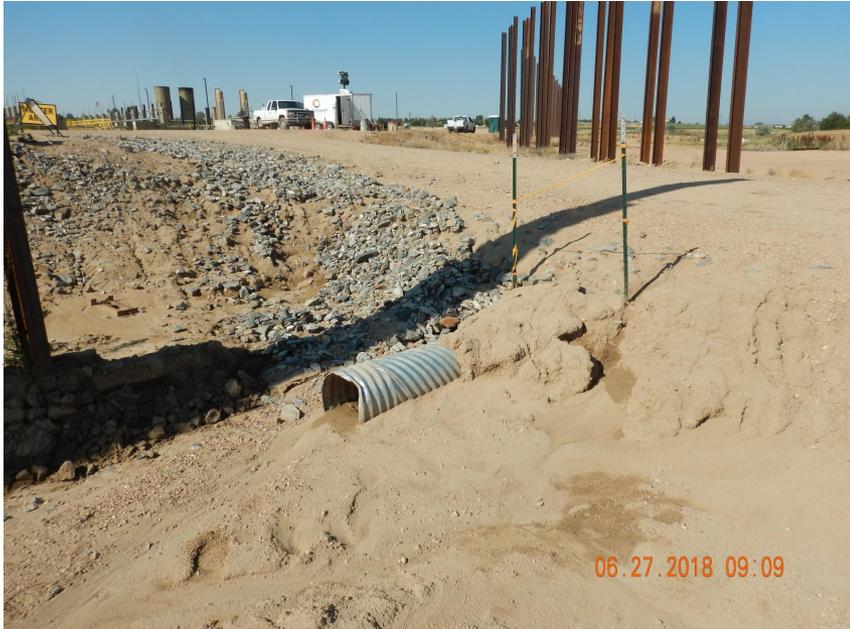
Photo 5. Photo taken from the east side of the entrance to the facility location, facing West. Rill erosion and sediment accumulation observed. Stormwater BMP maintenance in need of repair.

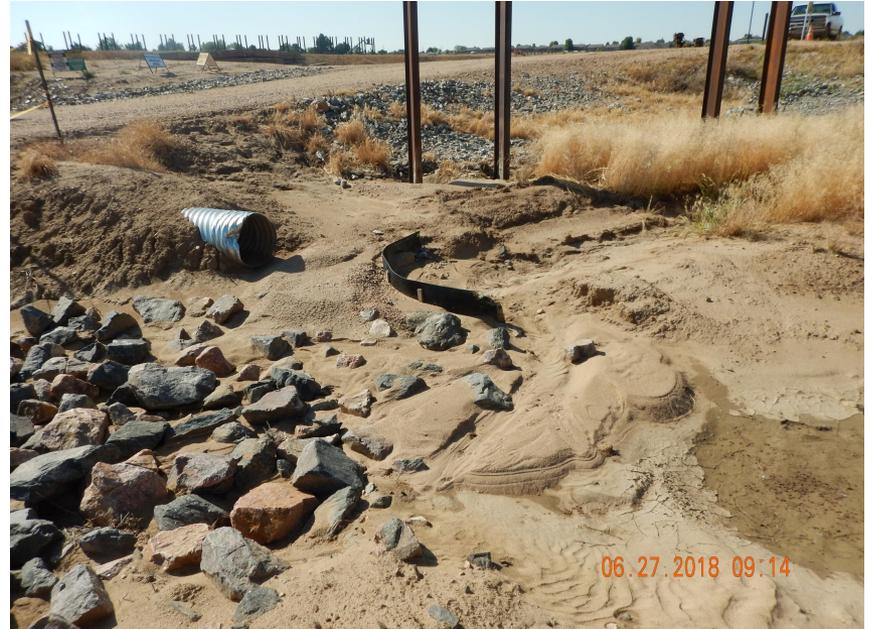
Photo 6. Photo taken from the west side of the entrance to the facility location, facing Southeast. See comments under Photo 5.

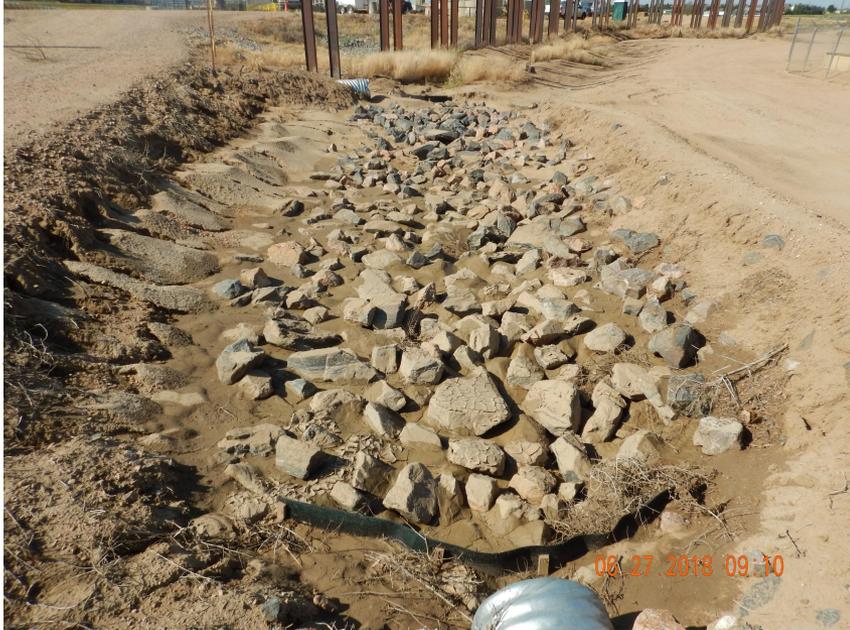
Photo 7. Photo taken from the west side near the entrance to the facility location, facing South. See comments under Photo 5.

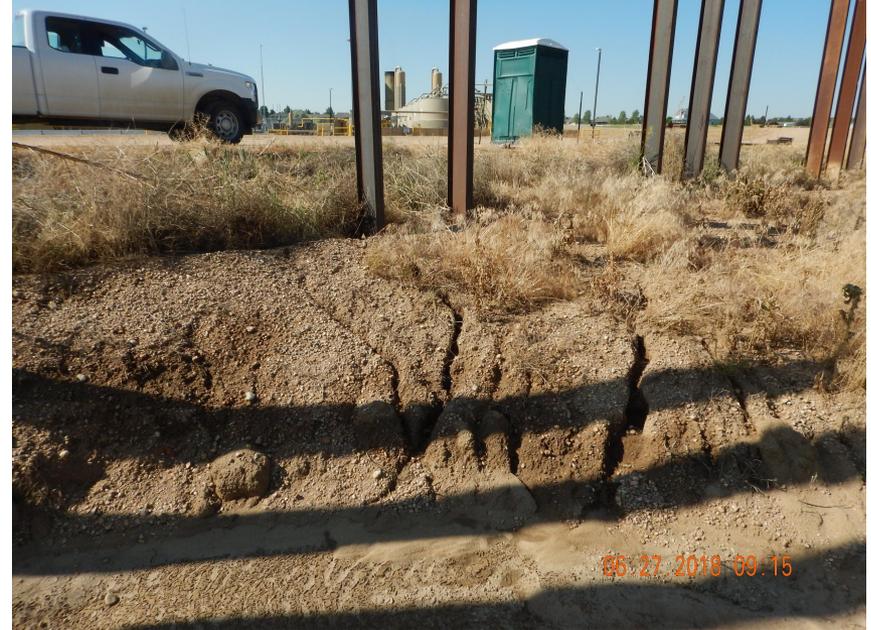
Photo 8. Photo taken from the northwestern perimeter of location, facing South. Rill erosion was observed along the northern perimeter of the location. Ditch BMP in need of maintenance from rill erosion off the northern perimeter. Note: Weed debris (Kochia weeds) was observed along portions of the perimeter and shall be controlled and managed per Rule 603.f.

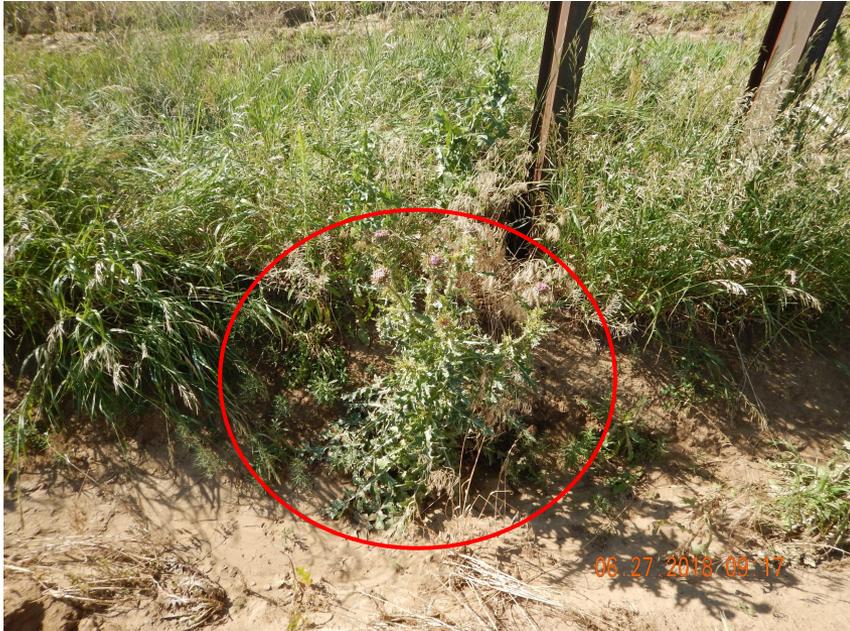
Photo 9. Photo taken from the northwestern perimeter of location, facing South. Musk thistle, a List B Colorado Noxious weed, was observed along portions of the location. Appears the Operator has recently performed noxious weed management; however, some individual species still need to be controlled and managed.

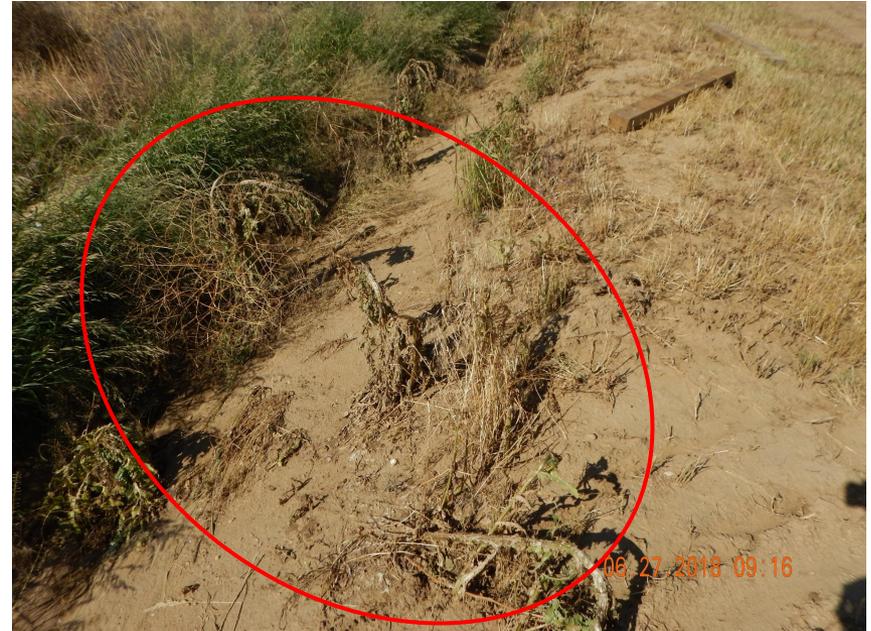
Photo 10. Photo taken from the northwestern perimeter of location, facing West. Photo illustrates Musk thistle that appears to be recently sprayed.

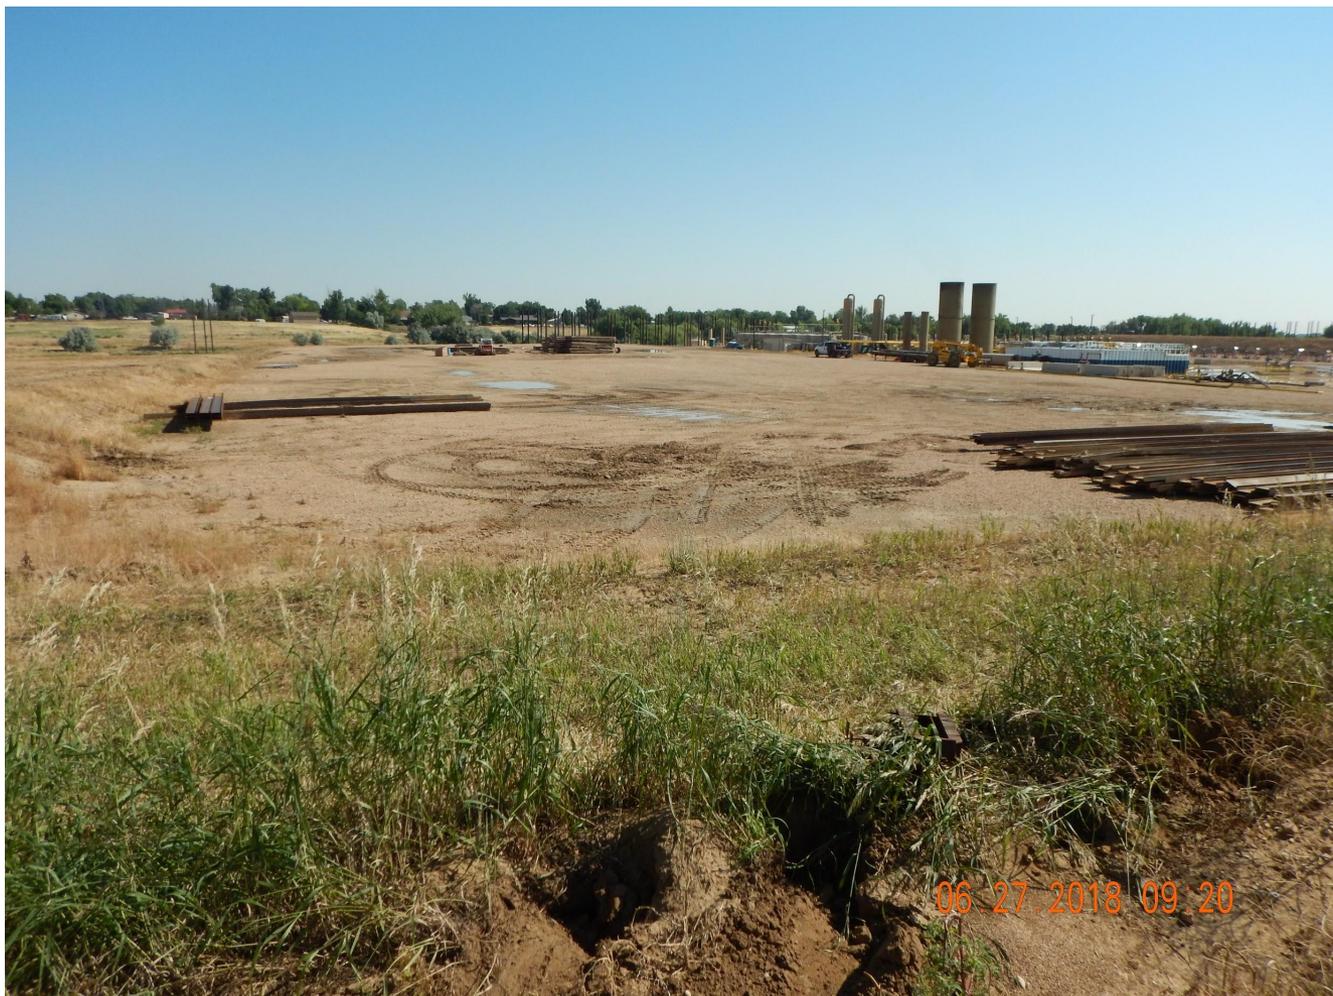
Photo 11. Photo taken of the southwestern perimeter of location, facing North. Photo illustrates the MLVT area that has not been reclaimed per Rule 1003.

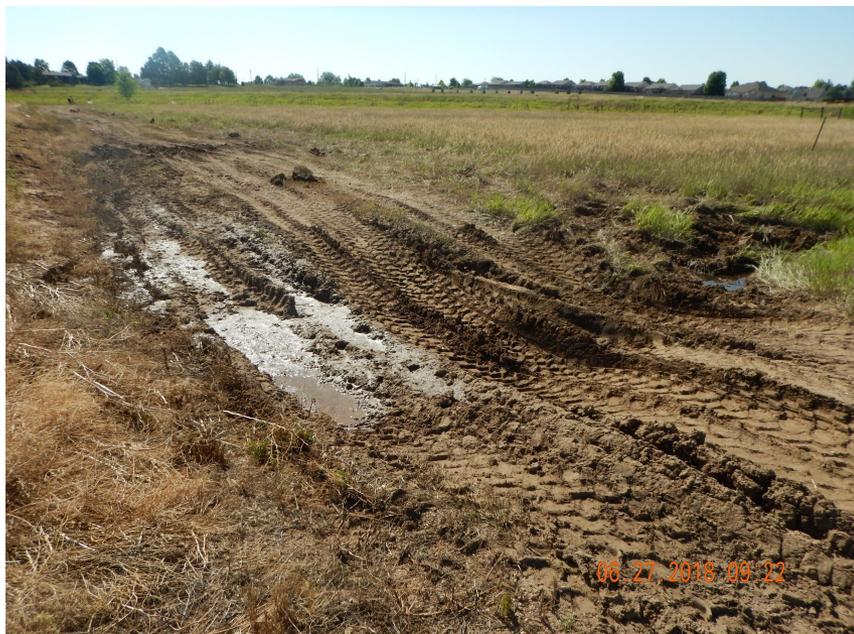
Photo 12. Photo taken from the southern perimeter of location, facing East. Surface damages due to sound wall removal shall be repaired and reclaimed. Note: Surface disturbance due to sound wall removal was observed outside of the permitted area along the west, east and northeastern areas.

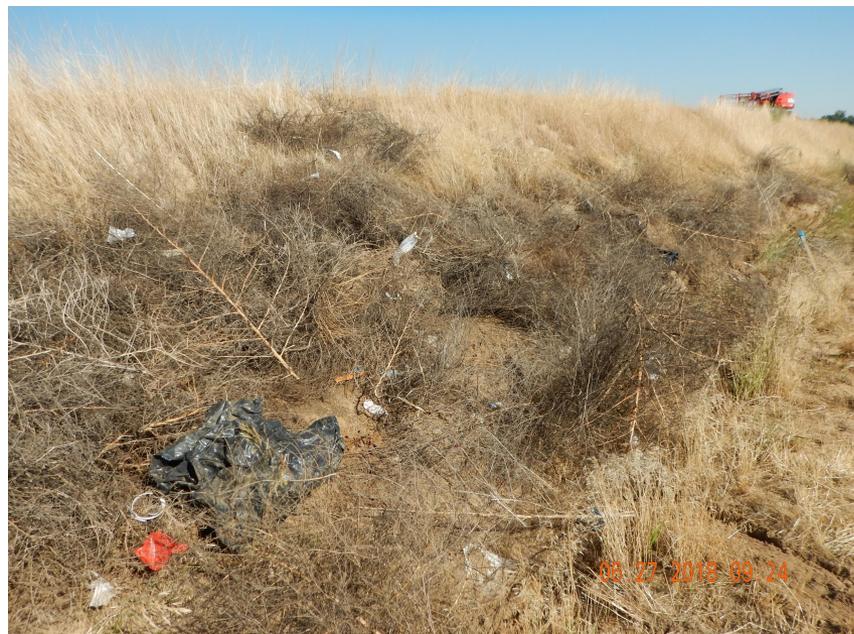
Photo 13. Photo taken from the southeastern perimeter of location, facing Northwest. Photo illustrates weed debris (Kochia weeds) and trash that shall be controlled and managed per Rule 603.f.

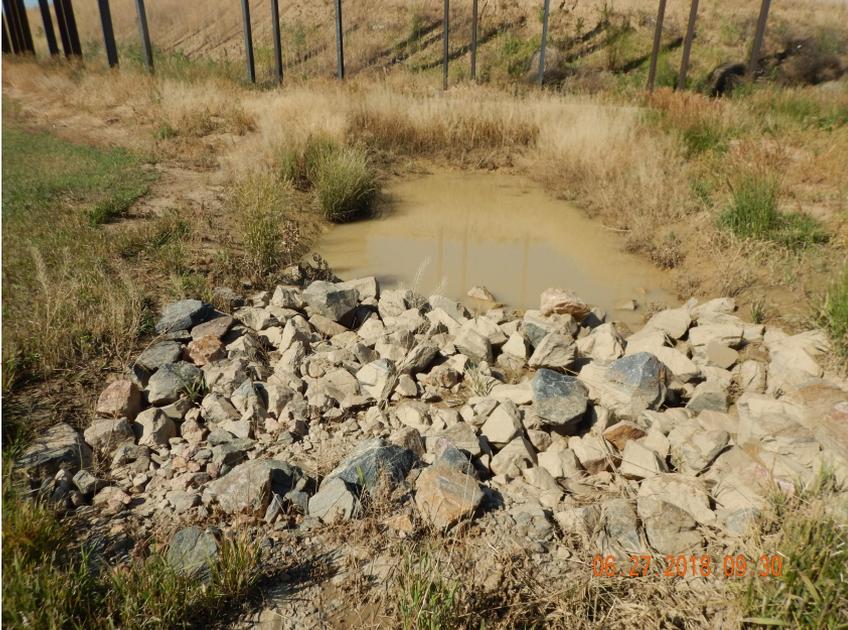
Photo 14. Photo taken from the northeastern perimeter of location, facing Southwest. Appears some sediment discharge was observed beyond the stabilized outlet area.

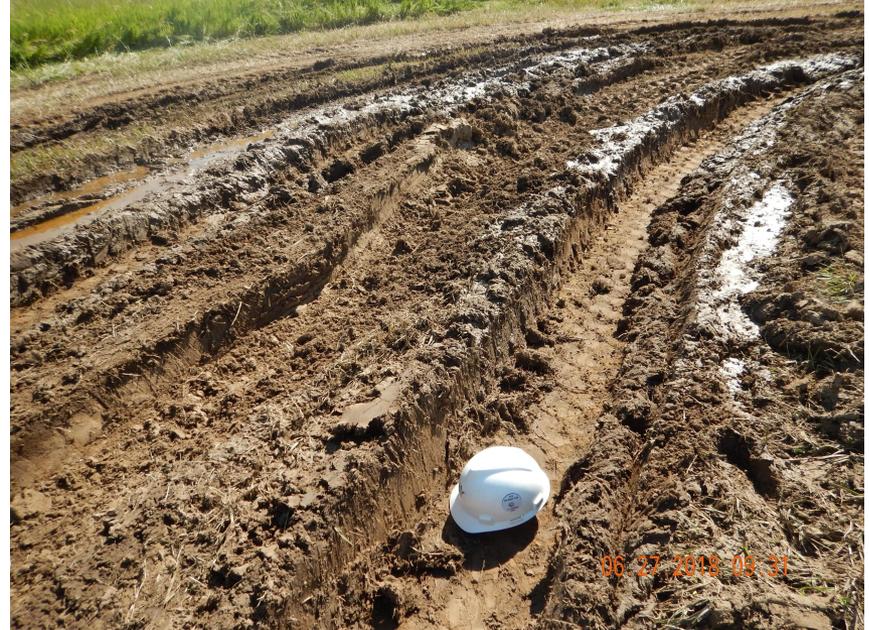
Photo 15. Photo taken from the northeastern perimeter of location, facing East. Photo illustrates rutting from equipment traffic due to sound wall removal.

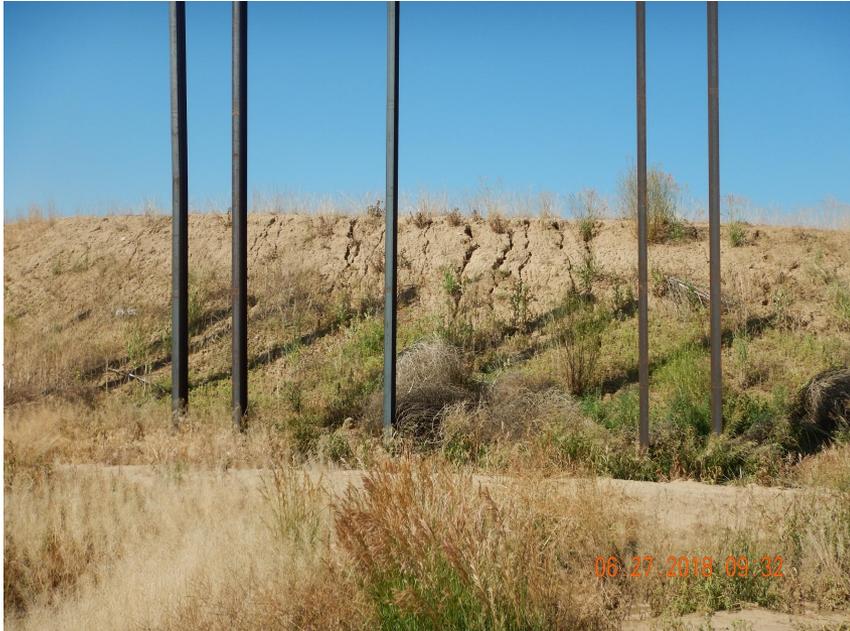
Photo 16. Photo taken from the northeastern perimeter of location, facing South. Photo illustrates rill erosion on the eastern earthen berm that has not been maintained to reasonably minimize erosion and site degradation per Rule 1002.e.

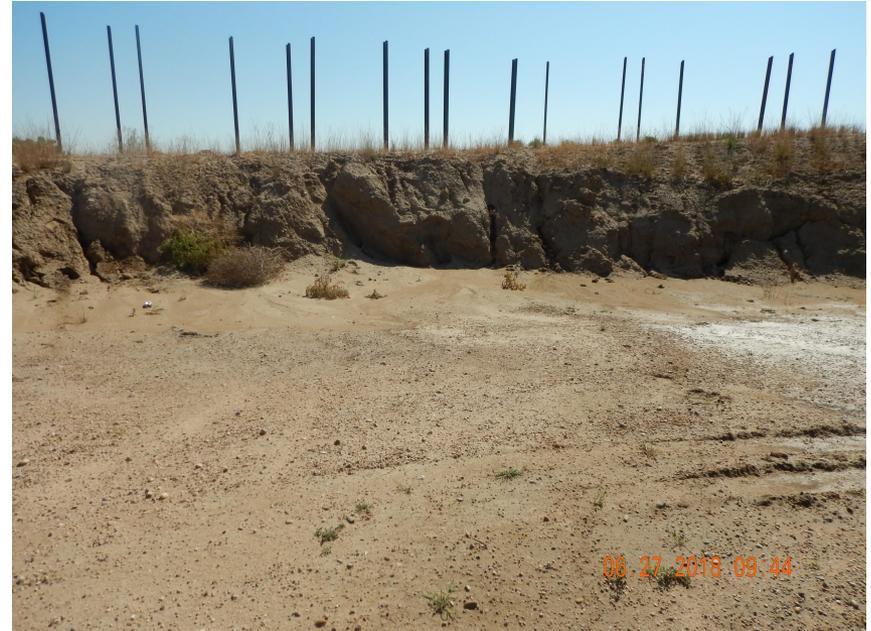
Photo 17. Photo taken from the northeastern well pad, facing East. Photo illustrates rill and gully erosion on the eastern earthen berm. See comments under Photo 16.

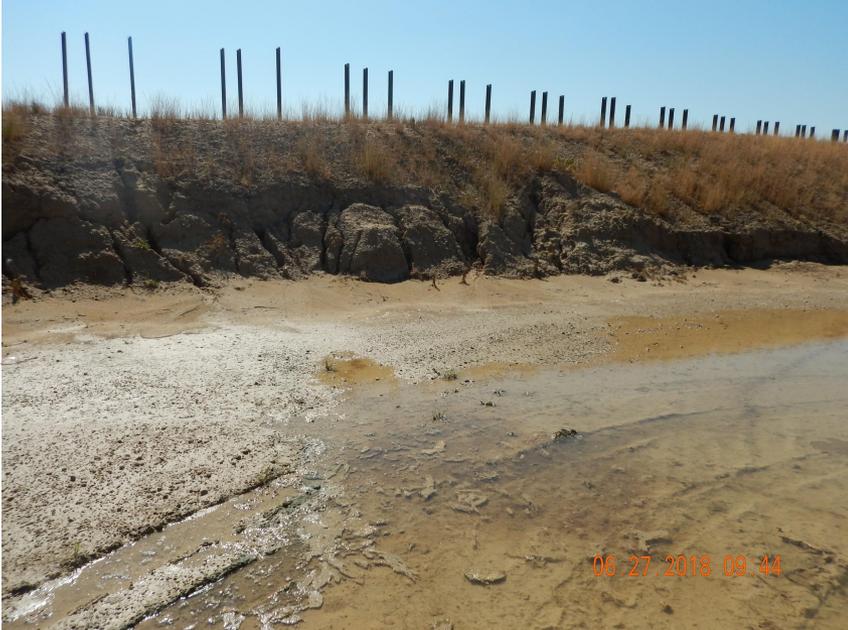
Photo 18. Photo taken from the eastern well pad, facing East. See comments under Photo 17.

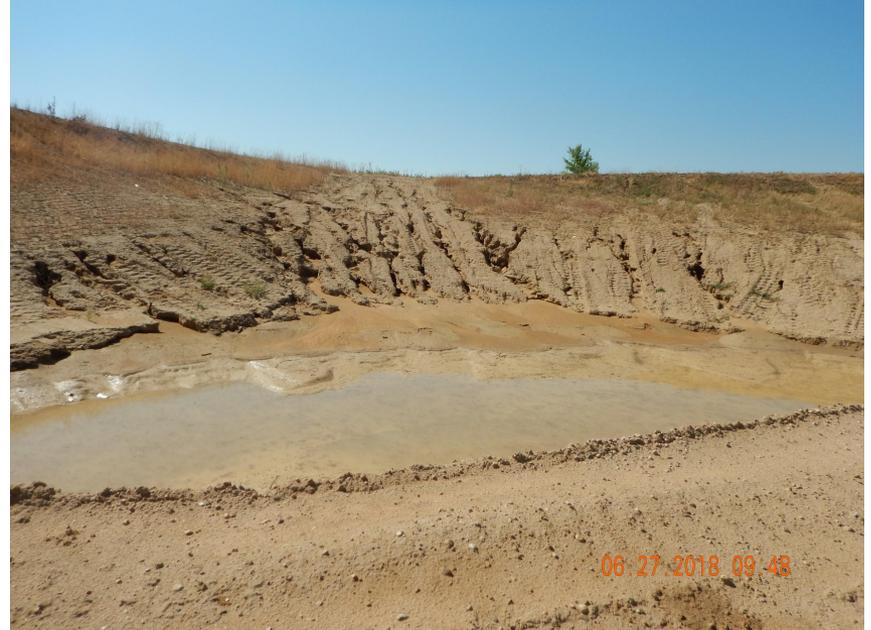
Photo 19. Photo taken from the southeast well pad, facing South. See comments under Photo 17.

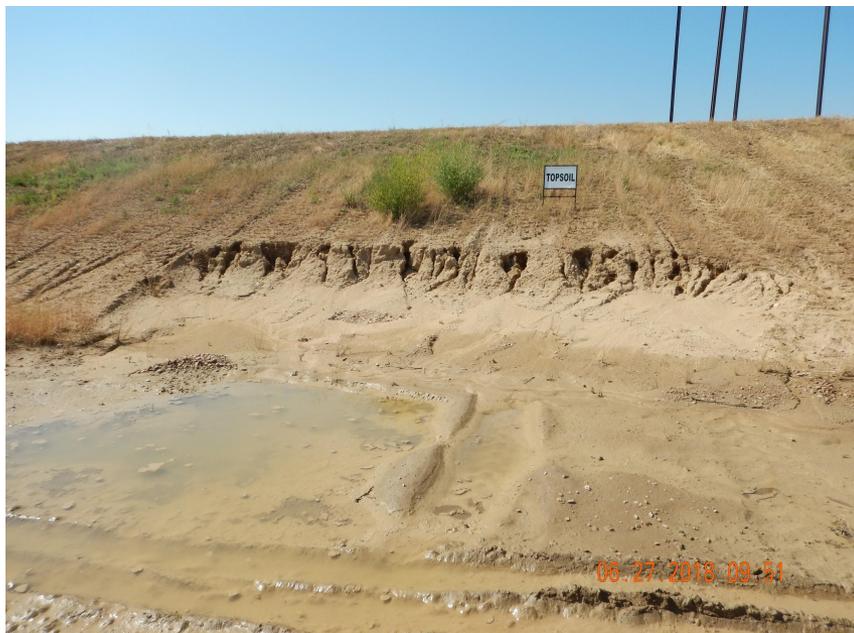
Photo 20. Photo taken from the southern well pad, facing South. Operator has failed to protect the topsoil stockpile from erosion per Rule 1002.c.

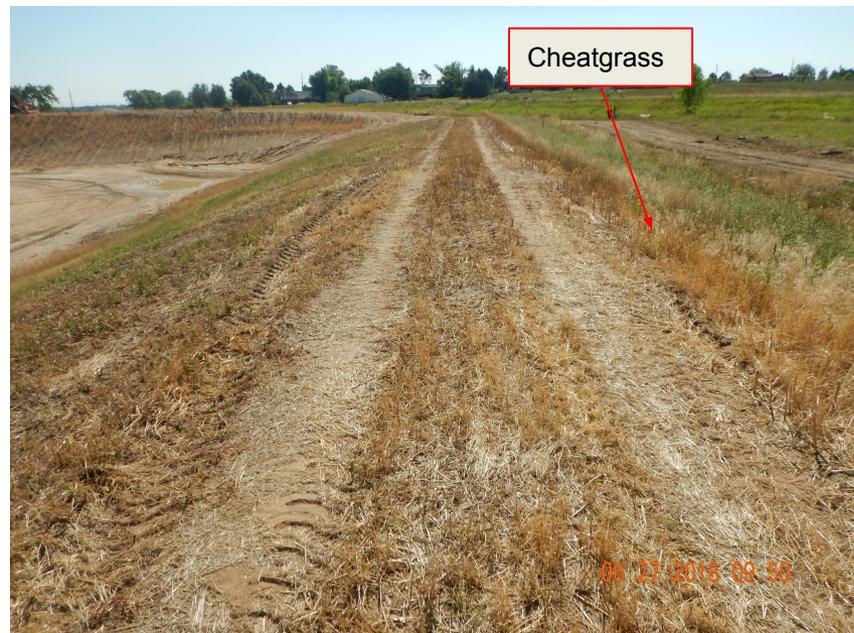
Photo 21. Photo taken from the topsoil stockpile, facing East. Operator has failed to protect the topsoil stockpile from compaction and weed establishment. Appears the Operator only seeded the north-facing slope while the south-facing slope has cheatgrass establishment.
