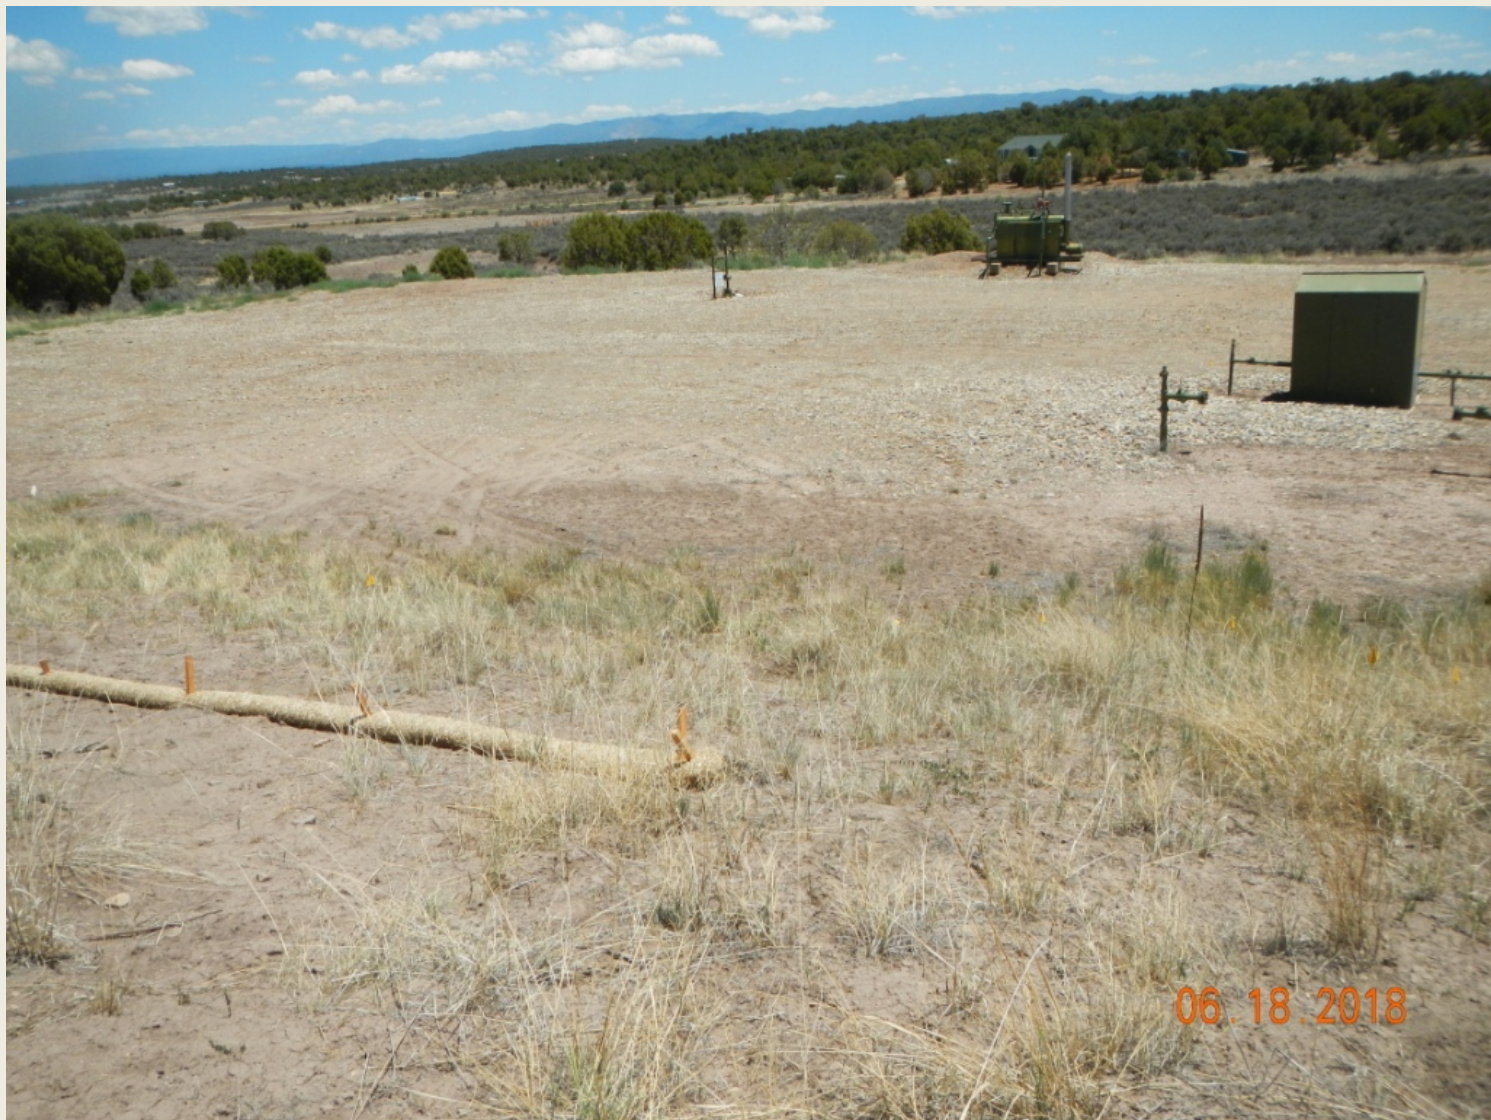
**Photo 1. View of the project area from the southwestern corner facing center.**

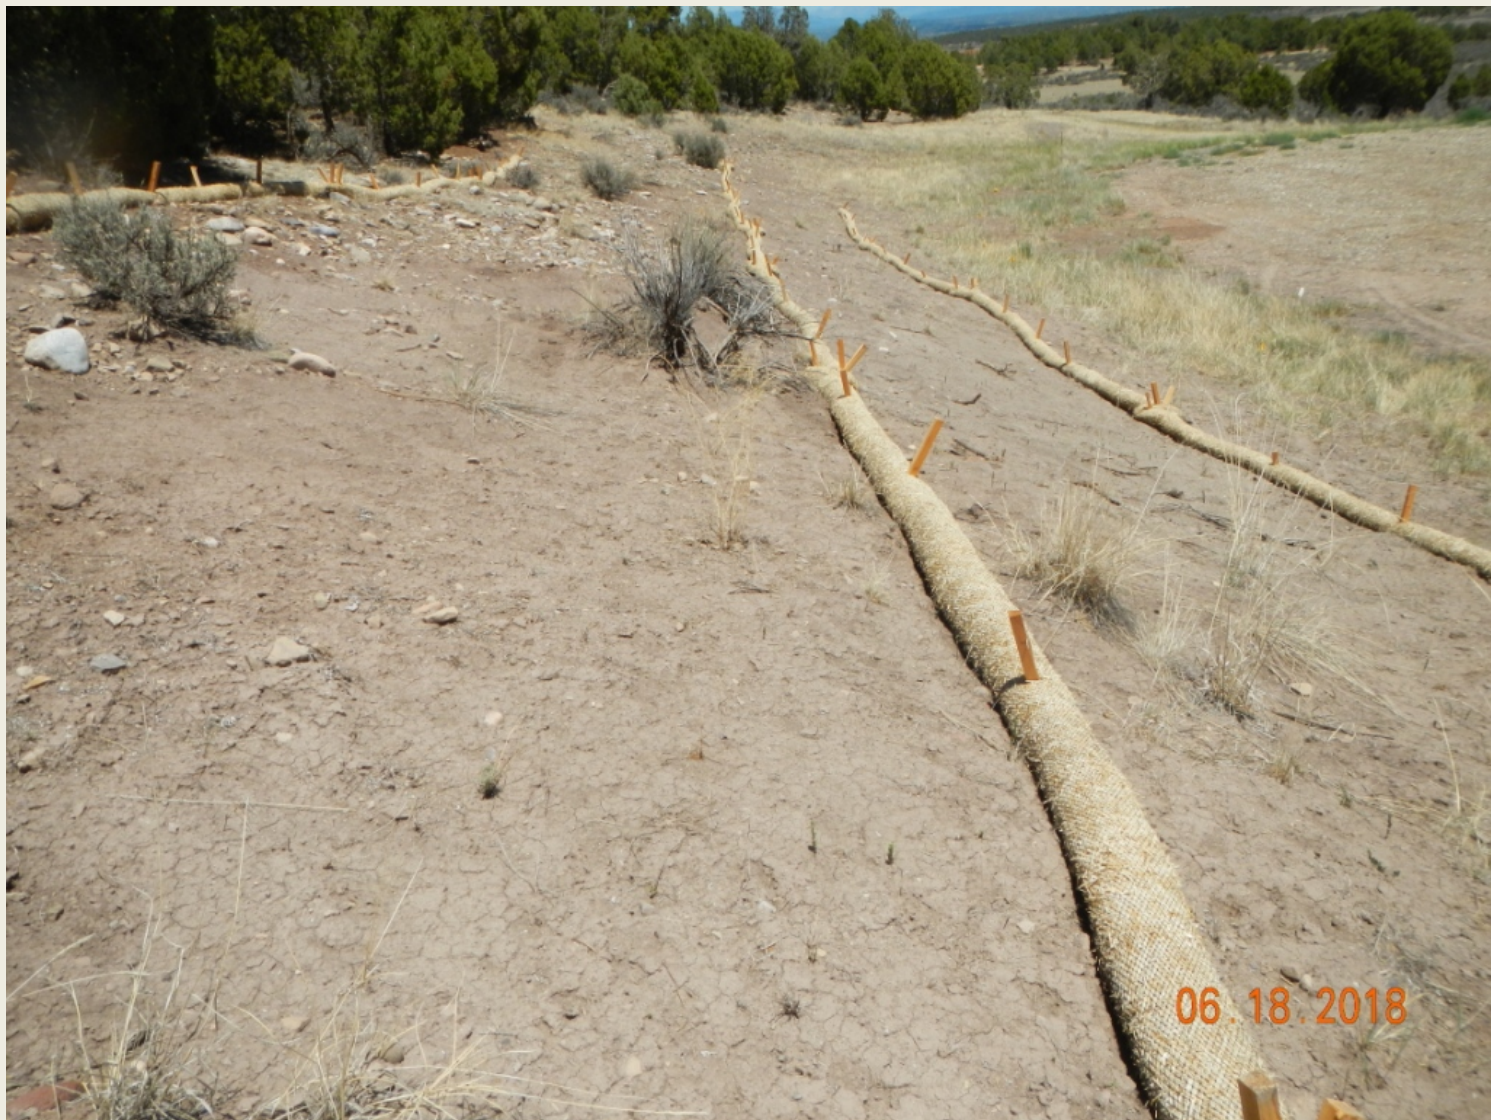
**Photo 2. View of the western cut-slope from the southwestern corner facing northward. Wattles are newly installed and rilling identified in earlier inspection is graded. Successful revegetation will help stabilize the slope.**

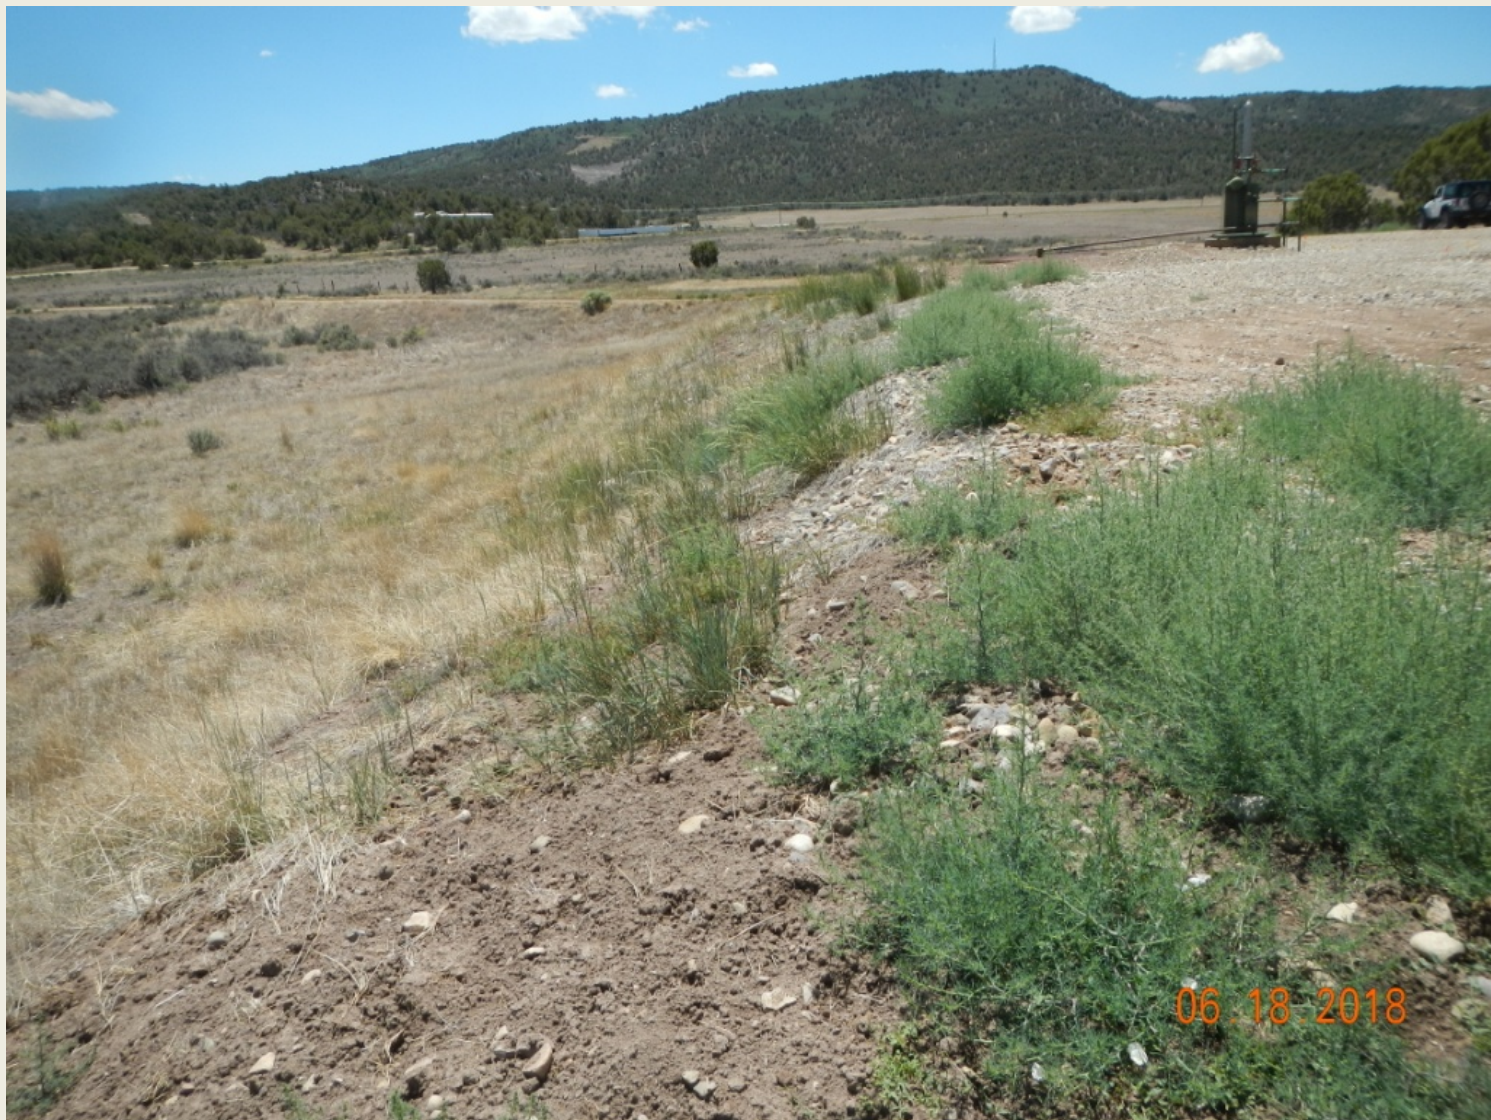
**Photo 3. View of the eastern portion of the project area from the northeastern corner facing southward.**

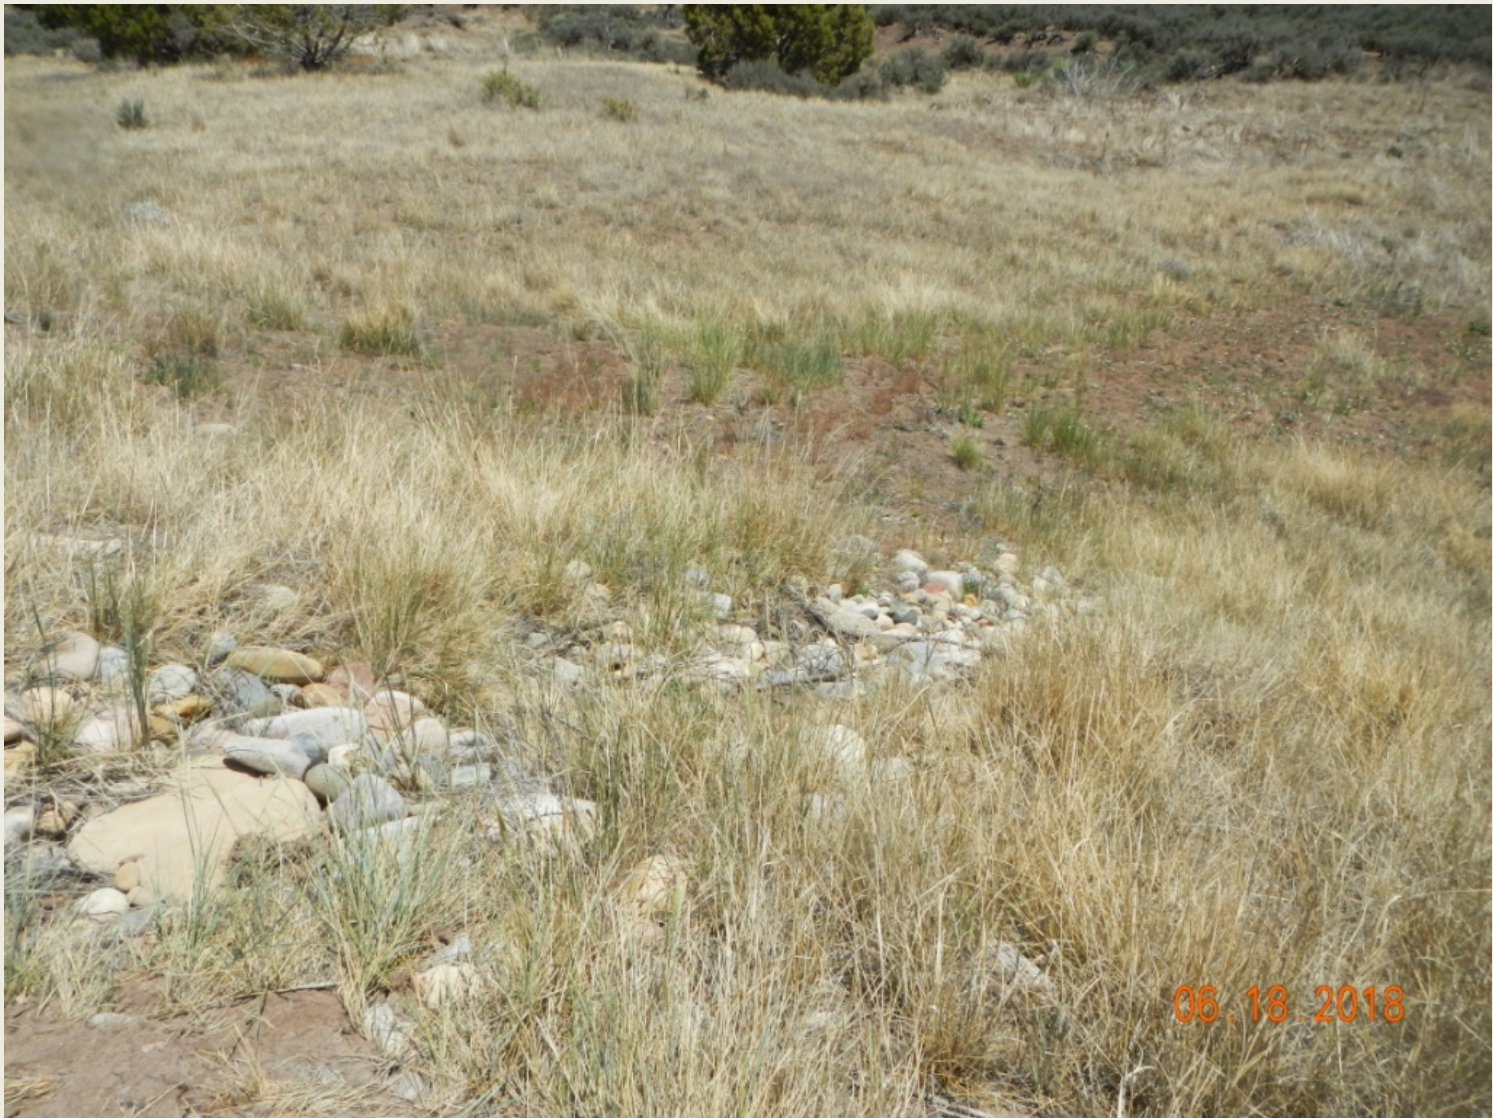
**Photo 4. View of cobble run-down in the eastern portion of the project area. Appears to be functioning at this time.**
