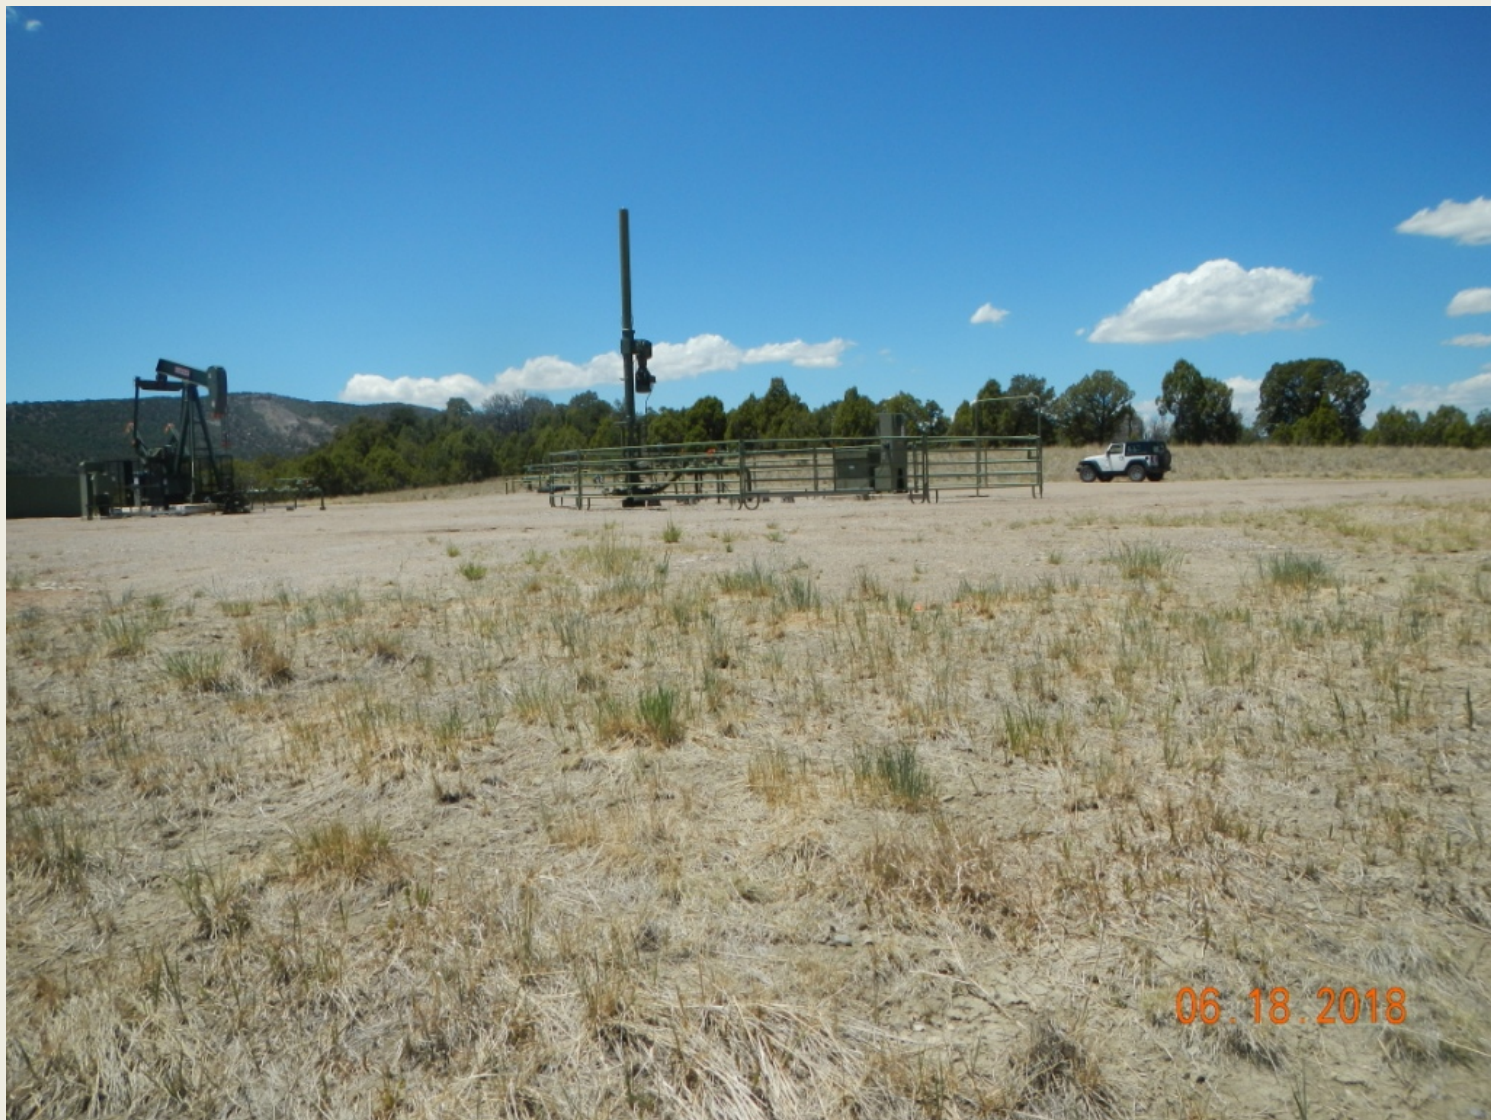
Photo 1. View of the project area from the eastern corner facing center.

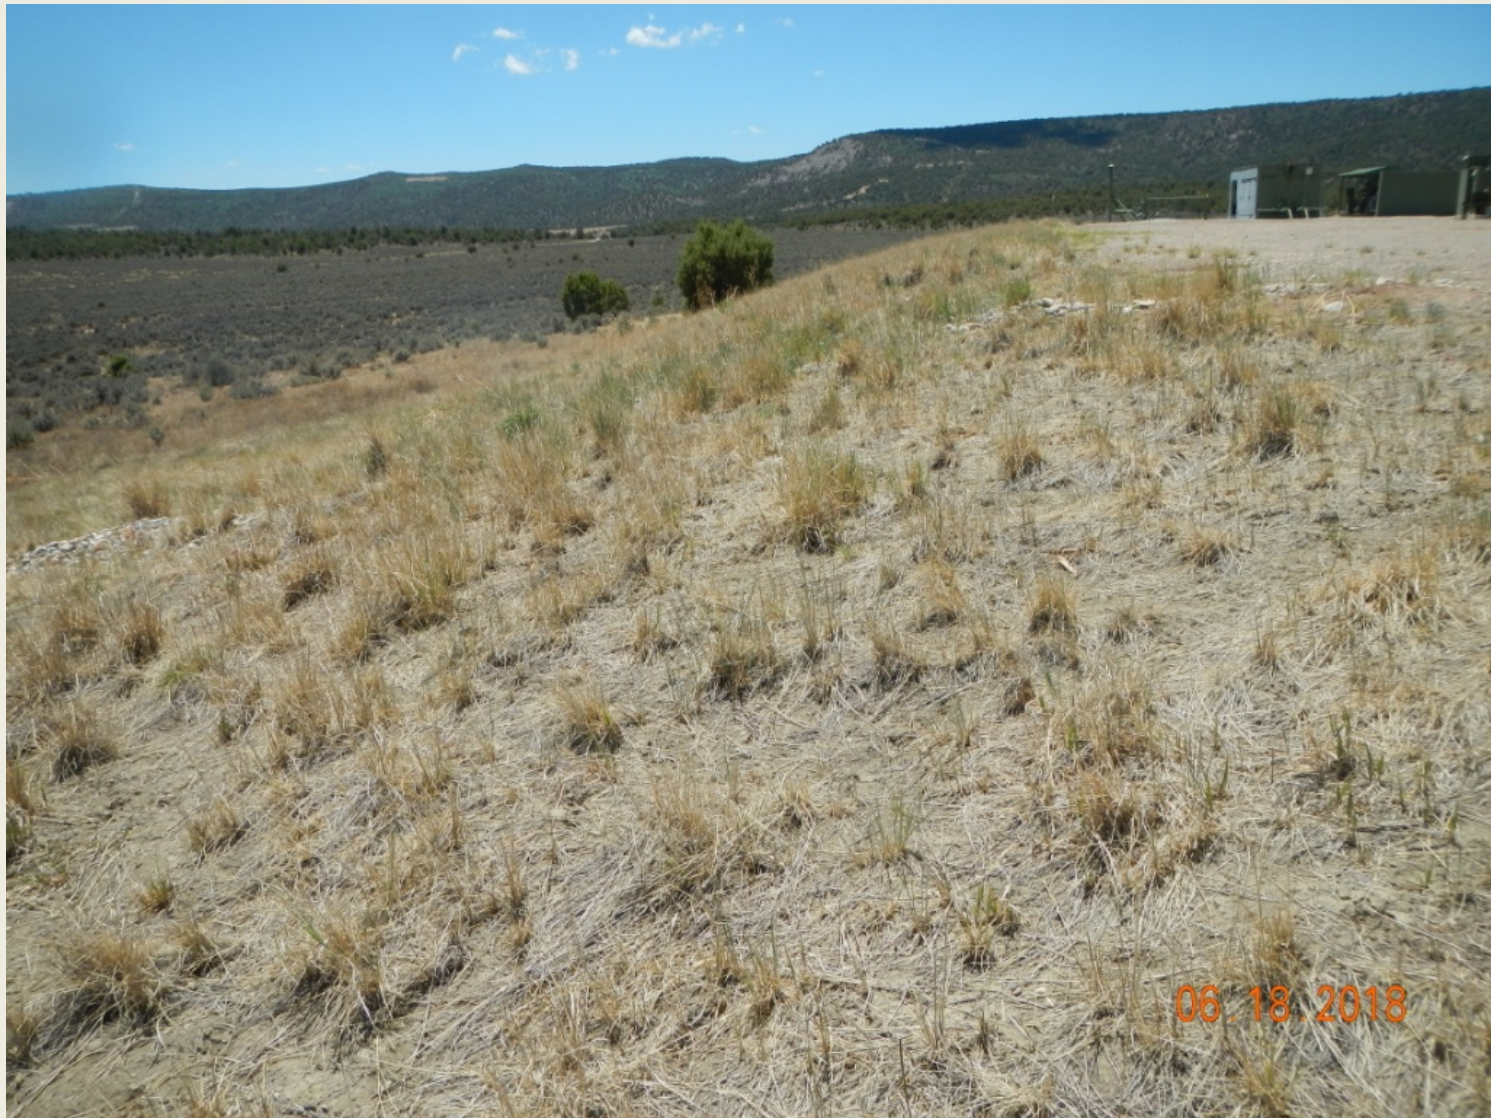
Photo 2. View of the eastern portion of the project area from the eastern corner facing from the southwestern corner facing southwestward. Revegetation is progressing with grasses such as intermediate wheatgrass (*Thinopyron intermedium*), western wheatgrass (*Pascopyrum smithii*), and sand dropseed (*Sporobolus cryptandrus*).

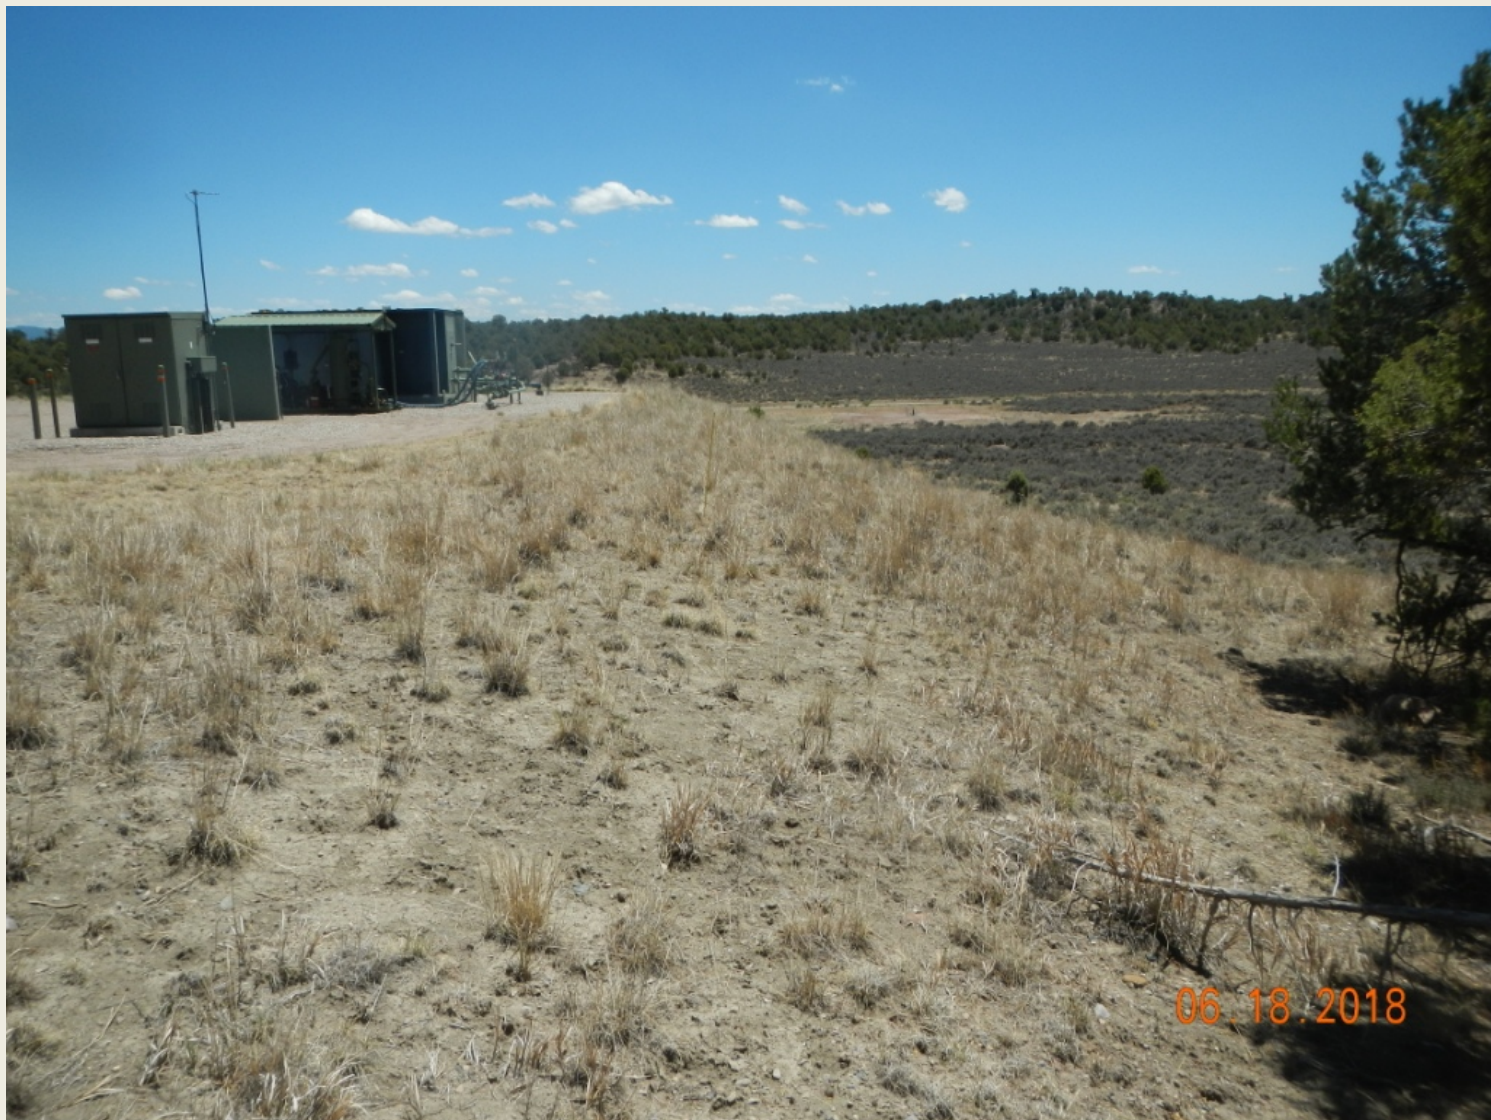
Photo 3. View of the southwestern portion of the project area from the southwestern corner facing southeastward.

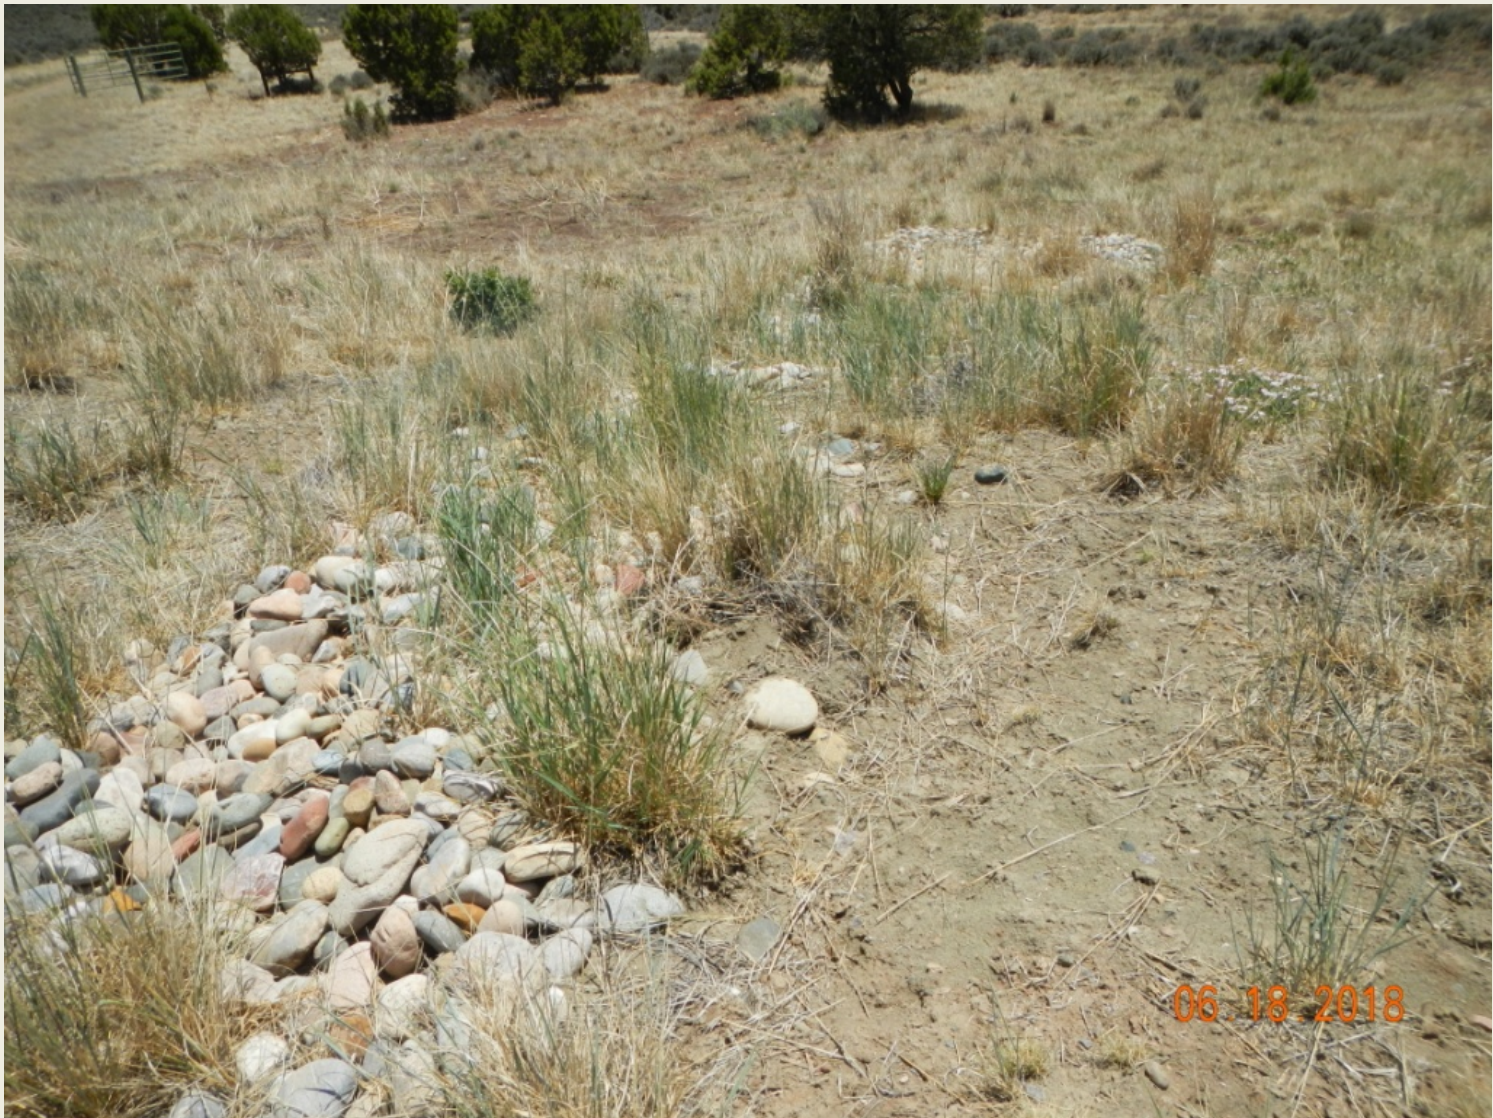
Photo 4. View of cobble run-down in the eastern portion of the project area. Appears to be functioning at this time.

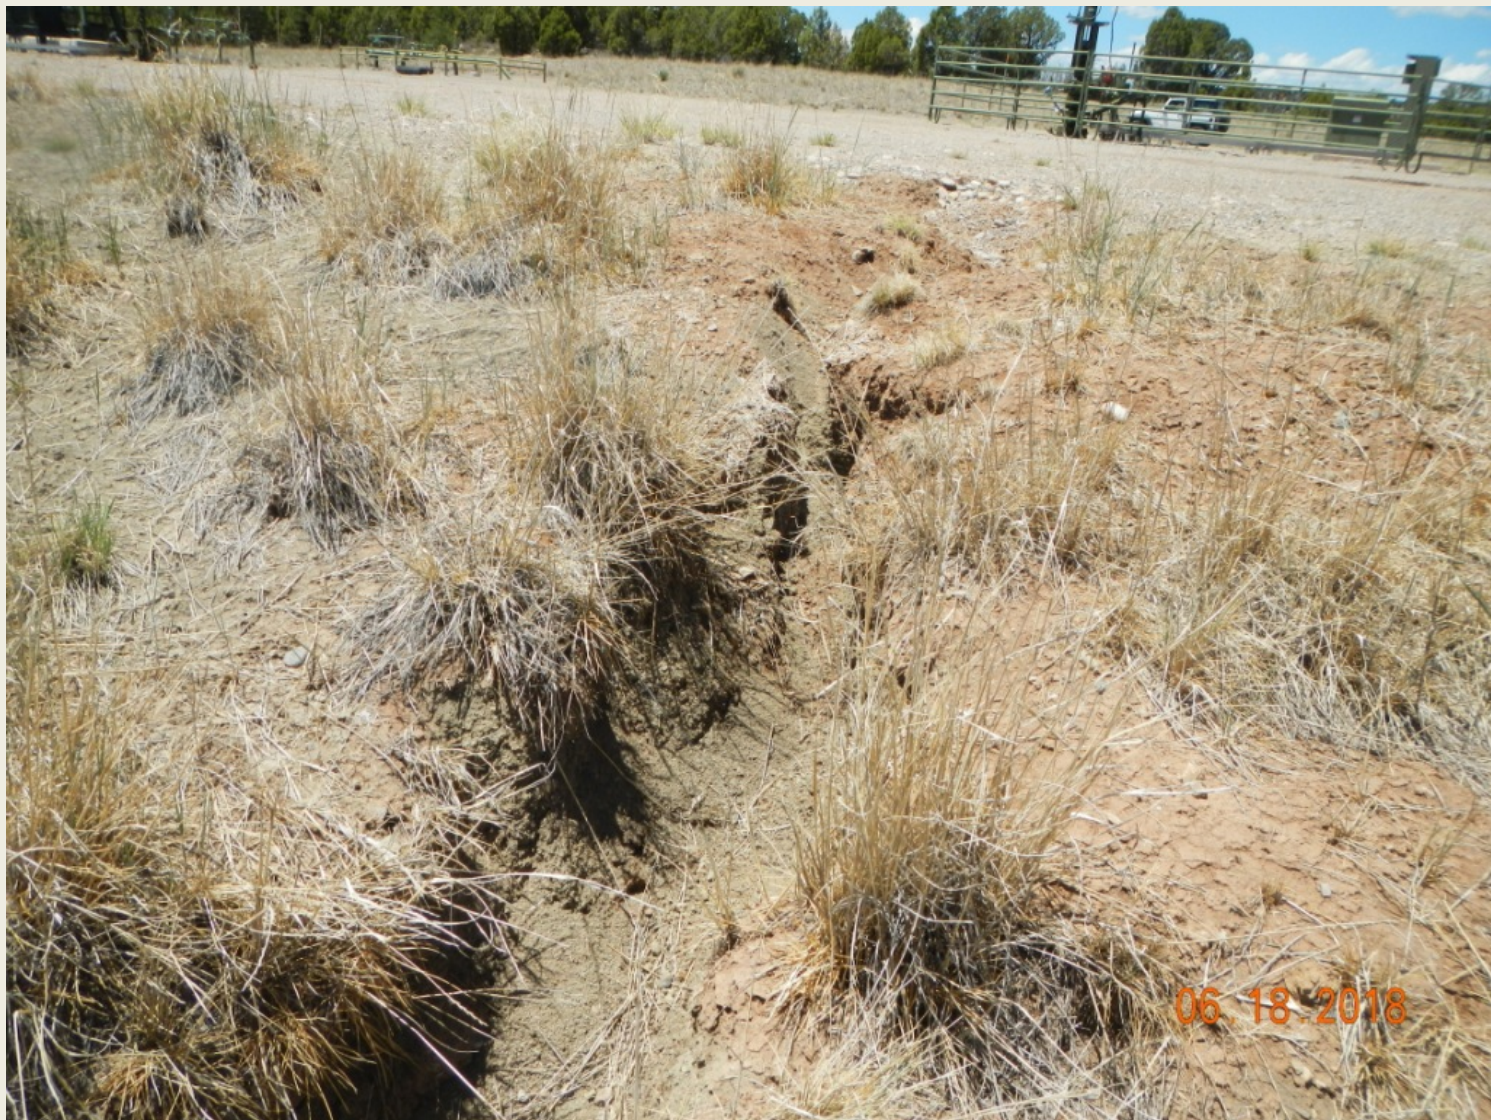
Photo 5. View of erosional channel approximately 2 feet wide and 2.5 feet deep in the eastern portion of the project area that needs stabilization.
