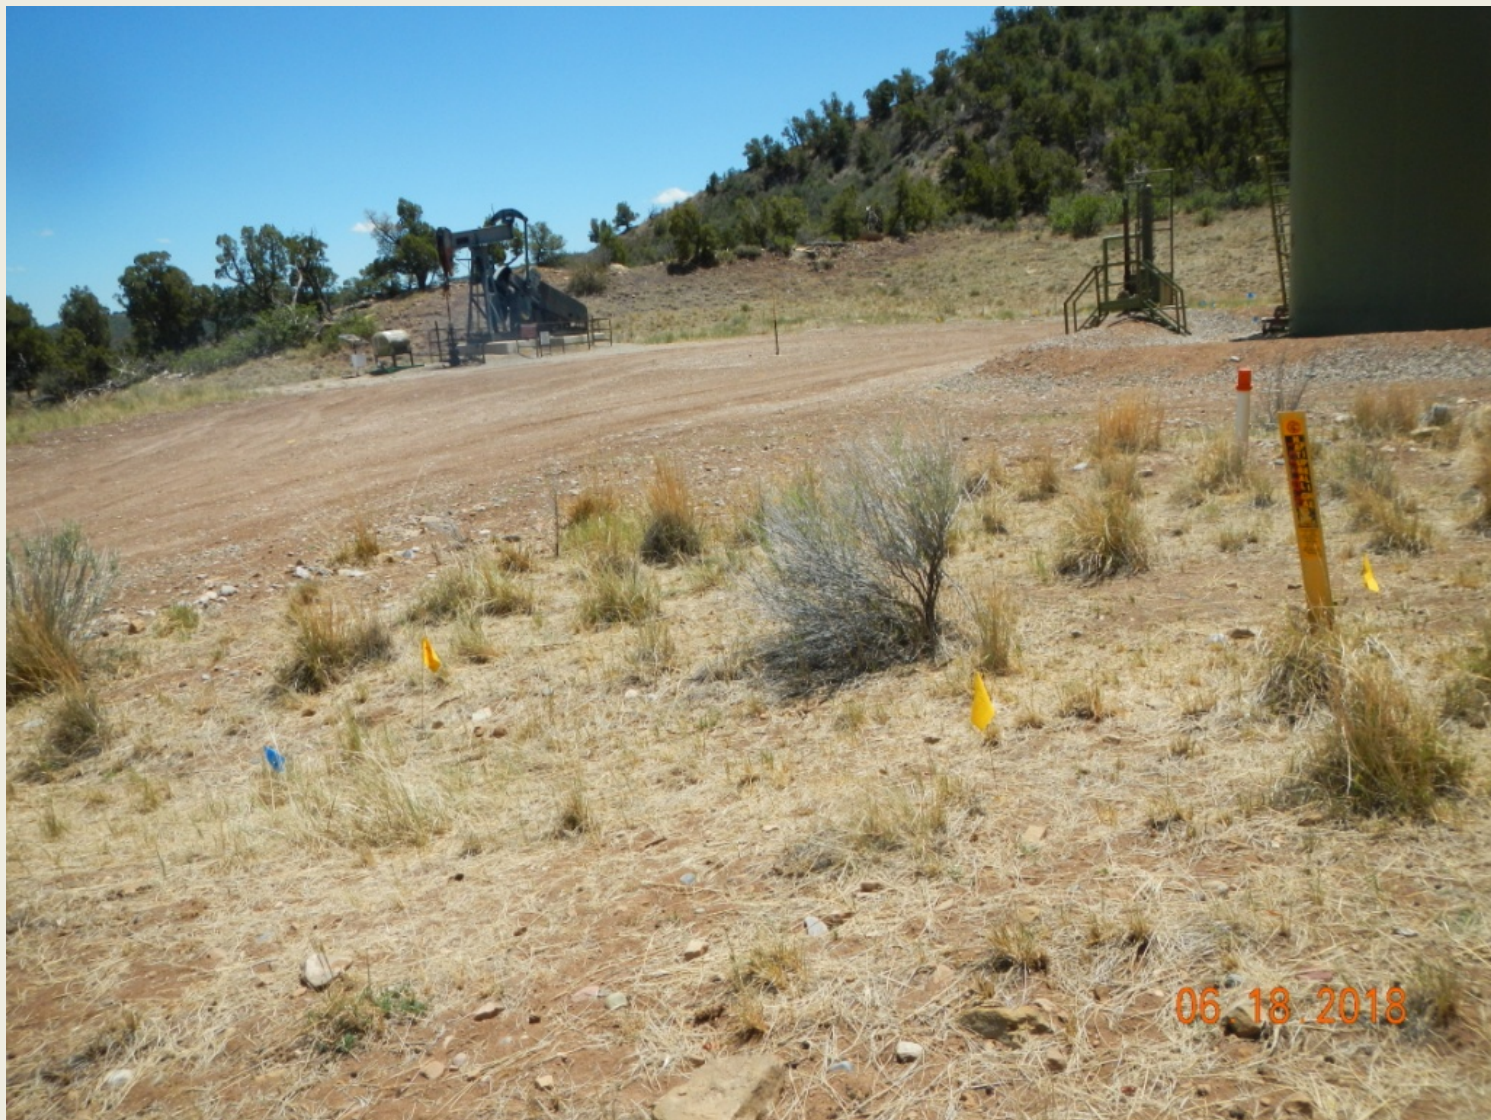
Photo 1. View of the project area from the western edge facing toward the center of the southern working area. Staked well is in place.

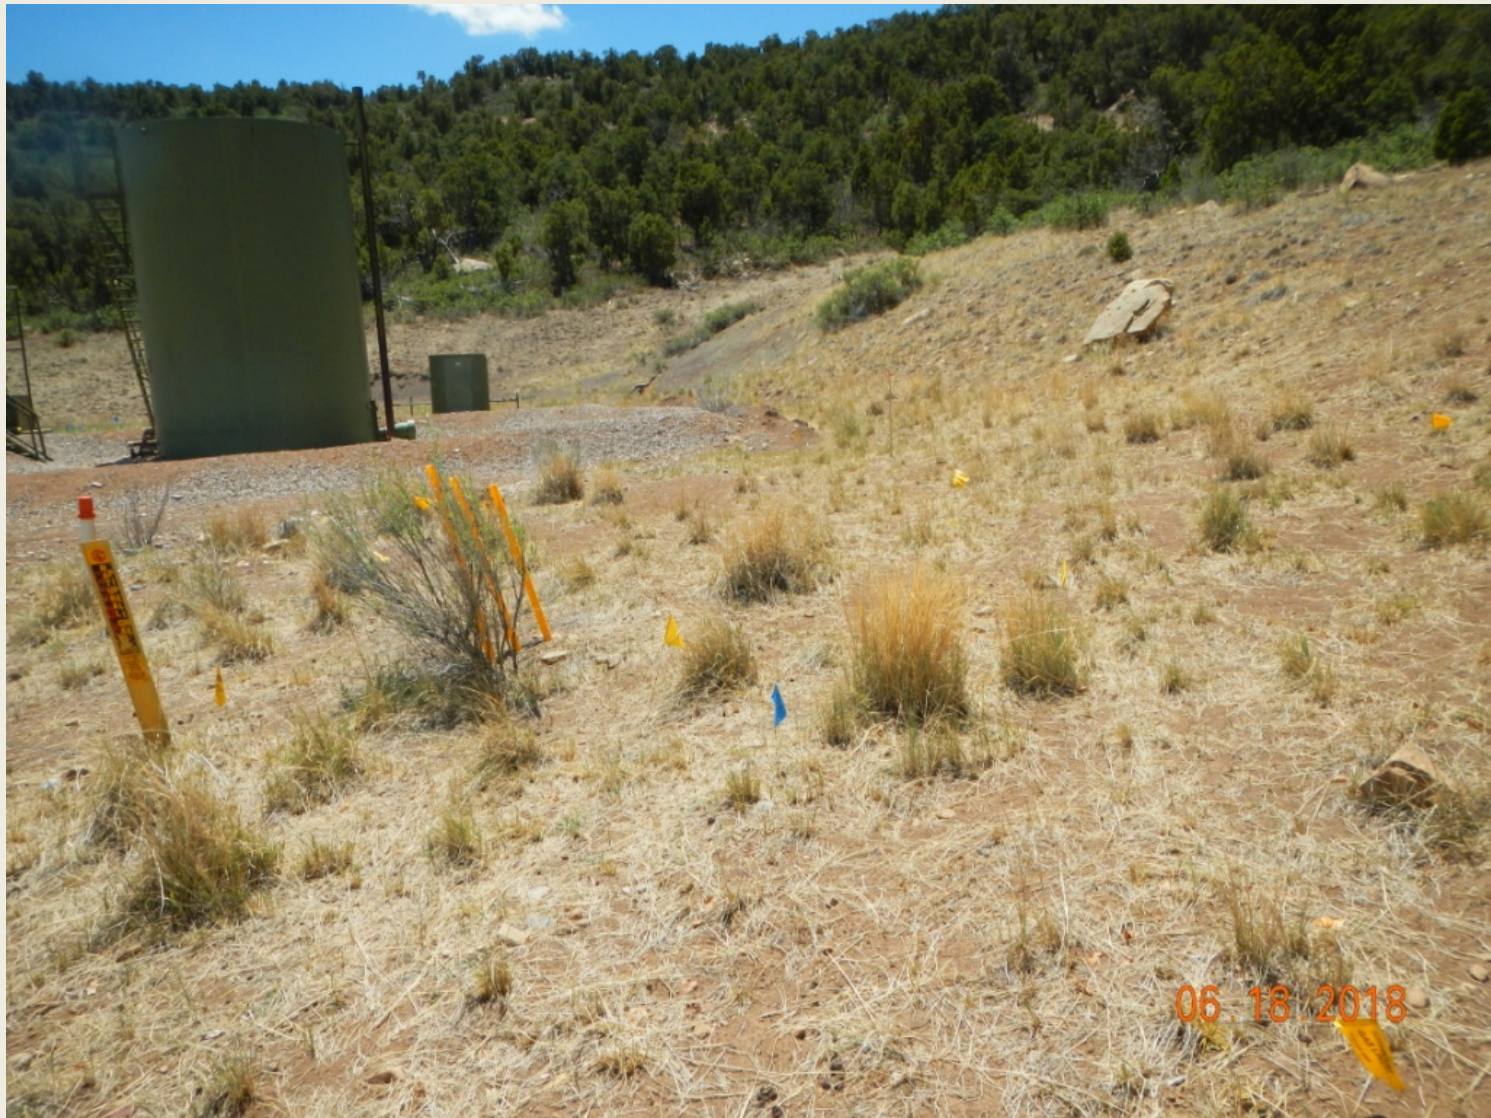
Photo 2. View of the southwestern portion of the project area from the western edge facing southward. Revegetation is progressing with shrubs and grasses such as rubber rabbitbrush (*Chrysothamnus nauseosus*), crested wheatgrass (*Agropyron cristatum*), and smooth brome (*Bromus inermis*).

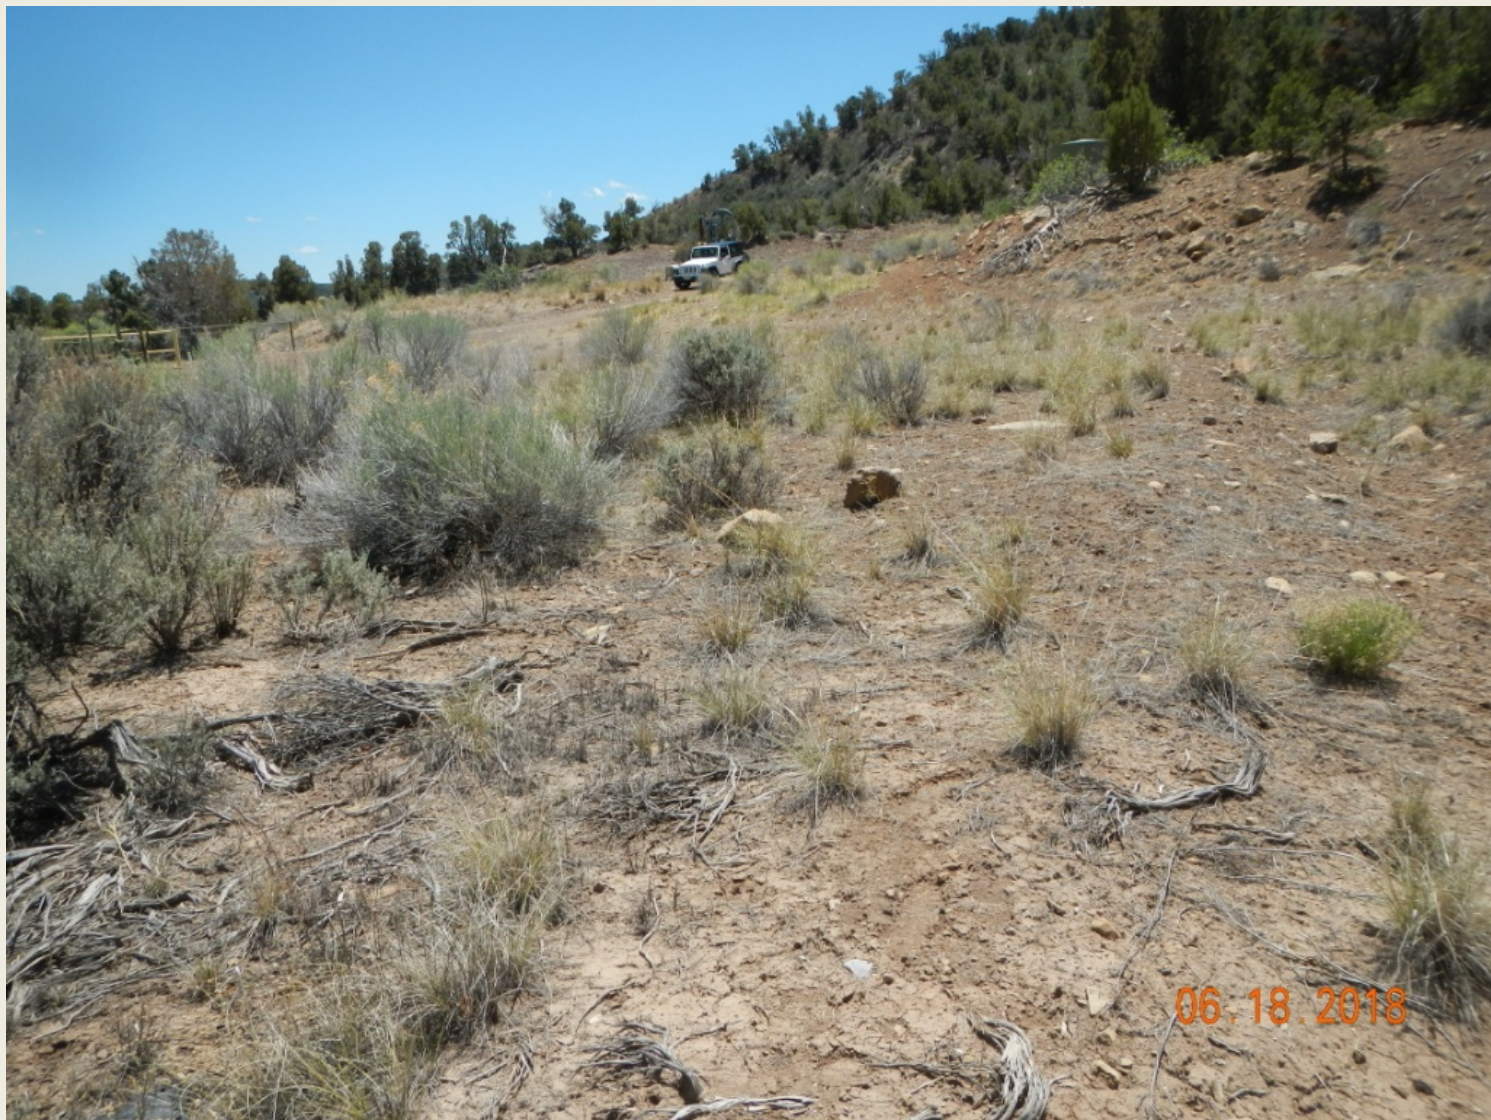
Photo 3. View of the northwestern corner of the northern portion of the project area facing southward.

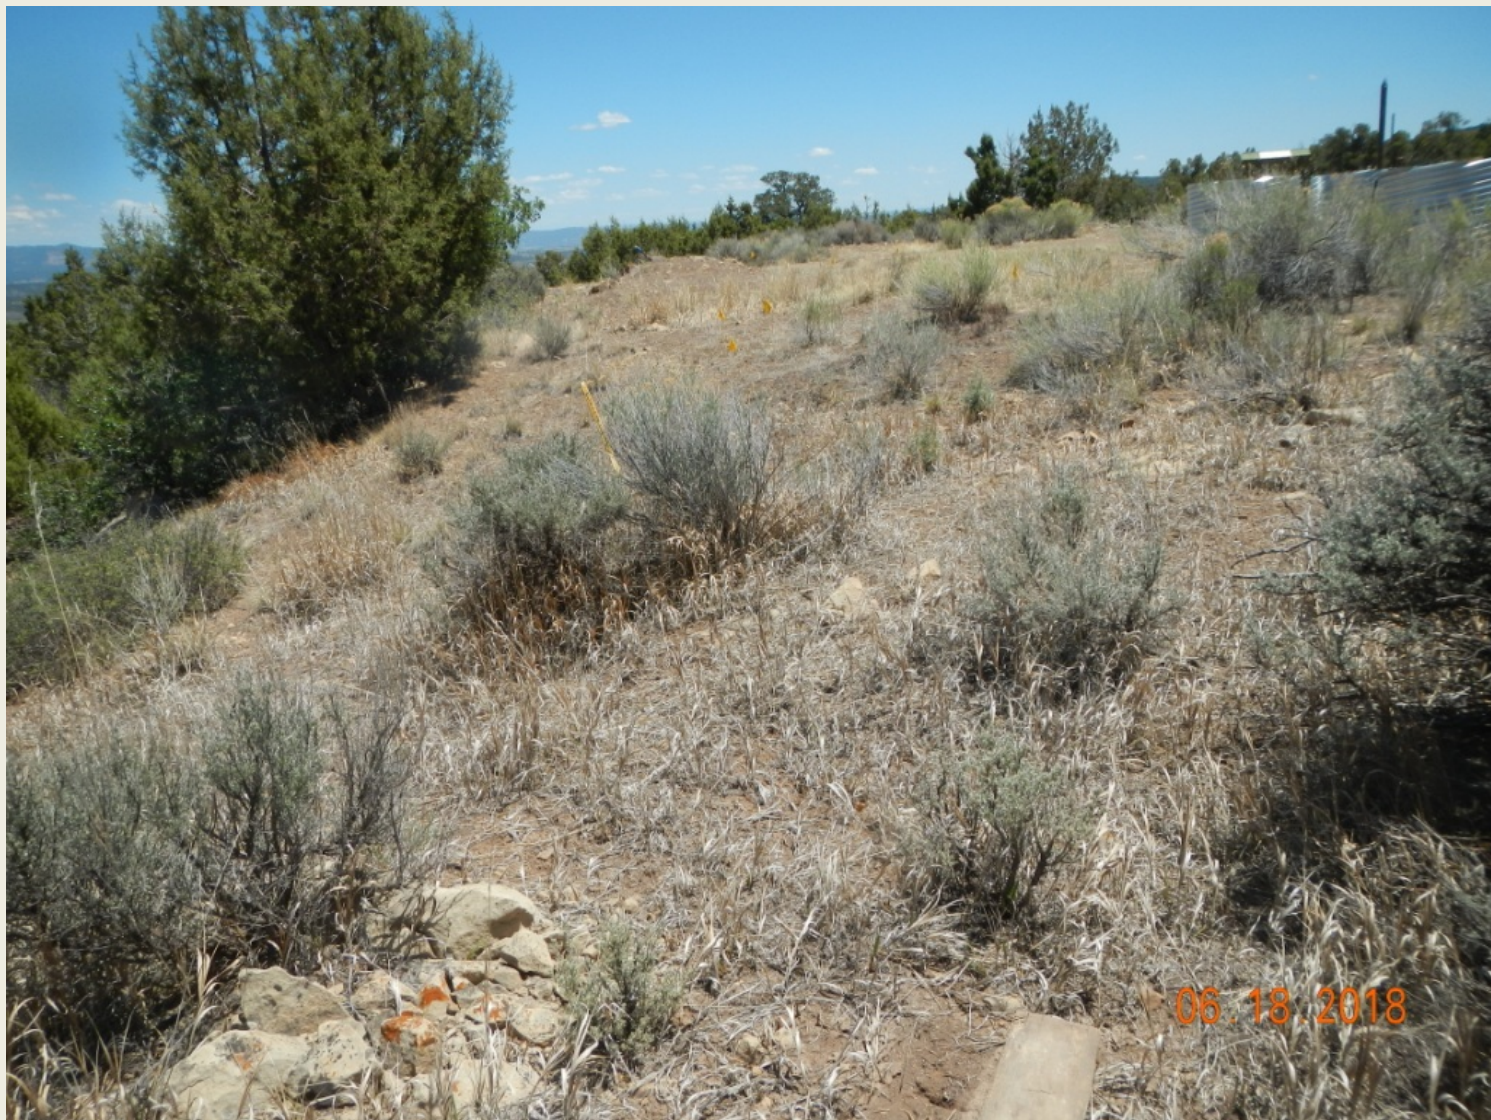
Photo 4. View of the northern portion of the project area from the northwestern corner facing eastward.

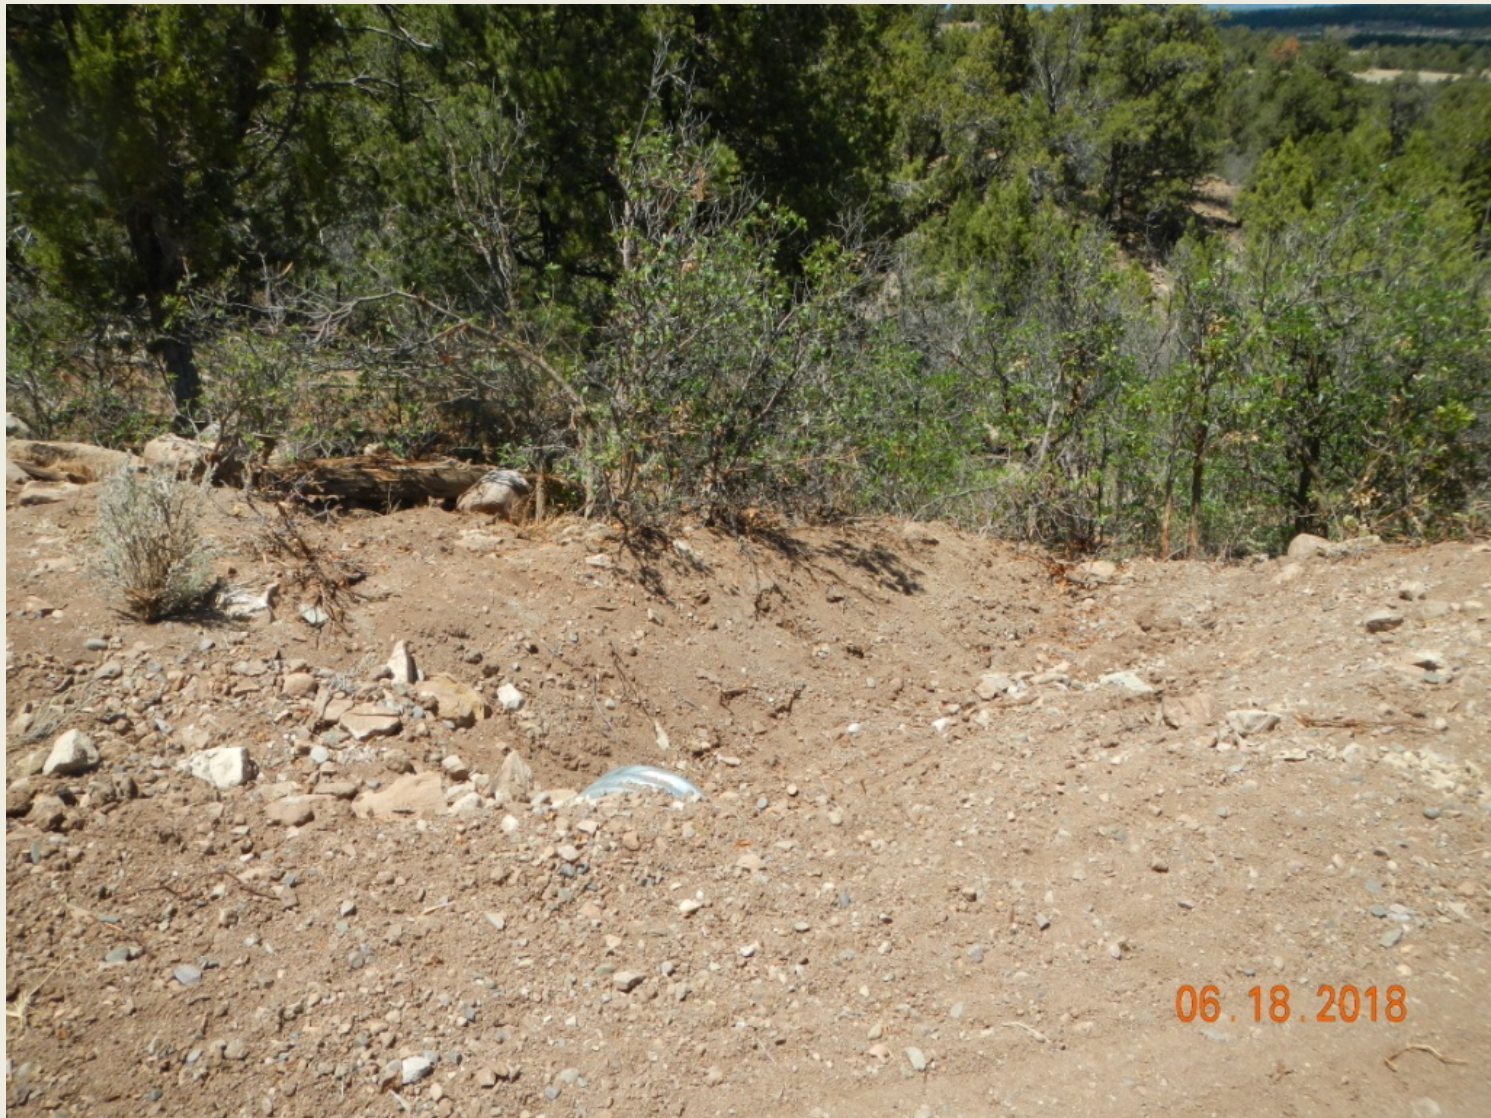
Photo 5. View of newly installed culvert outlet along the access road. It does not appear that stormwater flows exiting the culvert will be properly de-energized and will likely erode down the slope. Erosion and sediment controls should be installed to de-energize flows exiting the culvert and filter sediment. Loose soils need to be stabilized.

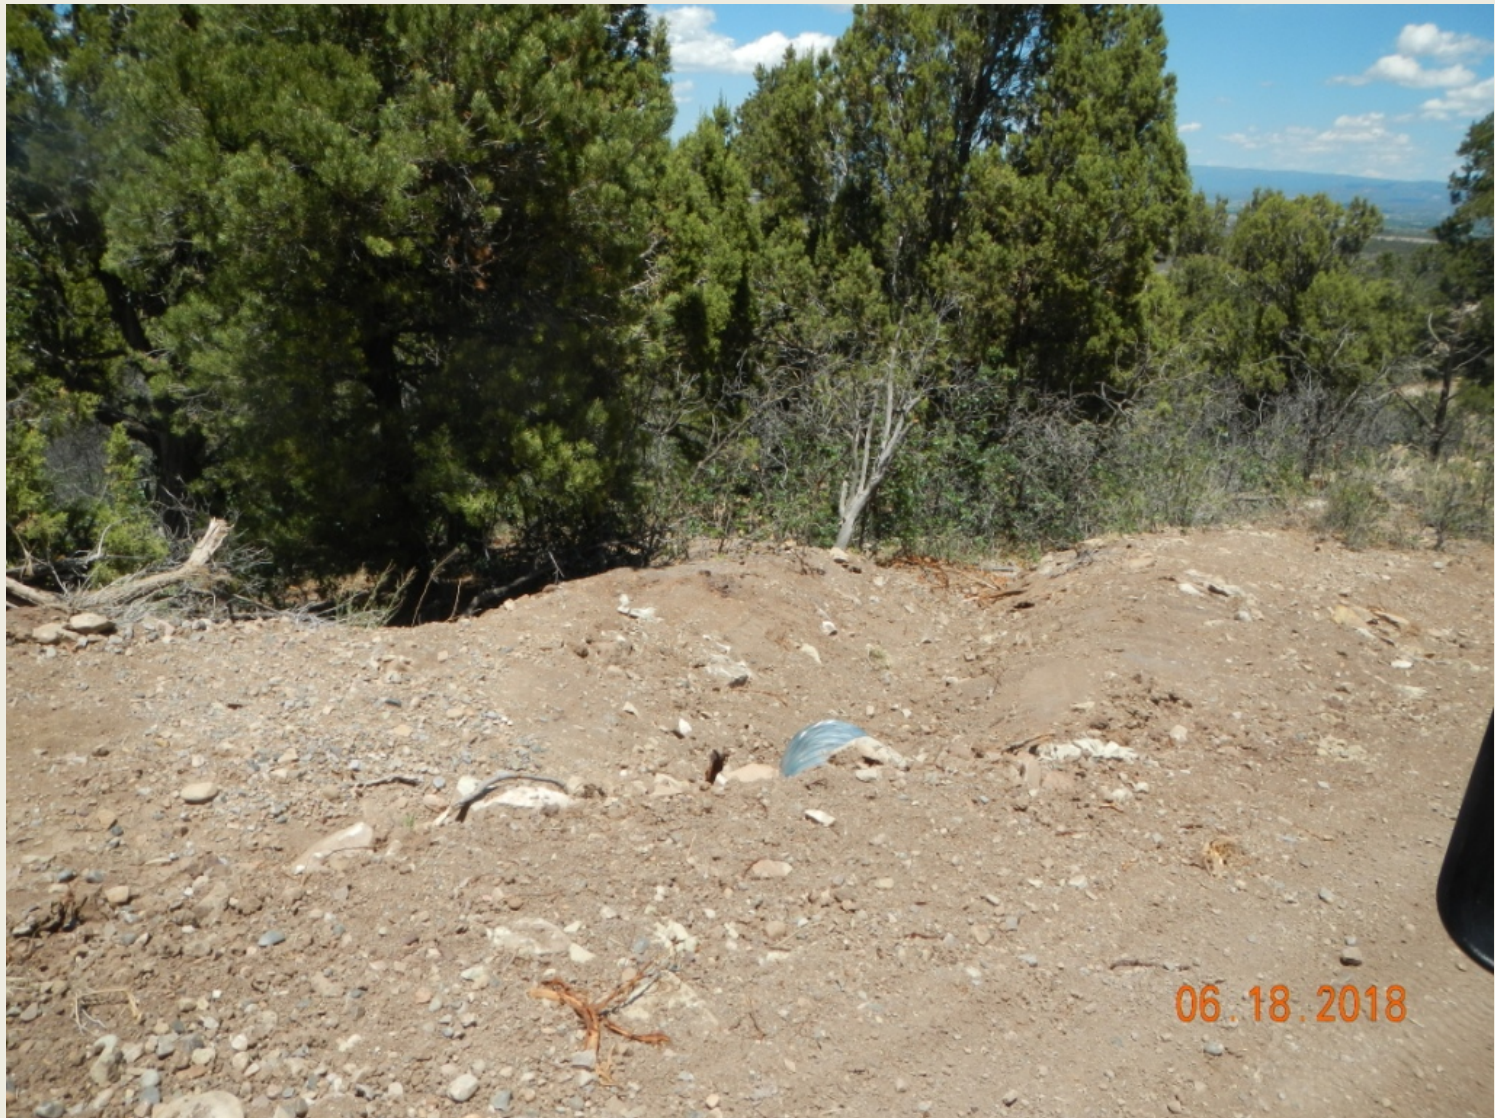
Photo 6. View of another newly installed culvert where loose soils are not properly stabilized and stormwater flows are diverted downslope without proper erosion and sediment controls.
