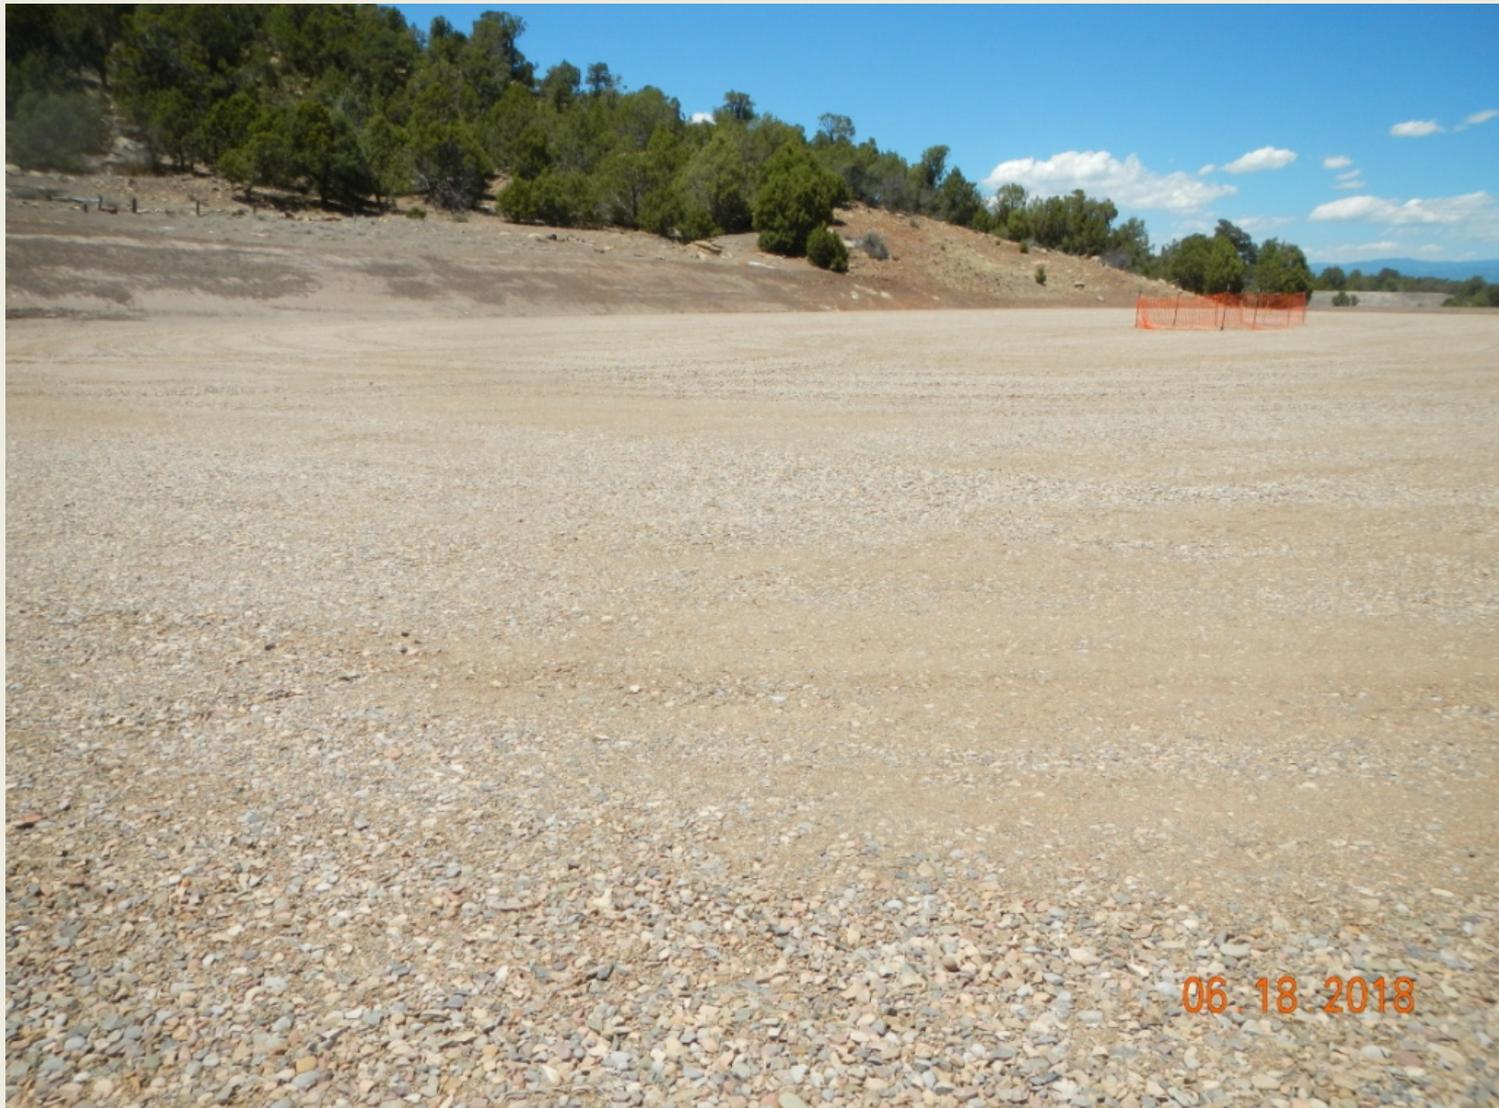
Photo 1. View of the project area from the southeastern corner facing center. Project area is re-graded and expanded.

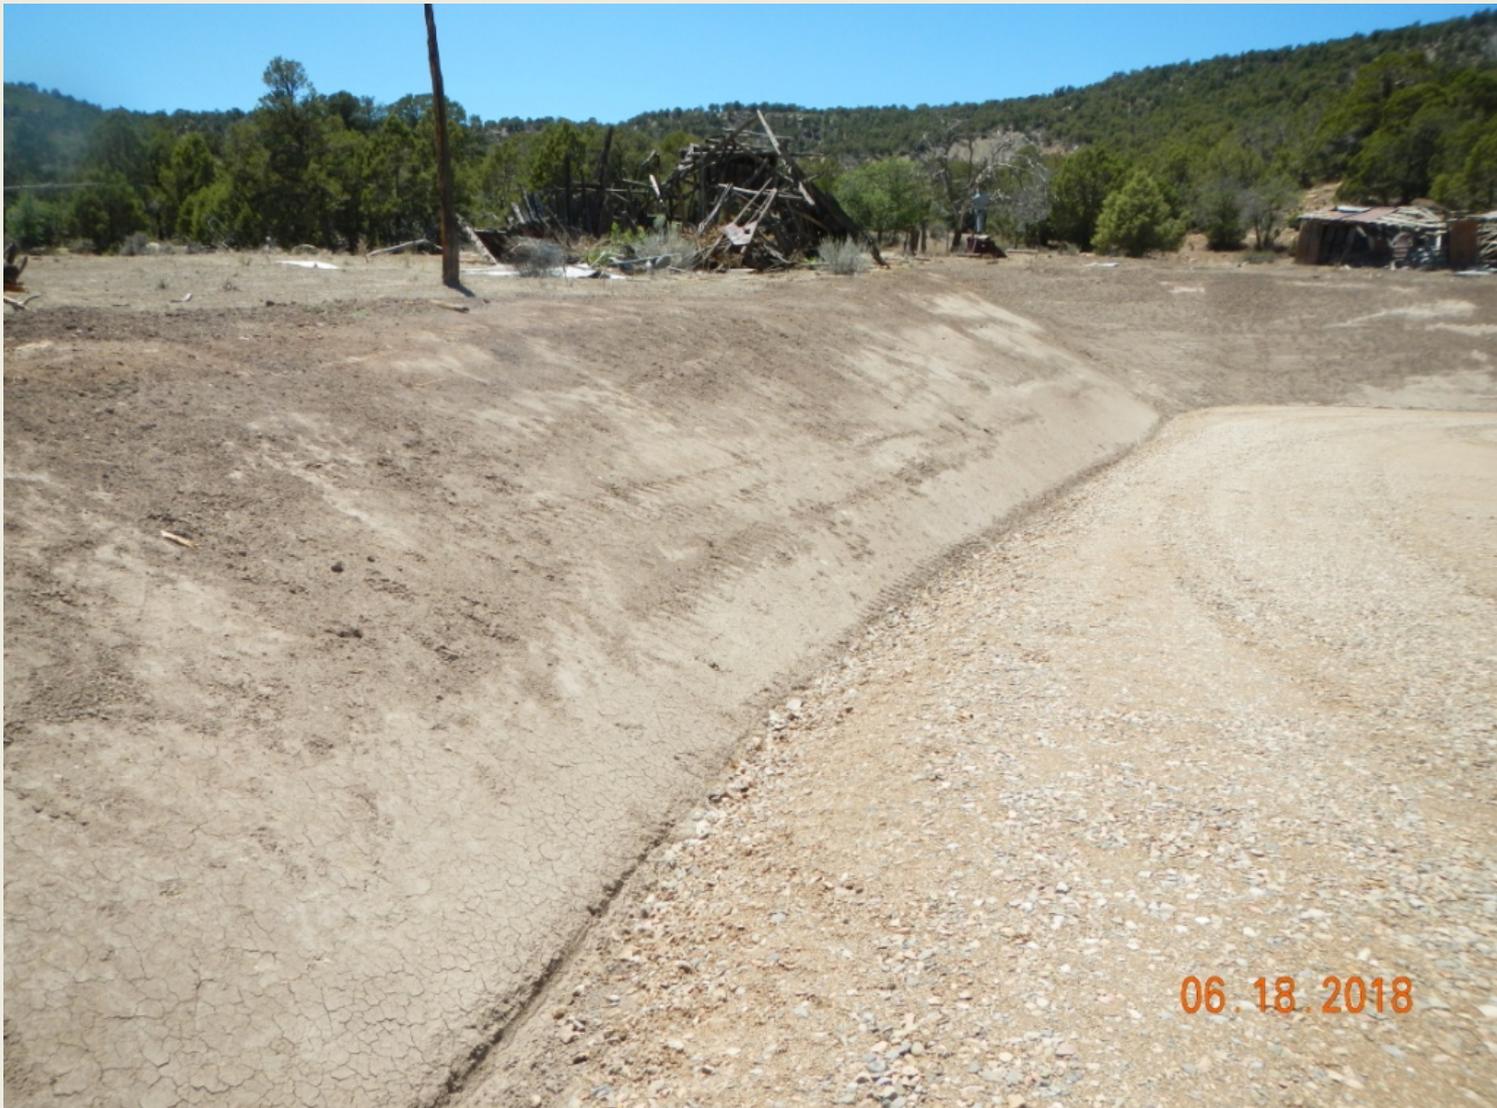
Photo 2. View of the southern portion of the project area from the southeastern corner facing westward. Run-on controls and stabilization measures are needed on these slopes until revegetation is achieved.

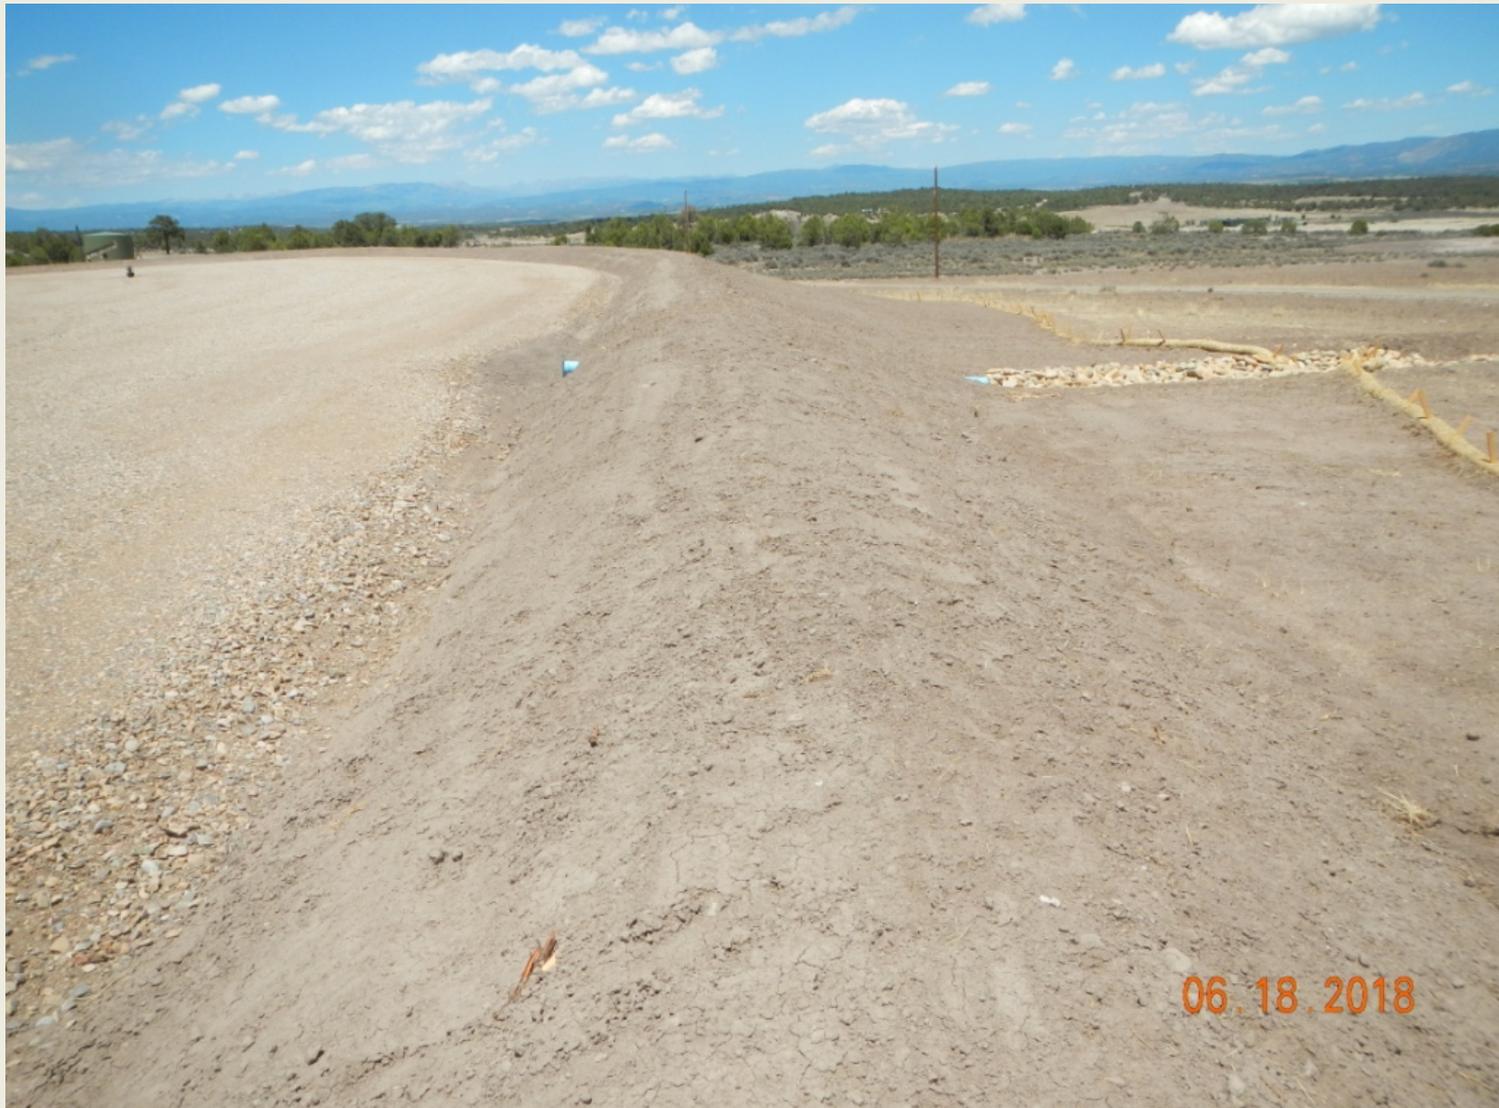
Photo 3. View of the portion of the project area from the southeastern corner facing northward. Berms and wattles in place. Erosion needs to be monitored until stabilization with vegetation is achieved.

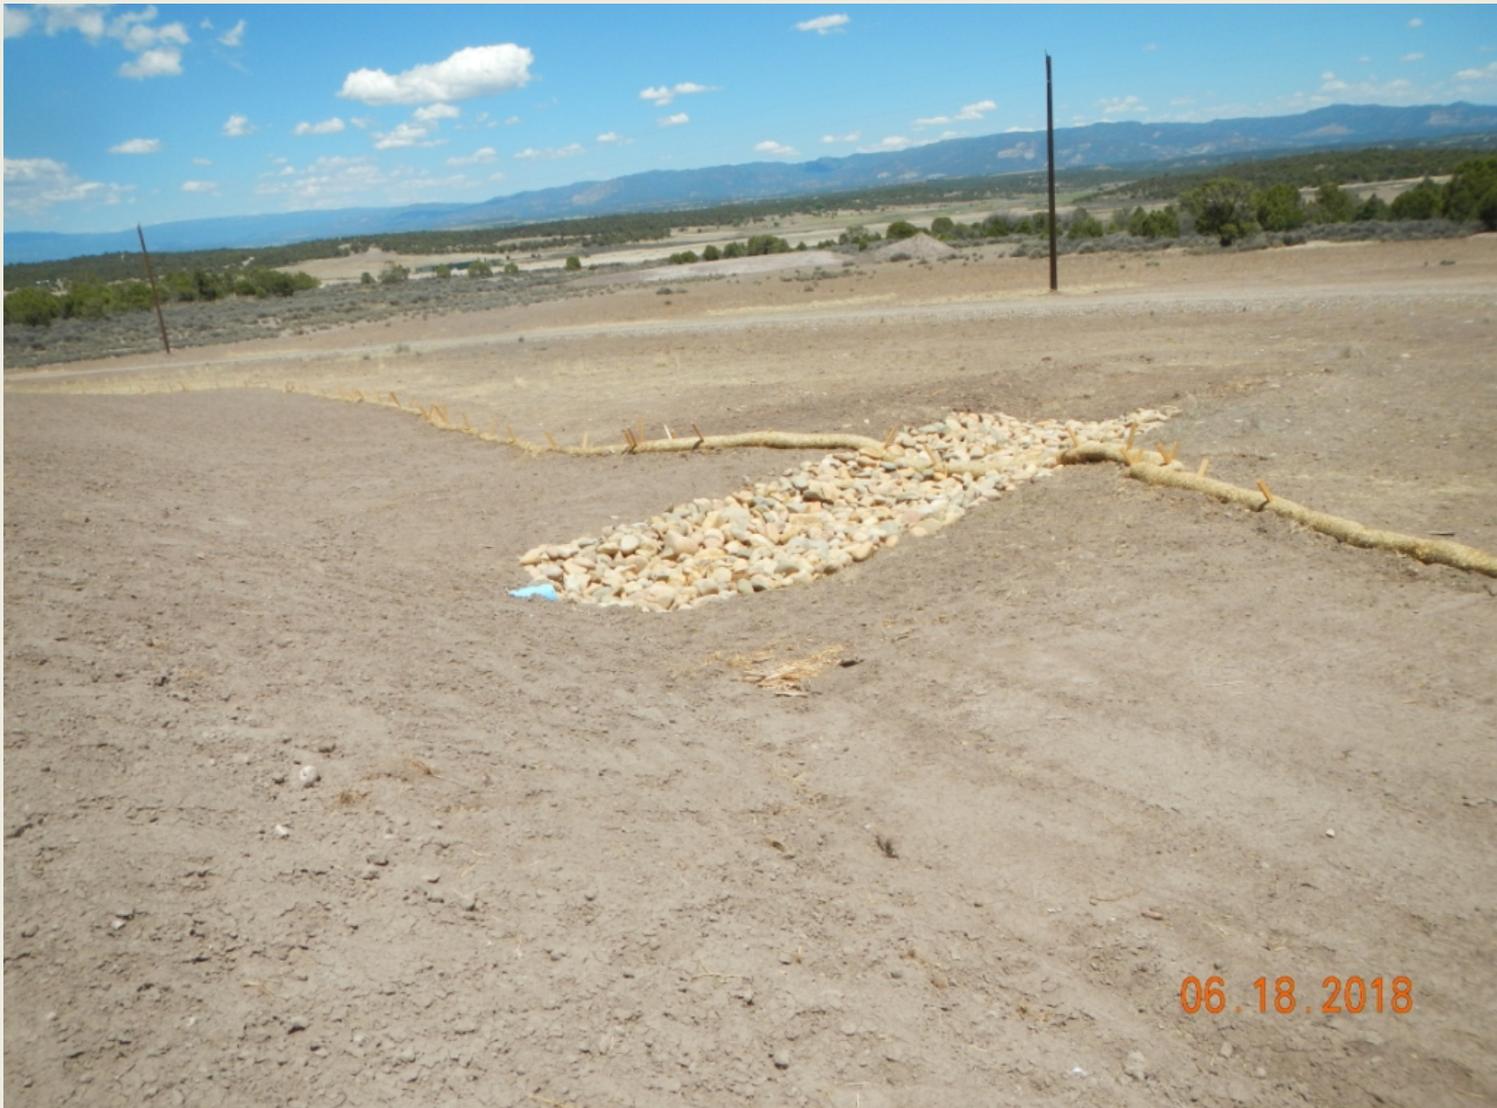
Photo 4. View of well pad drainage outlet armored with rock. Appears to be functioning.
