Inspection Photos

Location Name: De Beque Water Station

Facility ID: #441234

Inspection Date: June 20, 2018

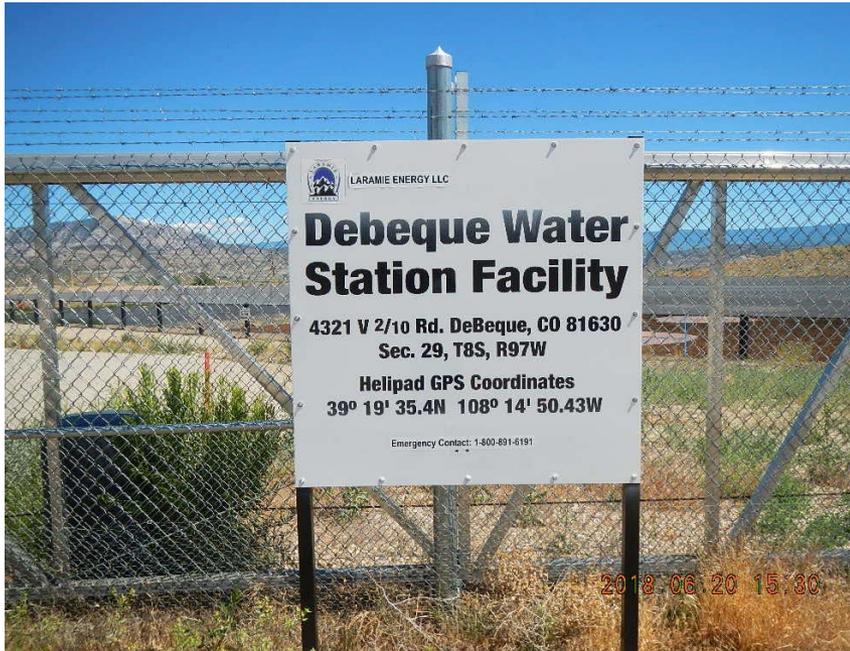
Photo #1 – Operator sign at entrance to facility.

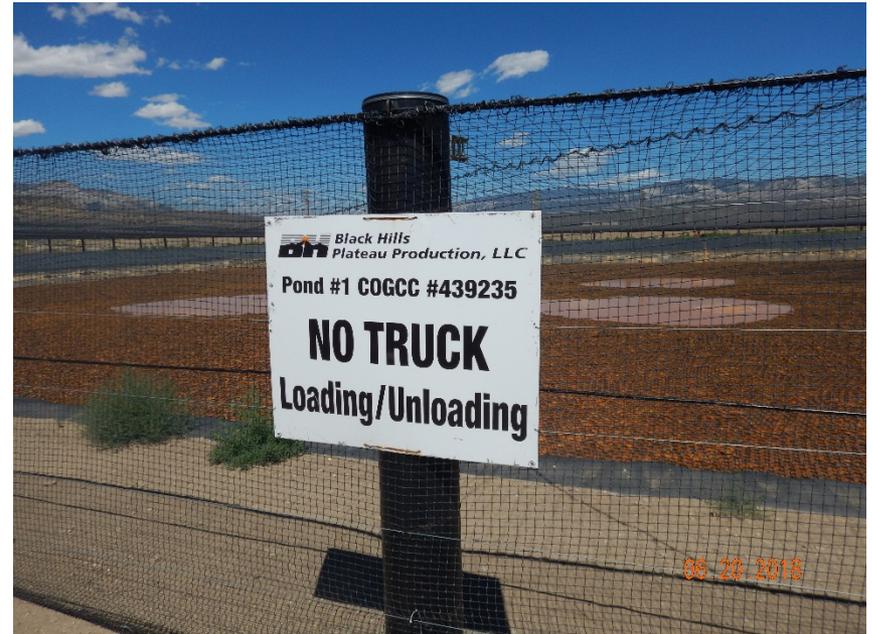
Photo #2 – Black Hills Plateau Production LLC sign located on west side of pit.

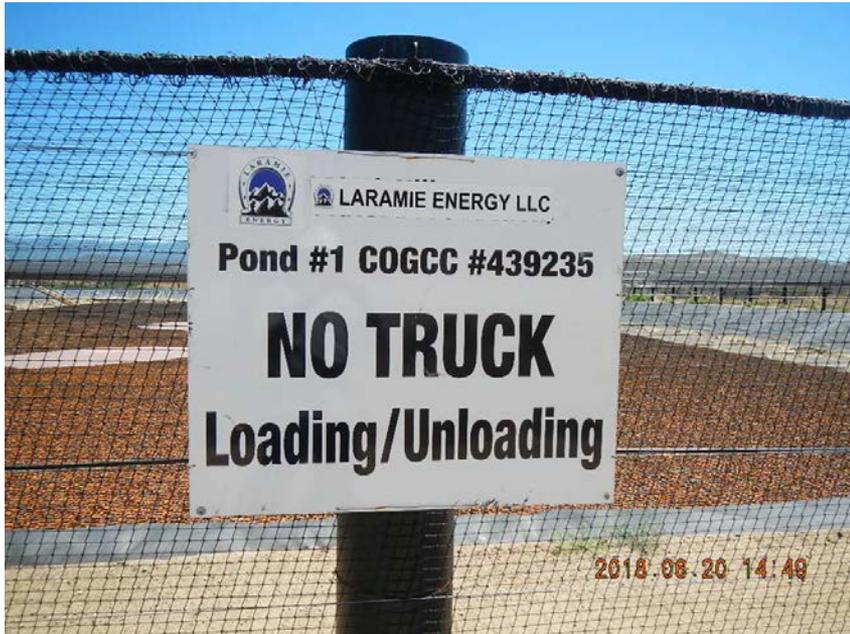
Photo #3 – Pit facility ID provided on sign at north end of pit.

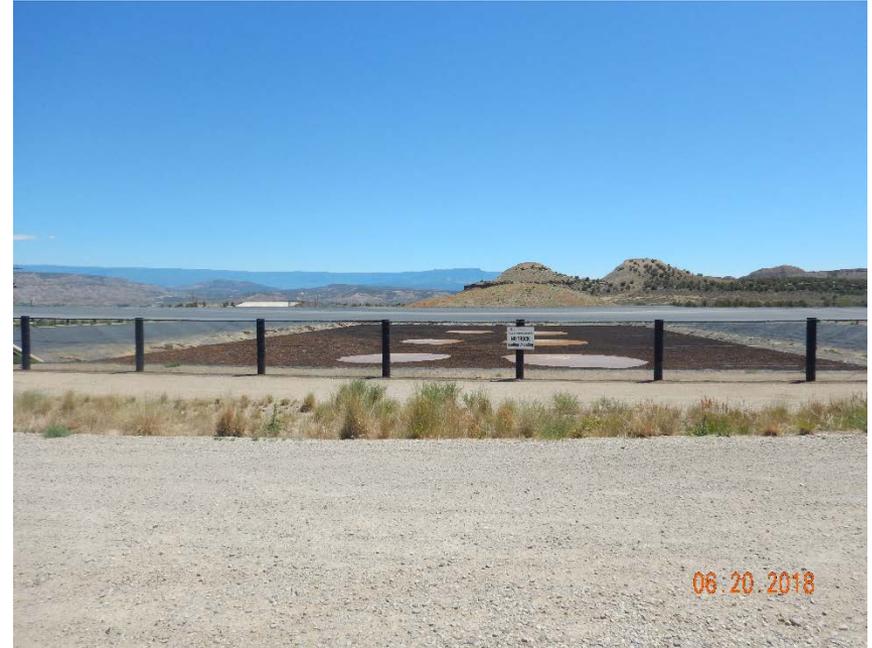
Photo #4 – Looking south over pit.

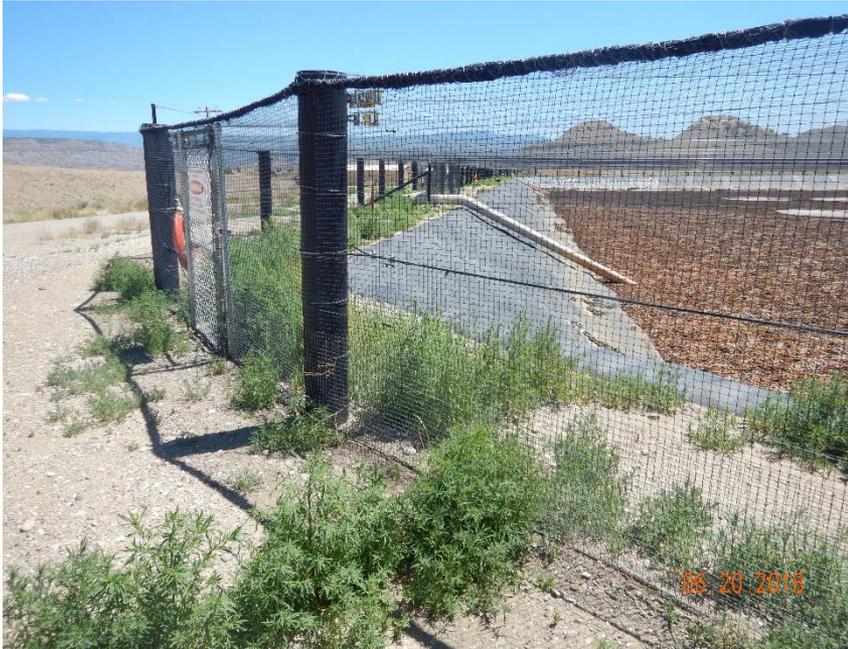
Photo #5 – Weeds encroaching on earthen berm, fence line, and pit liner at NE corner of pit. Note: Pit netting in good condition.

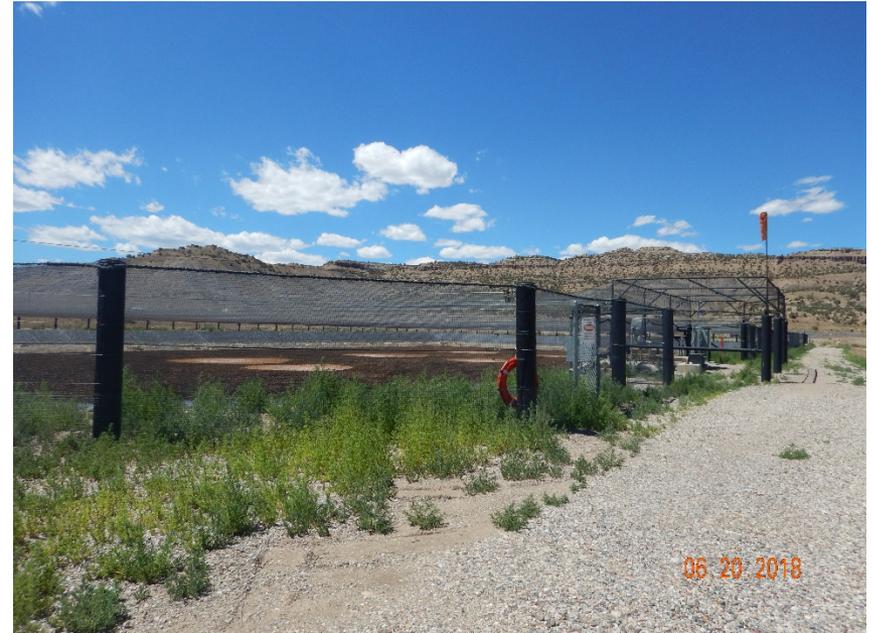
Photo #6 - Weeds encroaching on earthen berm, fence line, and pit liner at SE corner of pit. Note: Pit netting in good condition.

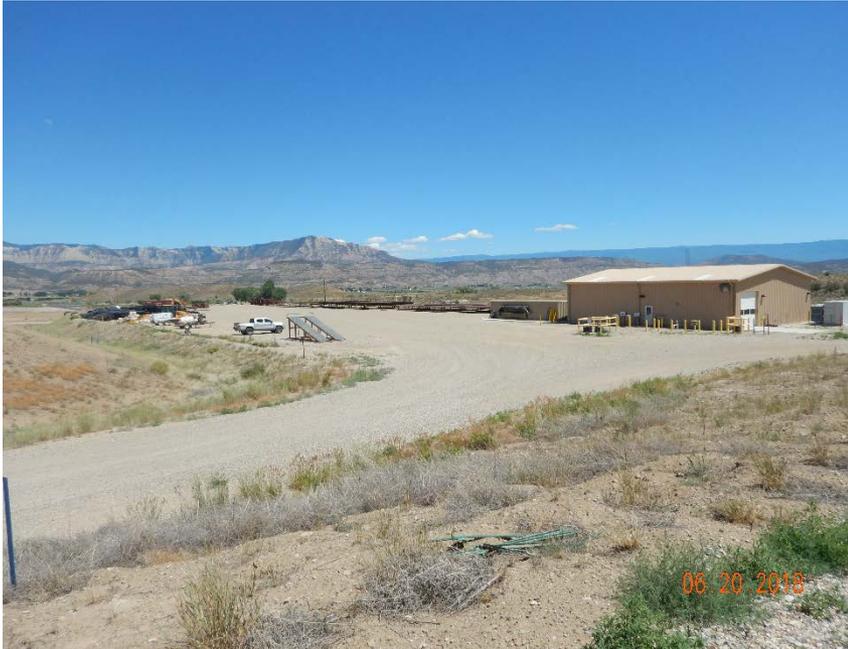
Photo #7 – Looking SE toward pump house and storage yard.

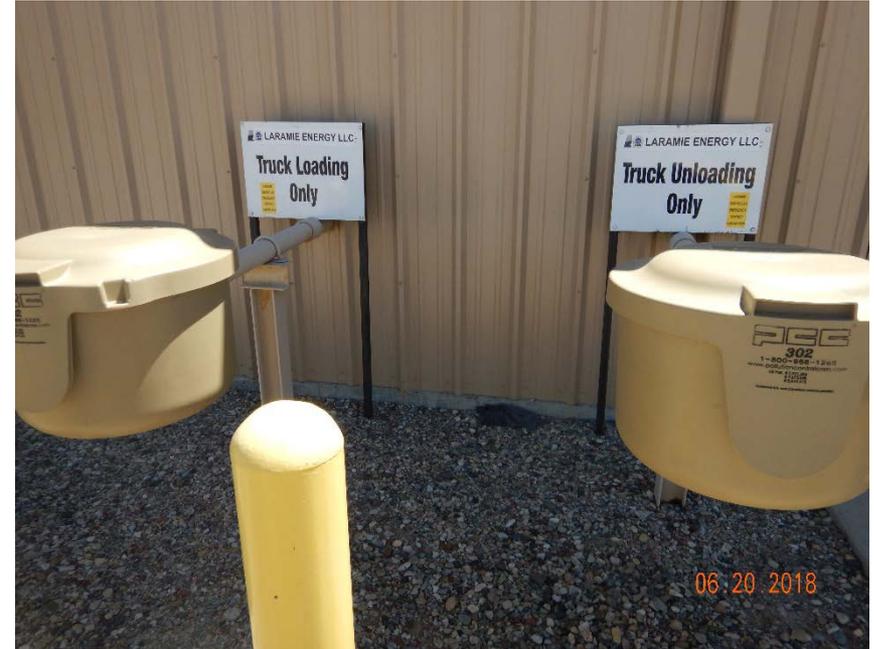
Photo #8 – Truck loadouts at NW corner of pump house.

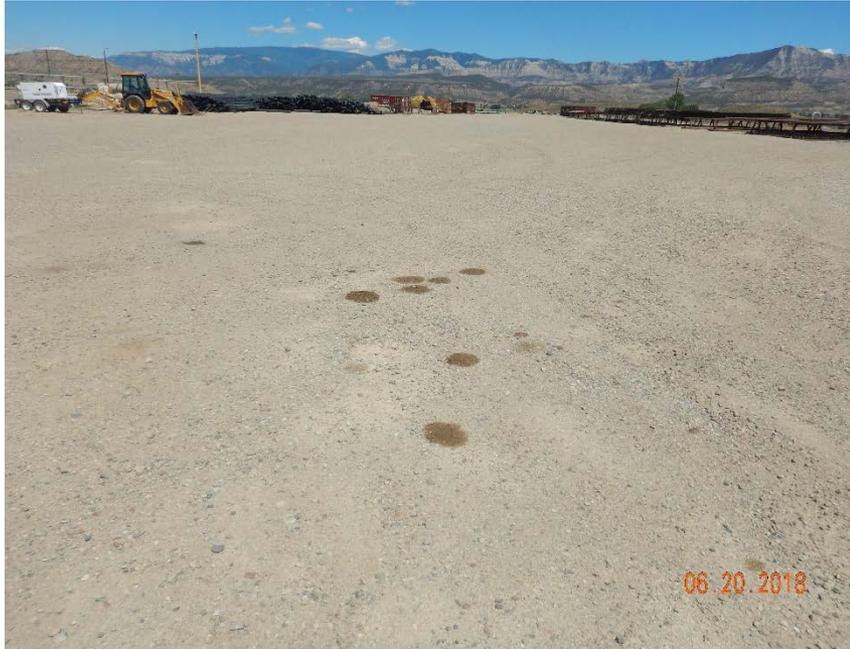
Photo #9 – Localized, oil-stained soil located north of truck loadouts.

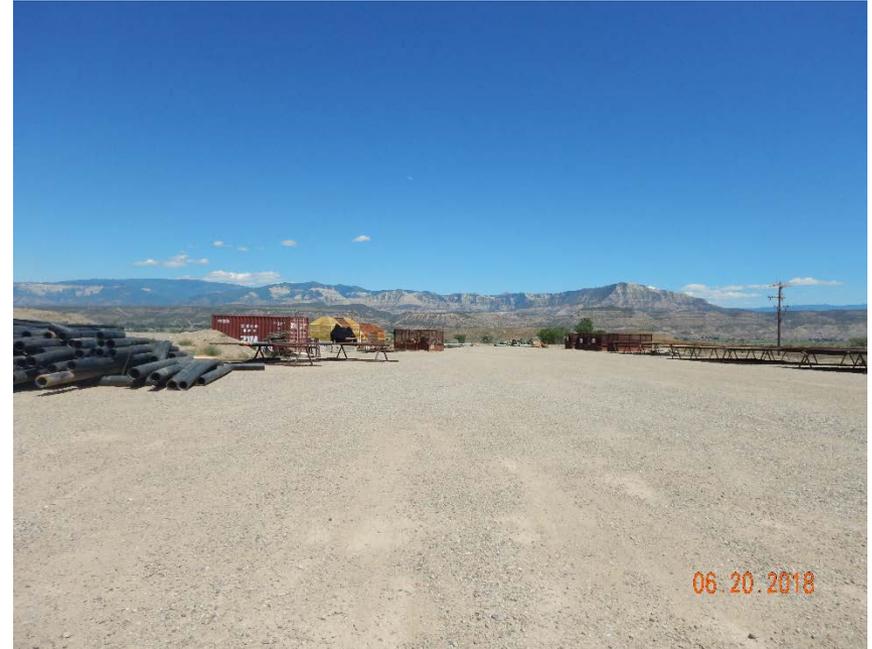
Photo #10 – Looking east at storage yard.

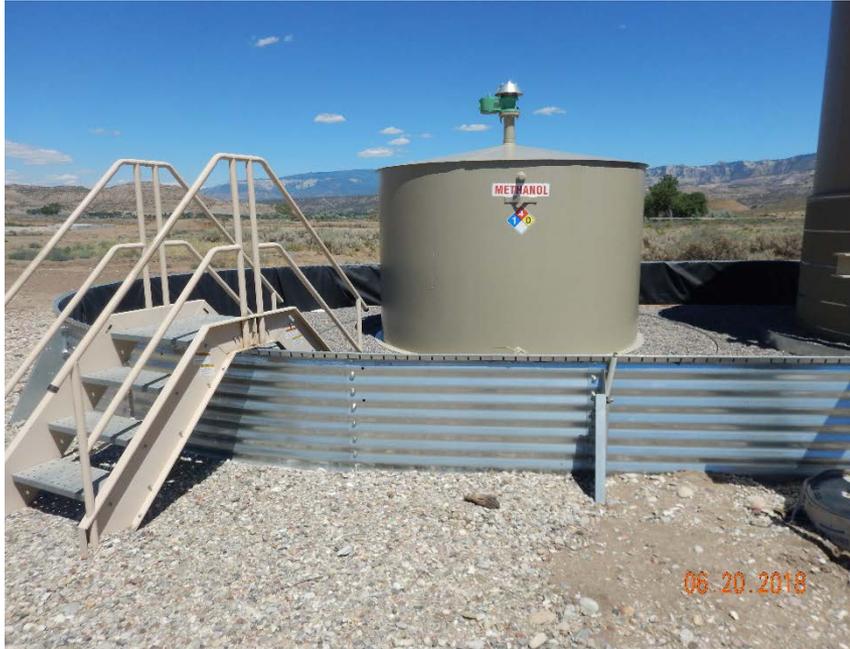
Photo #11 – 200 bbl methanol steel AST in lined earthen berm. Tank battery has been constructed at SE corner of location.

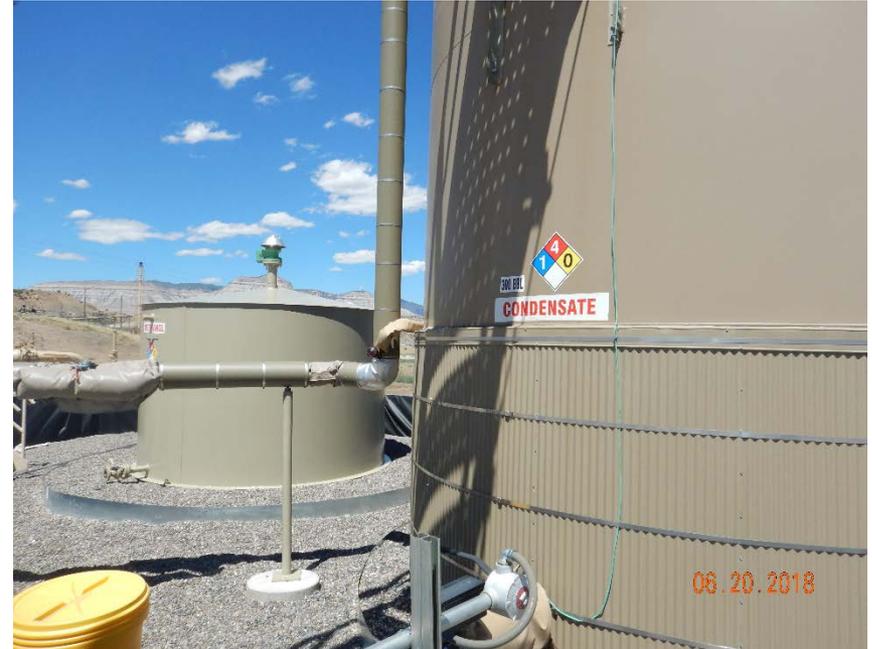
Photo #12 – Volume label and NFPA placard affixed to 300 bbl condensate steel AST.

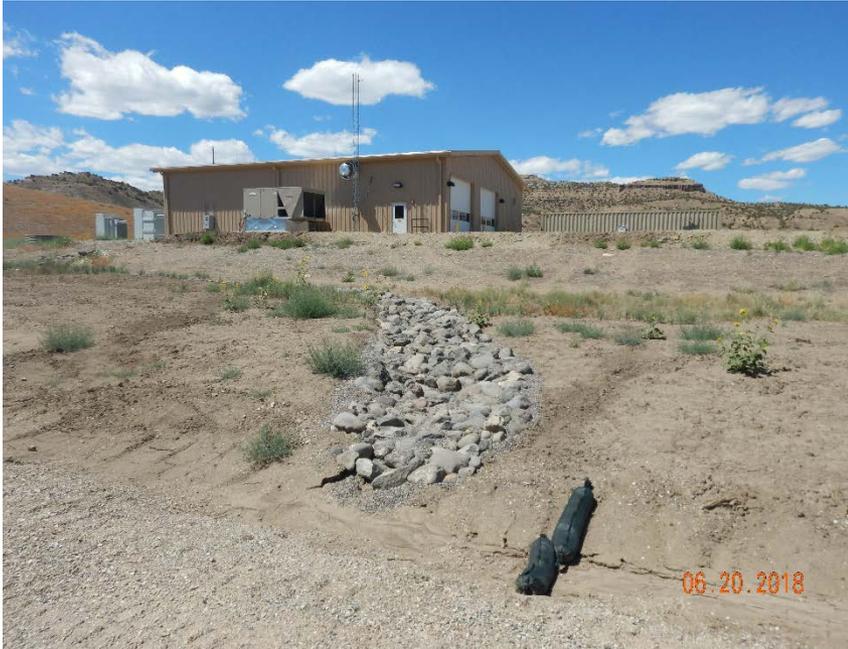
Photo #13 – Rock-lined erosion control channel and ditch with wattles in use south of pump house.

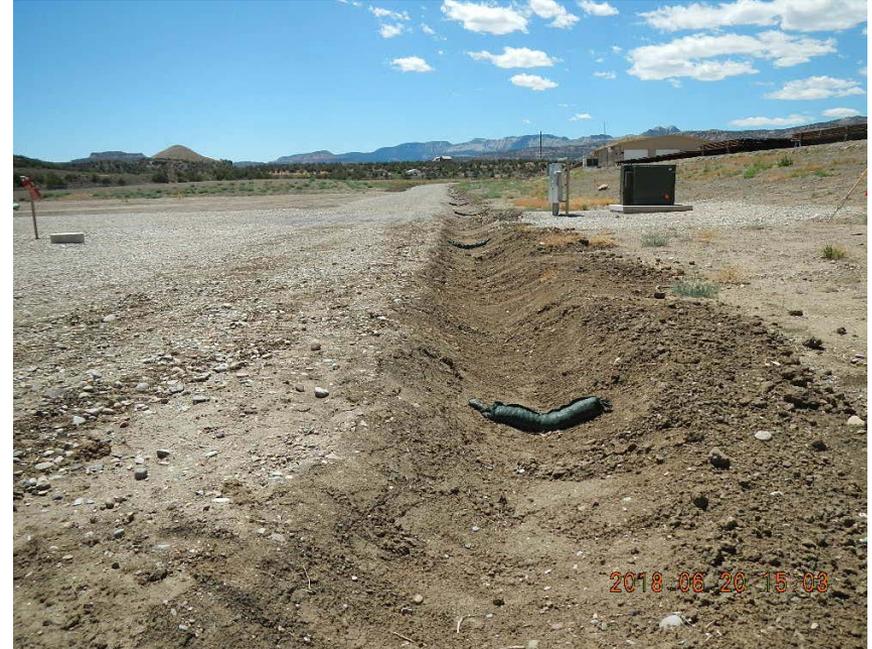
Photo #14 – Stormwater control ditch with wattles in use along access road to tank battery.

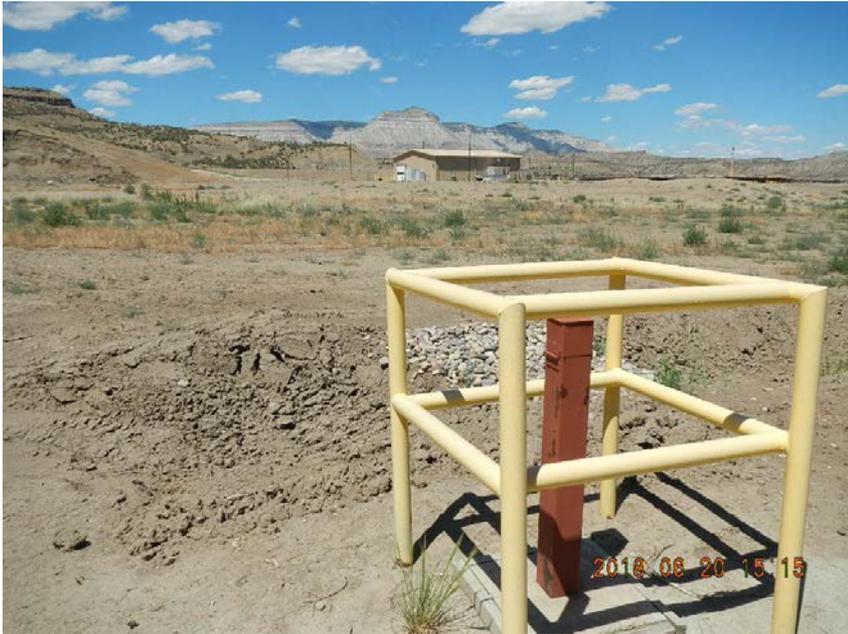
Photo #15 – Monitoring well located at SW corner of location.

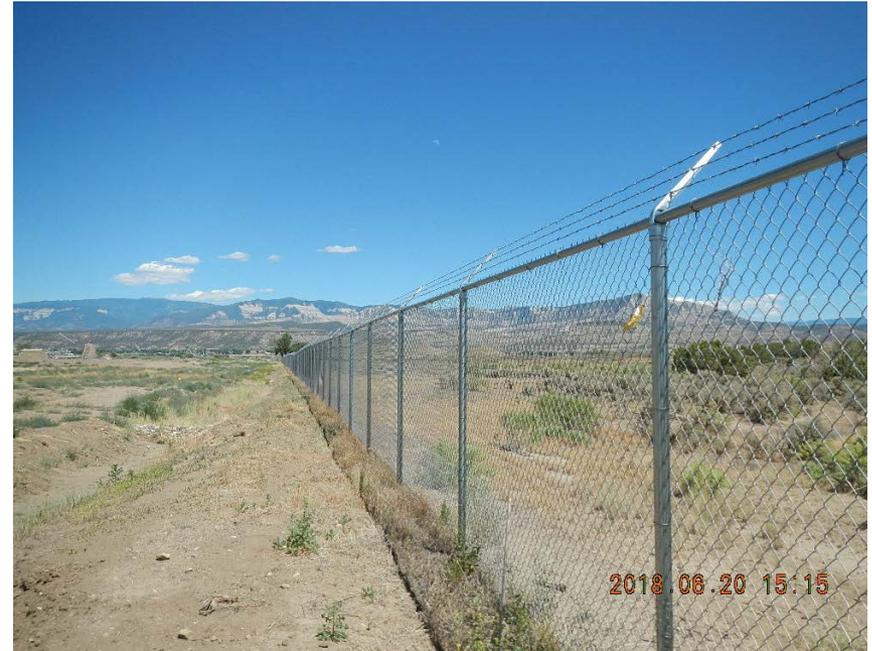
Photo #16 – View of fence line and fire road along south side of location. Fence is 6' tall chain link with ~2' of chicken wire at base to prevent wildlife access.

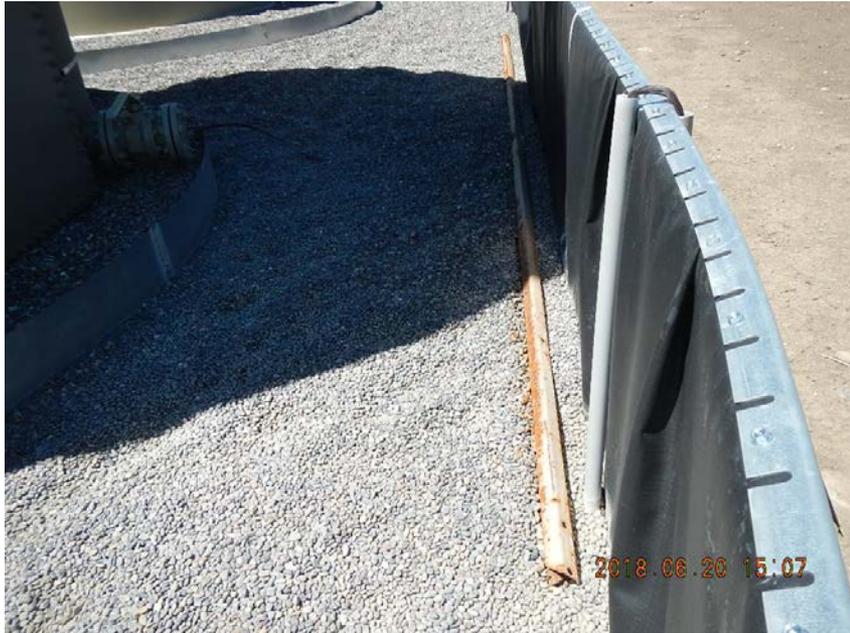
Photo #17 – ~20' angle iron segment stored inside of metal berm, located east of condensate AST.

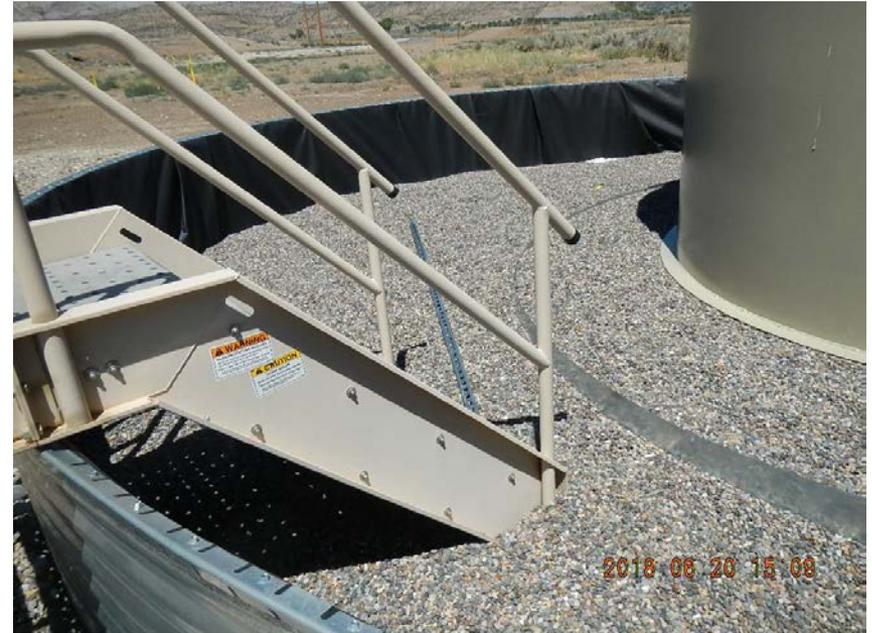
Photo #18 – ~10' metal post stored inside of metal berm on north side of methanol AST.

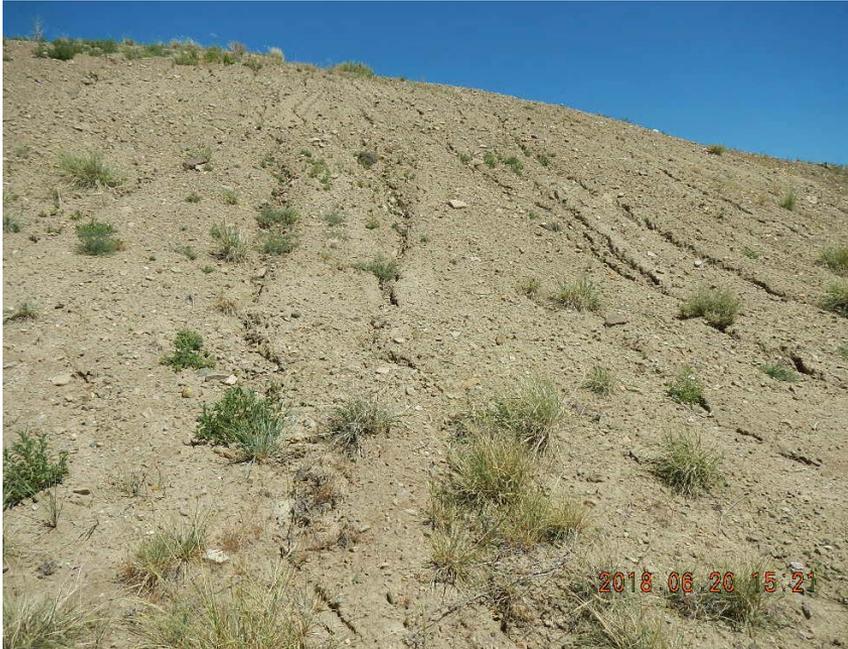
Photo #19 – Evidence of erosion and sediment transport along west side of soil stockpile.

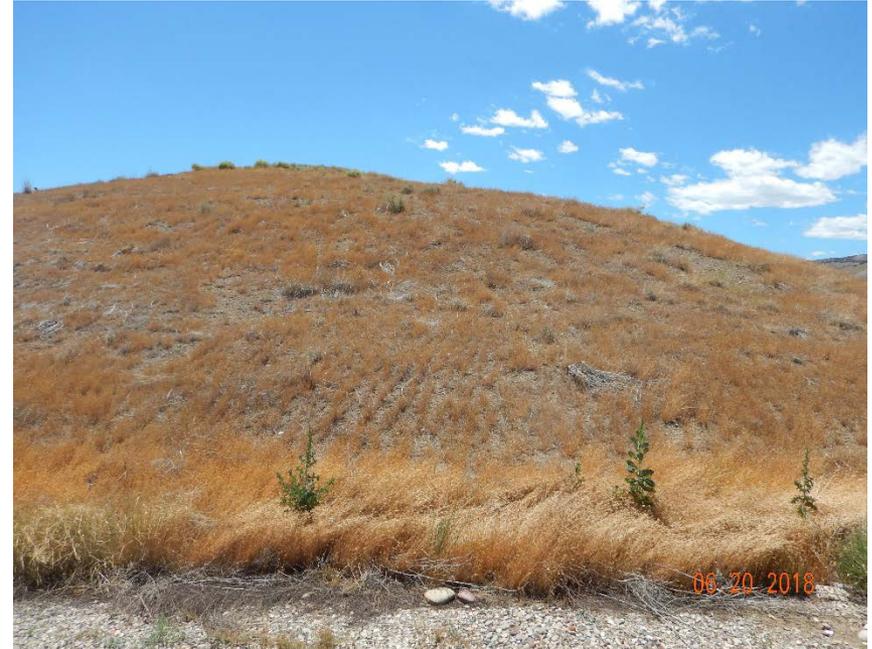
Photo #20 – Vegetative cover on east side of soil stockpile.
