Inspection Photos
Location Name: McCallum Unit 100
API: 05-057-06187

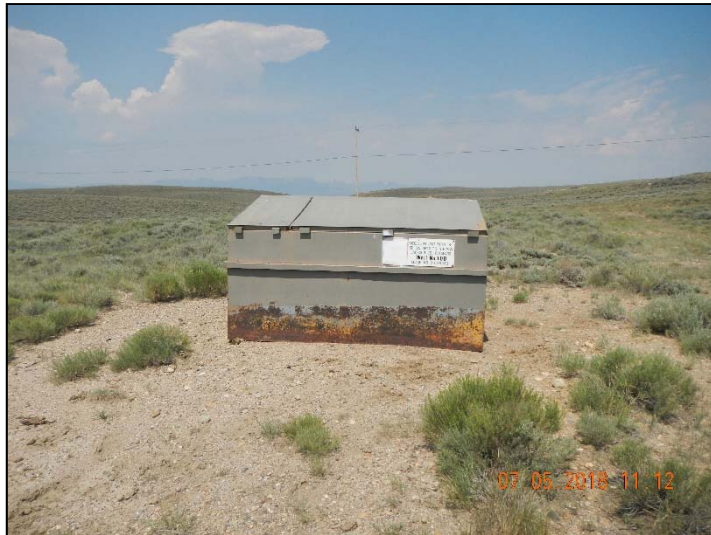
Photo 1. Overview of location taken at entrance facing northwest.

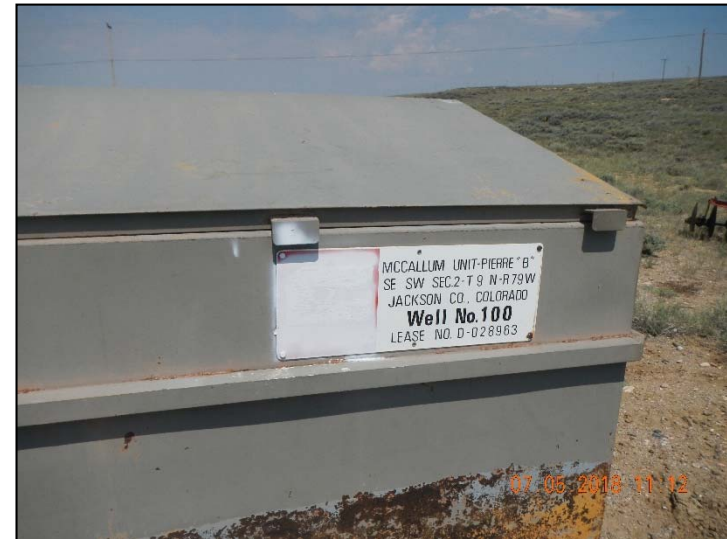
Photo 2. No current operator information or emergency contact information on wellhead sign.

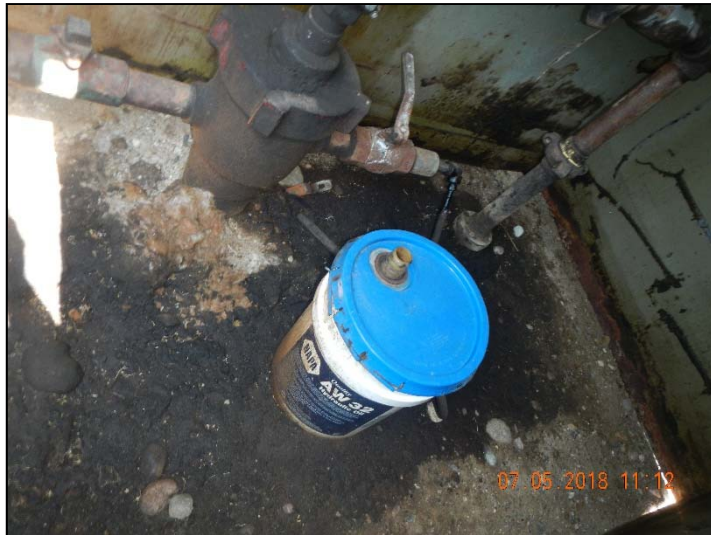
Photo 3. Stained soil at wellhead. Lube oil stored without secondary containment.

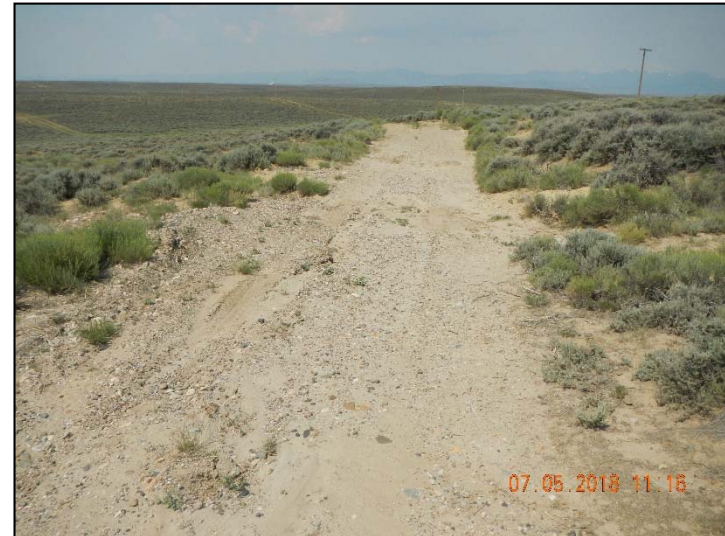
Photo 4. Sediment migration across lease road with slope.

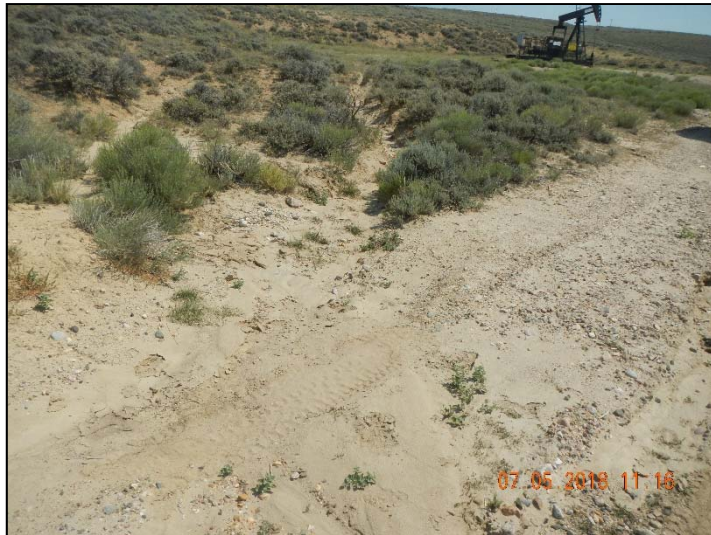
Photo 5. Sediment migration onto lease road.

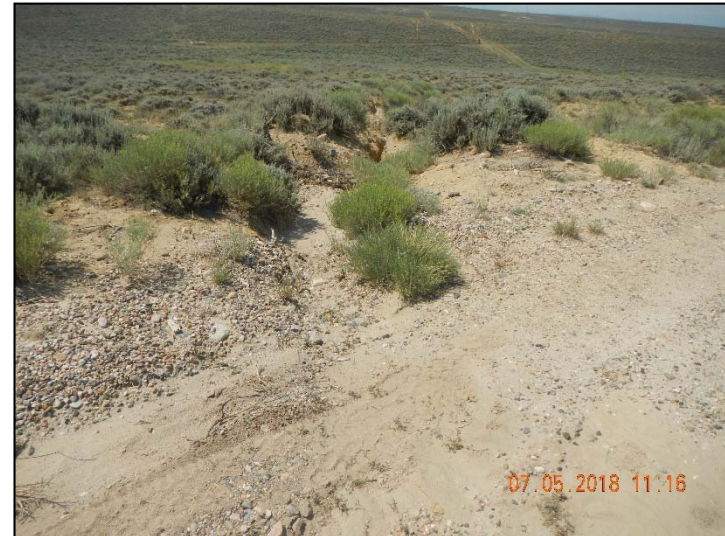
Photo 6. Sediment migration off lease road.
