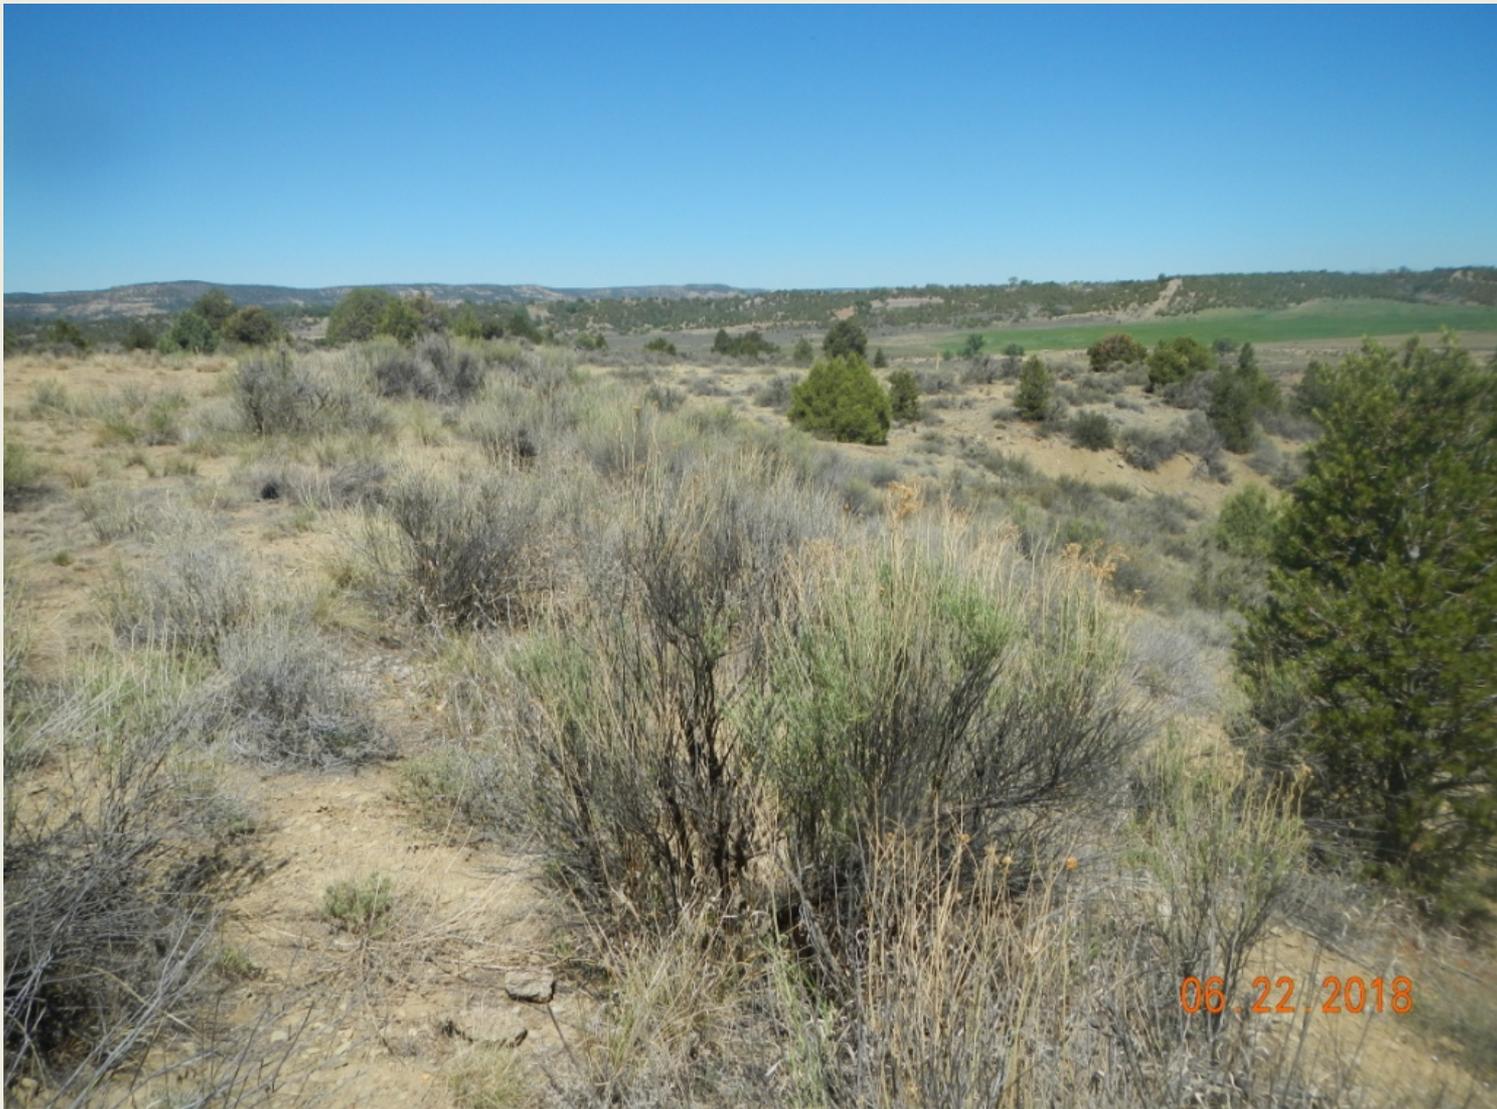
Photo 2. View of the northern portion of the project area from the northeastern corner facing westward. Revegetation is progressing with grasses and shrubs such as rubber rabbitbrush (*Chrysothamnus nauseosus*), antelope bitterbrush (*Purshia tridentata*), blue grama (*Bouteloua gracilis*).

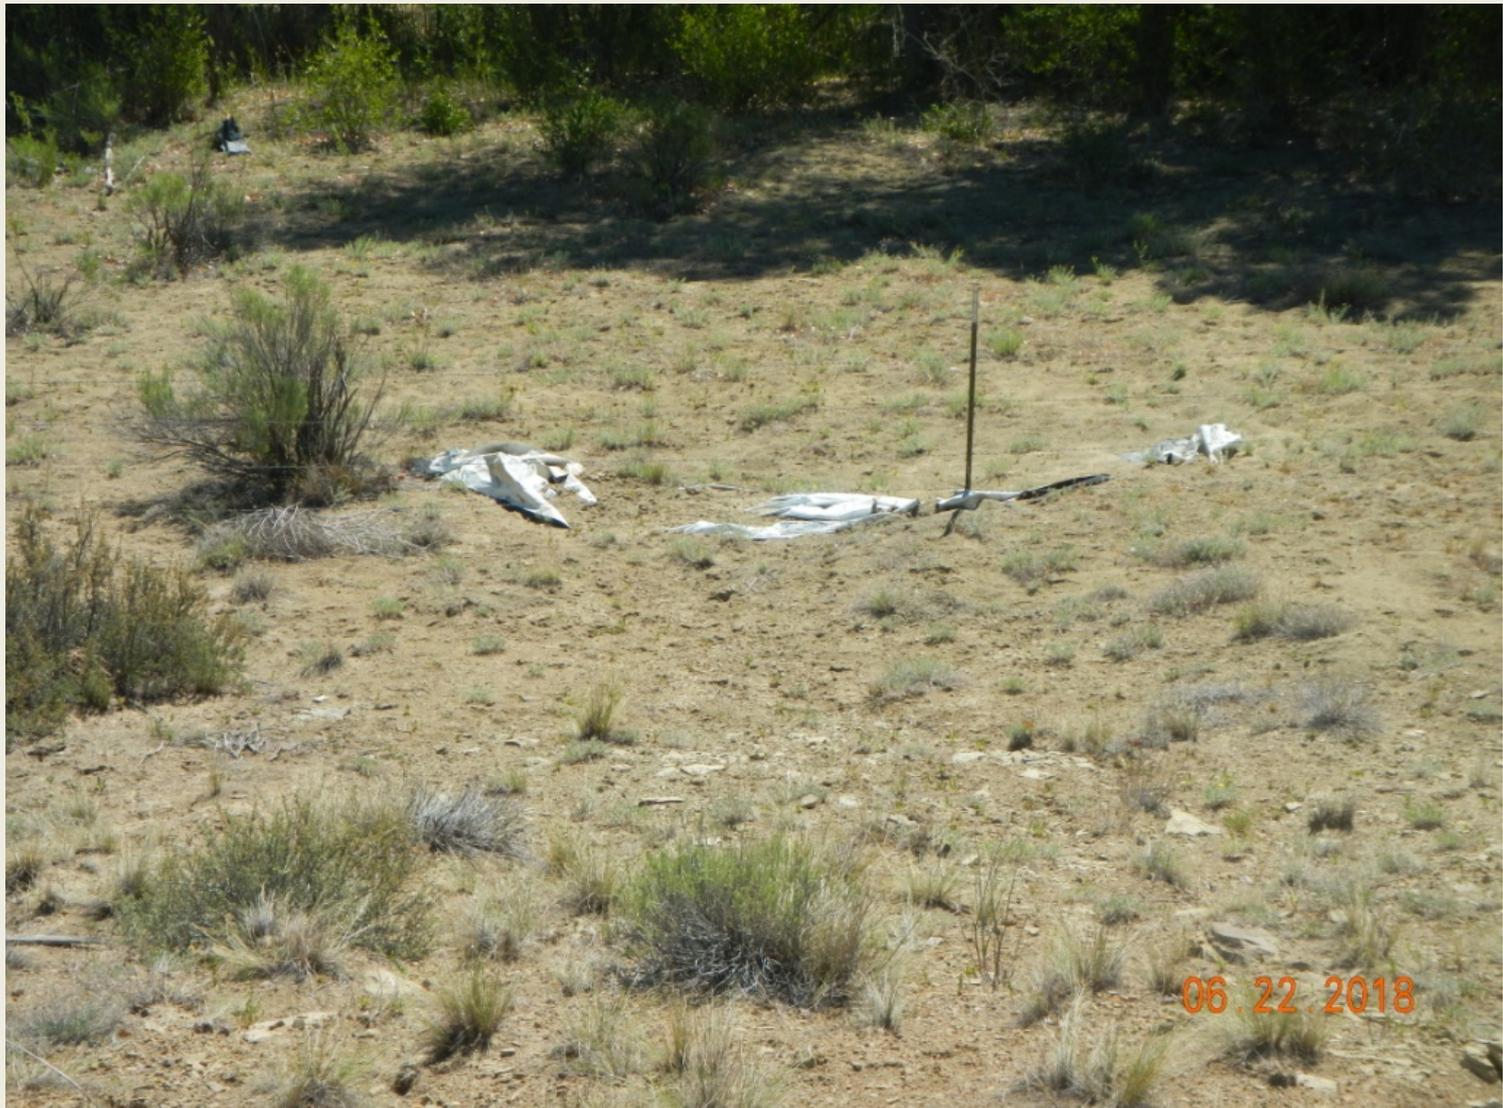
Photo 4. View of plastic debris along the edge of the eastern fenceline.

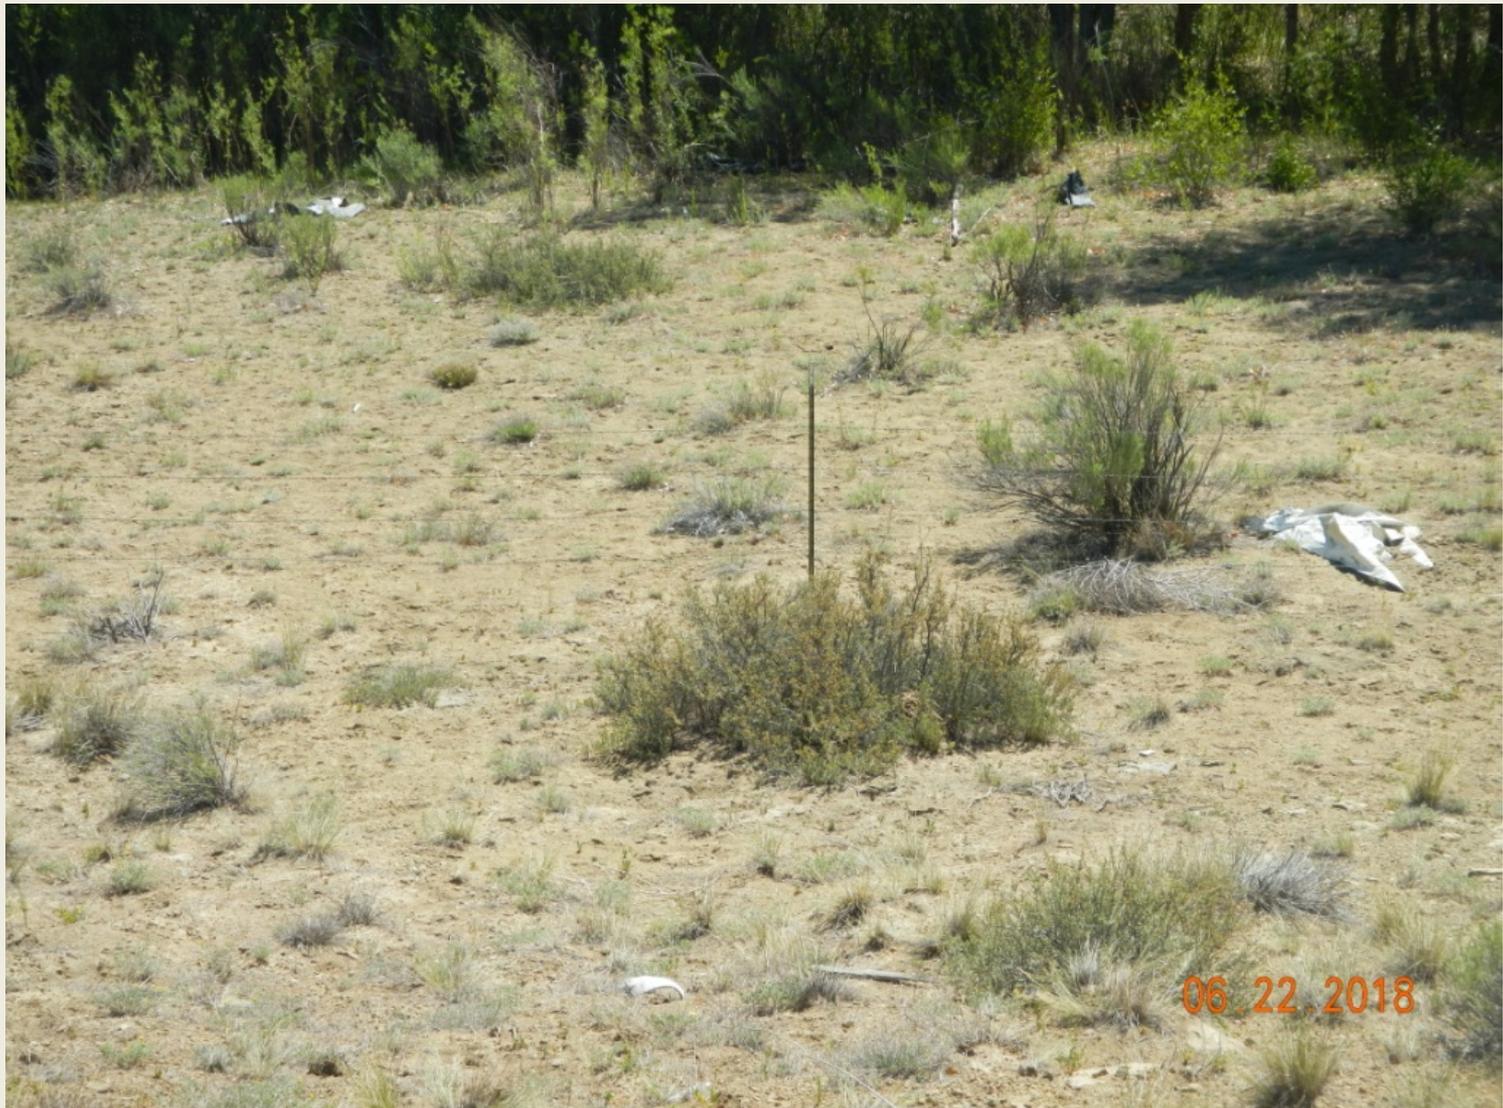
Photo 5. View of more plastic debris along the eastern project area.

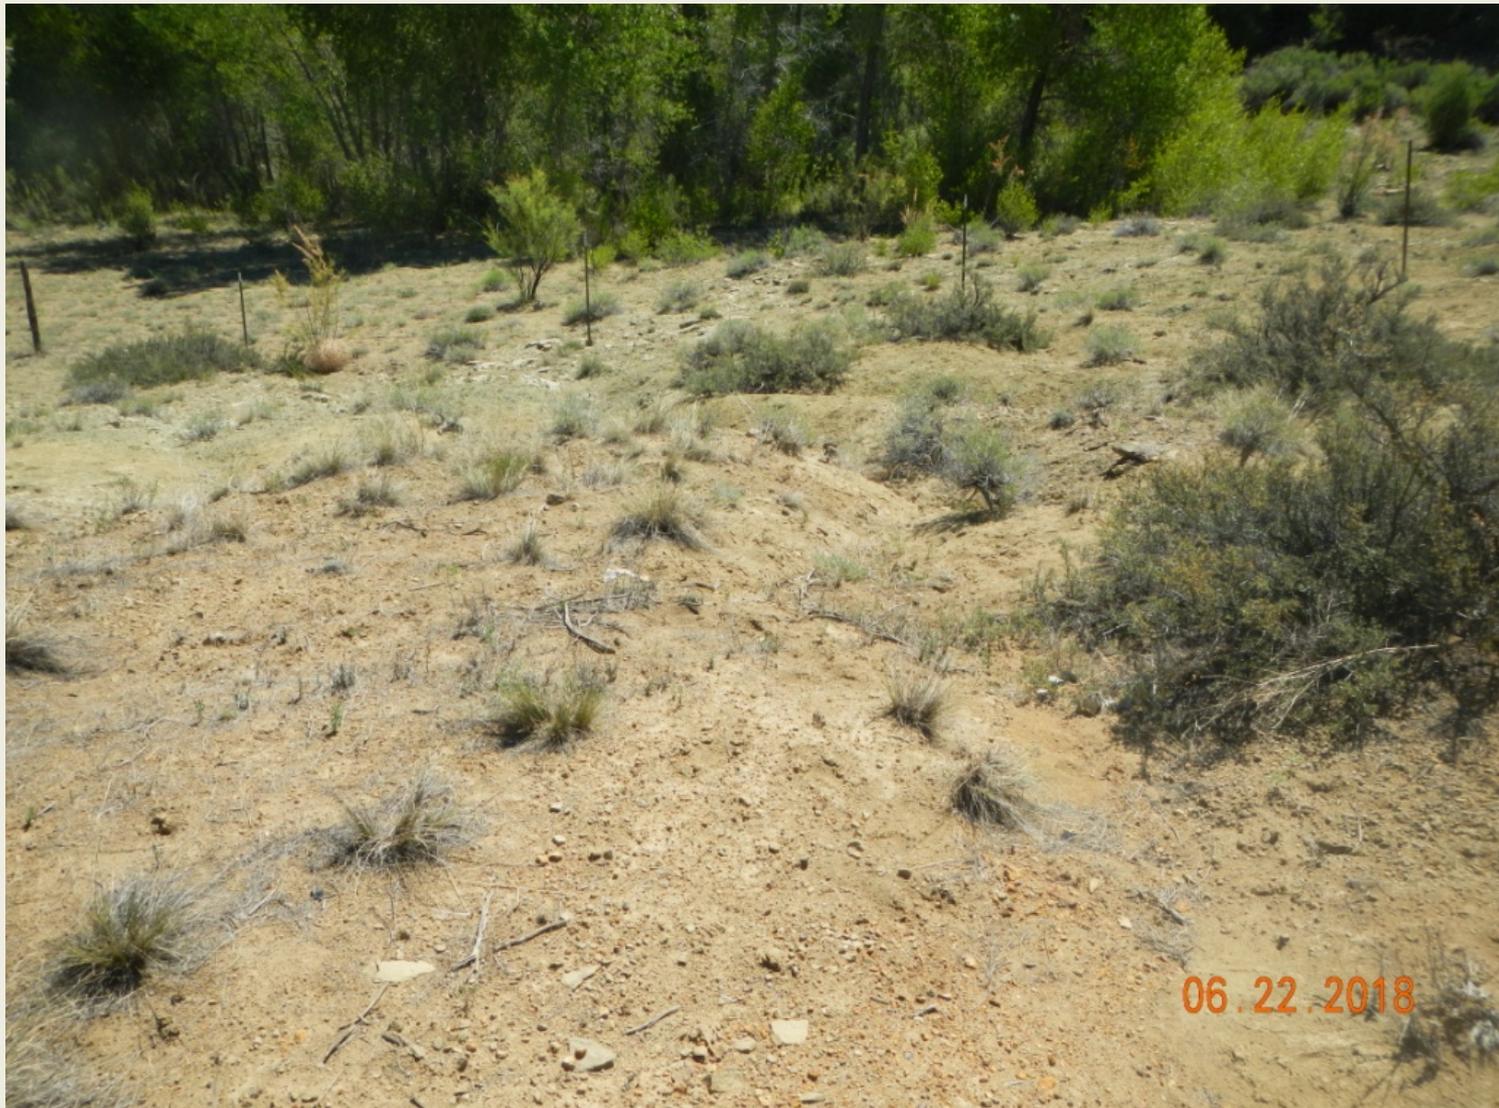
Photo 6. View of erosional channel approximately 3 feet wide and 1.5 feet deep in the eastern portion of the project area that needs stabilization.

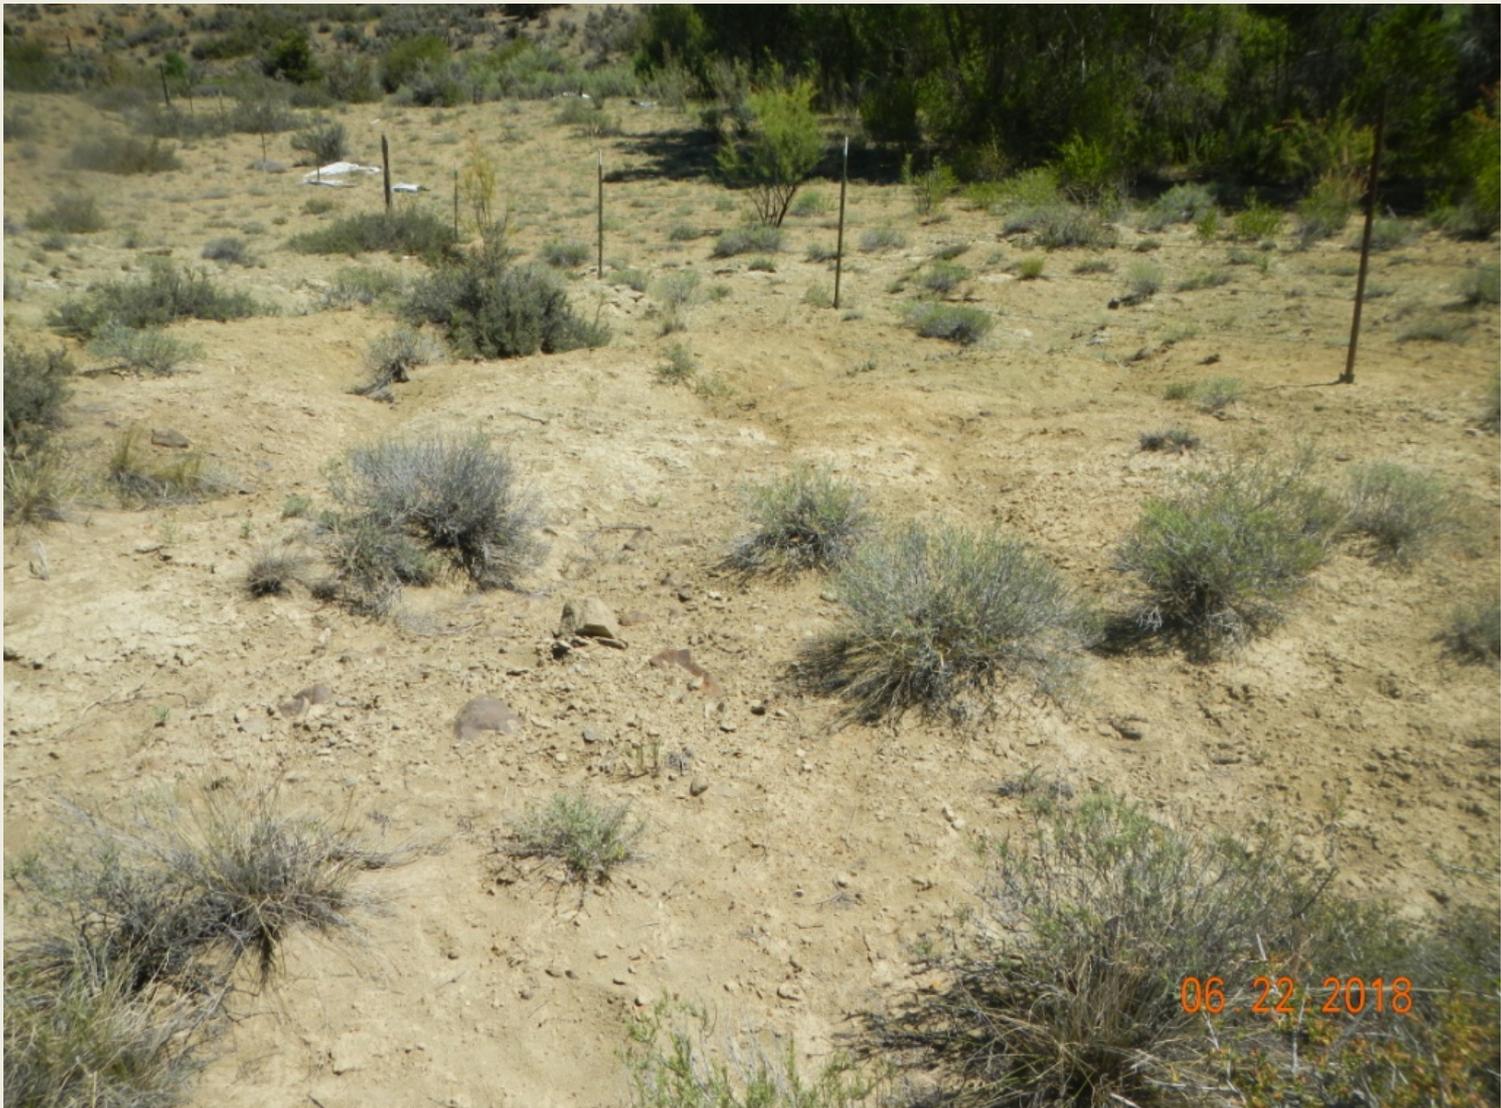
Photo 7. View of more erosional channels in the eastern portion of the project area.

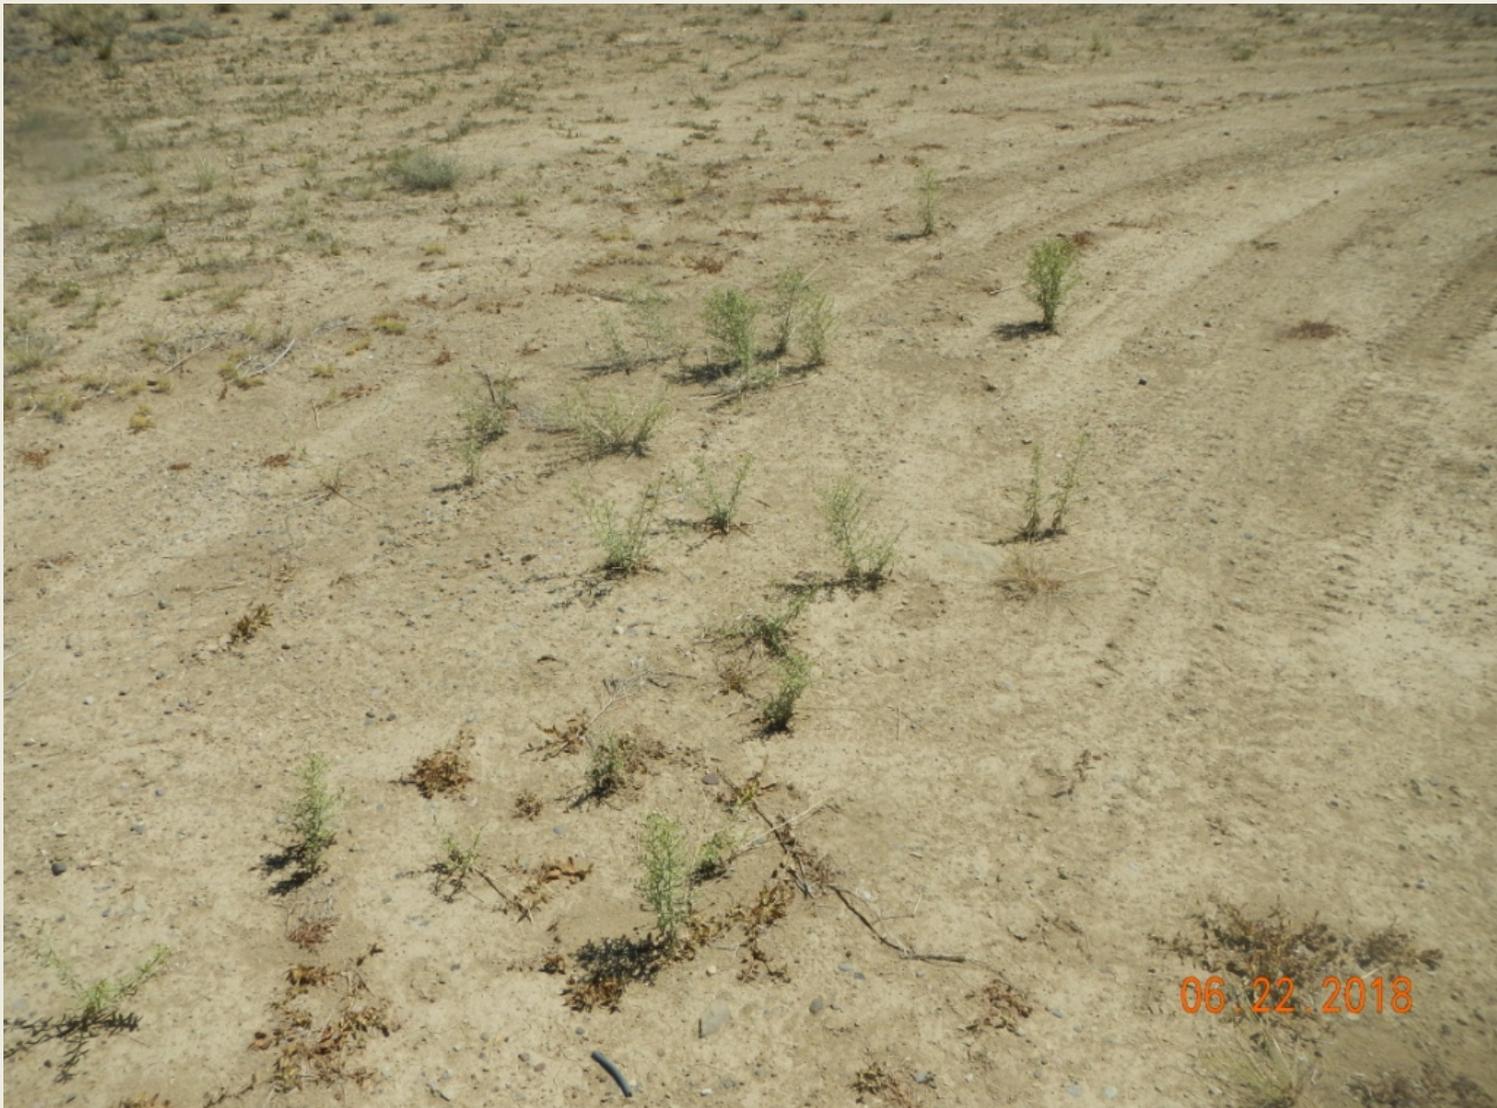
Photo 8. View of Russian knapweed (*Rhaponticum repens*) on the well pad.

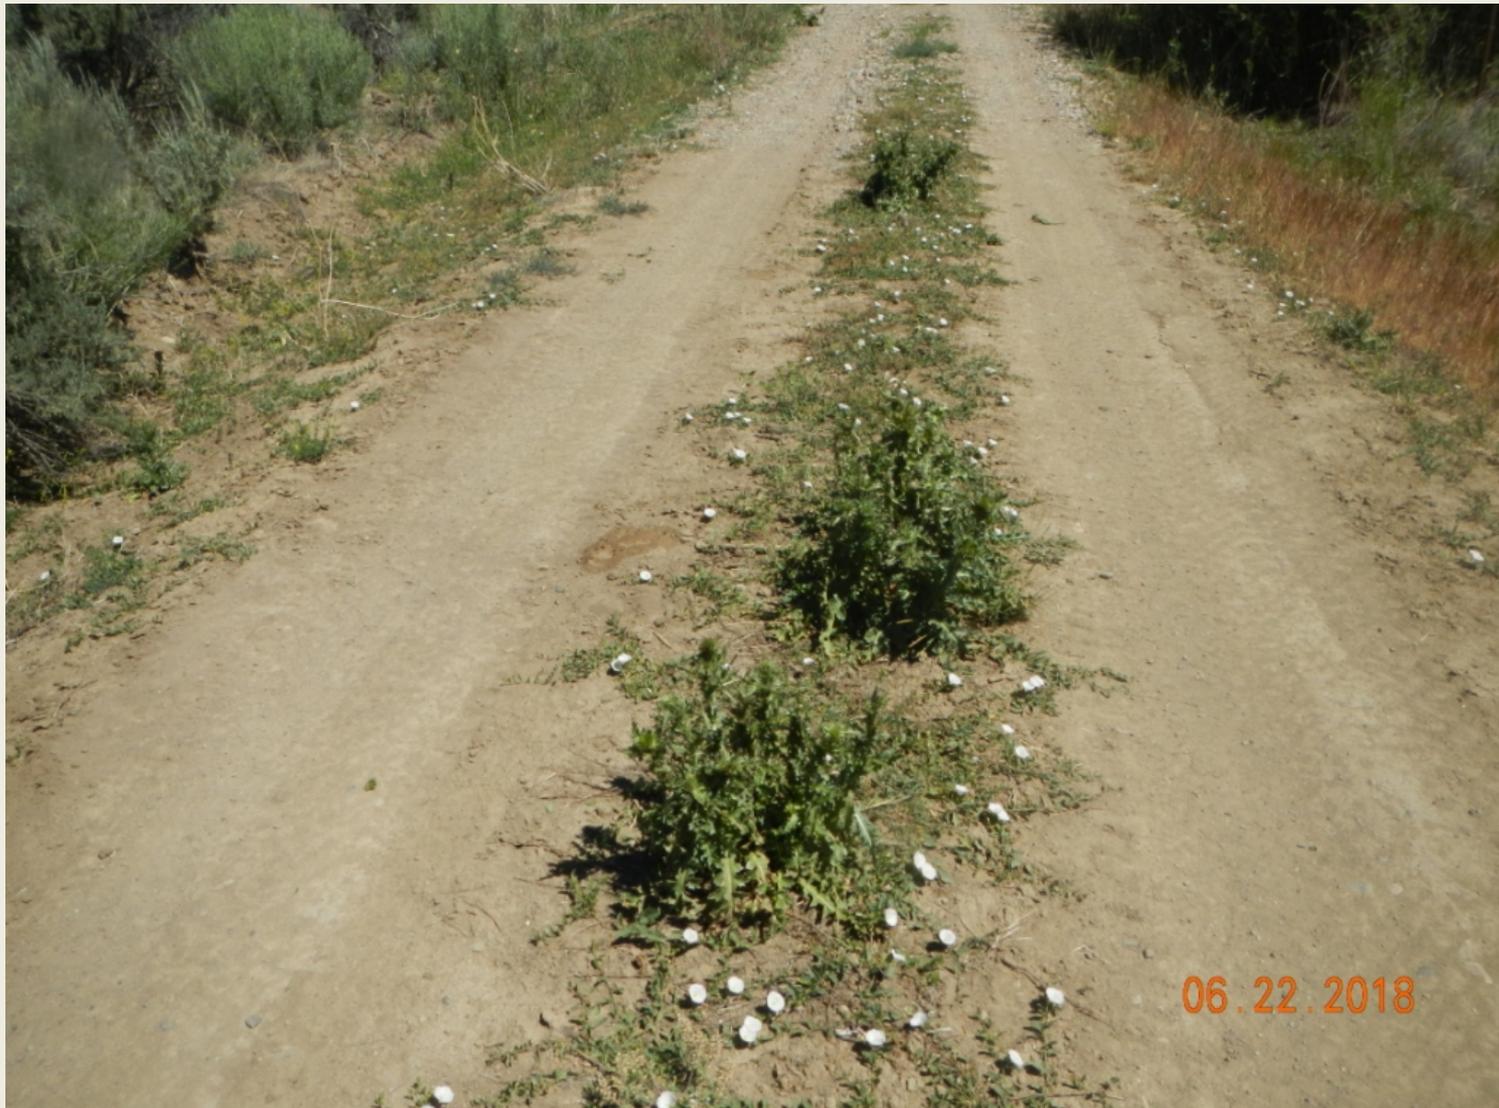
Photo 9. View of musk thistles (*Carduus nutans*) along the access road.
