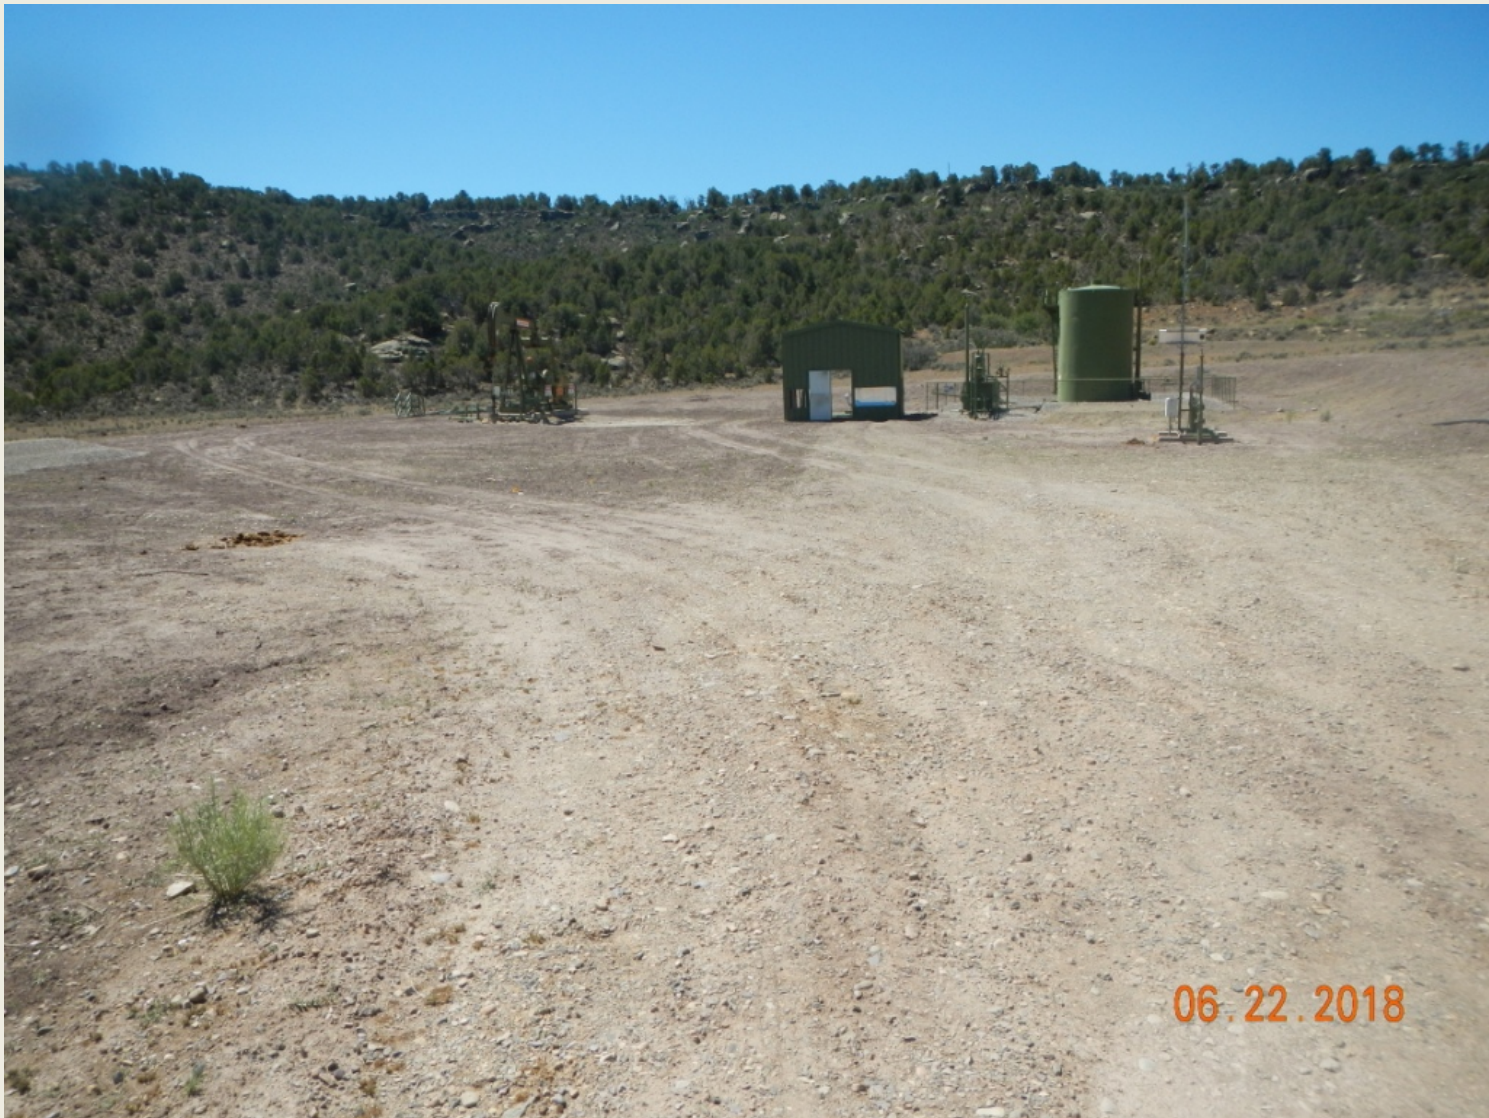
Photo 1. View of the project area from the northeastern corner facing center.

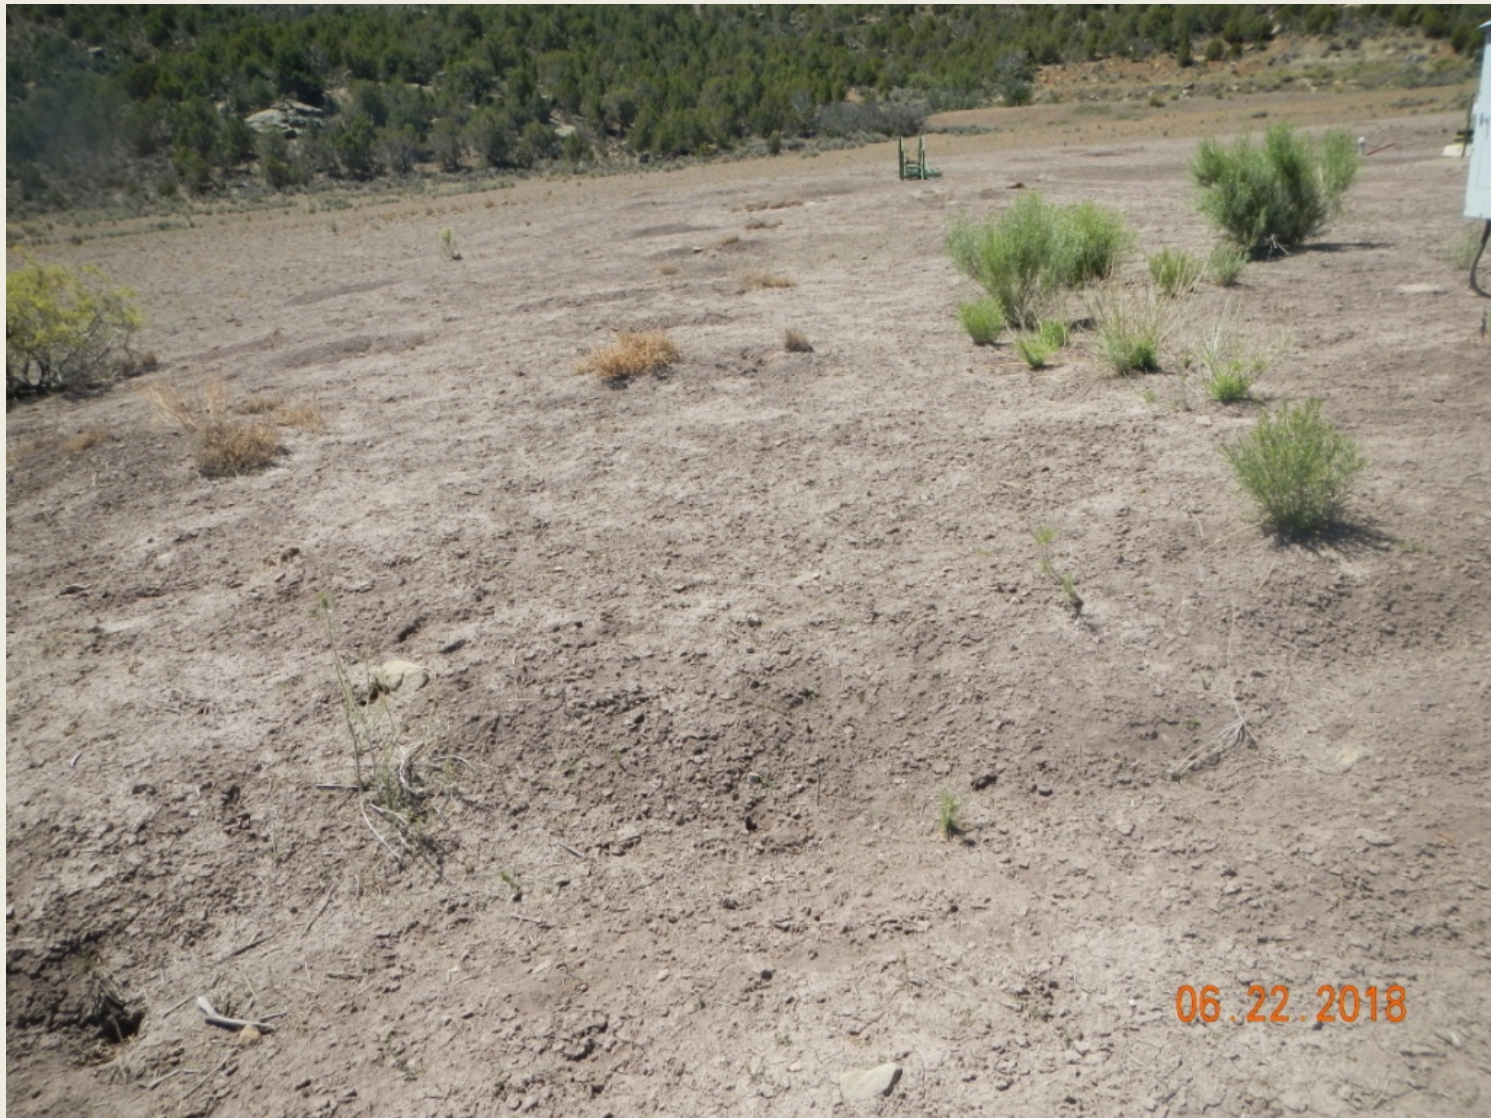
Photo 2. View of the eastern portion of the project area from the northeastern corner facing southward. Revegetation is sparse with widely spaced rubber rabbitbrush (*Chrysothamnus nauseosus*) and grasses in a dormant or deceased state.

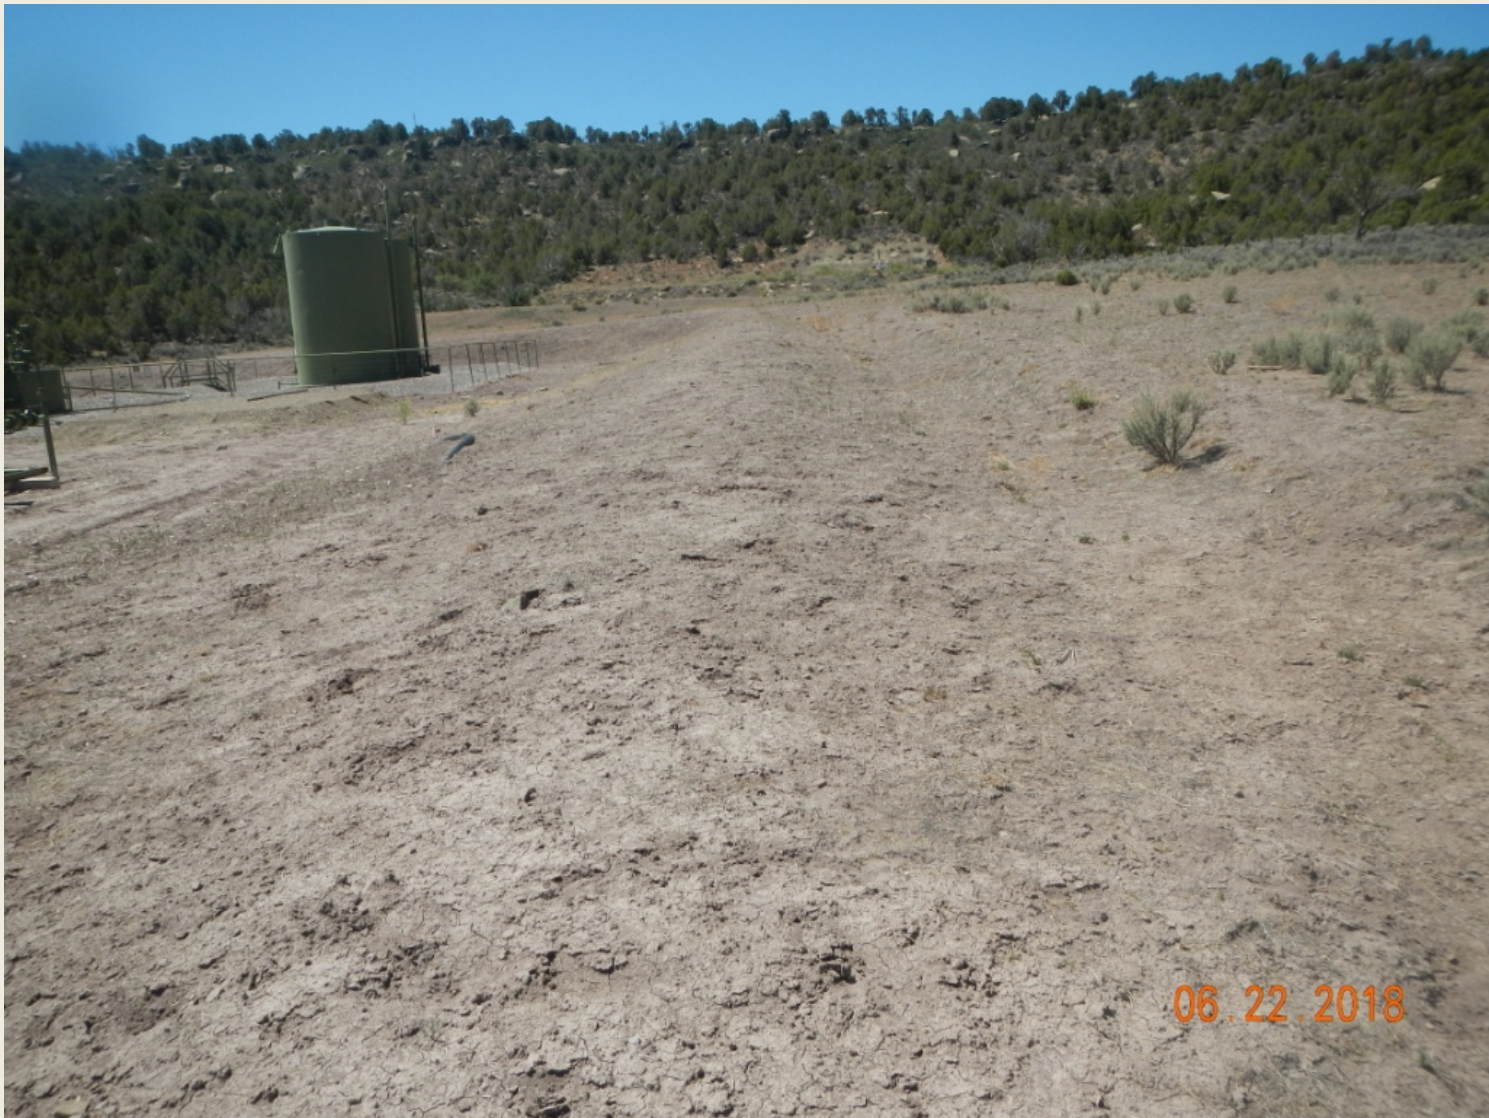
Photo 3. View of the western portion of the project area from the northwestern corner facing southward.

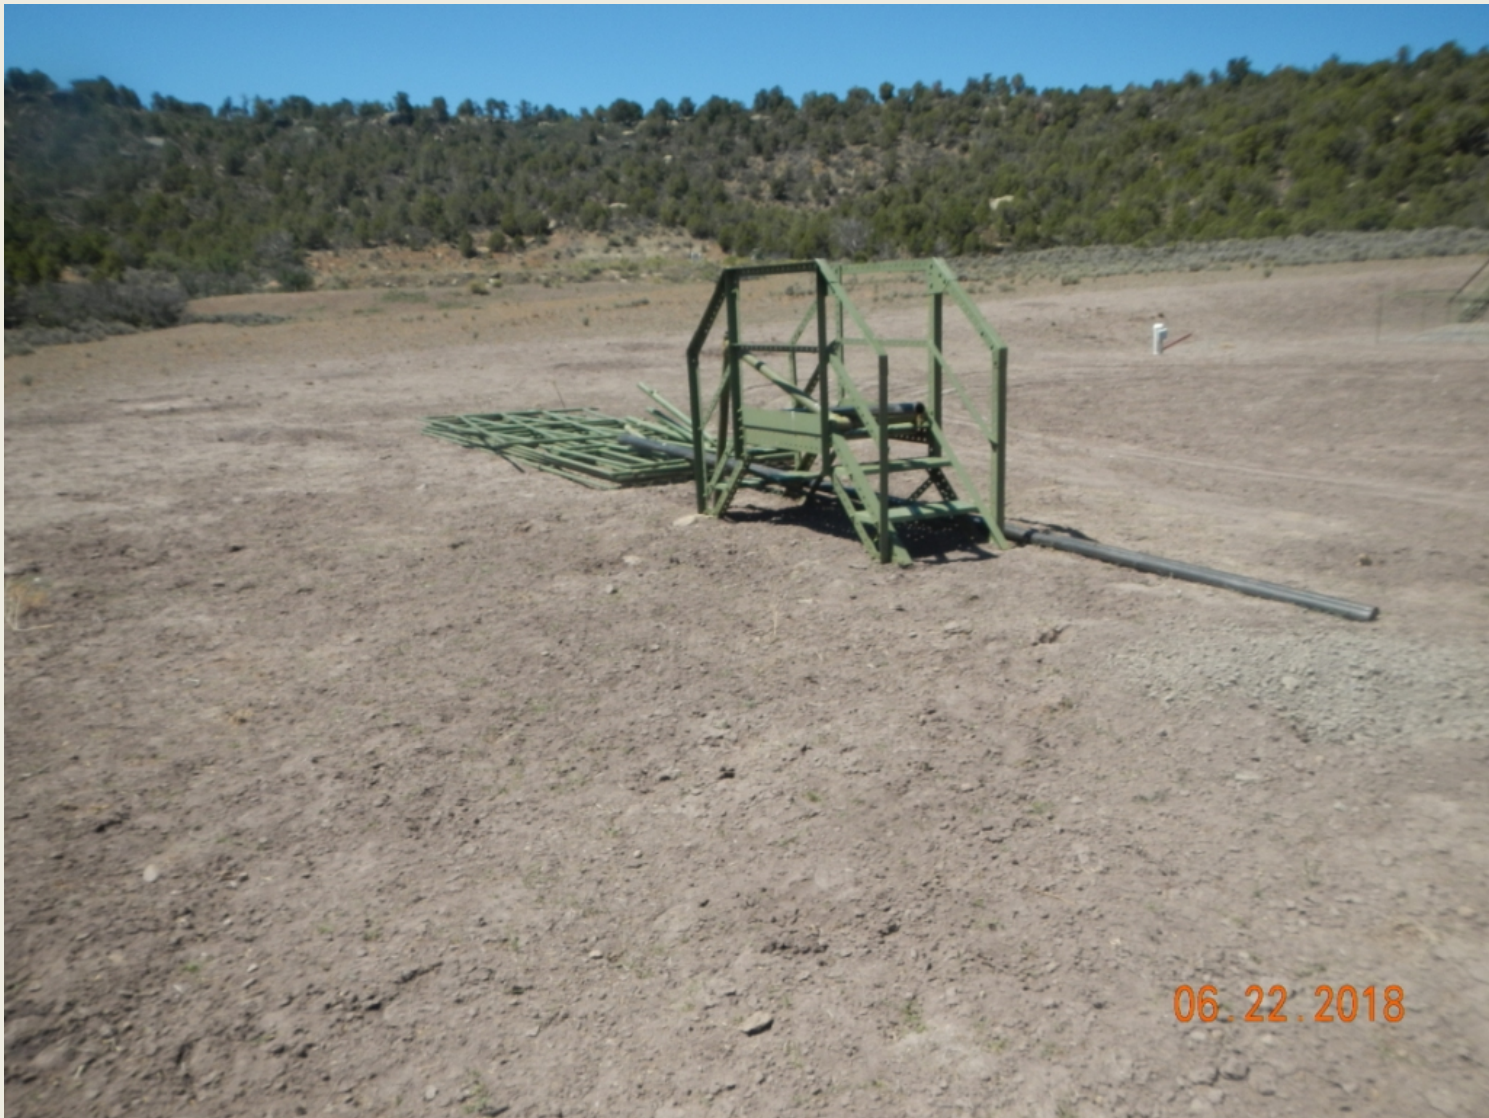
Photo 4. View unused equipment within the eastern project area.

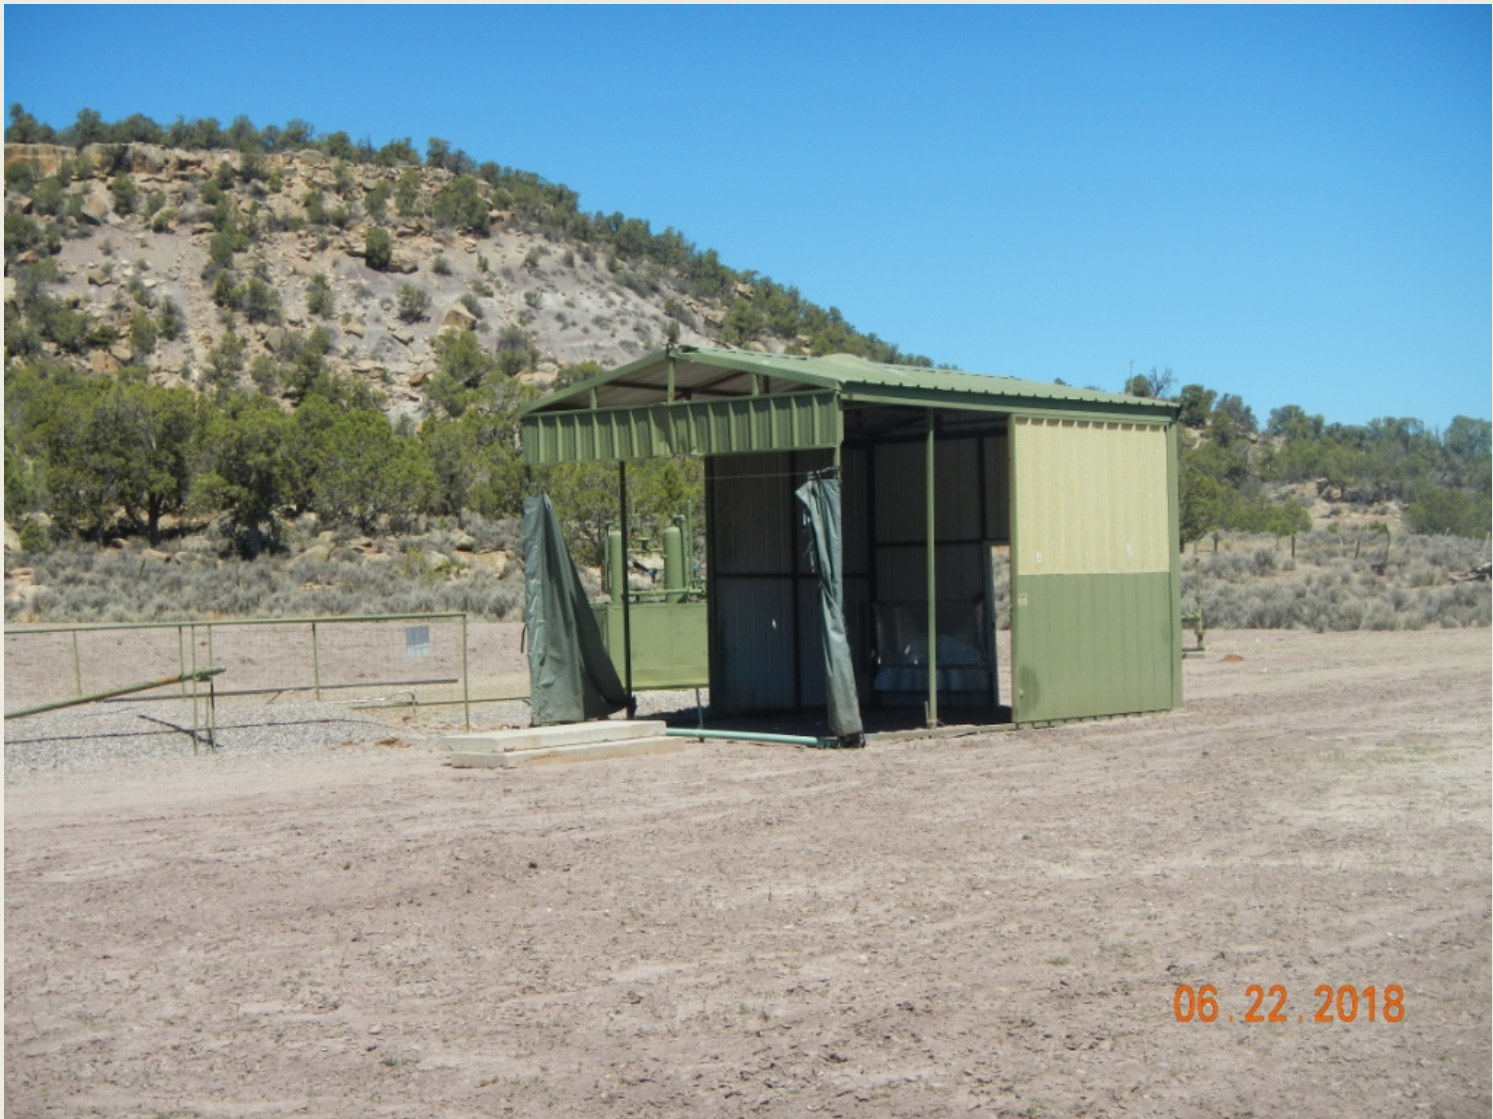
Photo 5. View of housing equipment that does not appear to be in use.

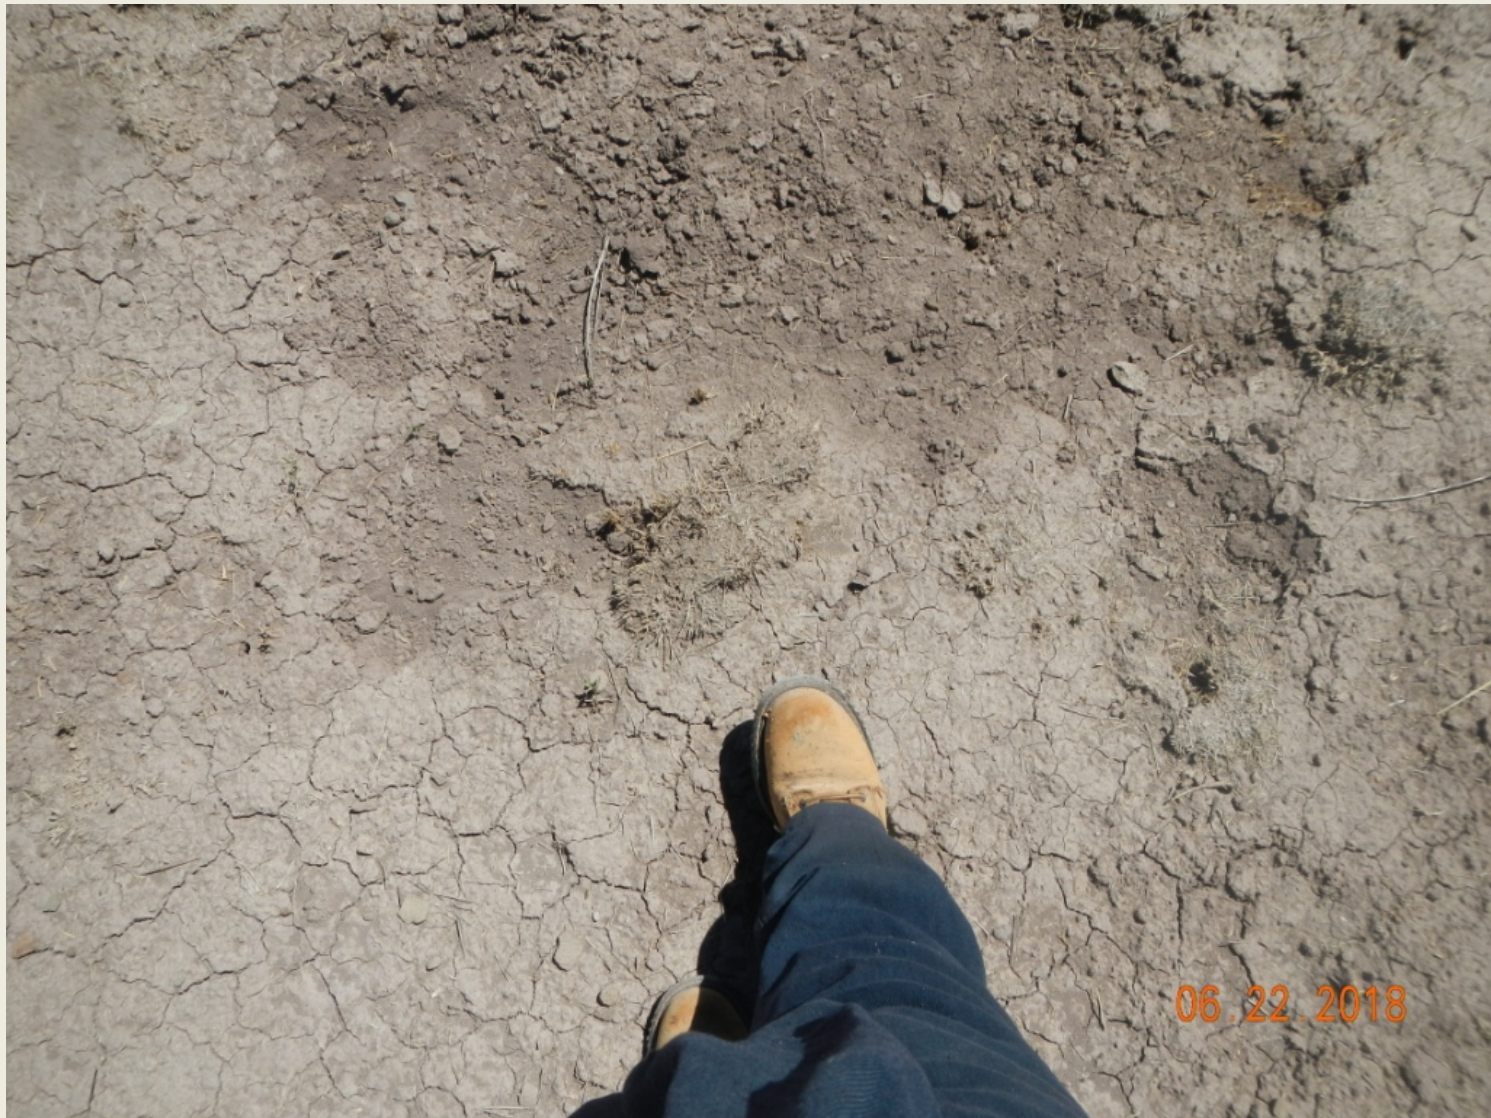
Photo 6. View of typical grass within the interim reclamation that is in poor condition.

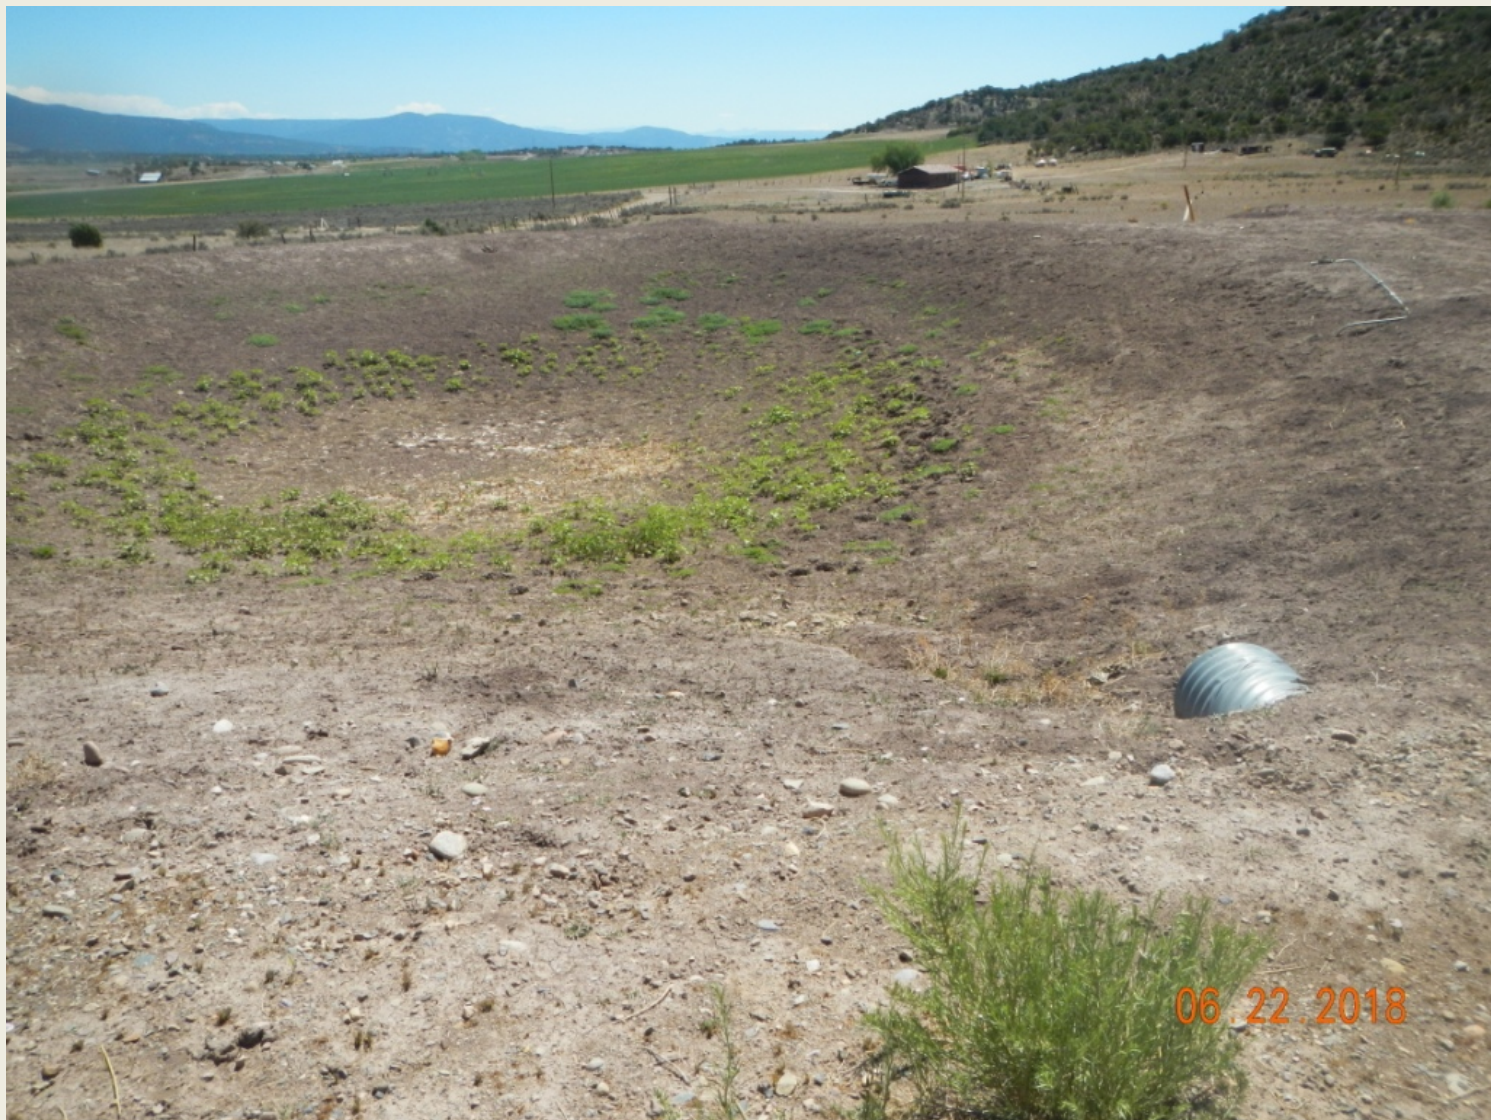
Photo 7. View of silt trap in the northeastern portion of the project area.

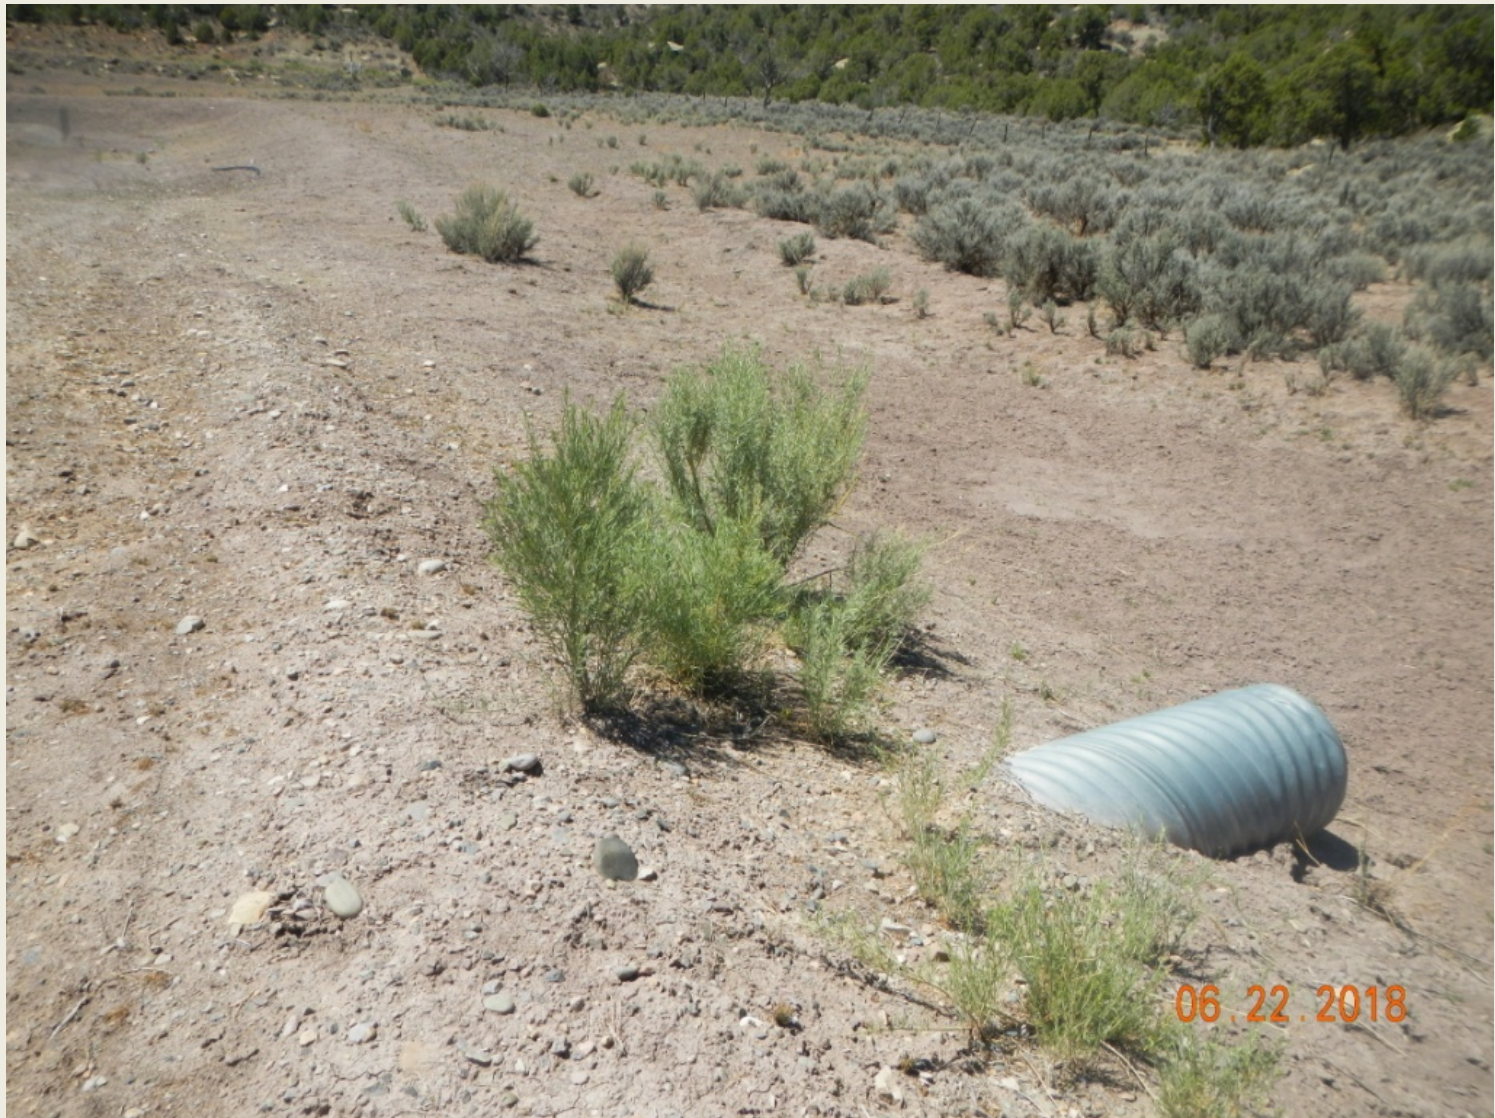
Photo 8. View of silt trap in the northwestern project area.
