Final Reclamation and Stormwater Inspection

June 28, 2018

Operator: PIONEER NATURAL RESOURCES USA INC – 10084

Location ID: 383615

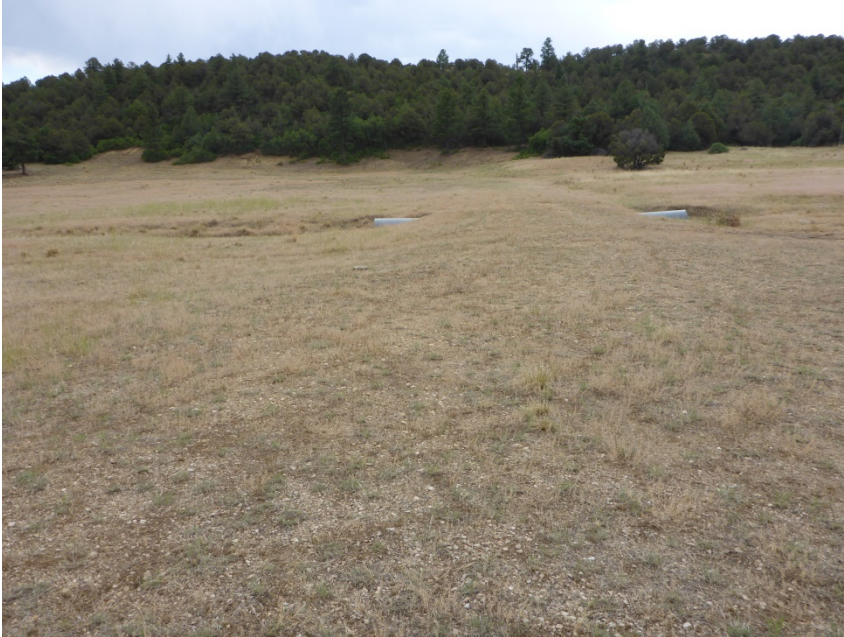
Photo 1. Photo taken from the access road looking towards the location, facing South. Appears the Operator has performed final reclamation activities on the well location and access road.

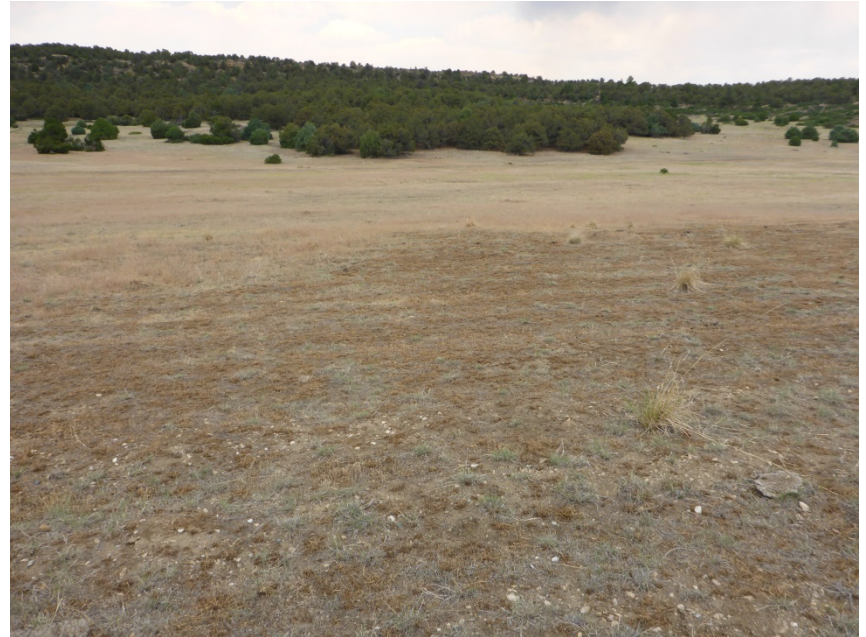
Photo 2. Photo taken from the well location, facing North. See comments from Photo 1.

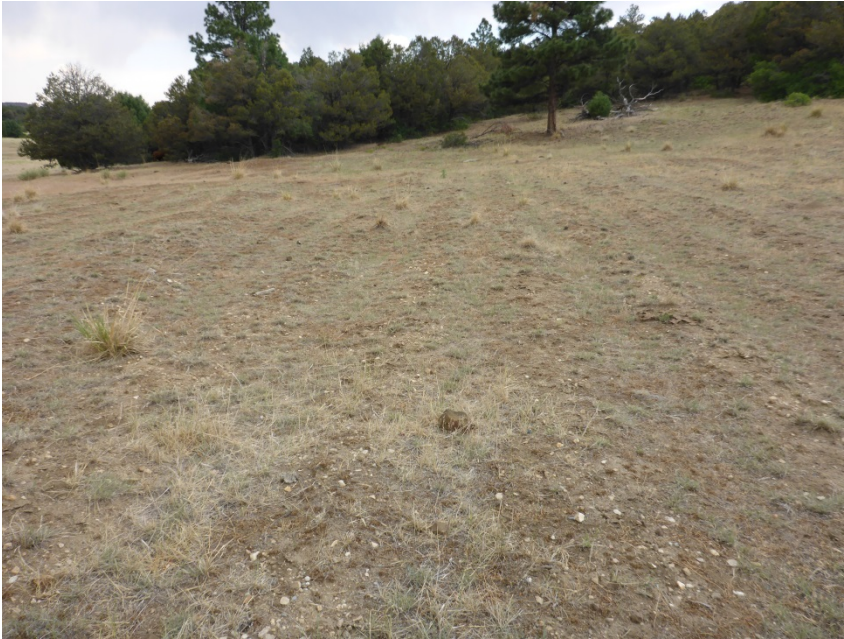
Photo 3. Photo taken from the well location, facing East. See comments from Photo 1.

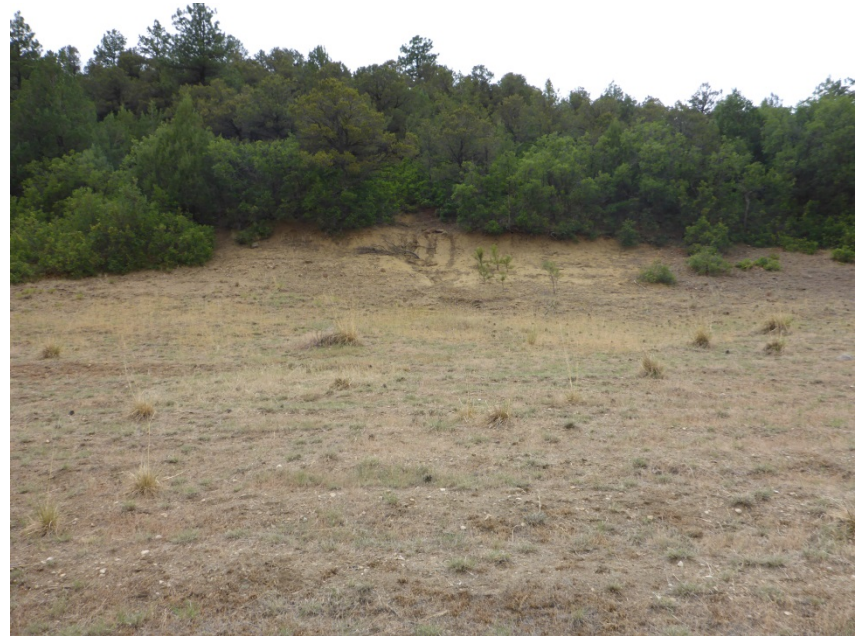
Photo 4. Photo taken from the well location, facing South. See comments from Photo 1.

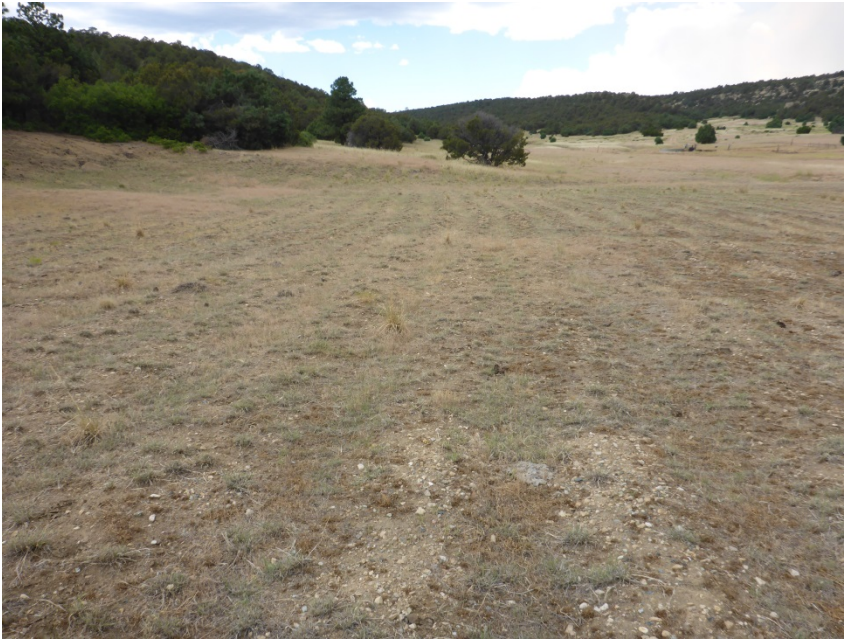
Photo 5. Photo taken from the well location, facing West. See comments from Photo 1.

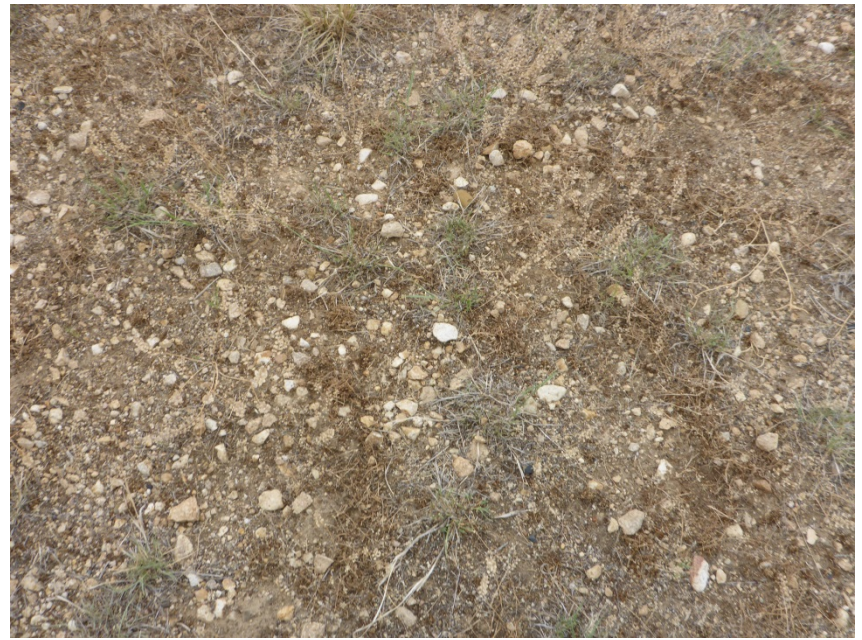
Photo 6. Photo taken from the South end of the location. Note the gravel that was not removed.

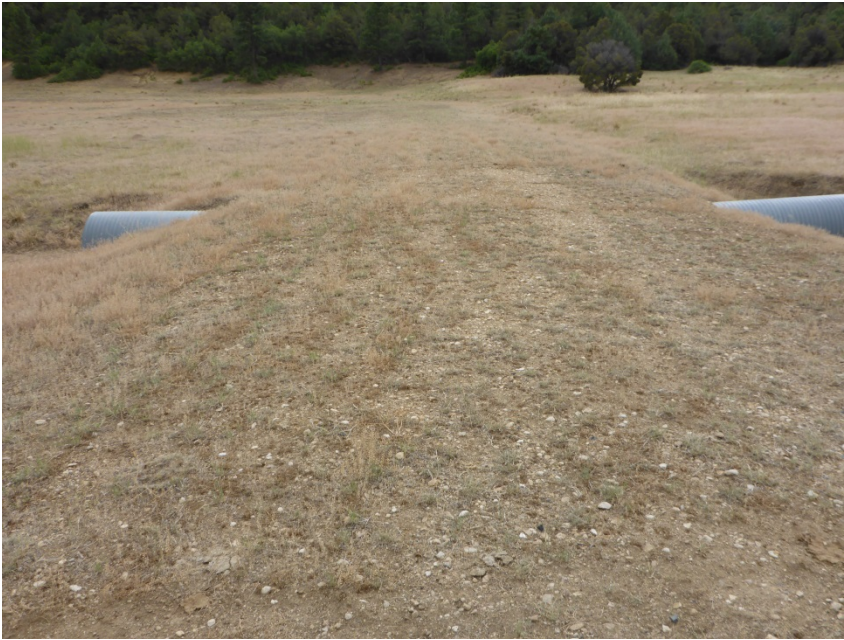
Photo 7. Photo taken from the access road, facing South. Note the culvert that is still on location.

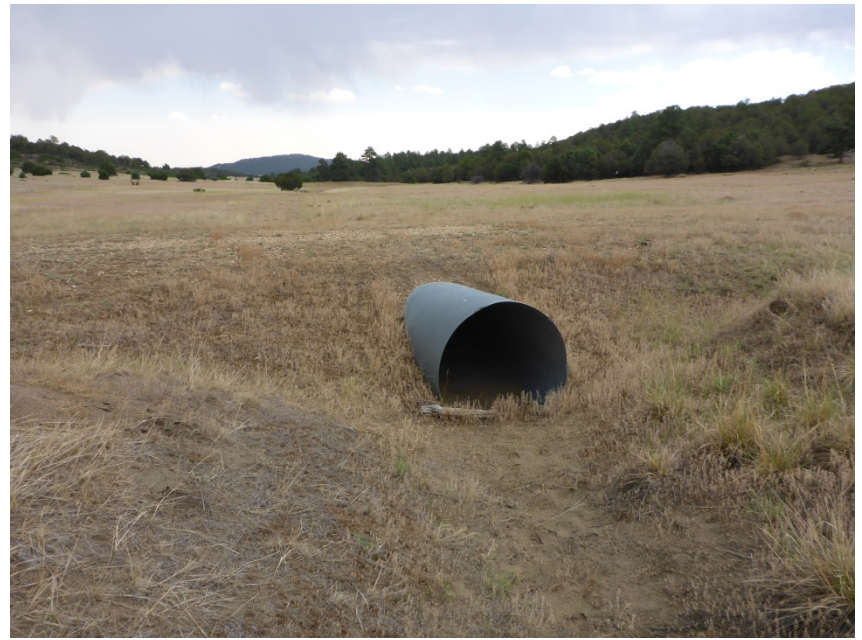
Photo 8. Photo taken from the access road, facing West. See comments from Photo 7.
