Final Reclamation and Stormwater Inspection

June 28, 2018

Operator: PIONEER NATURAL RESOURCES USA INC – 10084

Location ID: 383608

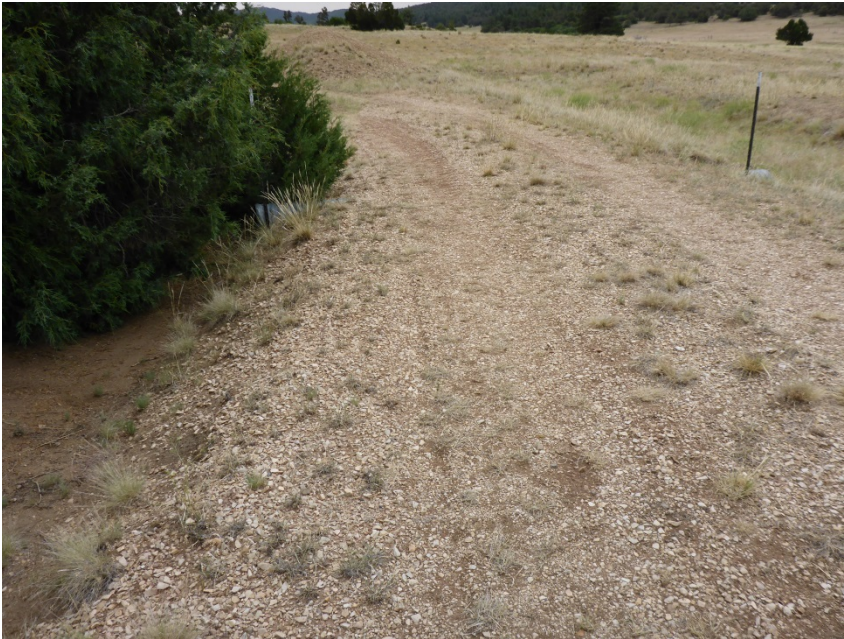
Photo 1. Photo taken from the access road looking towards the location, facing East. Appears the Operator has performed final reclamation activities on the well location and access road.

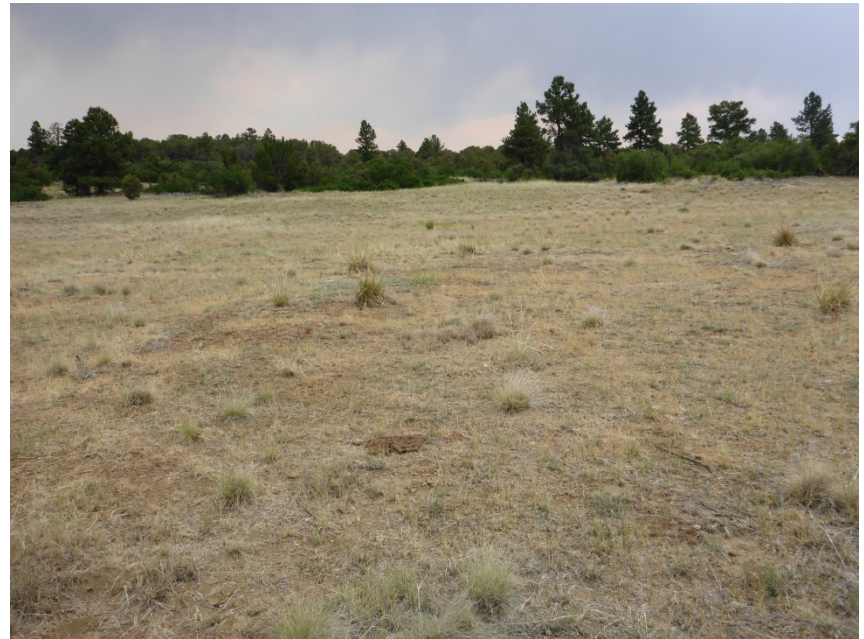
Photo 2. Photo taken from the well location, facing North. See comments from Photo 1.

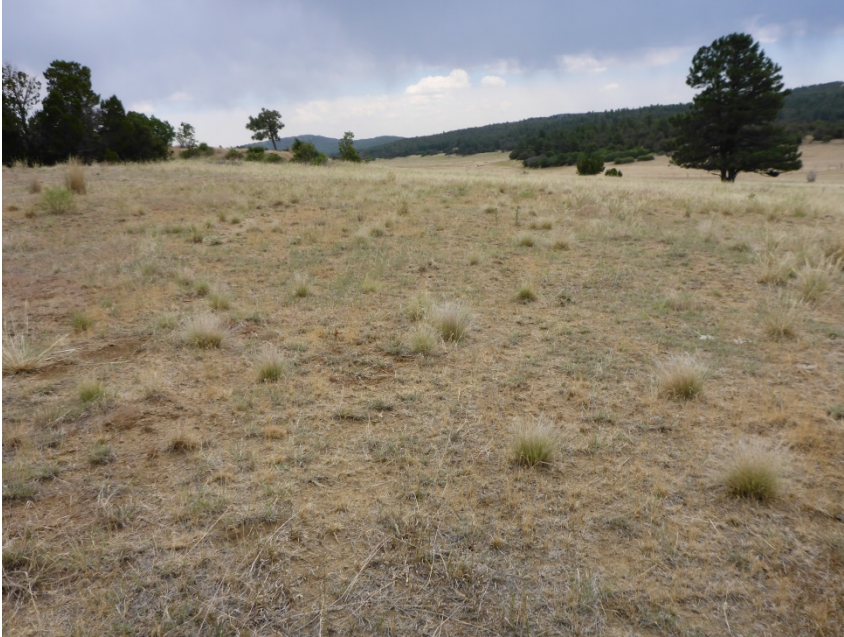
Photo 3. Photo taken from the well location, facing East. See comments from Photo 1.

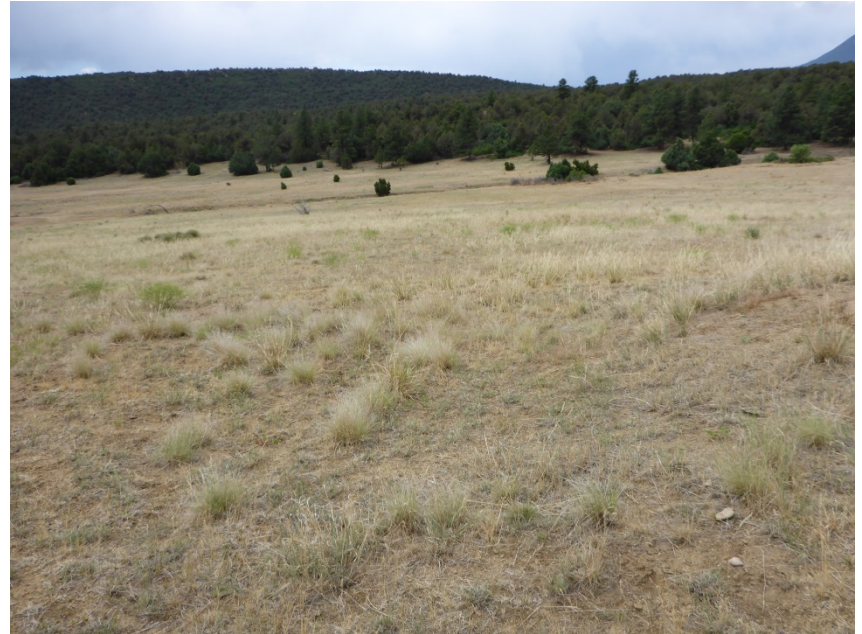
Photo 4. Photo taken from the well location, facing South. See comments from Photo 1.

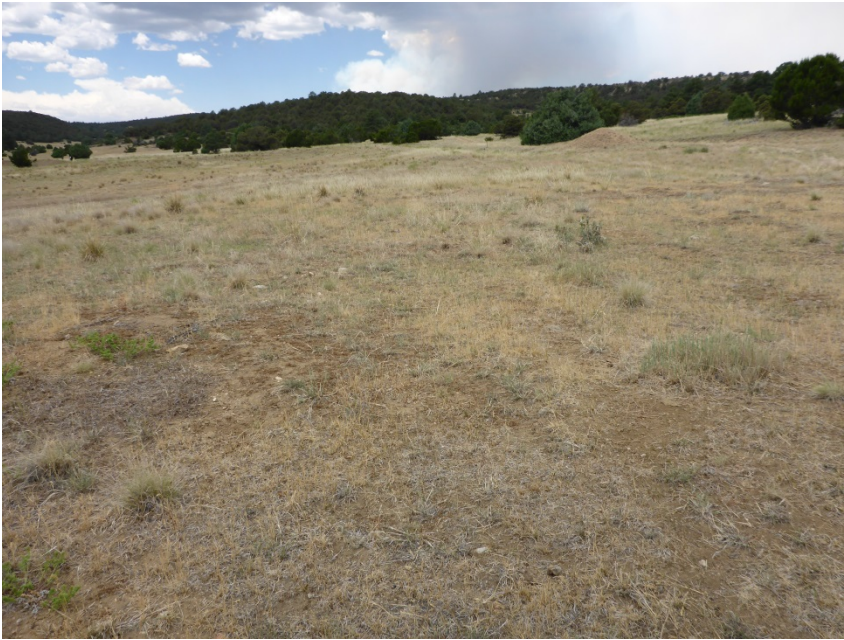
Photo 5. Photo taken from the well location, facing West. See comments from Photo 1.

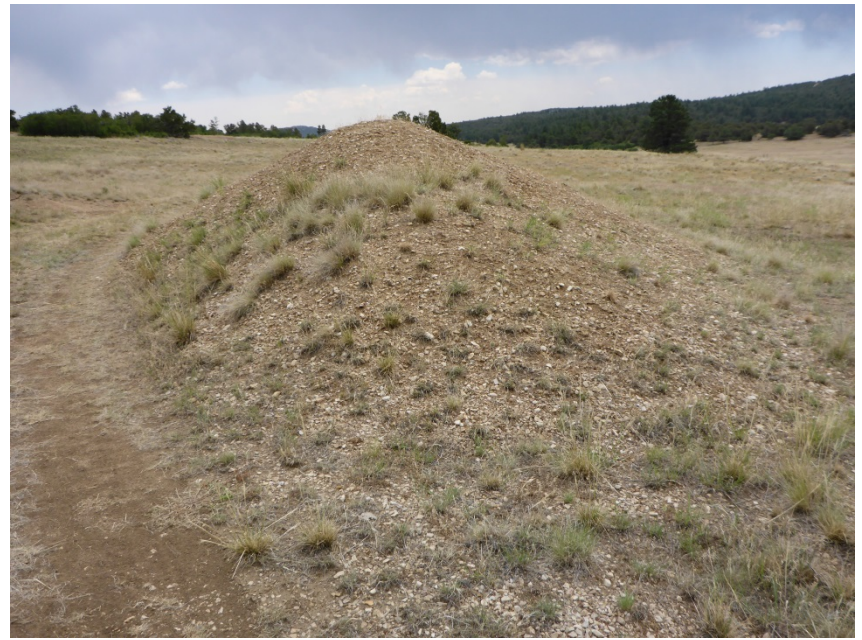
Photo 6. Photo taken from the West end of the location. Note the gravel stockpile that was not removed.

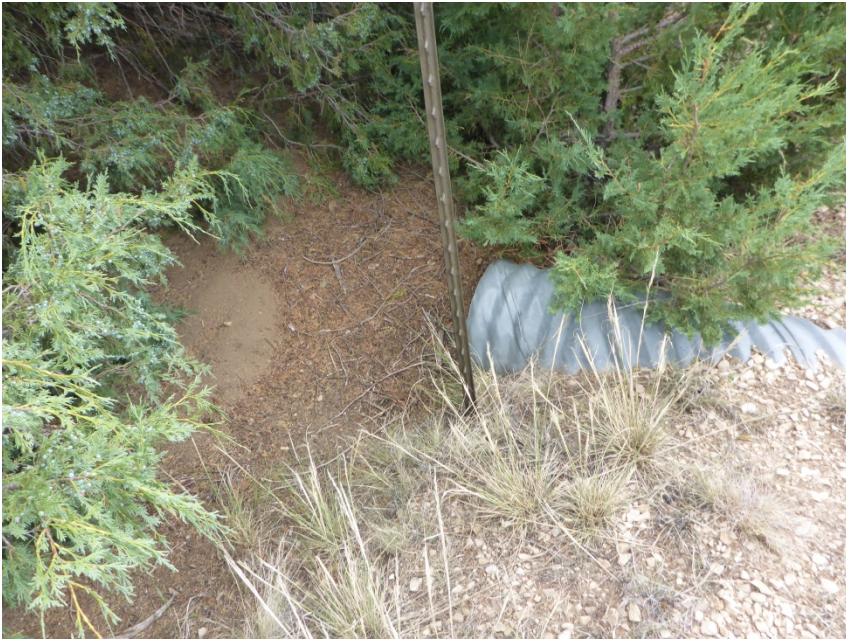
Photo 7. Photo taken from the access road. Note the culvert that is still on location.

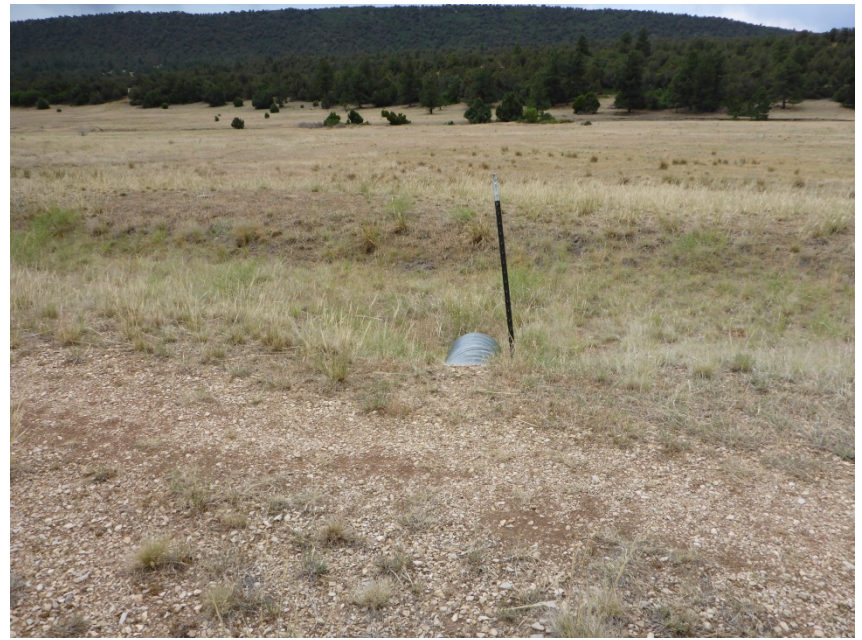
Photo 8. Photo taken from the access road, facing South. See comments from Photo 7.

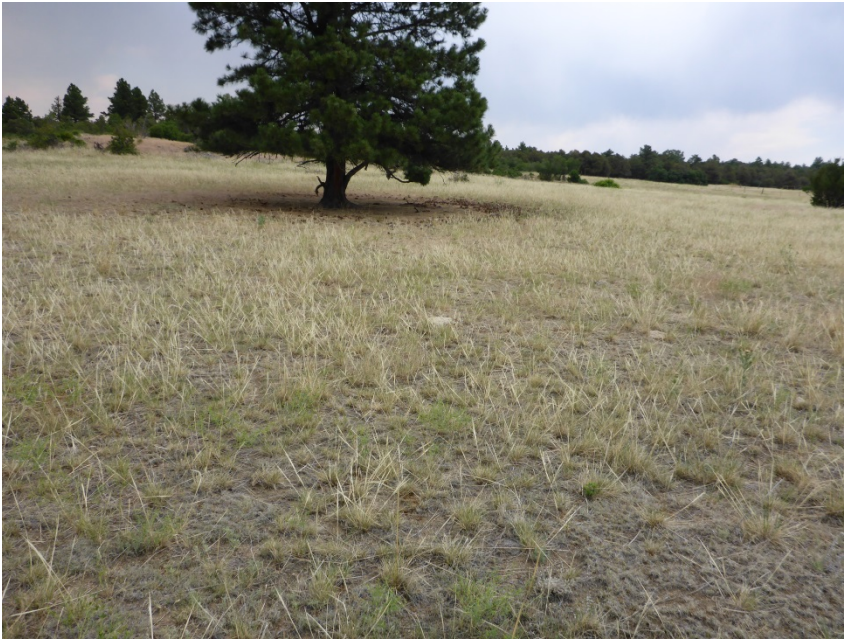
Photo 9. Photo taken from the Reference Area, facing North.

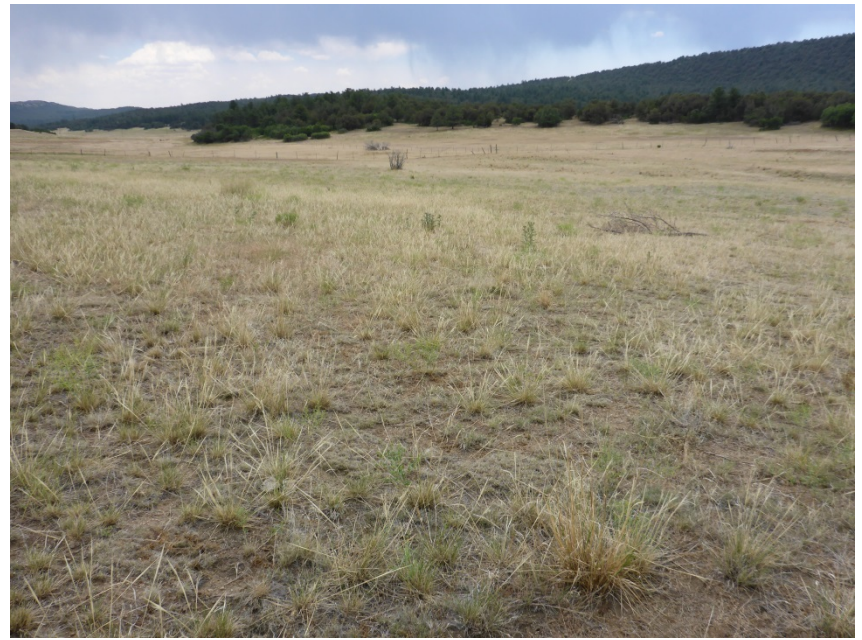
Photo 10. Photo taken from the Reference Area, facing East.

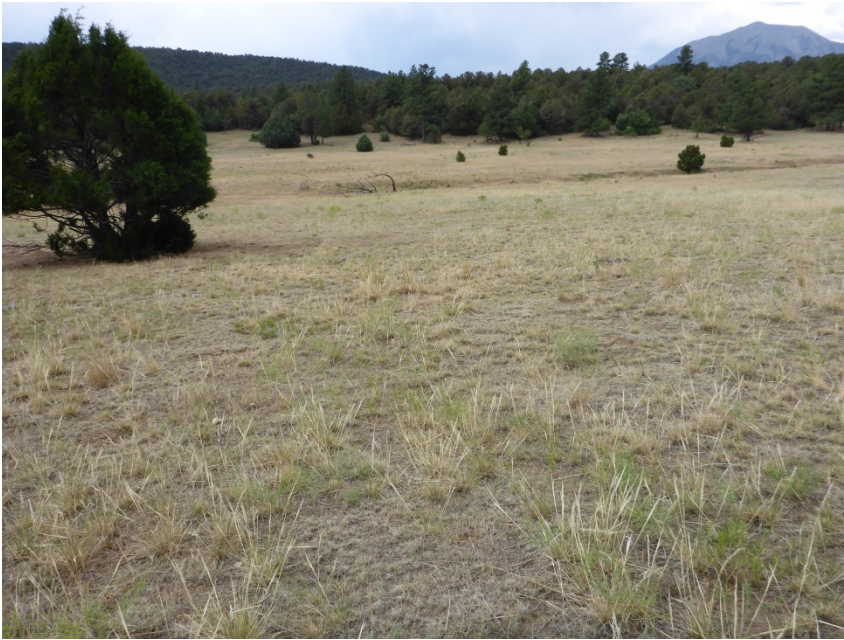
Photo 11. Photo taken from the Reference Area, facing South.

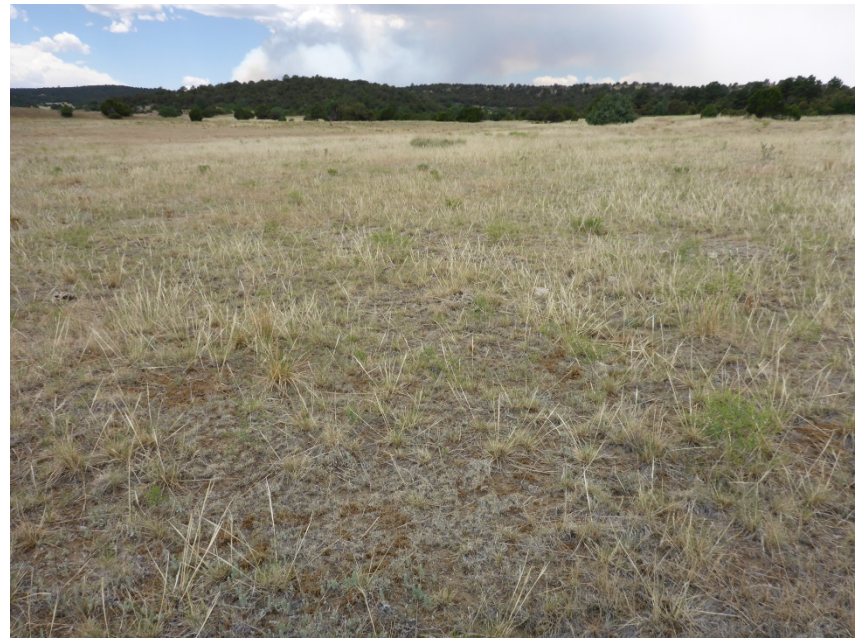
Photo 12. Photo taken from the Reference Area, facing West.
