**Inspection Photos**  
**Location Name: Tierra Piedra SWD Facility**  
**API: 05-007-06307**

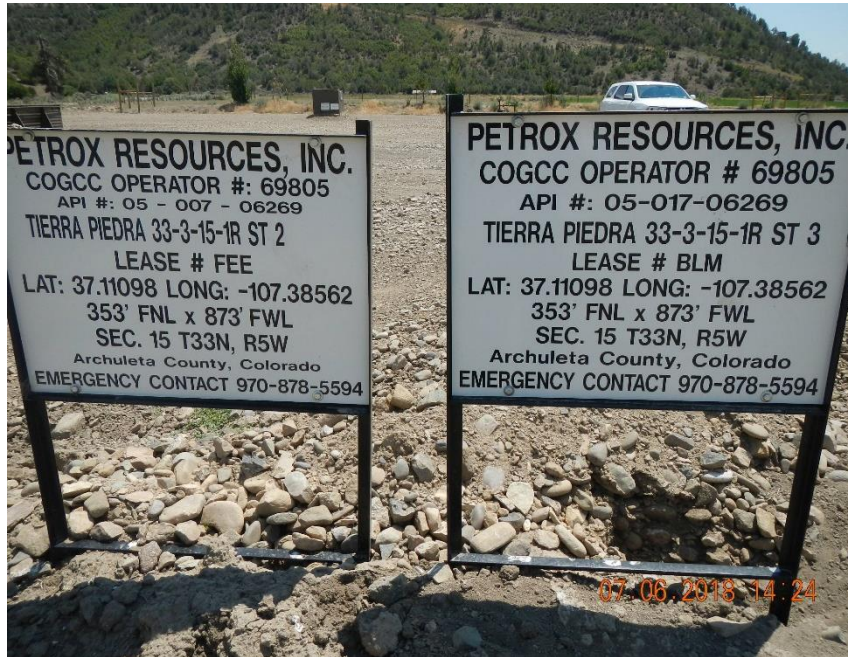
County code on sign for side track #3 is incorrect.

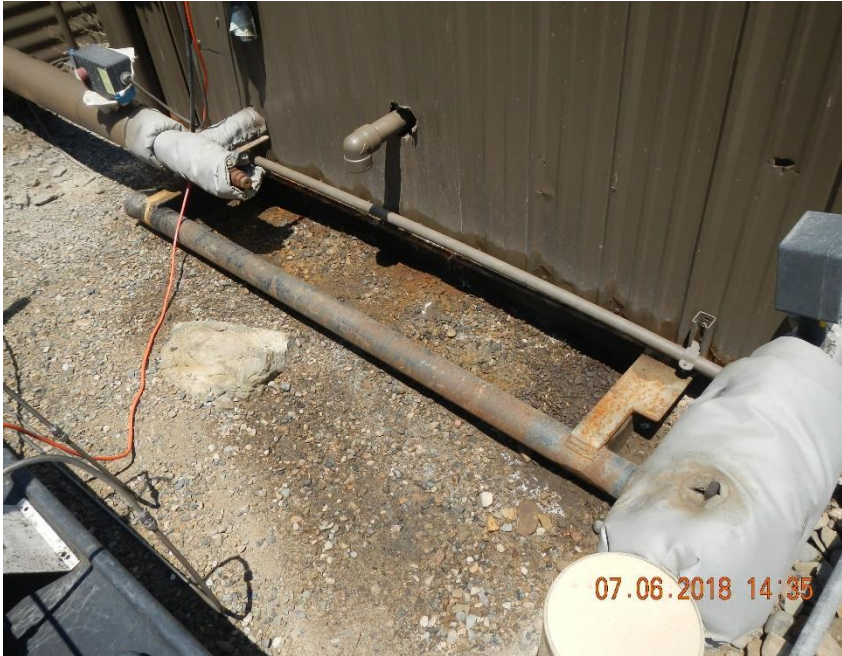
**West side of injection pump house with stained soil present.**

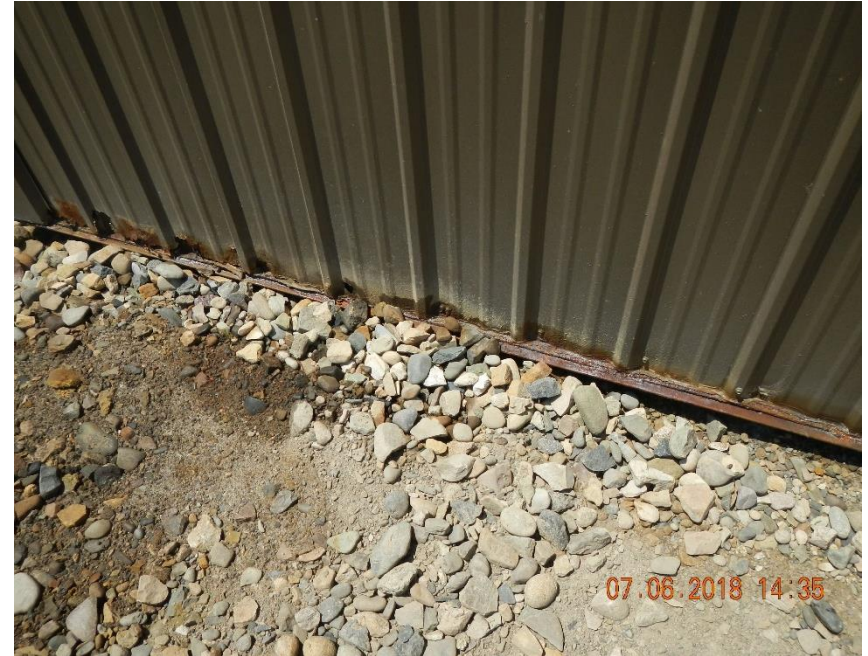
**Southwest corner of injection pump house with wet/stained soil and corroded metal .**

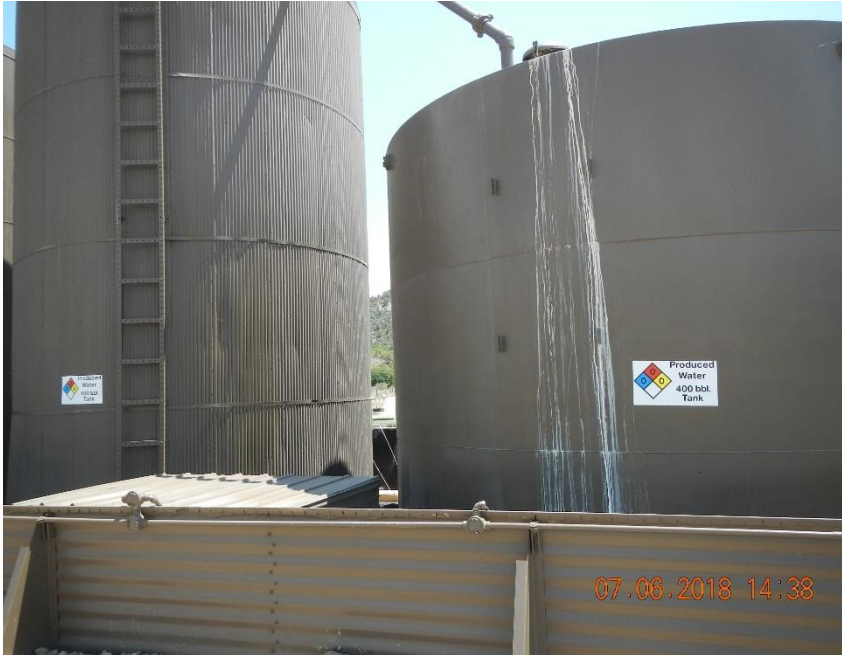
**Staining on western produced water AST.**

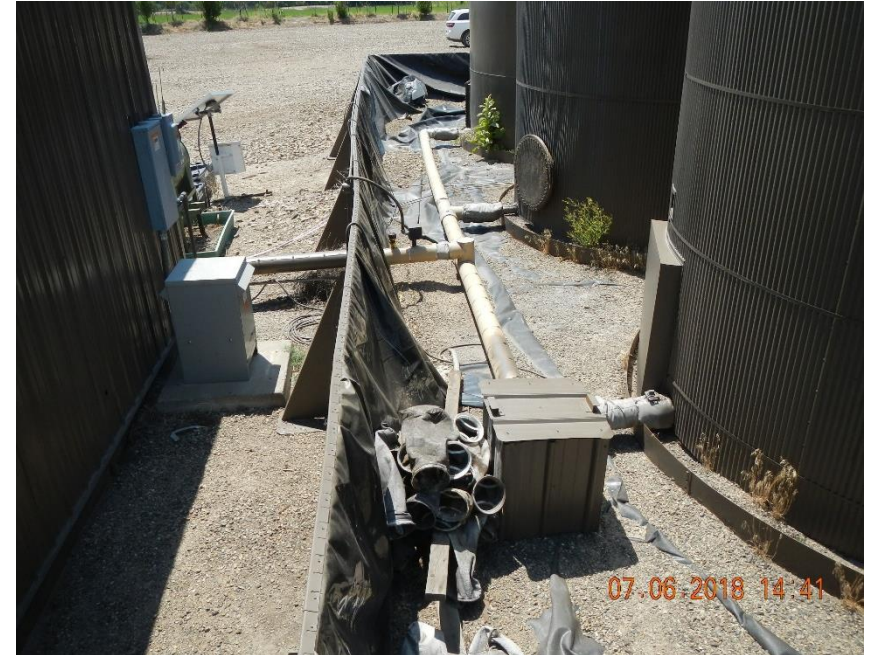
**Penetration through liner and secondary containment ring where release reportedly occurred.**
