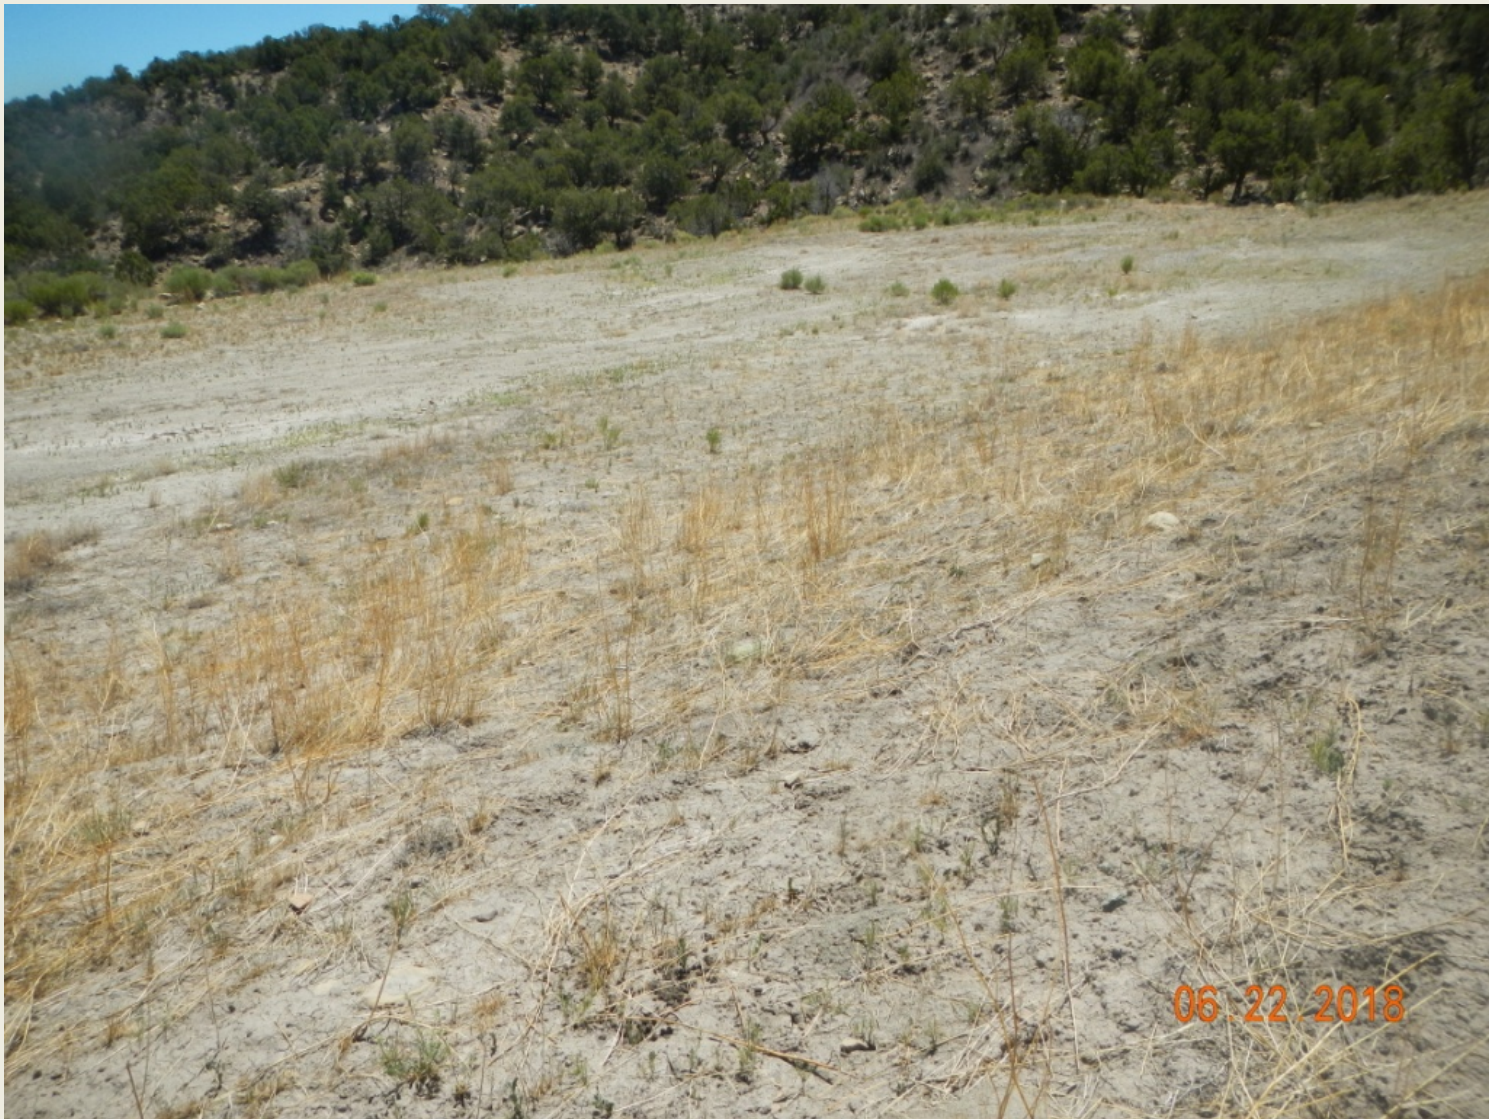
Photo 1. View of the project area from the northwestern corner facing center. Well pad is not recontoured.

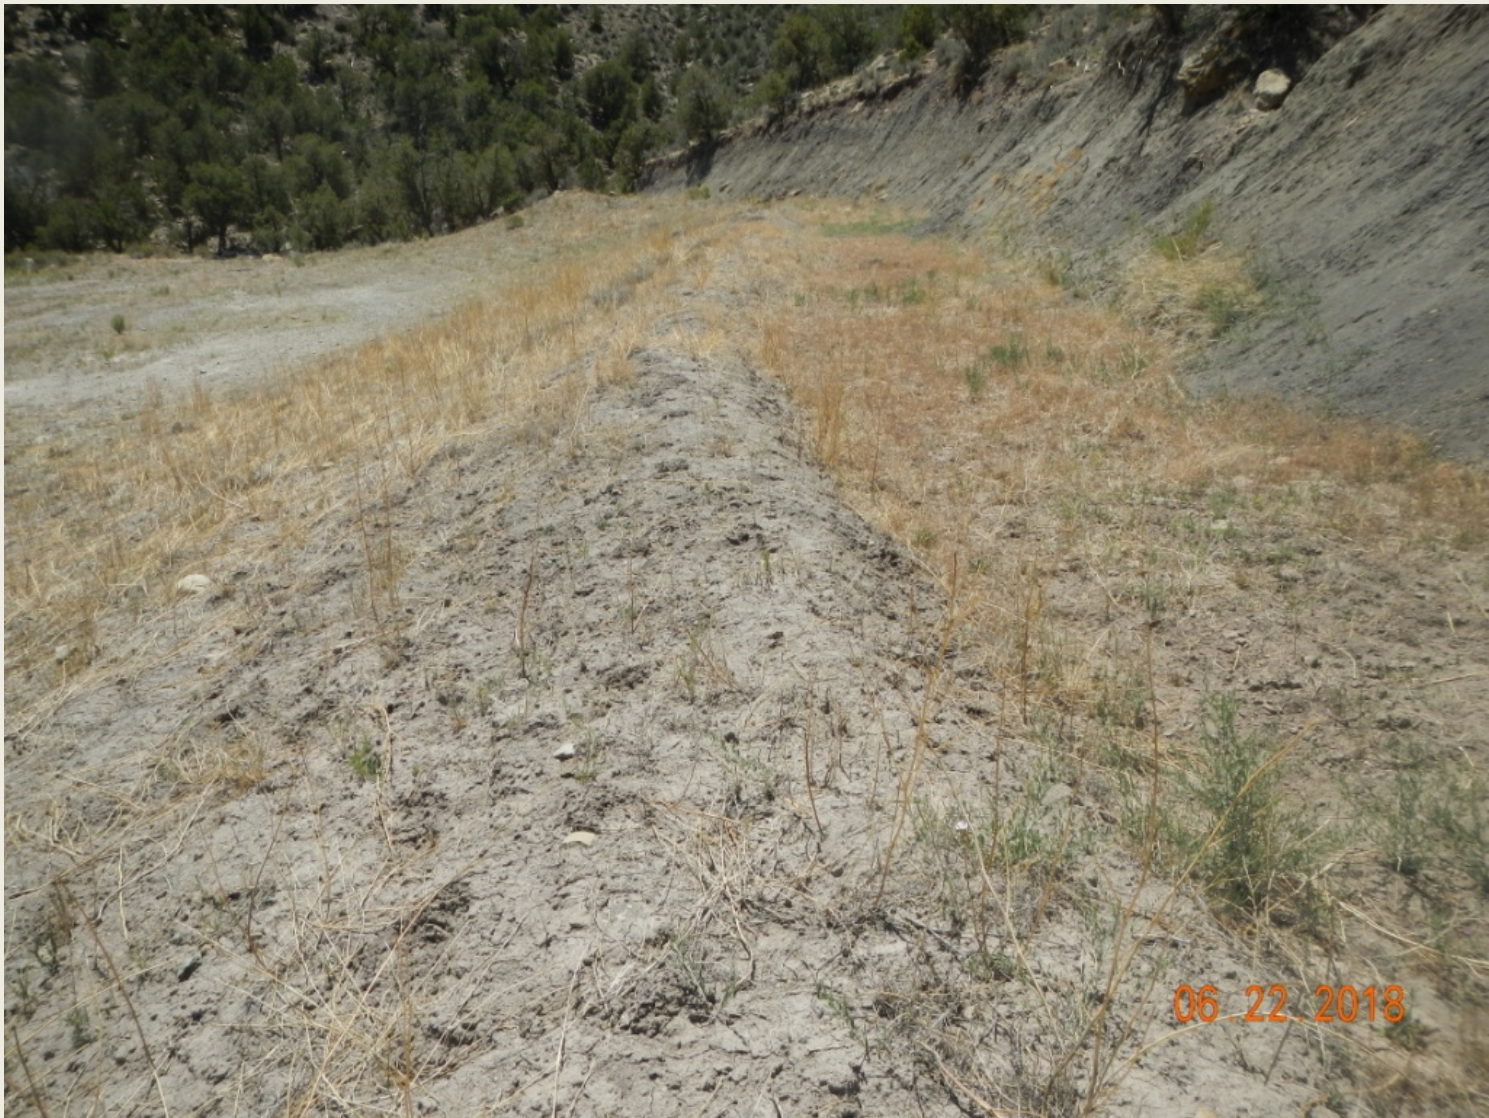
Photo 2. View of the western portion of the project area from the northwestern corner facing southward. Stormwater diversion is still in place and is full of sediment.

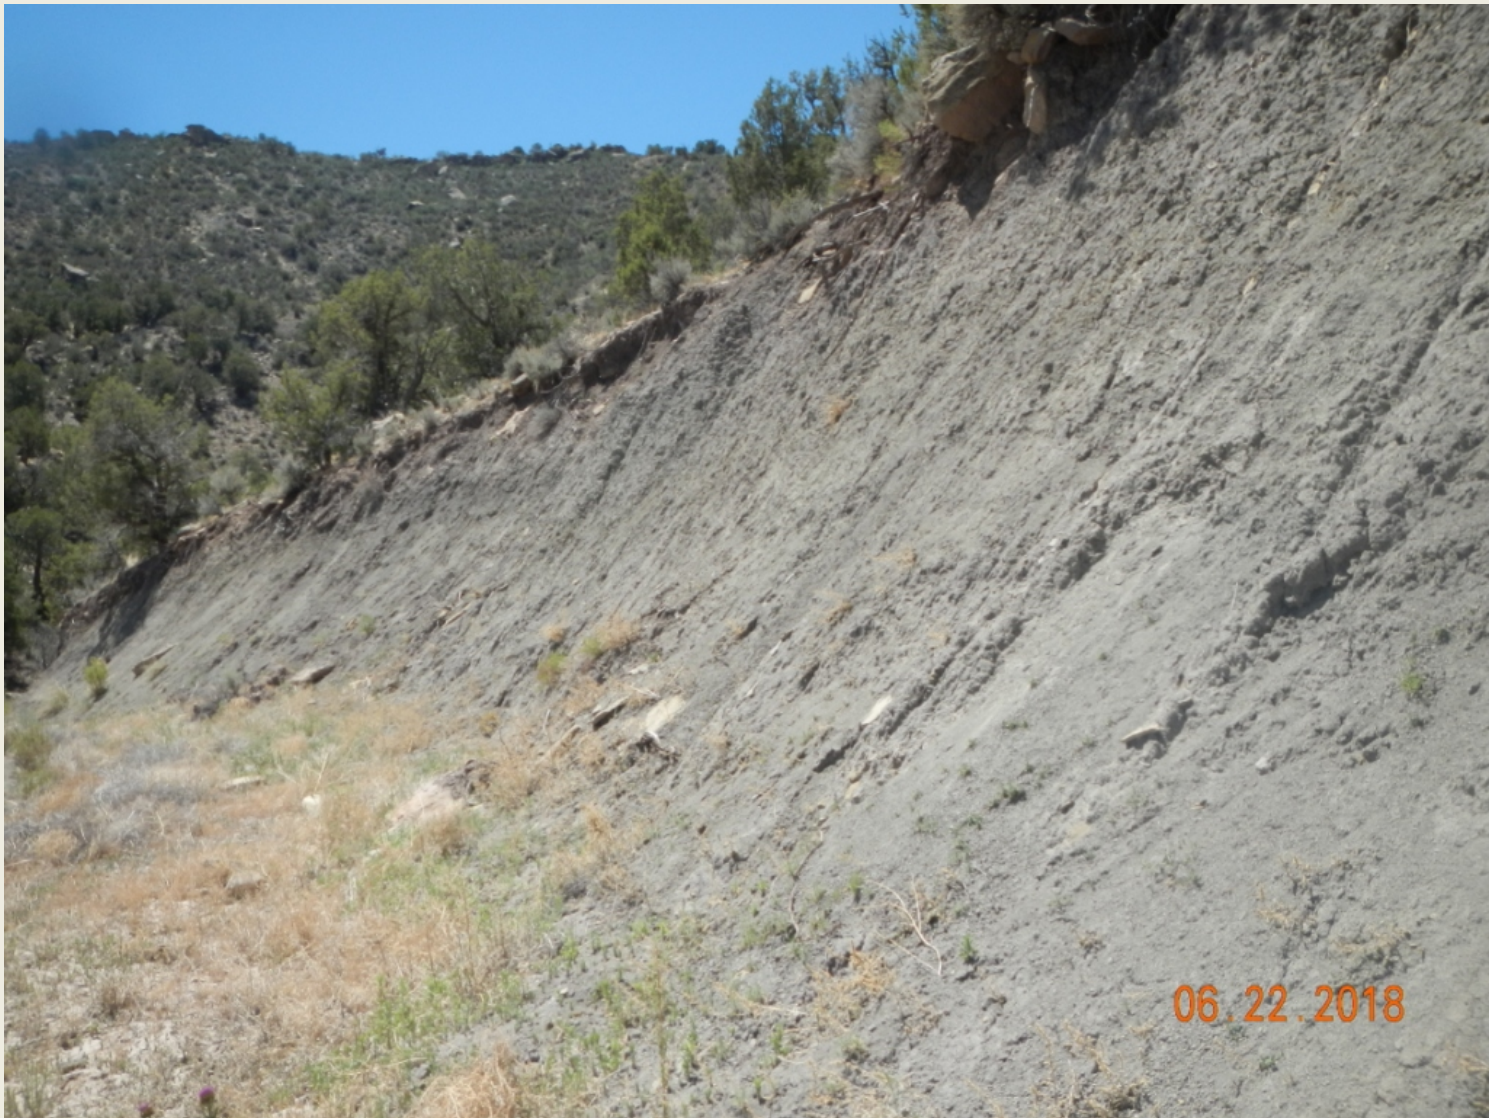
Photo 3. View of cut-slope approximately 20 feet tall along the western edge of the project area. Proper recontouring and revegetation is needed to stabilize this slope. Vegetation undercutting at the top of the slope, and sediment deposition at the toe of the slope are evidence that the slope is actively eroding.

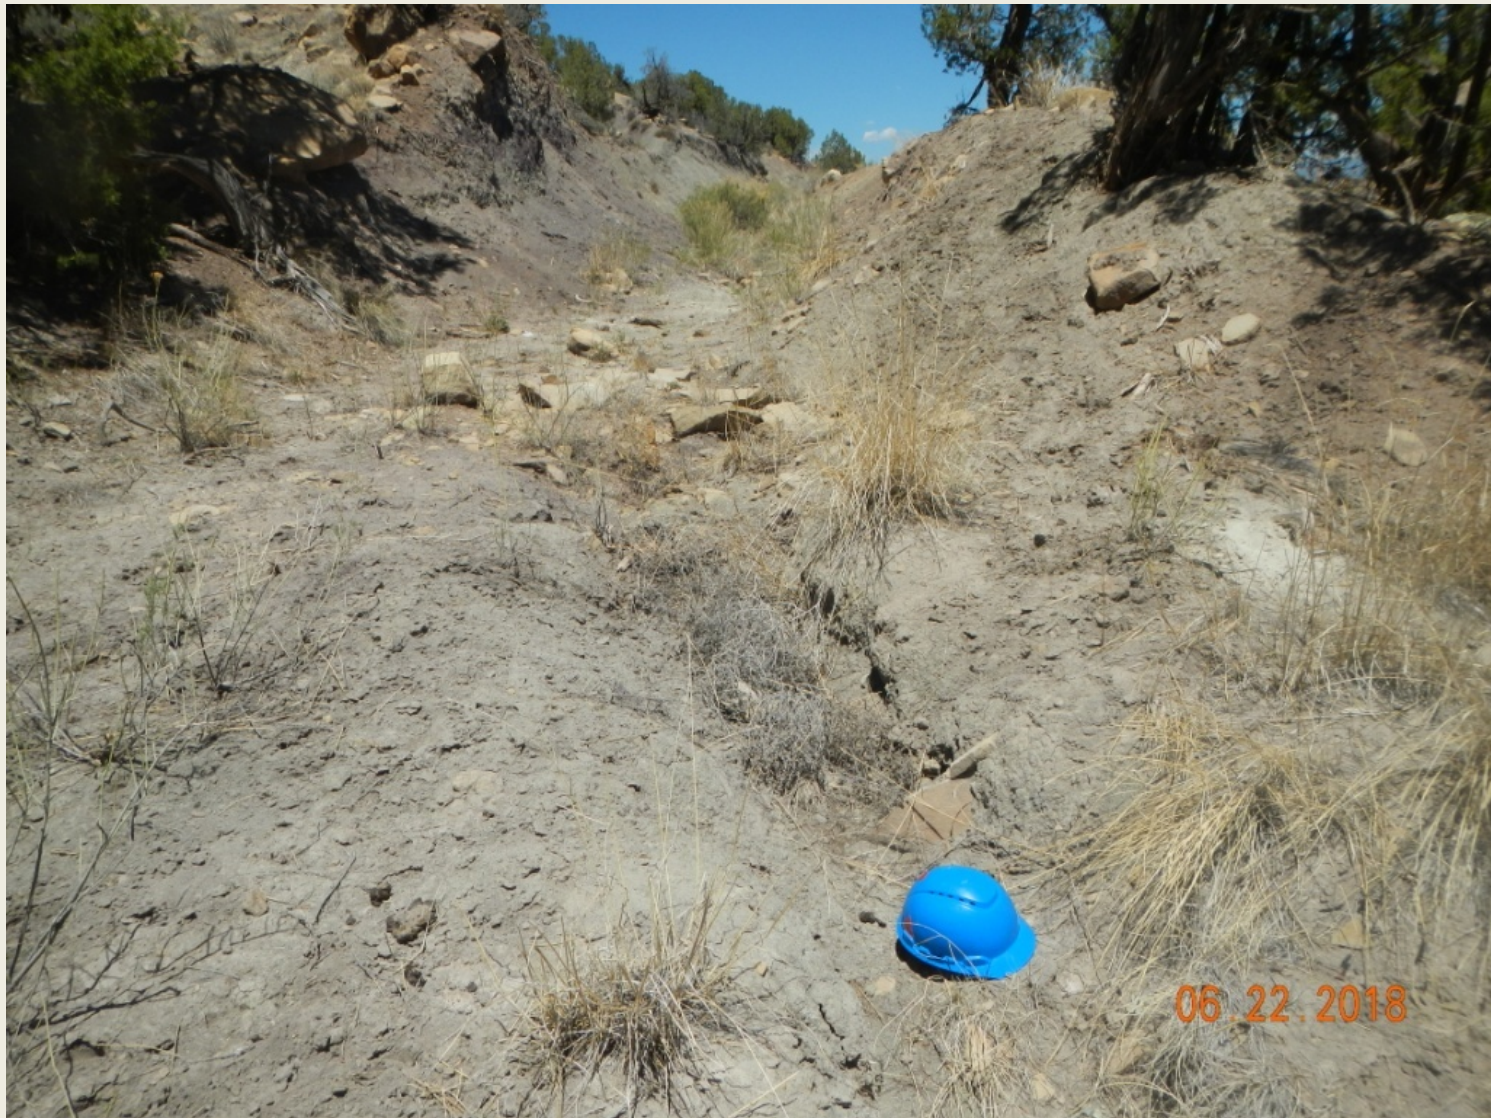
Photo 4. View of area in the southwestern corner of the project area where diversion feeds into an ephemeral drainage. Erosional channel approximately 2 feet wide and 18 inches deep is forming in this area.

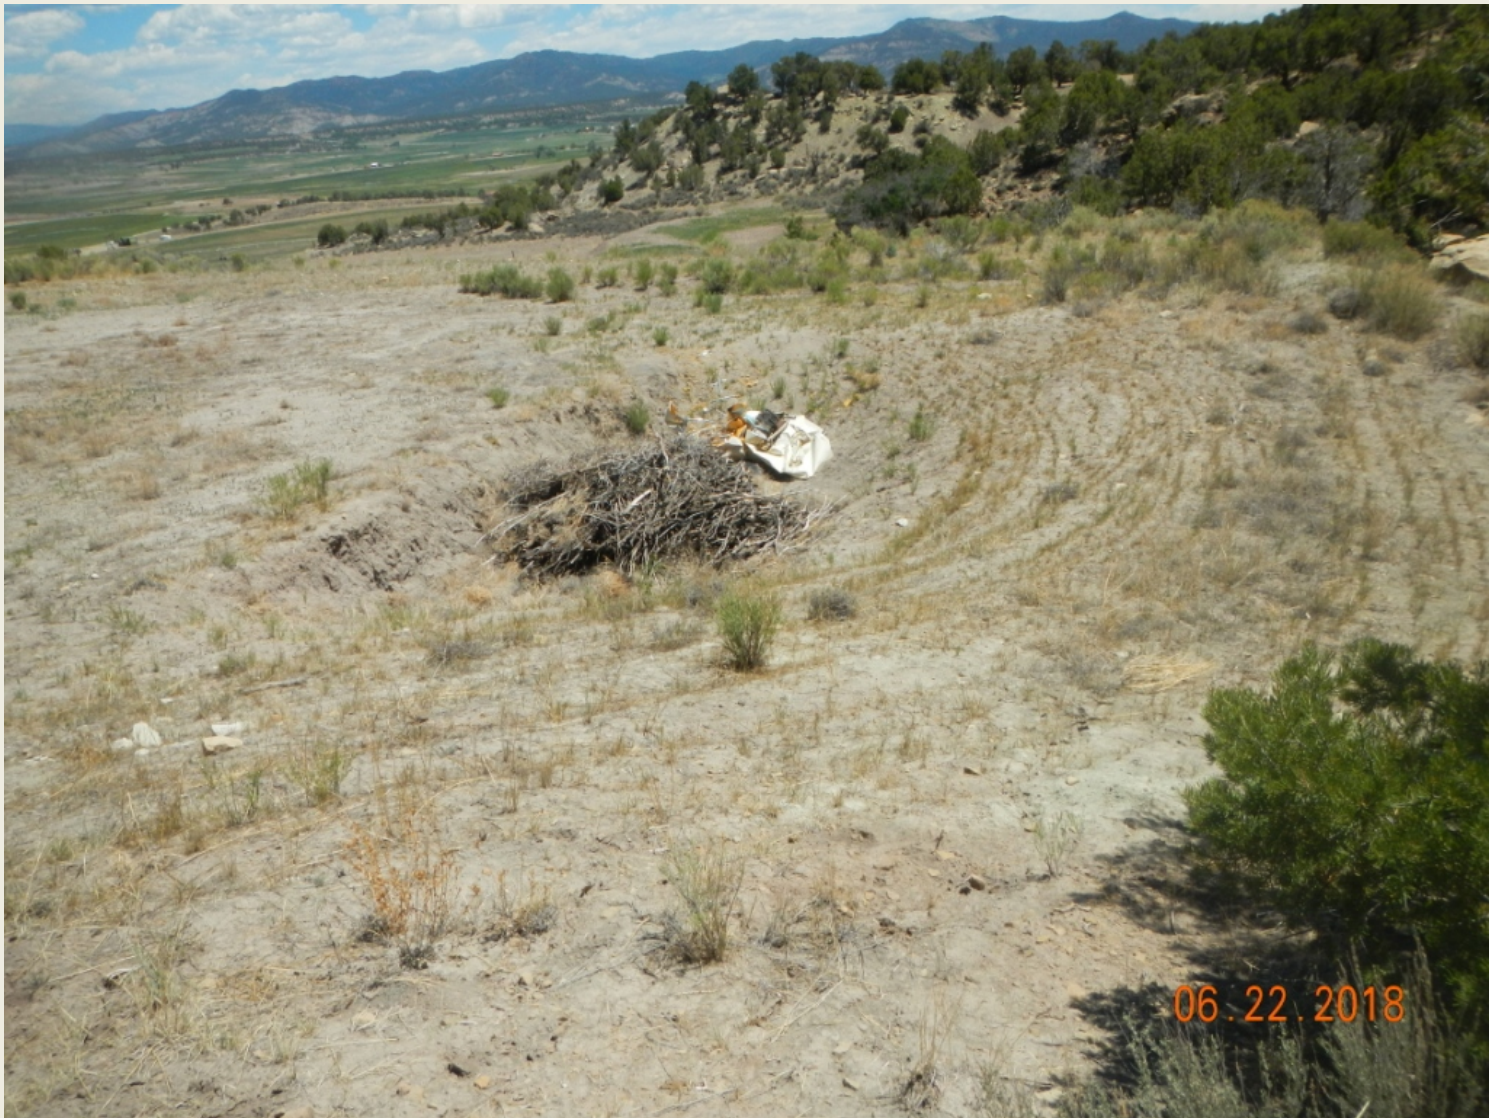
Photo 5. View of the southern portion of the project area from the southwestern corner facing northward. A pit area is present and contains waste and wood debris.

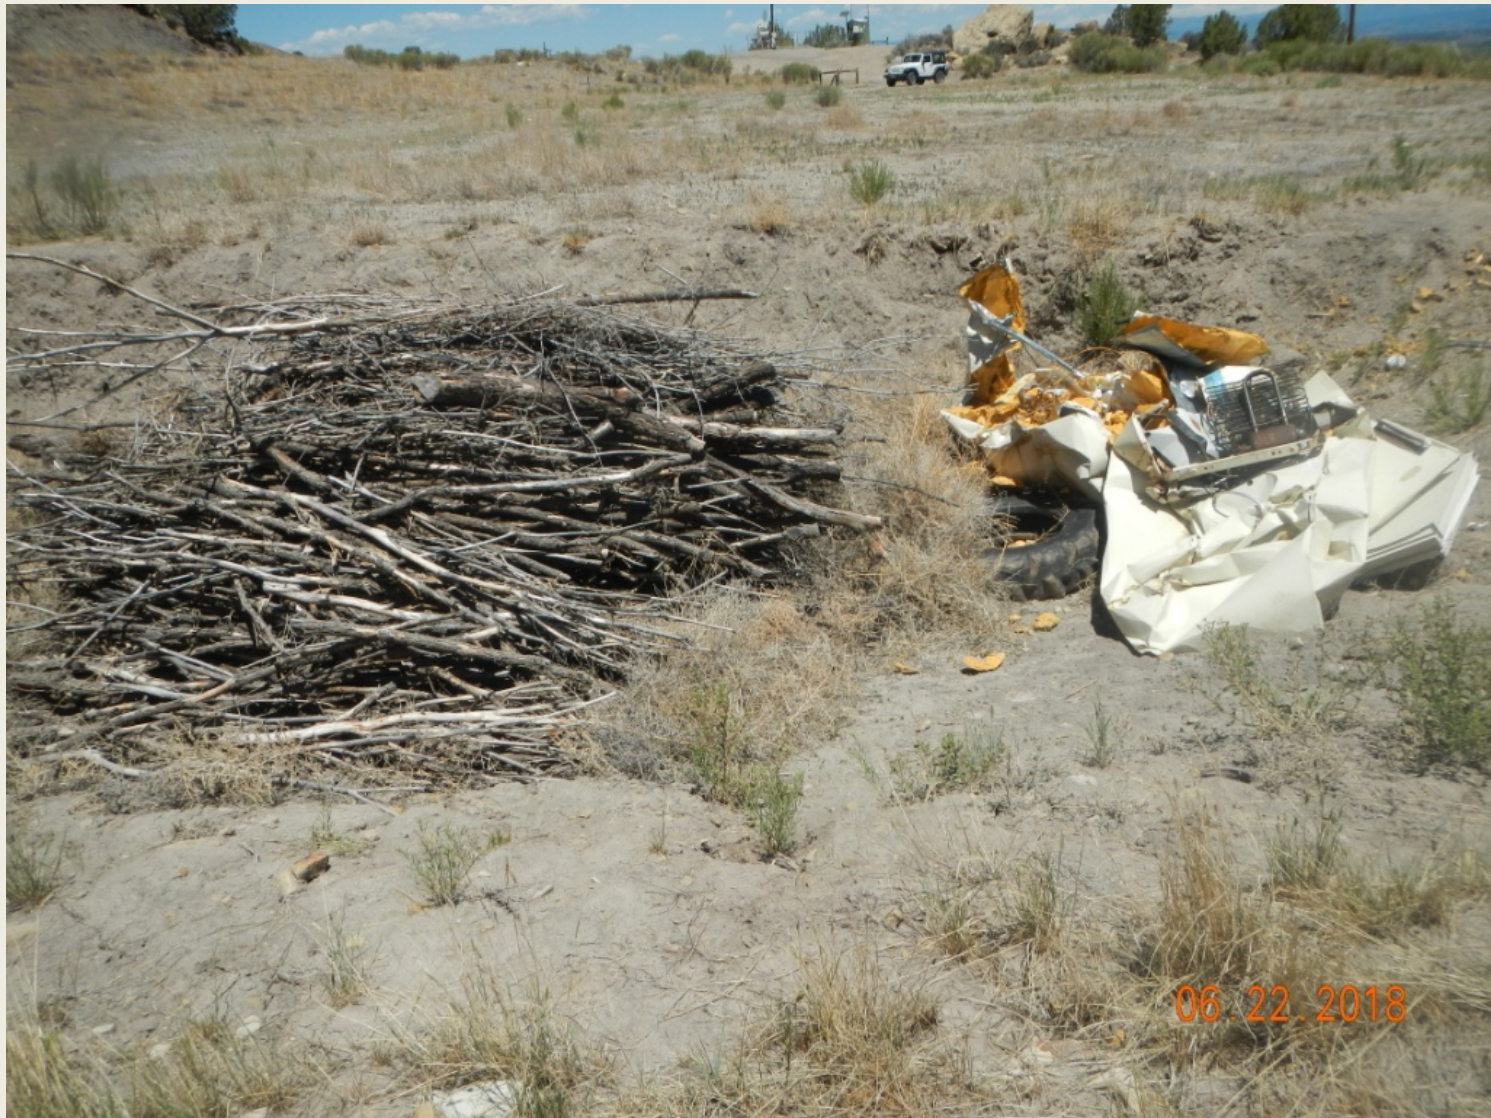
Photo 6. Close-up view of pit area, approximately 6 feet deep in the southern project area, and wood debris/waste.

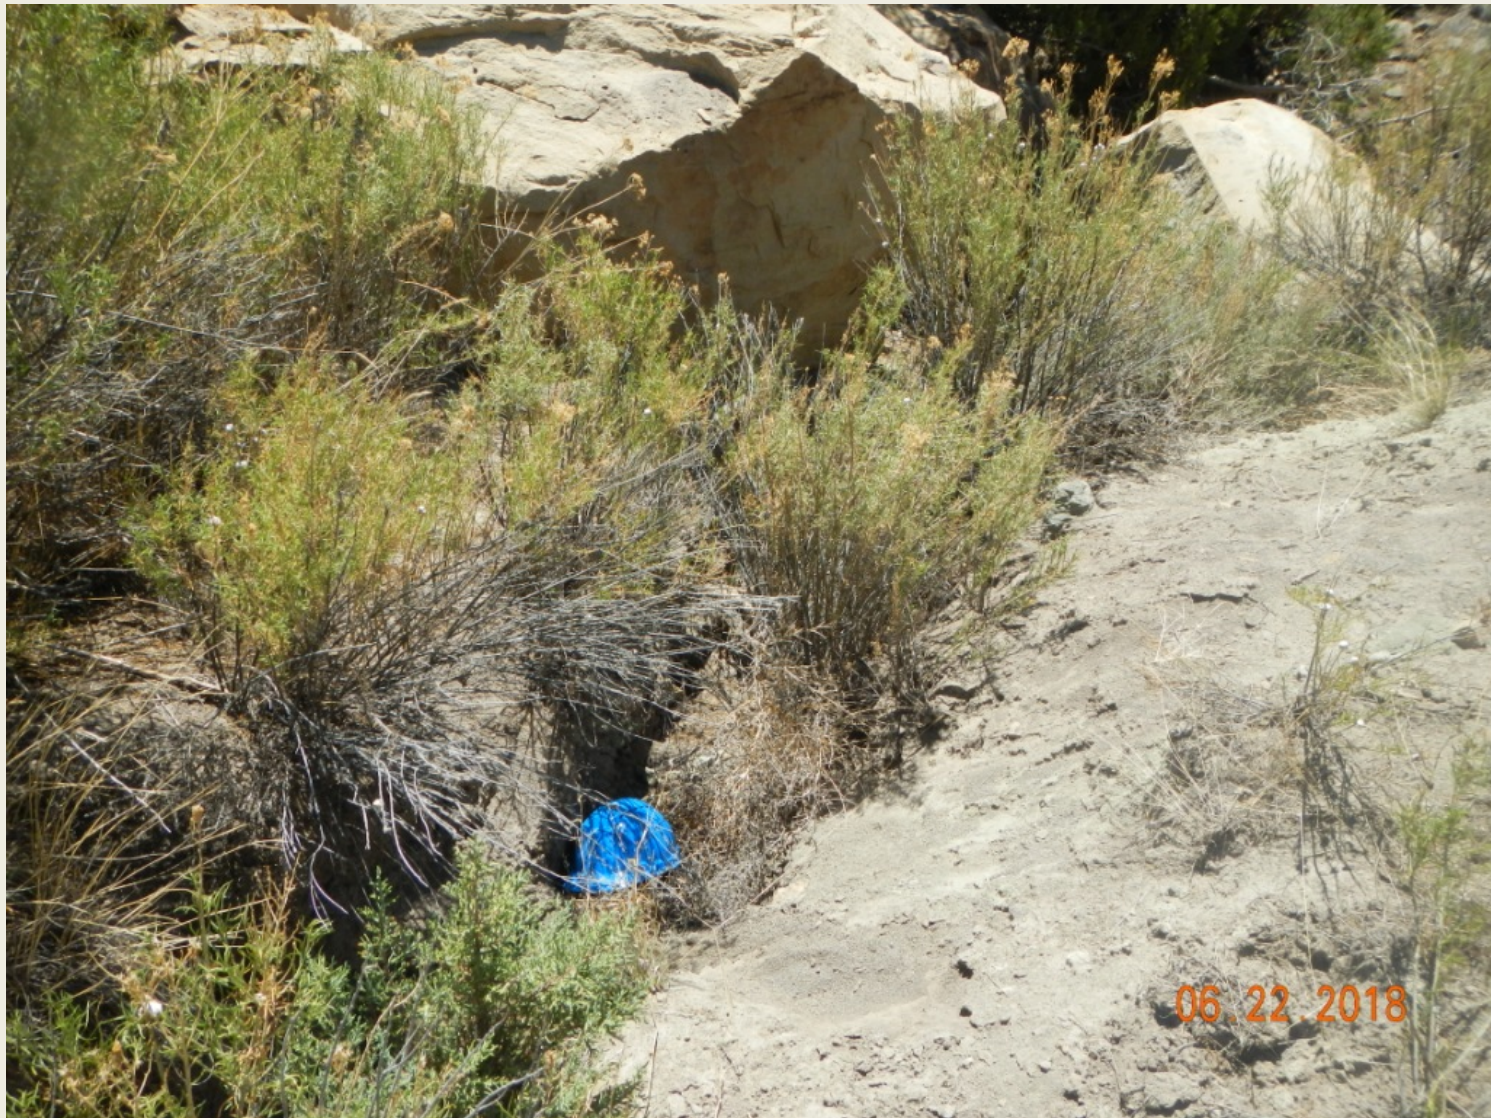
Photo 7. View of erosional channel approximately 2.5 feet deep and 2 feet deep along the southern edge of the project area.

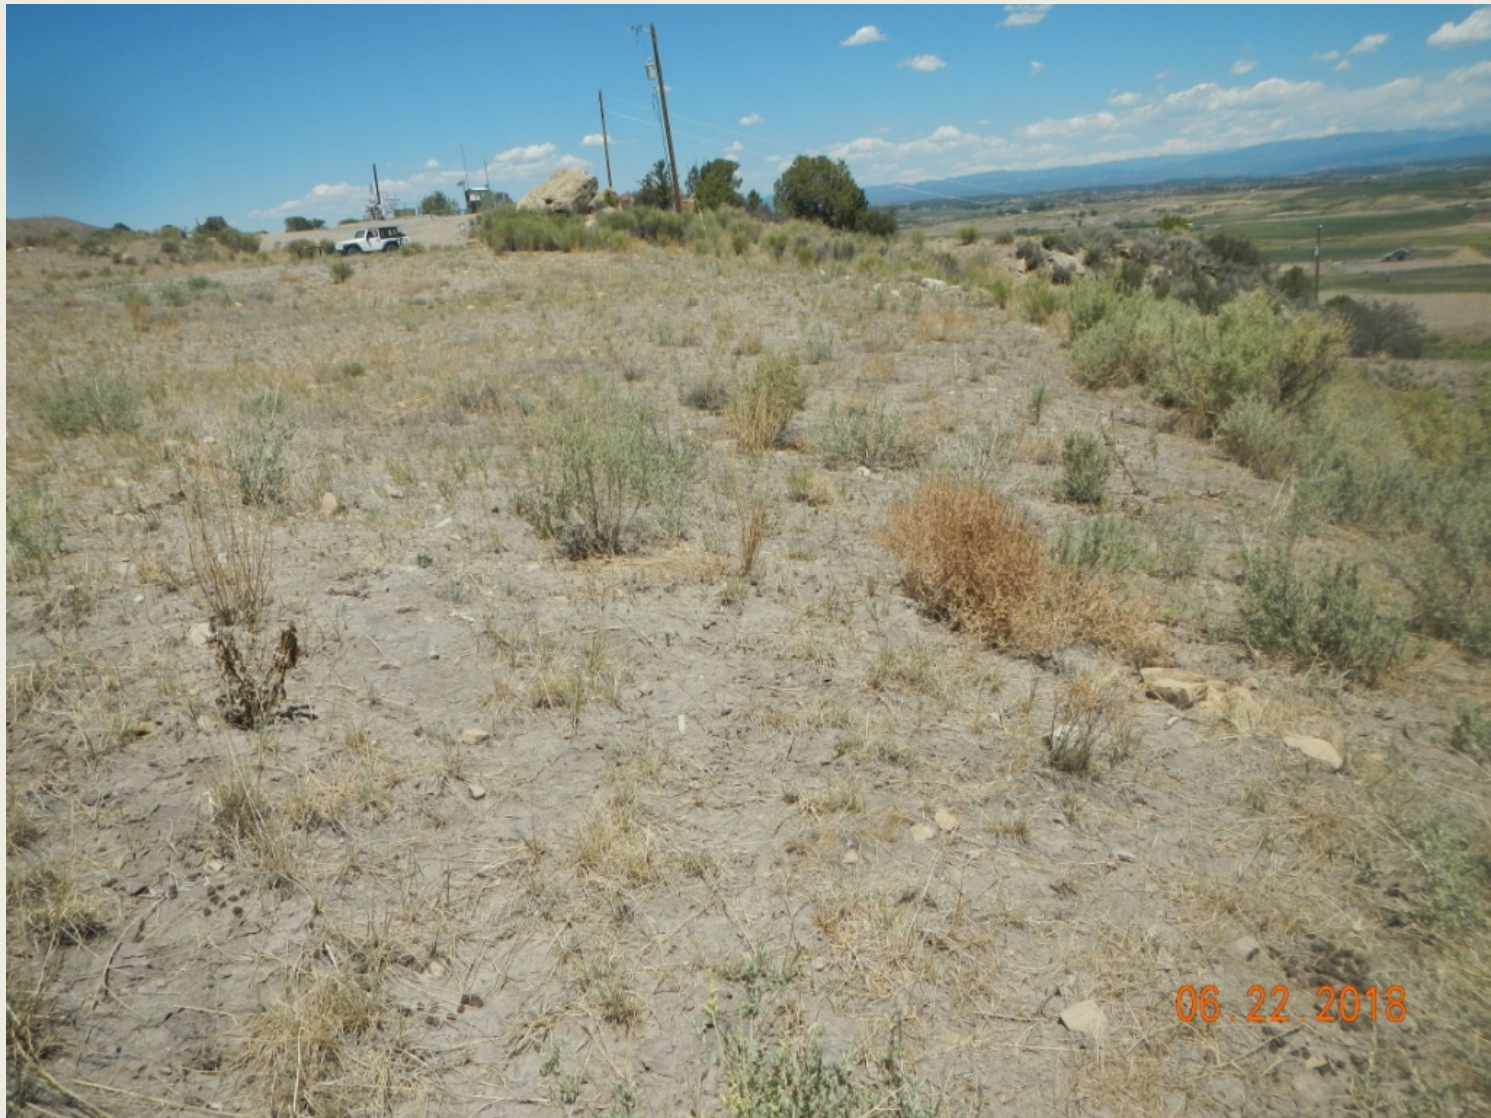
Photo 8. View of the eastern portion of the project area from the southeastern corner facing northward. Some vegetation such as crested wheatgrass (*Agropyron cristatum*) and fourwing saltbush (*Atriplex canescens*) is becoming established within the eastern project area.

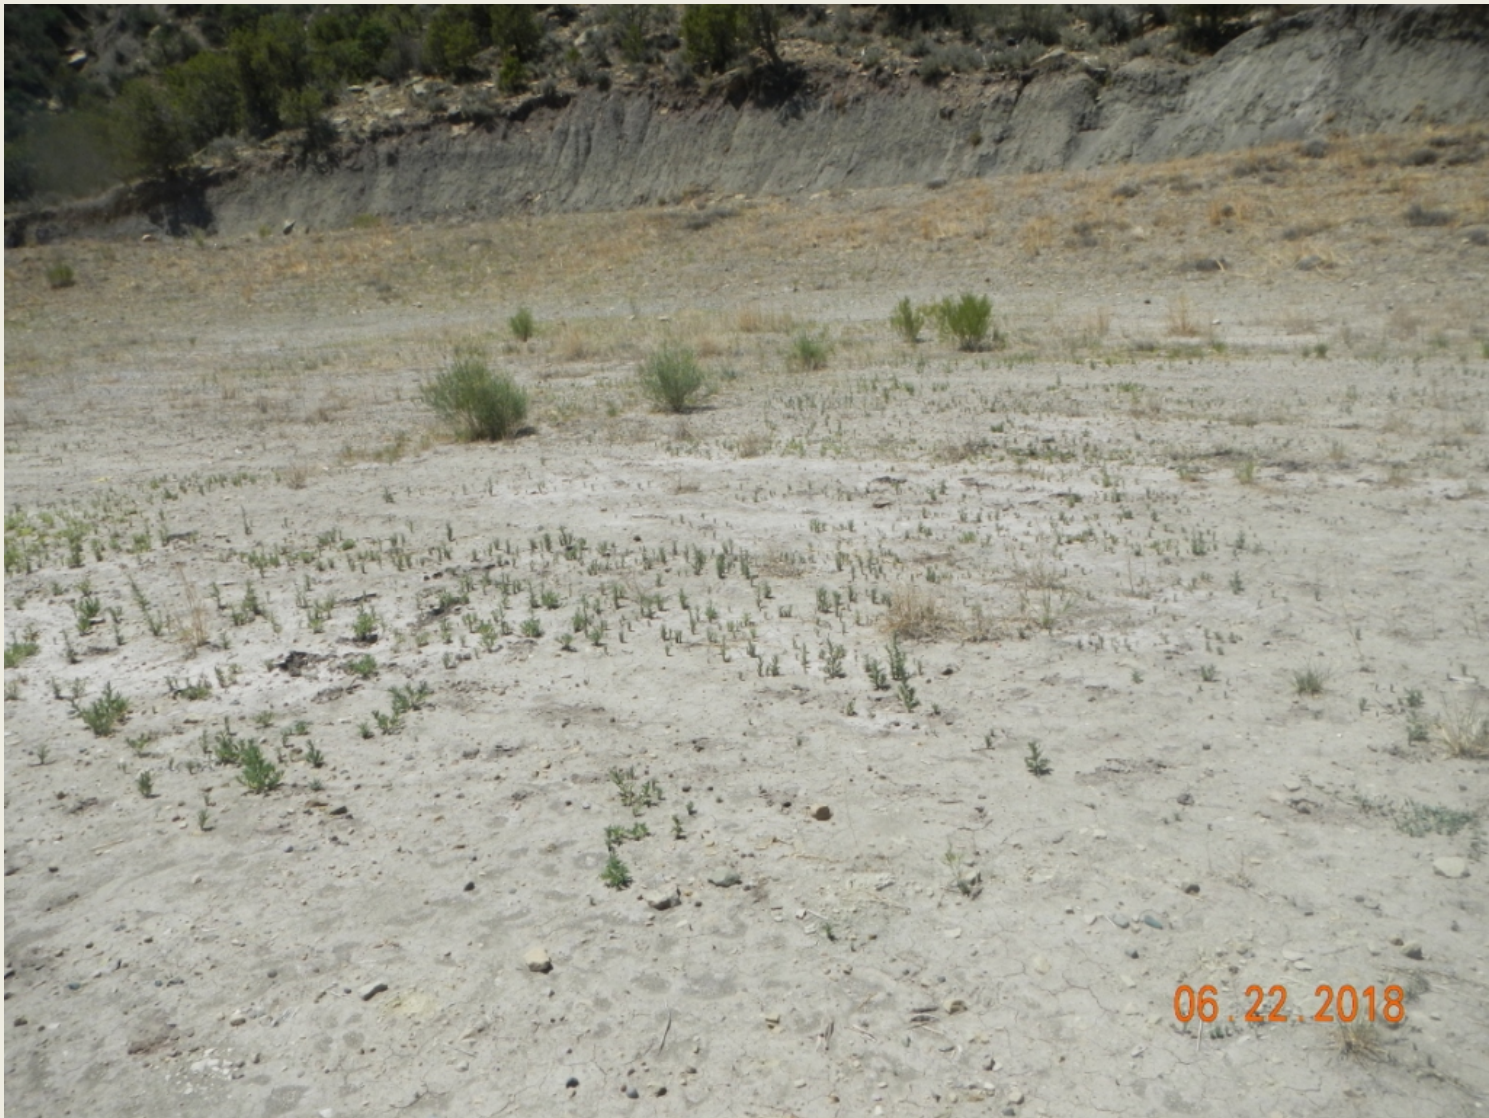
Photo 9. View of flat, well pad surface.

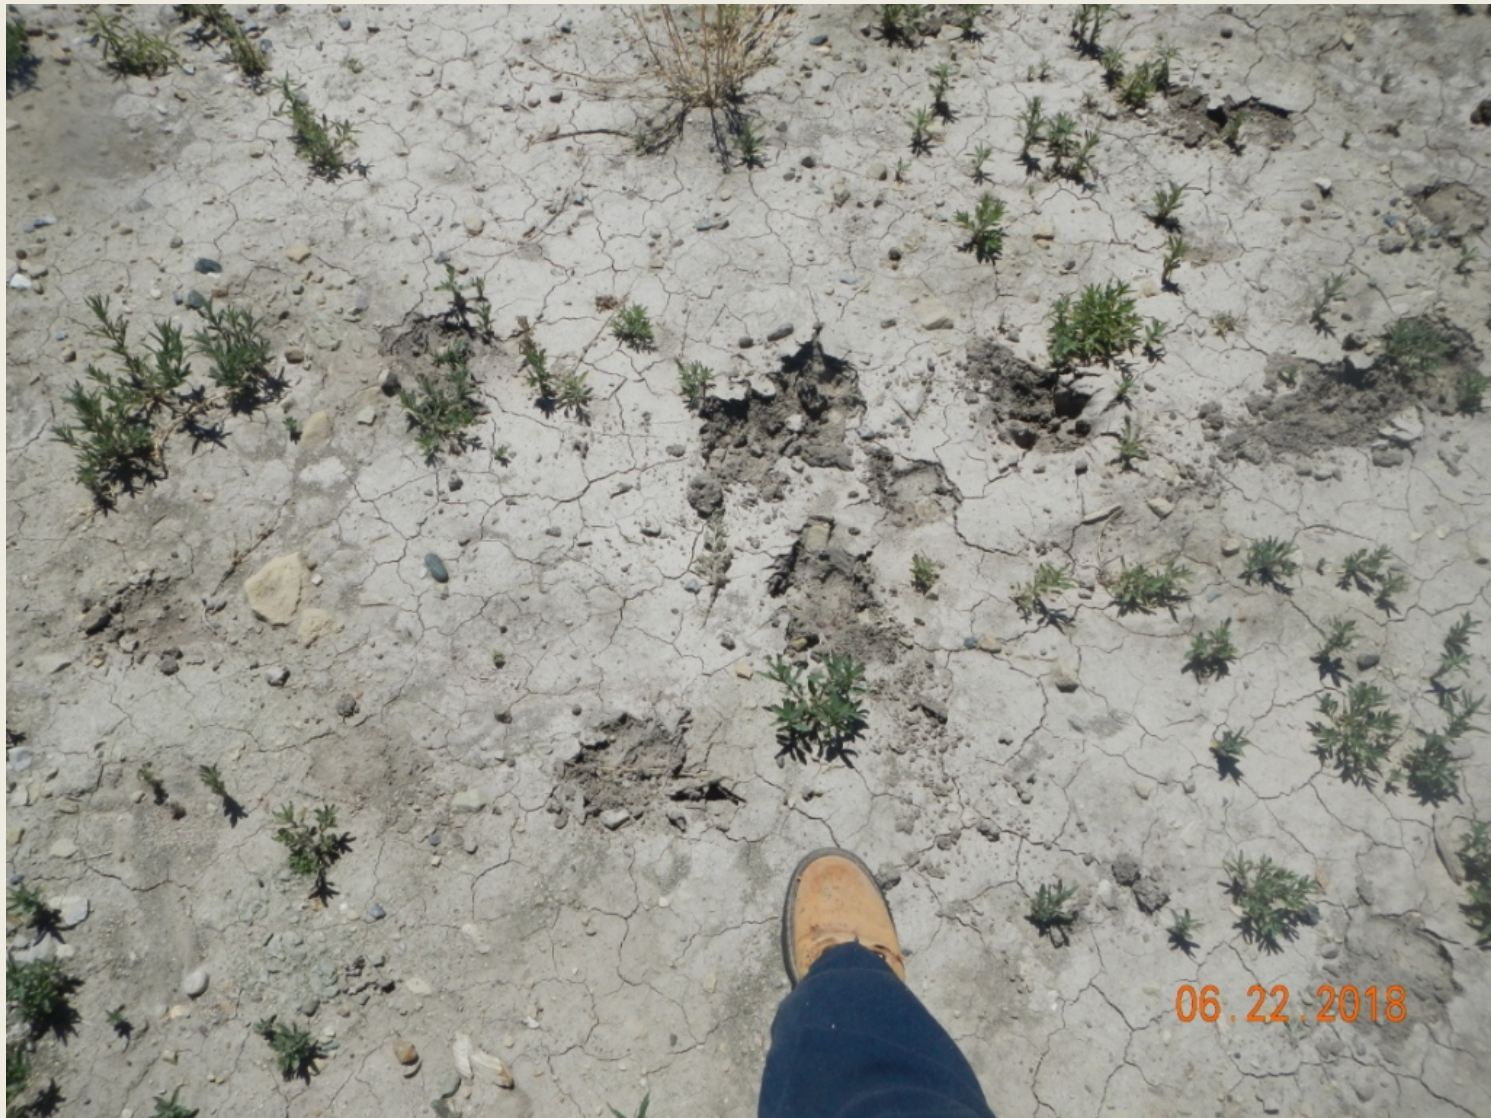
Photo 10. Birdseye view of vegetation, largely kochia (*Kochia scoparia*) on the flat well pad surface. White soils do not appear to contain topsoil.

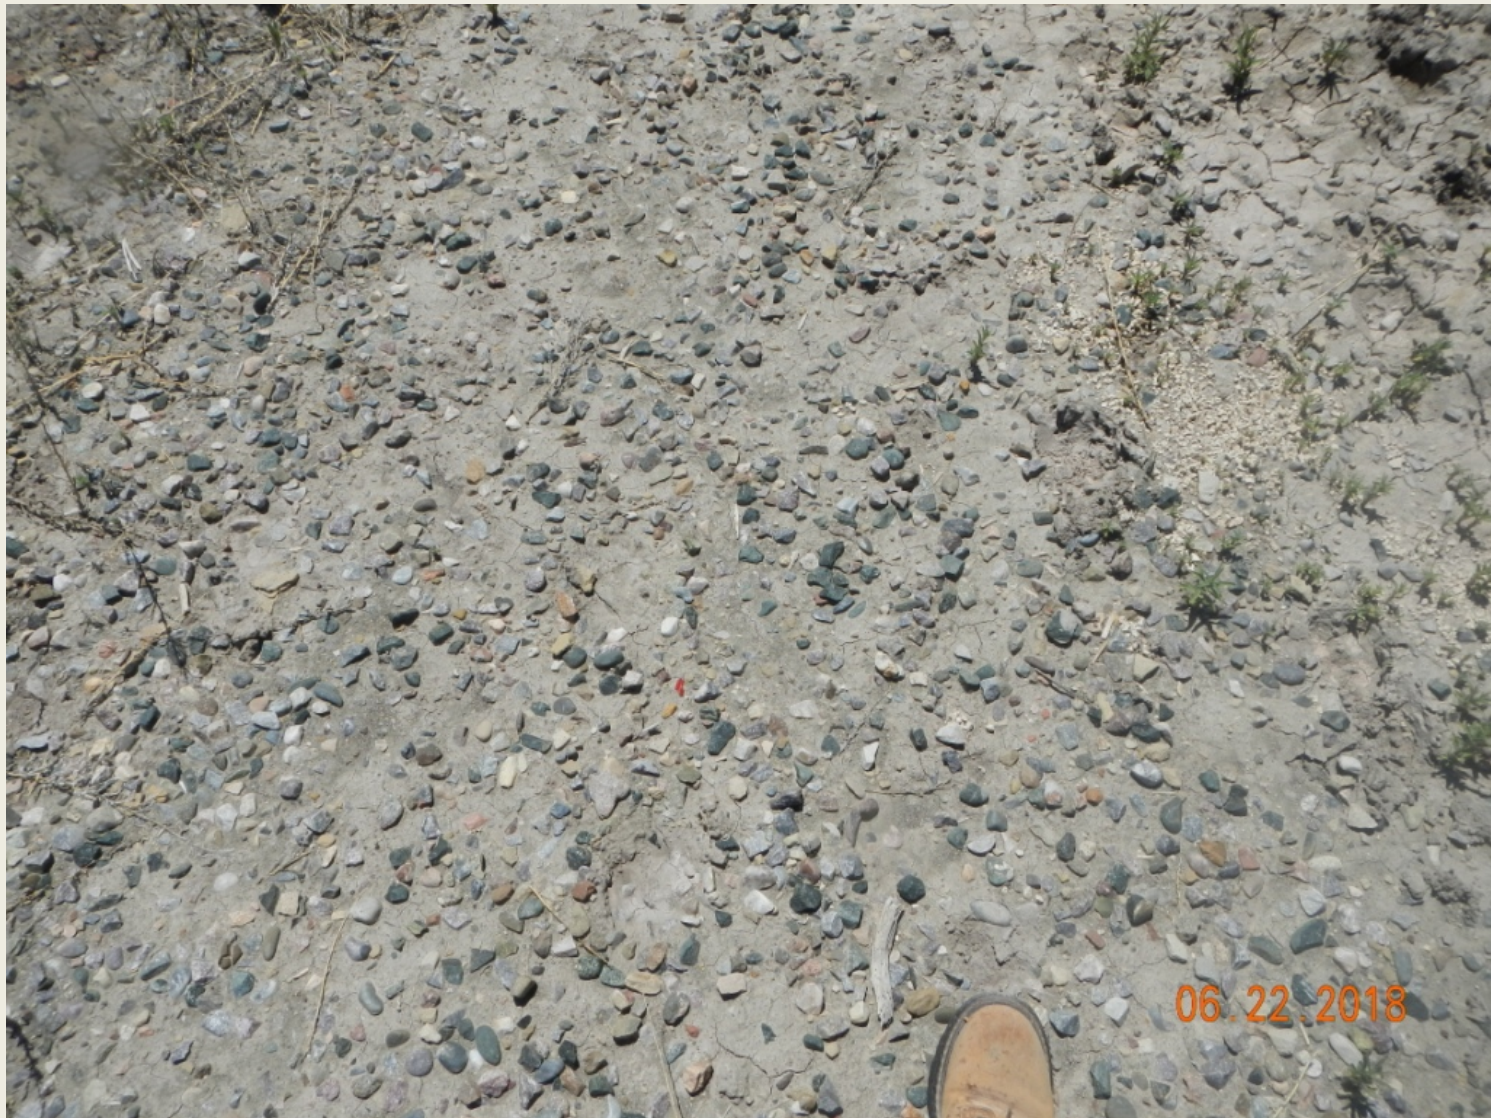
Photo 11. Birdseye view of gravel still in place in portions of the flat well pad surface.

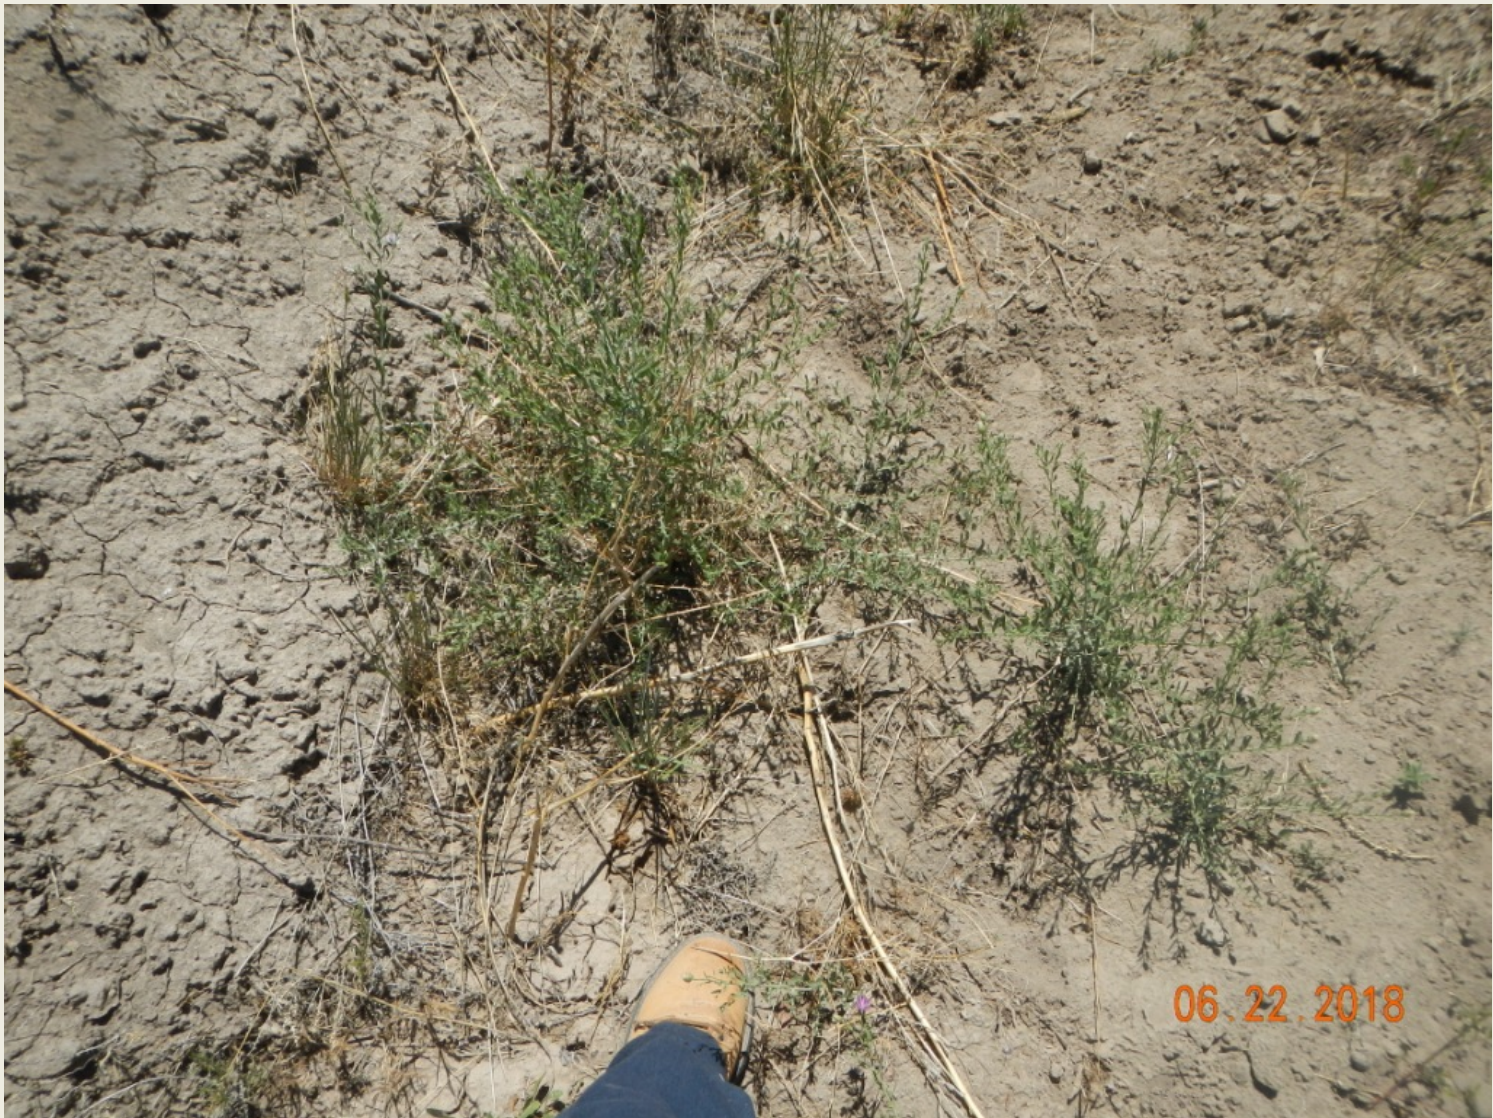
Photo 12. View of Russian knapweeds (*Rhaponticum repens*) within the project area.

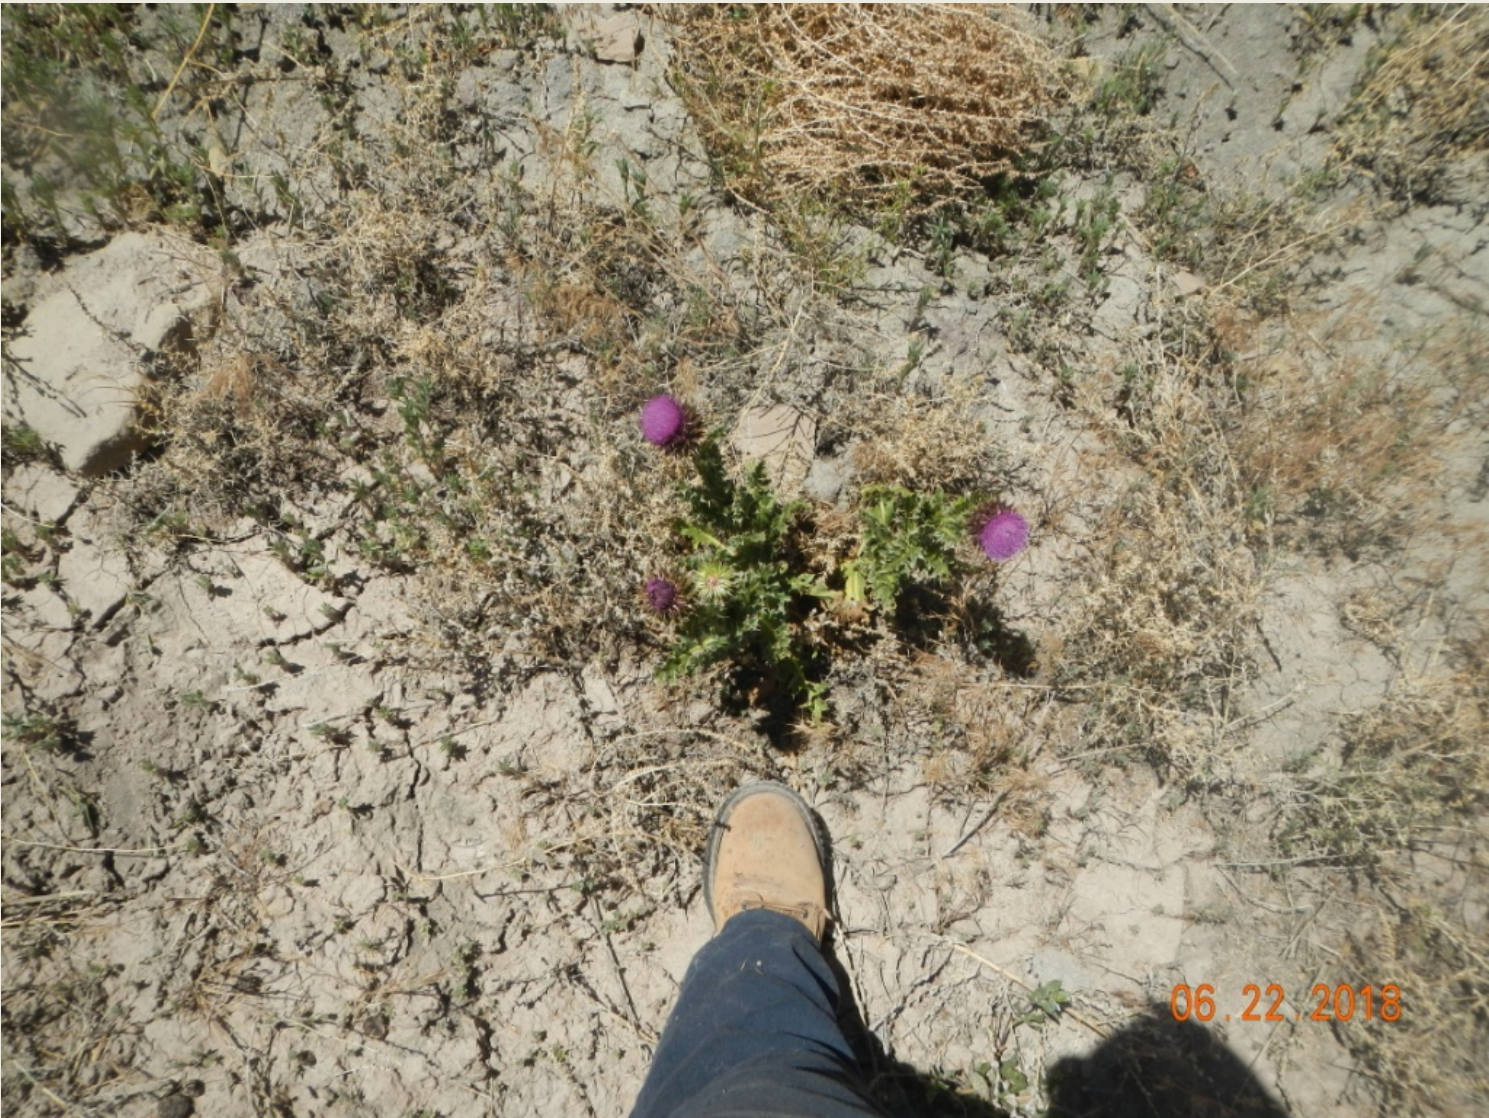
Photo 13. View of musk thistle (*Carduus nutans*) within the project area.
