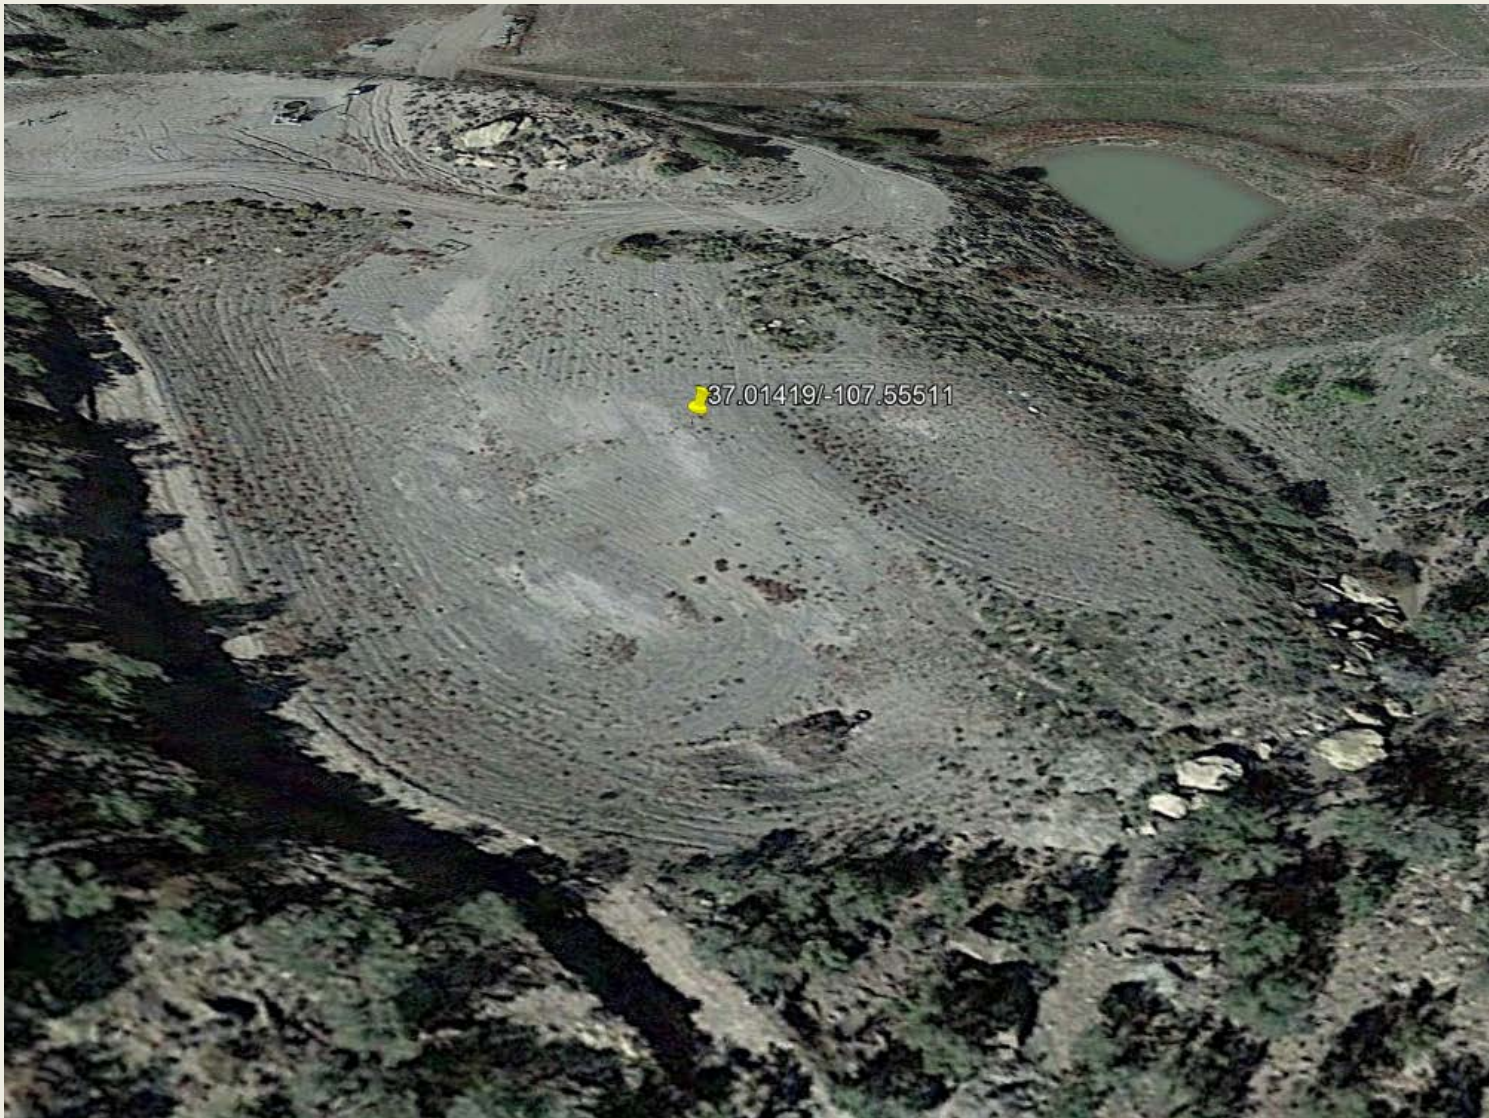
Photo 14. Aerial view of location on October 25, 2016 (GoogleEarth). Form 4 documentation indicates reclamation was conducted on March 31, 2016. Imagery indicates that recontouring was not conducted, site was not properly de-compacted (bare areas with no furrowing), and topsoil was not redistributed (light colored soil on well pad surface) per 1004 rules.
