GV 17-32
Api# 05-045-06629
Inspection # 689701592

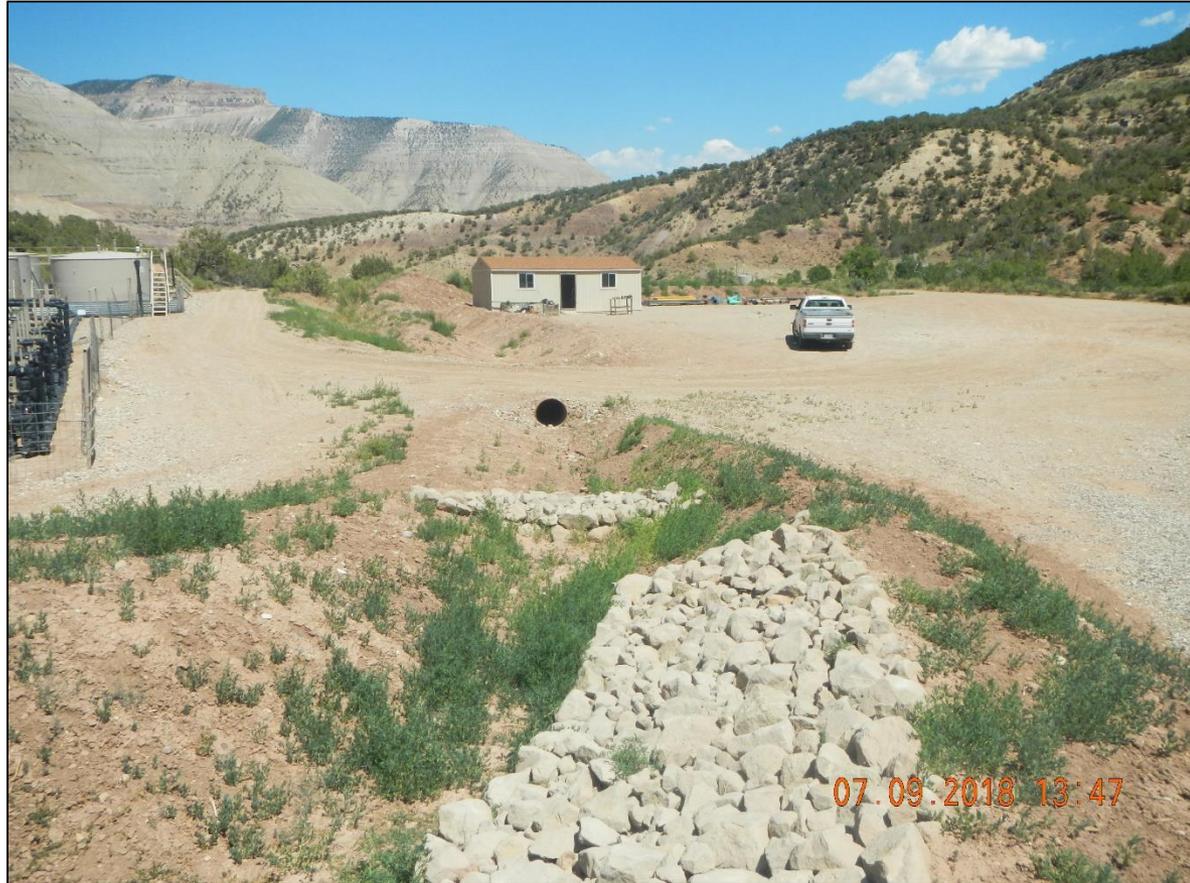
BMPs have maintained.

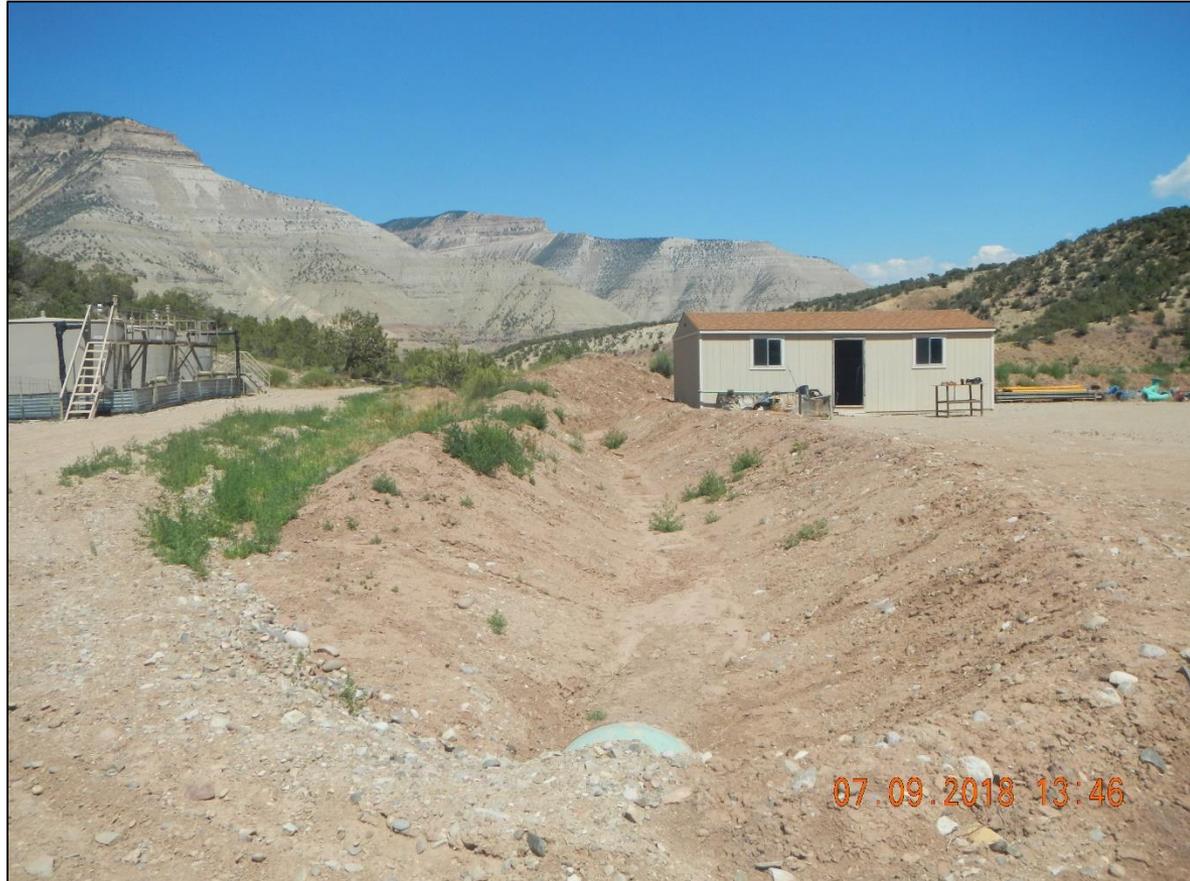
BMPs have been maintained.

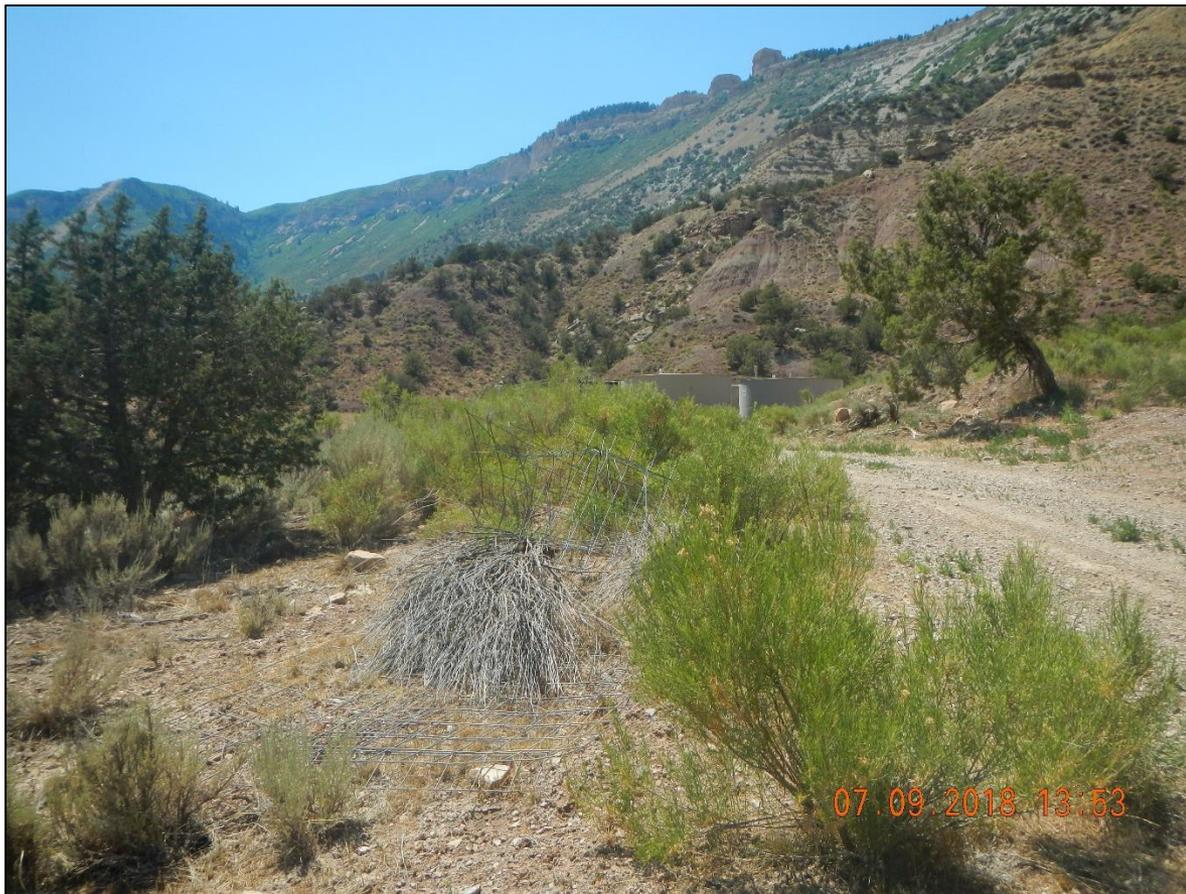
Fence panels off the side of road at Y into tank facility.

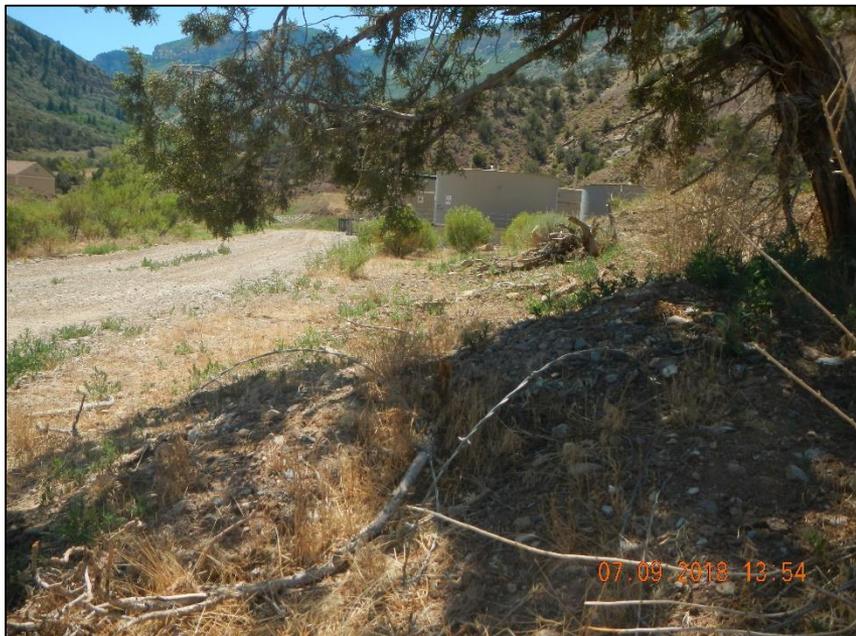
Barb wire under tree at facility Y entrance.

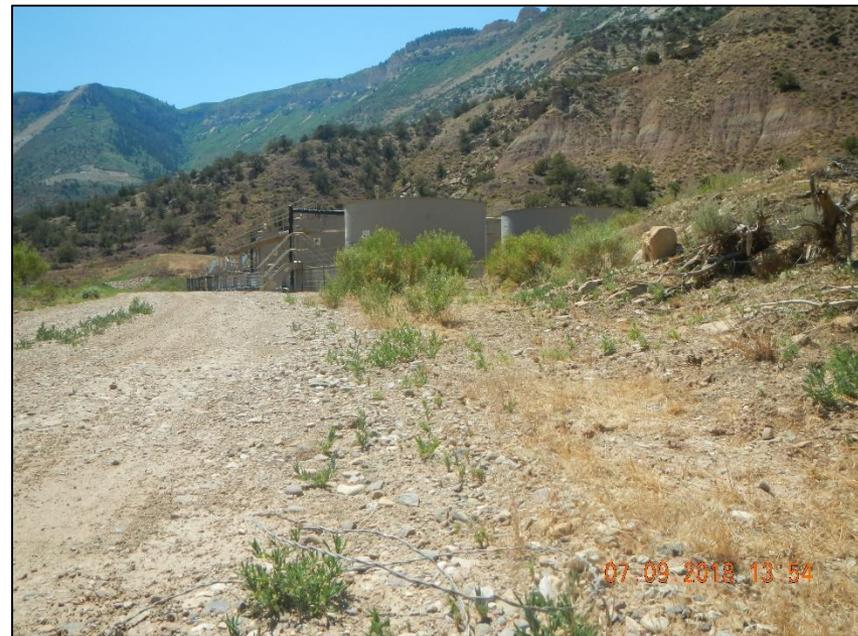
Fence wire on road into facility.
