PUCKETT 12-31D
Api# 05-045-07757
Inspection # 689701600

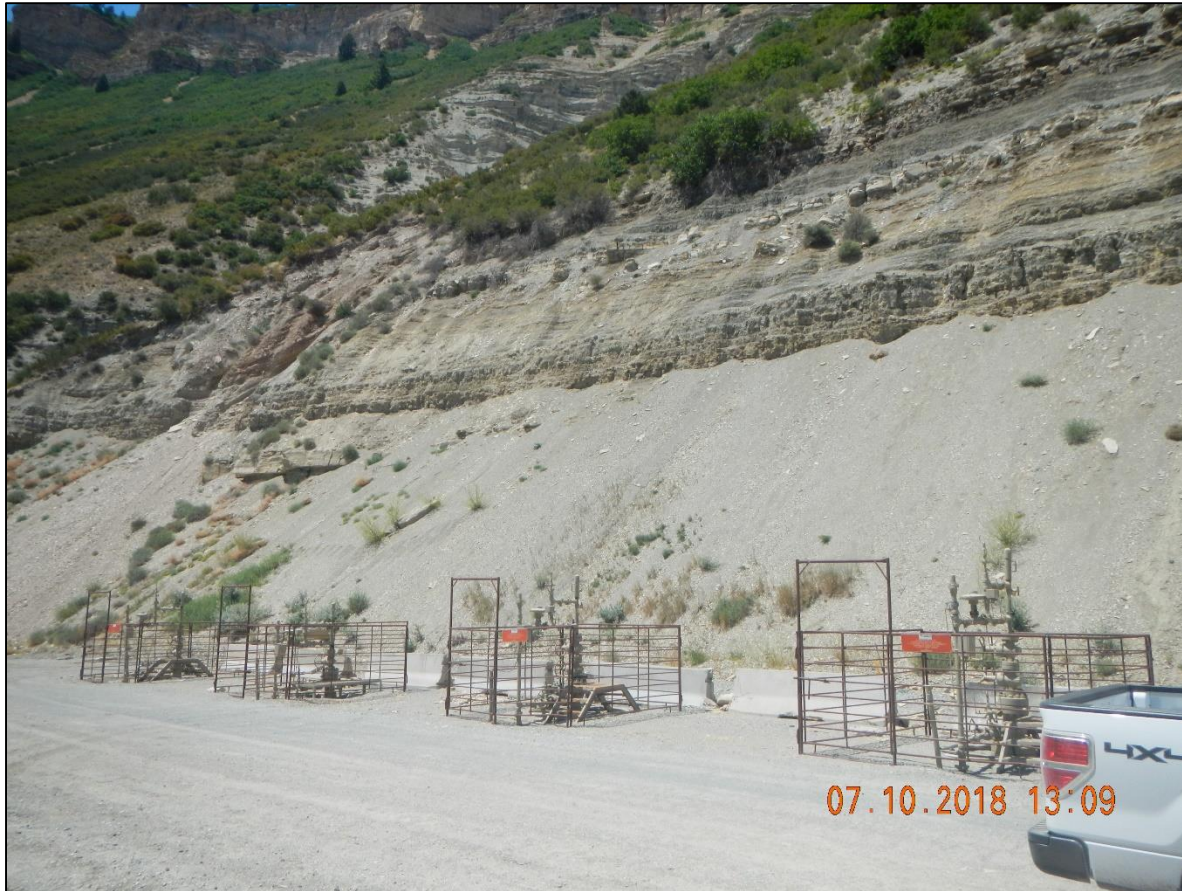
Well pad photo

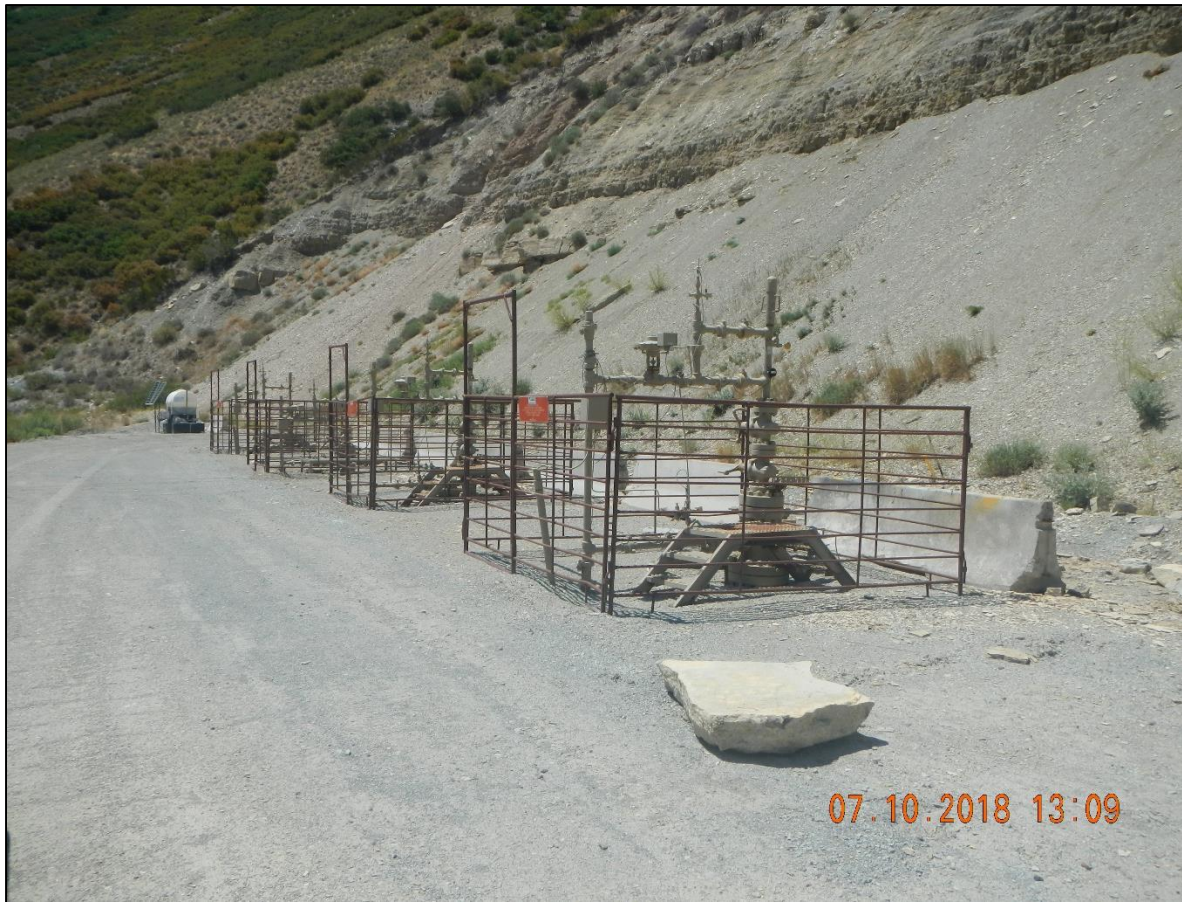
Fallen rock from unstable cut slope.

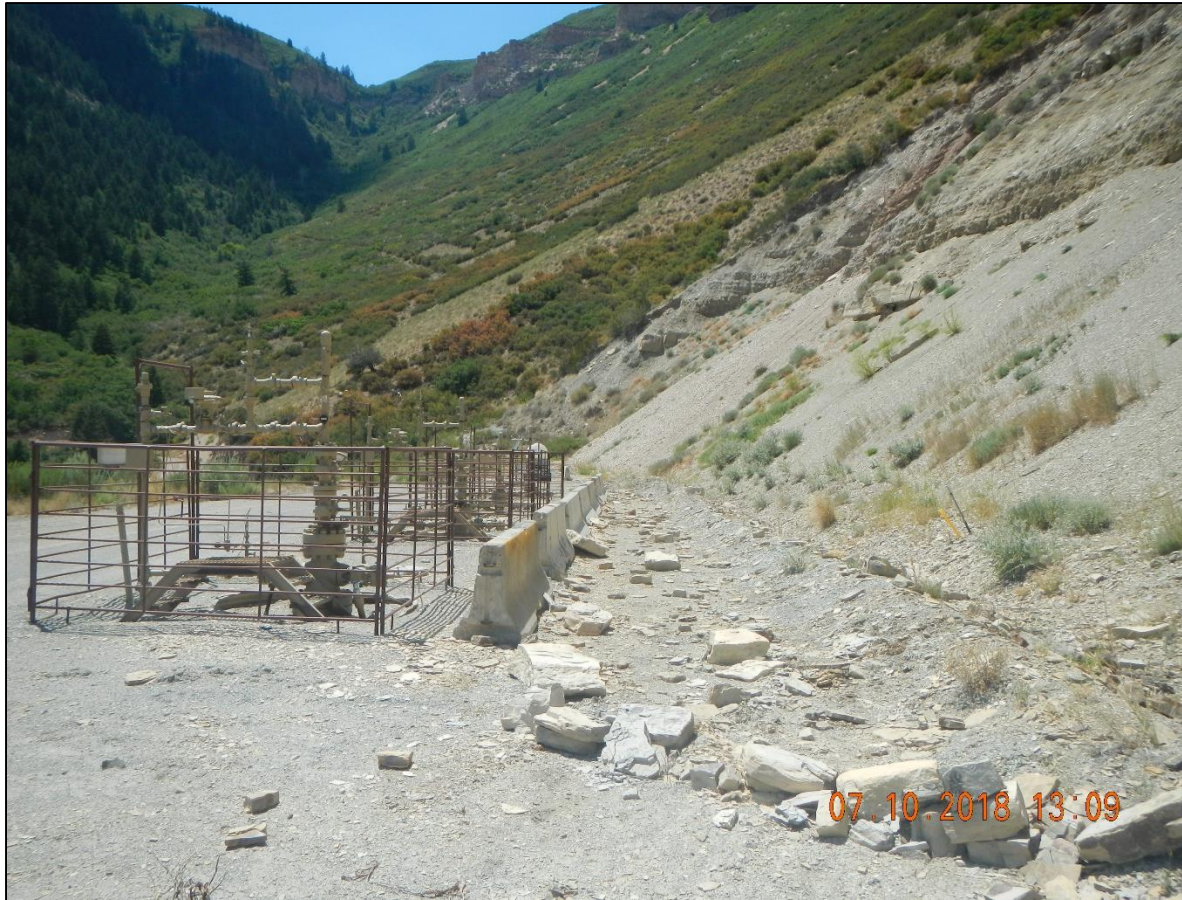
Fallen rock from unstable cut slope.

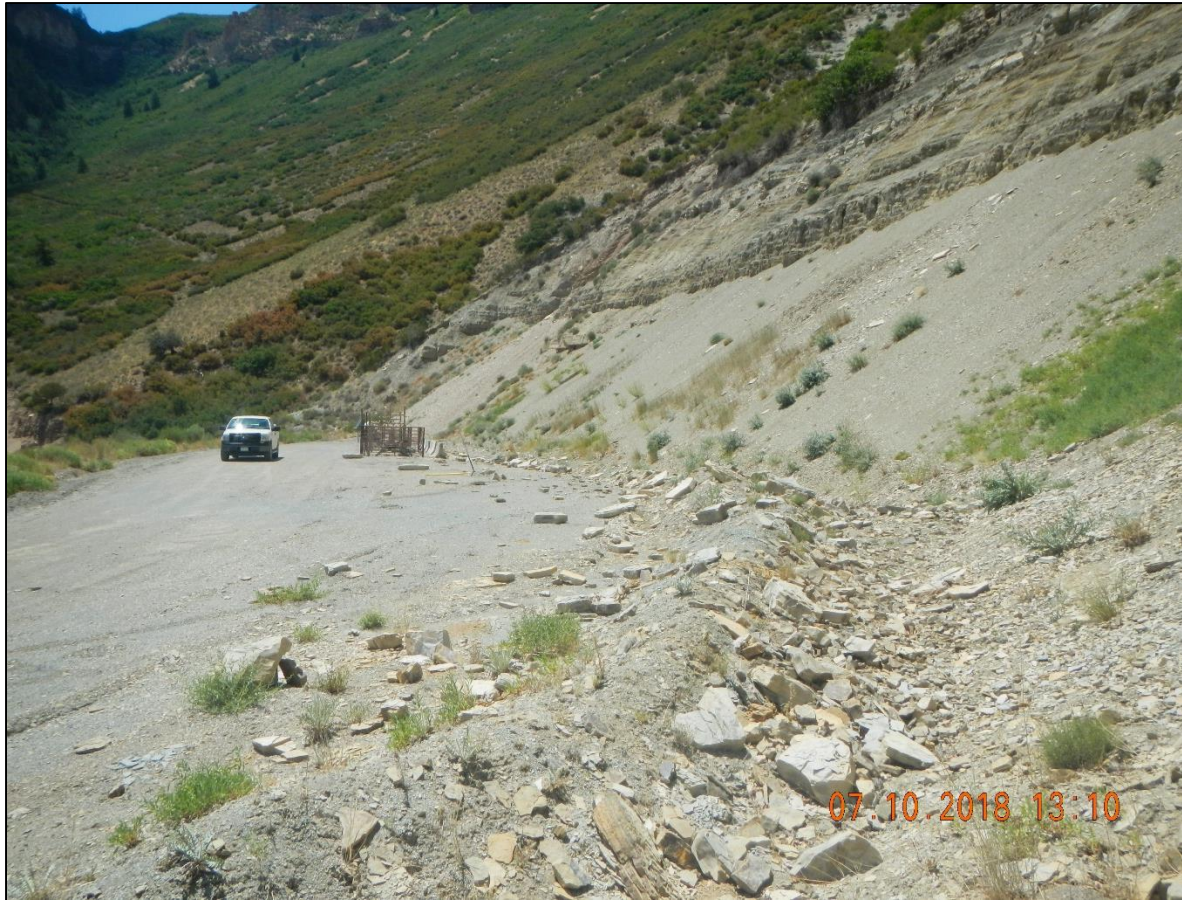
Fallen rock from unstable cut slope.

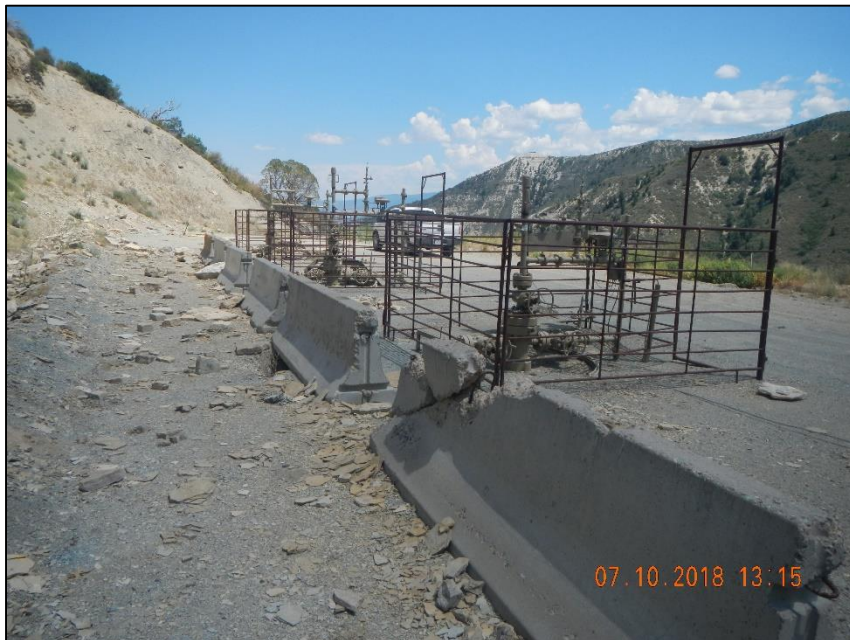
Damaged jersey barrier.

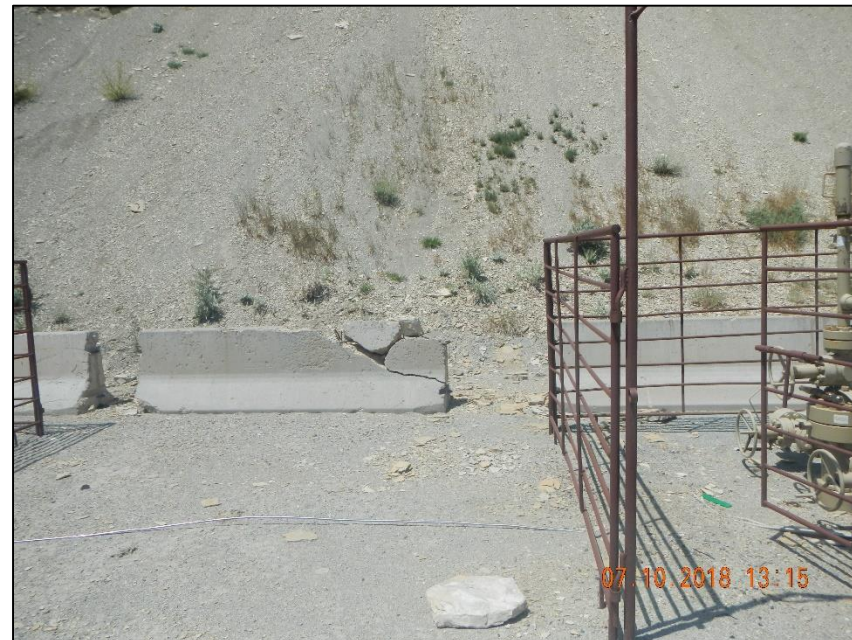
Damaged jersey barrier.

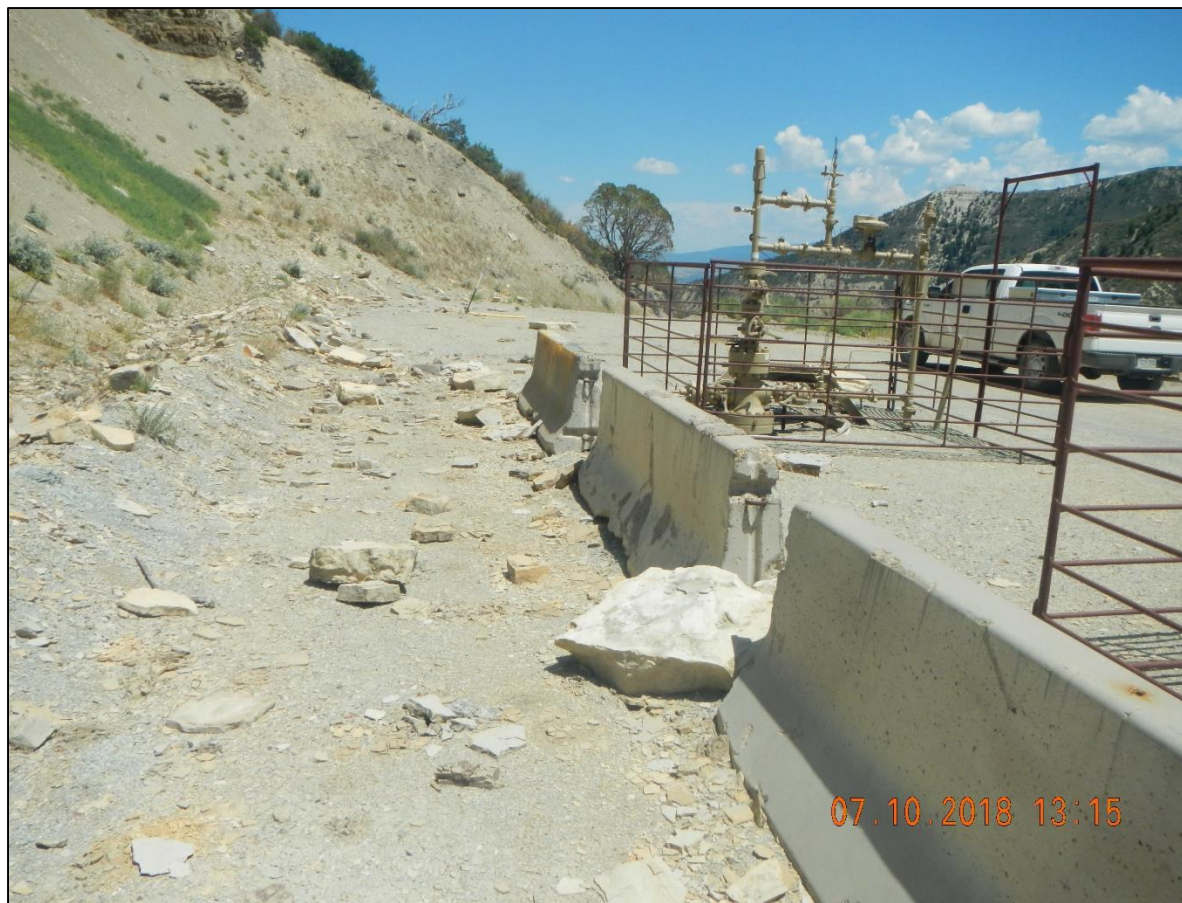
Fallen rock from unstable cut slope.

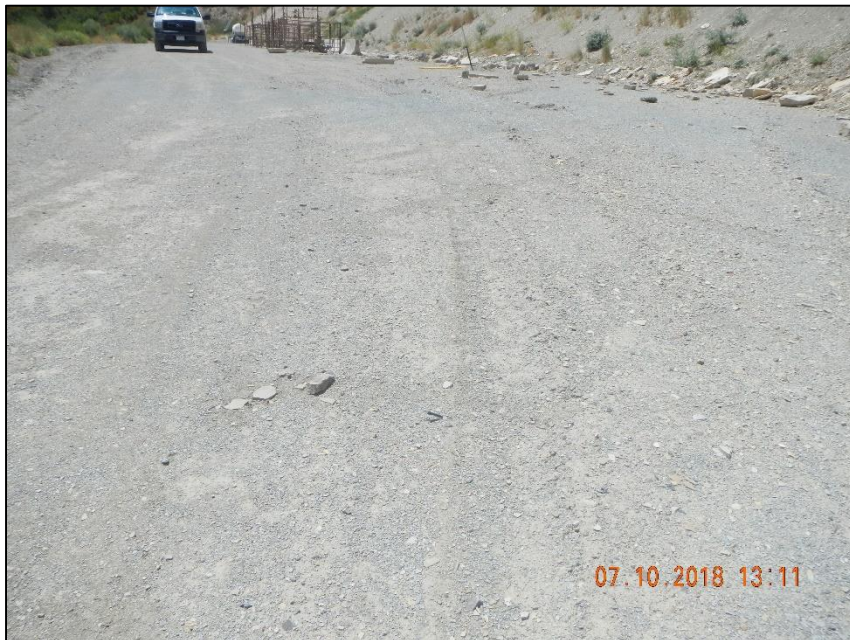
Electric cable cut, buried and exposed across location to wells.

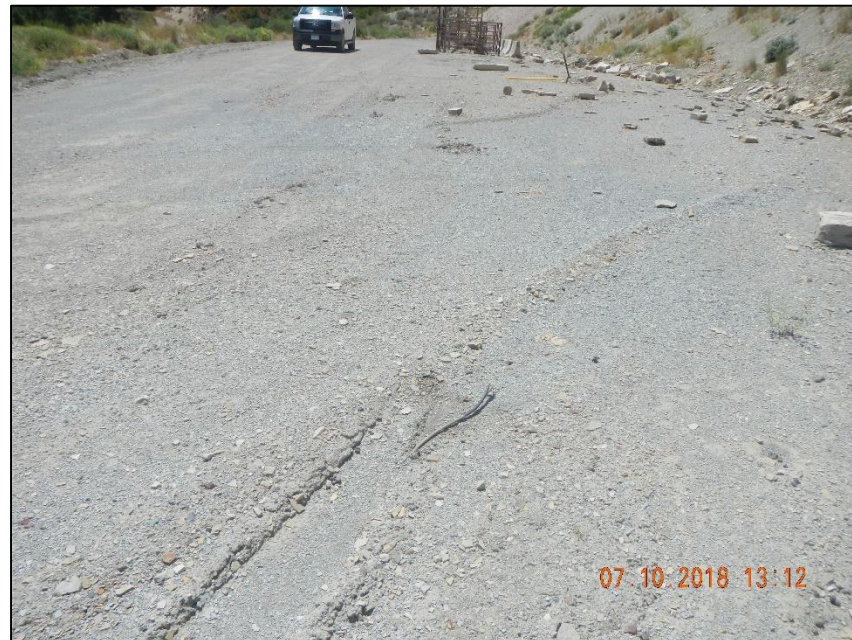
Electric cable cut, buried and exposed across location to wells.

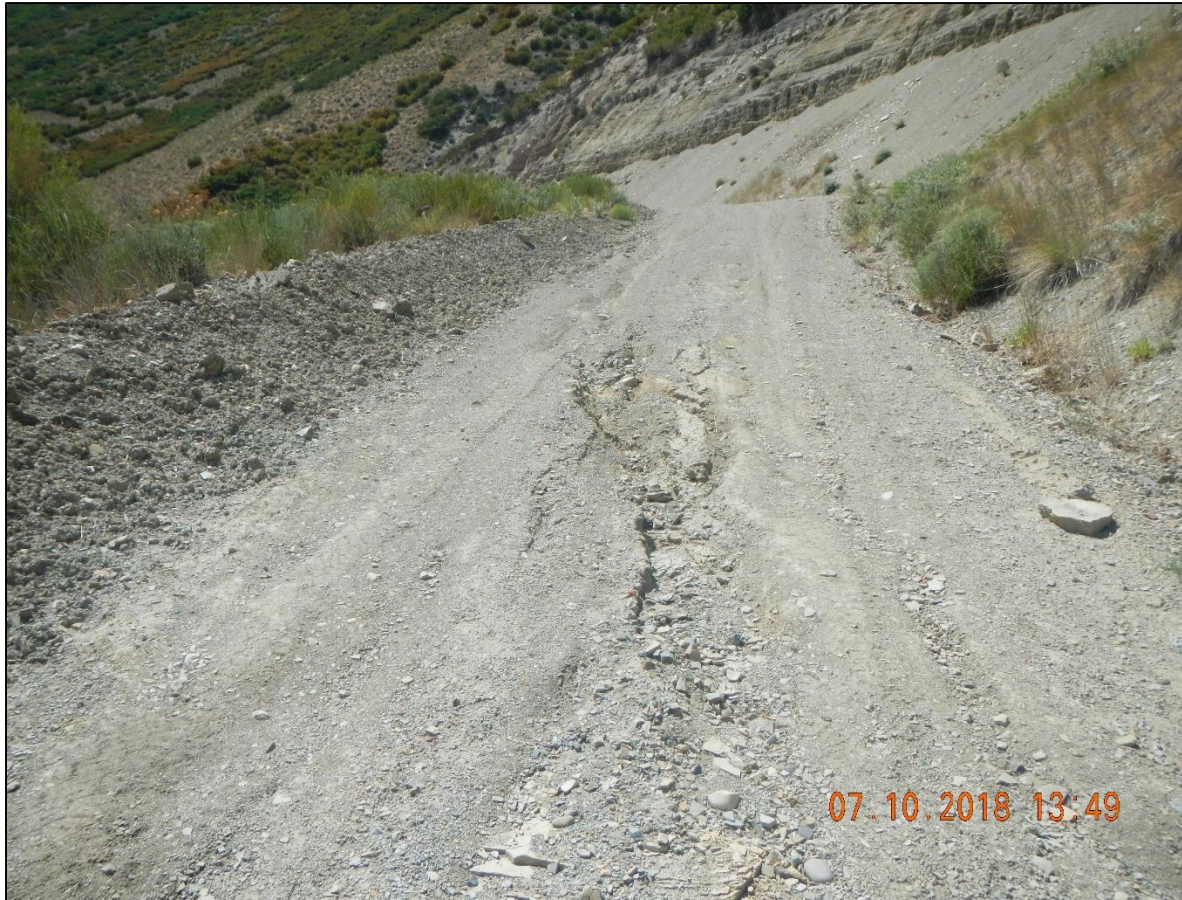
Washing of road up to well pad from tank facility.
