Apex - O&G, CDPHE Stormwater

Client	Extraction Oil & Gas
Location	Triple Creek
Phase	Production
Task # (billing phase)	436824
SWMP Administrator	Blake Ford
Permit #	COR03M013
Inspector	Sage Maher
Inspector's Title	Environmental Scientist
Date of Inspection	06/25/2018
Weather at Time of Inspection	80 Sunny

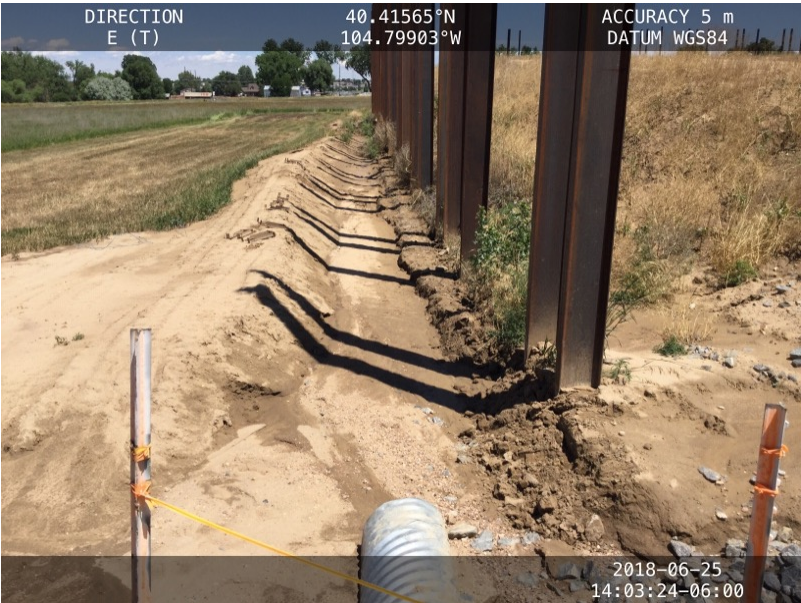
CA #	8585
BMP/Item	Construction Phasing
Existing Status	Hold
New Status	Hold - Field Report
Category	XOG - Reclamation
Location	Outer disturbance
Ft2 Estimate	0
Action	Maintenance Needed
Description of Corrective Action	
Initiate interim reclamation practices. Redistribute topsoil / grade to match surrounding topography. Stabilize disturbance with crimped straw mulch and seed.	
Date of Record	06/27/2018
Existing Date Verified	06/20/2018
New Date Verified	06/25/2018

06/20/2018 - Soundwall removal is underway, site is in production.,

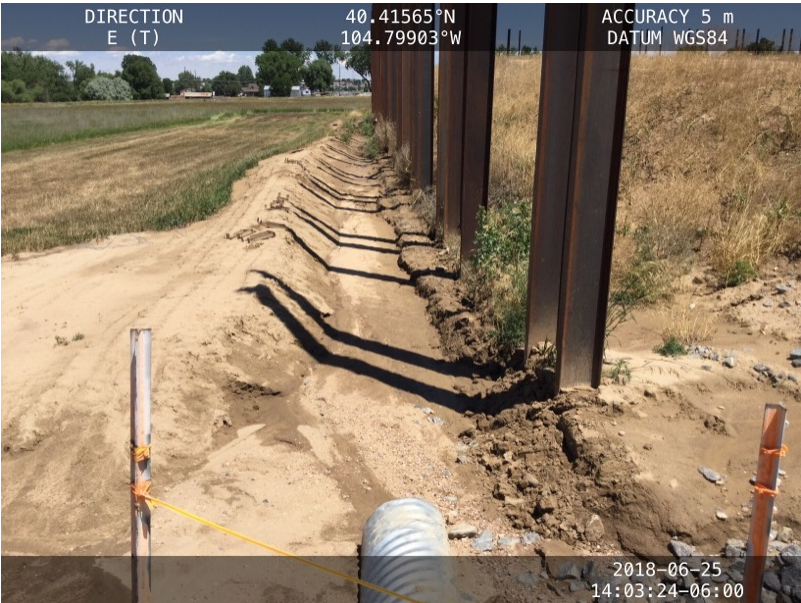
CA # (use "99999")	99999
BMP/Item	Diversion Ditch and Berm
Status	Pending
Category	XOG - Stormwater
Location	North east corner side perimeter
Ft2 Estimate	
Action	Maintenance Needed
Description of Corrective Action	Accumulated sediment deposit in the ditch. Remove accumulated sediment to keep berm at 18" per specs.
Date of Record	06/25/2018
Date Verified	06/25/2018

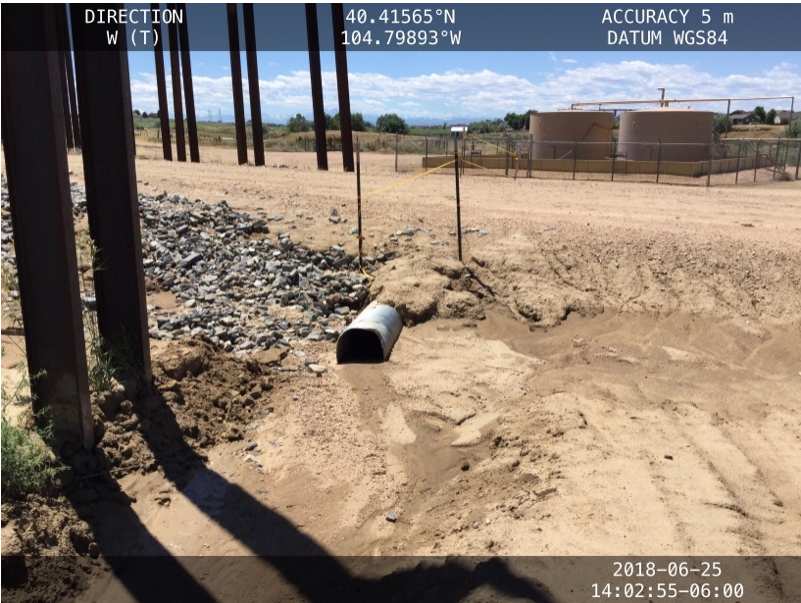
CA # (use "99999")	99999
BMP/Item	Culvert
Status	Pending
Category	XOG - Stormwater
Location	North Easter corner of perimeter
Ft2 Estimate	
Action	Maintenance Needed
Description of Corrective Action	
Remove accumulated sediment at the north easter side of culver. Ensure 1' clearance on both sides and install culver protection if needed.	
Date of Record	06/25/2018
Date Verified	06/25/2018

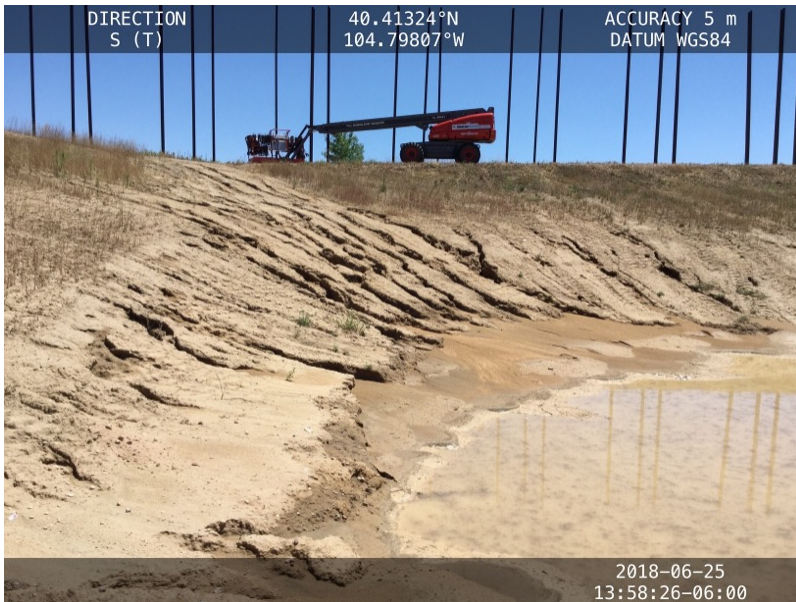
CA # (use "99999")	99999
BMP/Item	Erosion
Status	Pending
Category	XOG - Stormwater
Location	South eastern side of top soil pile
Ft2 Estimate	
Action	Maintenance Needed
Description of Corrective Action	
	Stabilize cut slope, and surface roughening to prevent further erosion.
Date of Record	06/25/2018
Date Verified	06/25/2018
