Photo log for Response to June 12, 2018 Inspection

COGCC conducted an inspection of the Lilli Unit 16-6 location (Location ID 326799) on June 12, 2018 (Document 684905510). During that inspection, COGCC made the following observation:

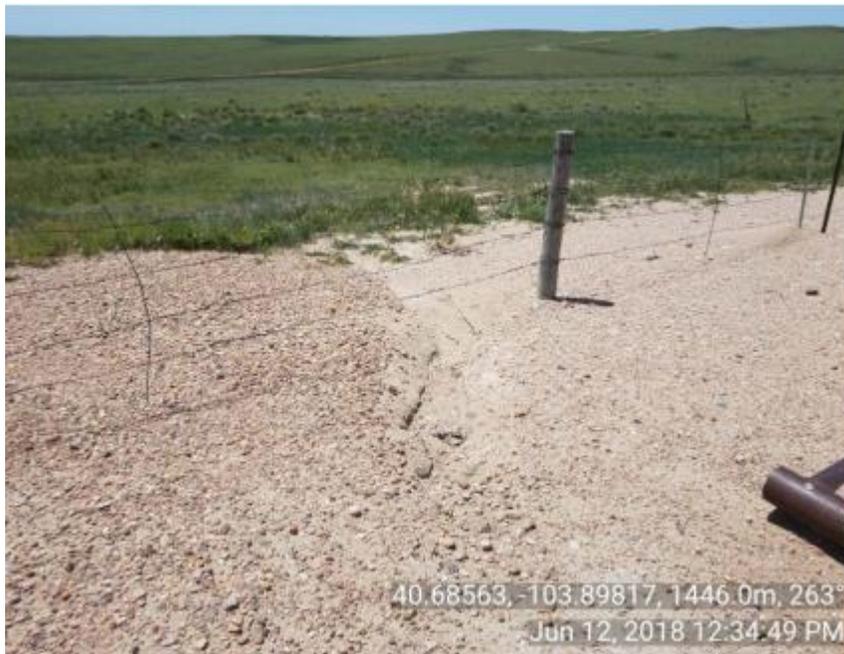
COGCC – 6/12/18

Storm Water: Stormwater erosion S of wellhead. Install or repair required BMPs per Rule 1002.f.

COGCC Photo 3: Stormwater erosion at S of wellhead
