# Inspection Photos

Operator: FOUNDATION ENERGY  
MANAGEMENT LLC - 10112

Location ID: 447523

Inspection Doc. Number: 682503562  
Weld County, CO

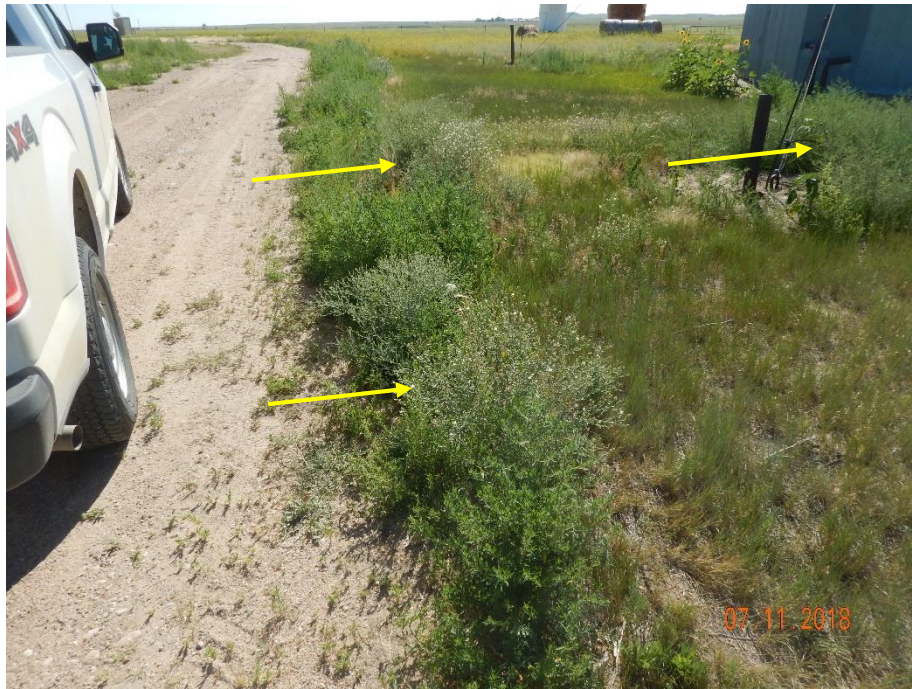
**Photo 1:** Photo taken from the southern area of the location, facing east. Photo shows Diffuse Knapweed remains prevalent throughout the location. Plants are flowering or have matured and preparing to seed.

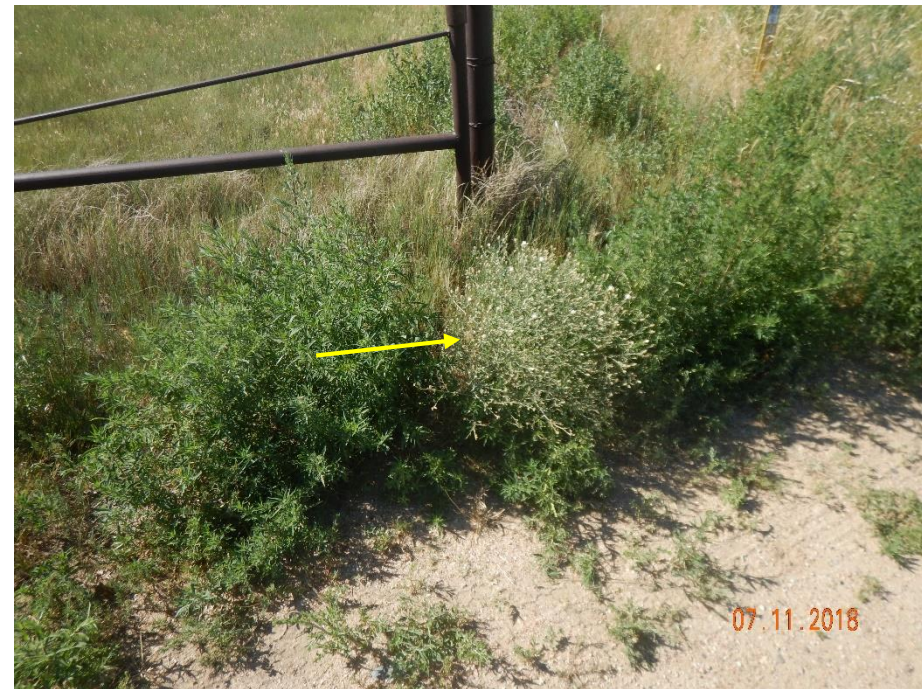
**Photo 2:** Photo taken from the southern access gate of the location. See comments under photo 1.

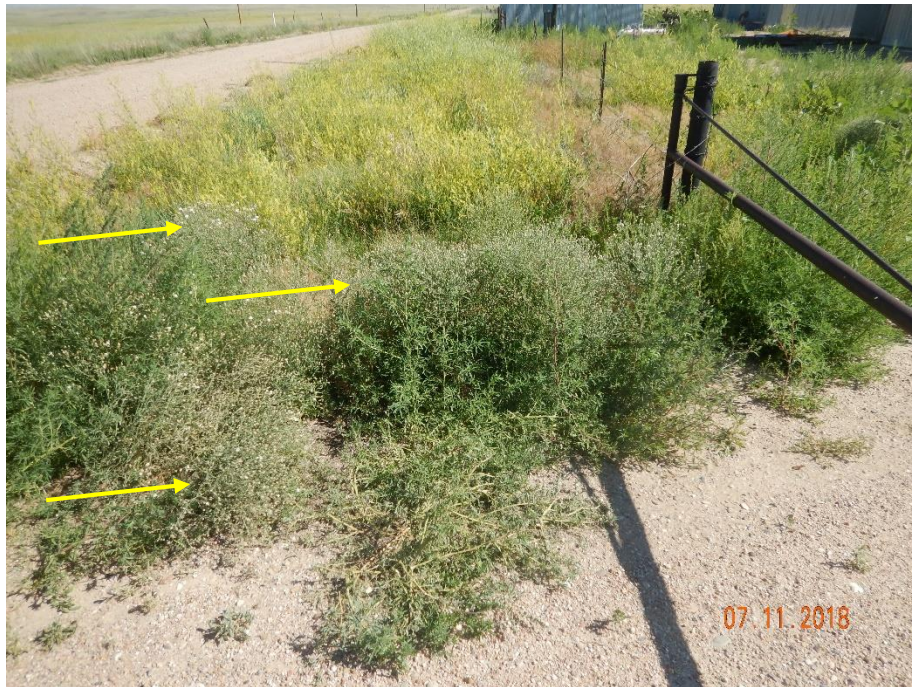
**Photo 3:** Photo taken from the southern access gate of the location, facing north. See comments under photo 1.

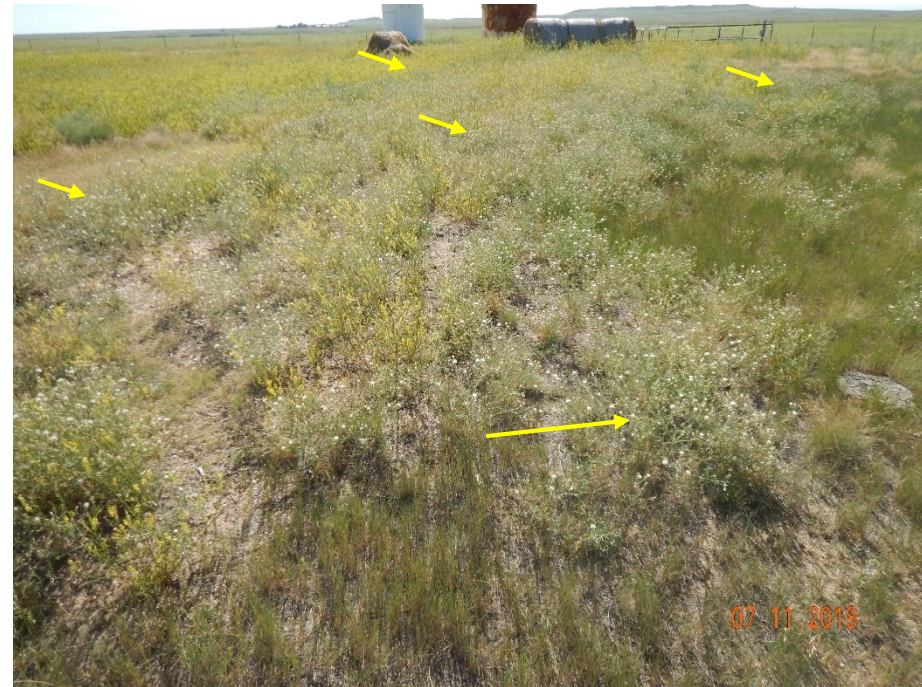
**Photo 4:** Photo taken from the south end of the location, facing east. Photo shows Diffuse Knapweed (lighter, grey-green plants) remain prevalent throughout the location. Plants are flowering or have matured and preparing to seed.

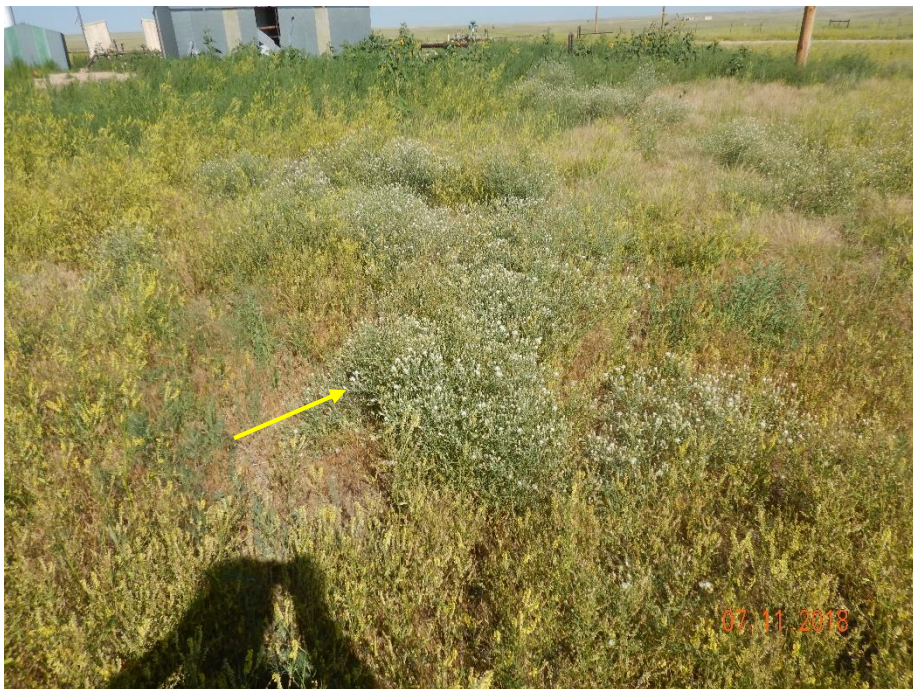
**Photo 5:** Photo taken from the central area of the location, facing west. Photo shows Diffuse Knapweed (lighter, grey-green plants) remain prevalent throughout the location. Plants are flowering or have matured and preparing to seed.

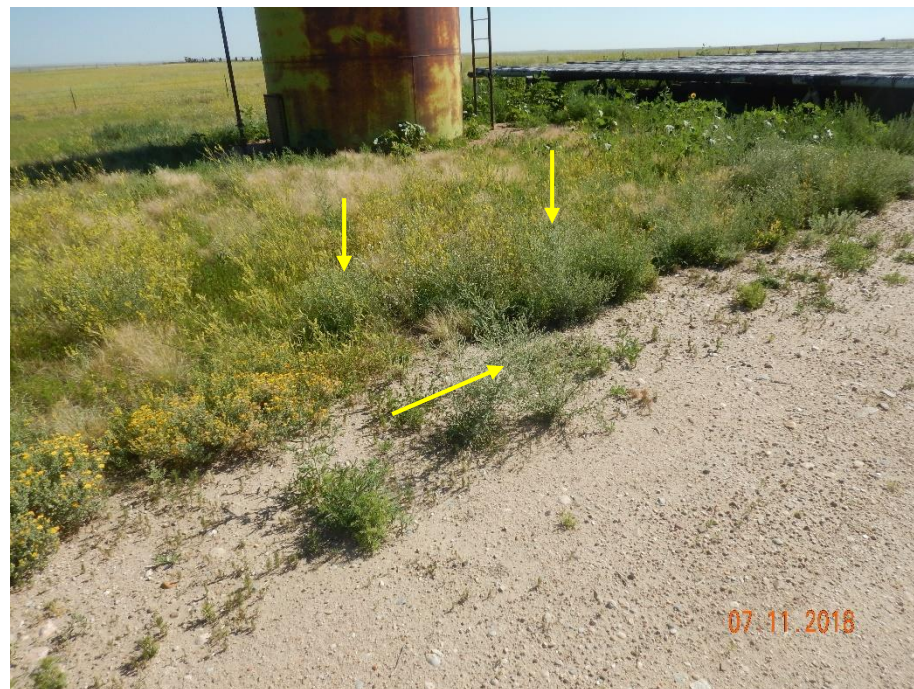
**Photo 6:** Photo taken from the northwestern area of the location, facing north. See comments under photo 5.

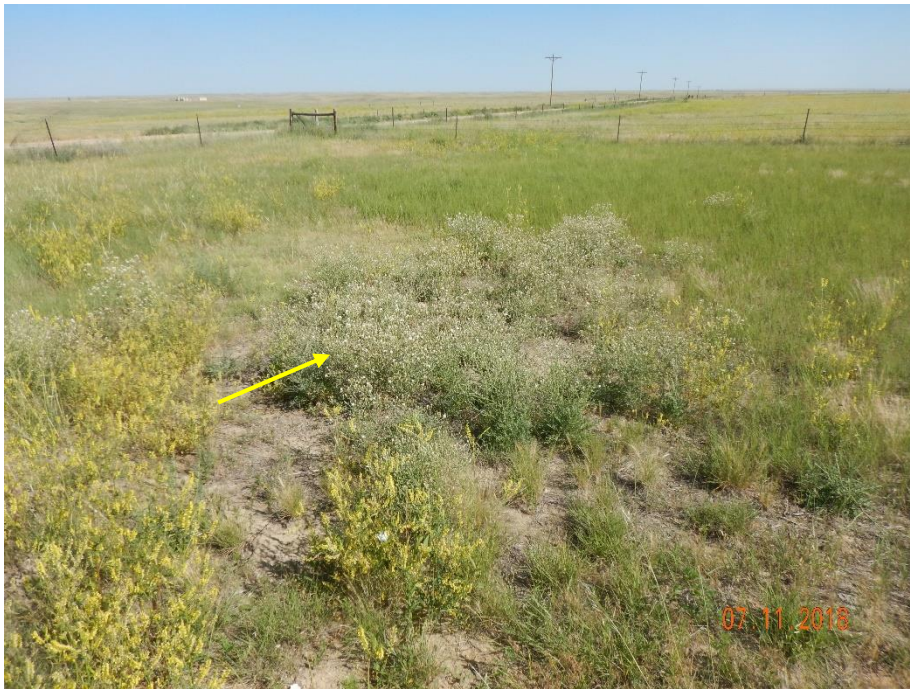
**Photo 7:** Photo taken from the northwestern area of the location, facing north. See comments under photo 5.

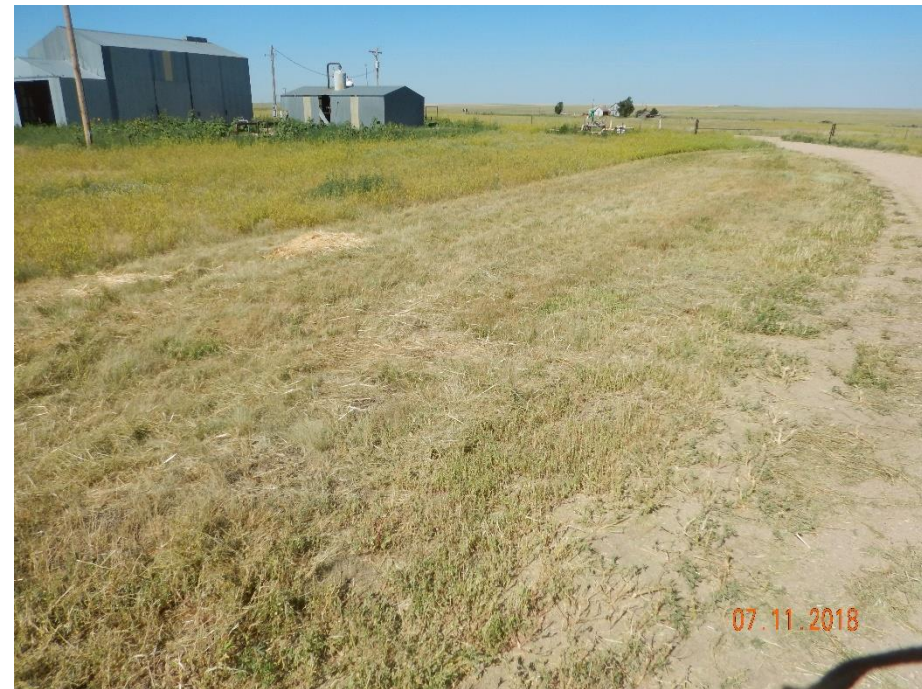
**Photo 8:** Photo taken from the northern end of the location, facing west. Photo shows operator appears to have mowed areas of the location. It is unclear if the intent was for weed management, if so mowing operations appear to have been inadequate. Photo also shows carcass identified in previous inspection has been removed.

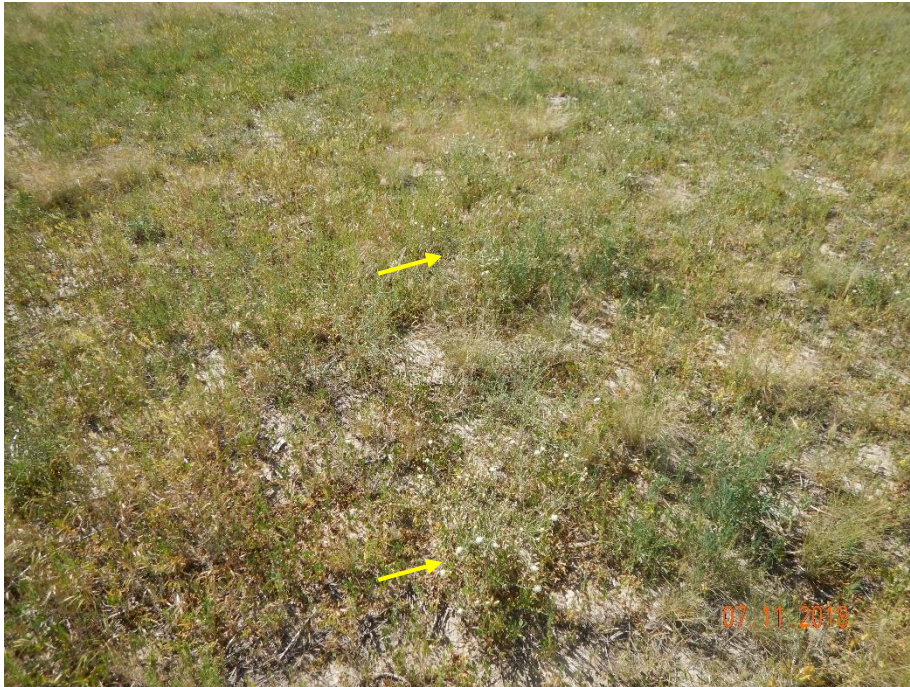
**Photo 9:** Photo taken from the adjacent lands north of the location. Noxious weeds have encroached onto the adjacent lands from the location. Previous inspection required management and removal of these noxious weeds.

Photo shows Diffuse Knapweed (lighter, grey-green plants, white colored flowers) remains prevalent throughout the location and have not been managed/removed. Plants are flowering or have matured and preparing to seed.

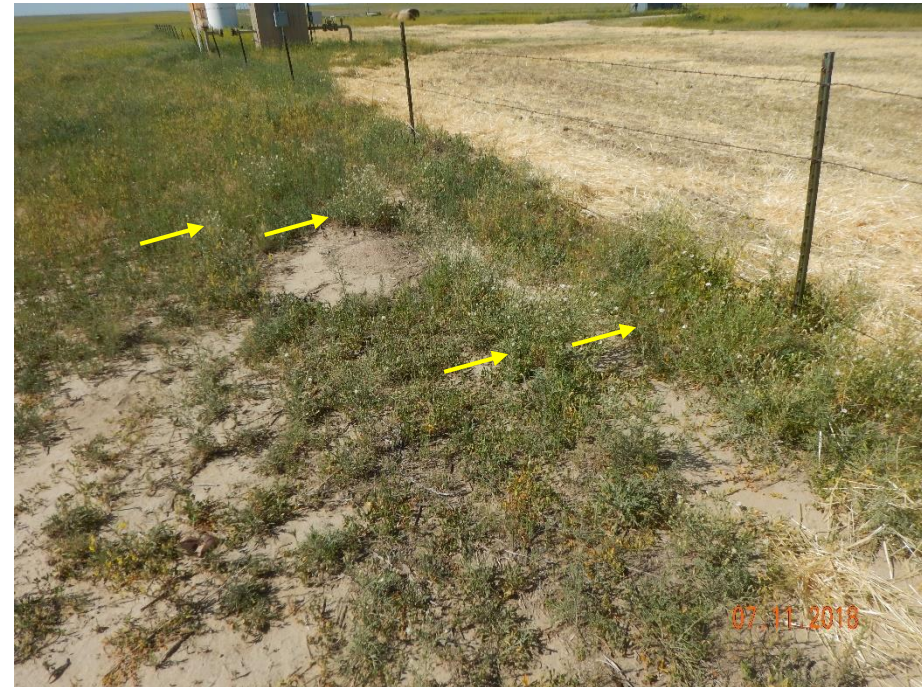
**Photo 10:** Photo taken from the adjacent lands east of the location, facing southwest. See comments under photo 9.

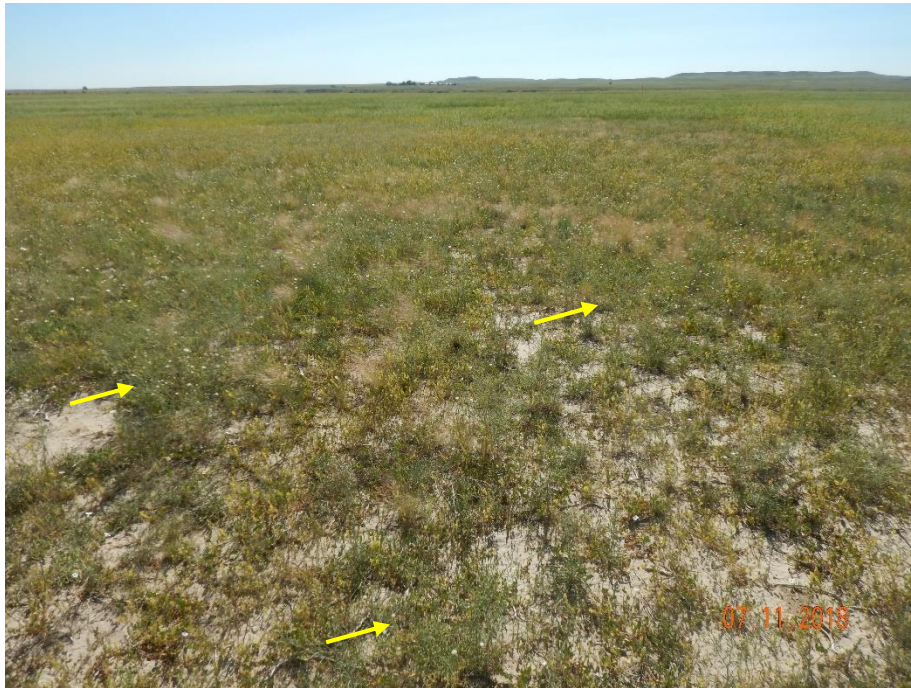
**Photo 11:** Photo taken from the adjacent lands east of the location, facing east. Noxious weeds have encroached onto the adjacent lands from the location. Previous inspection required management and removal of these noxious weeds.

Photo shows Diffuse Knapweed (lighter, grey-green plants, white colored flowers) remains prevalent throughout the location and have not been managed/removed. Plants are flowering or have matured and preparing to seed.

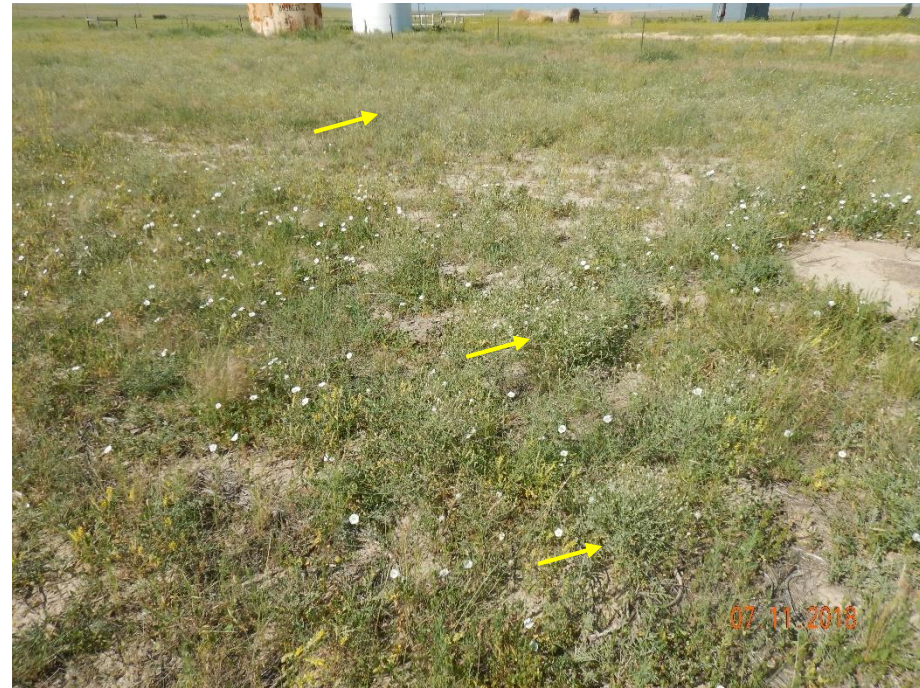
**Photo 12:** Photo taken from the adjacent lands east of the location, facing west. See comments under photo 11.

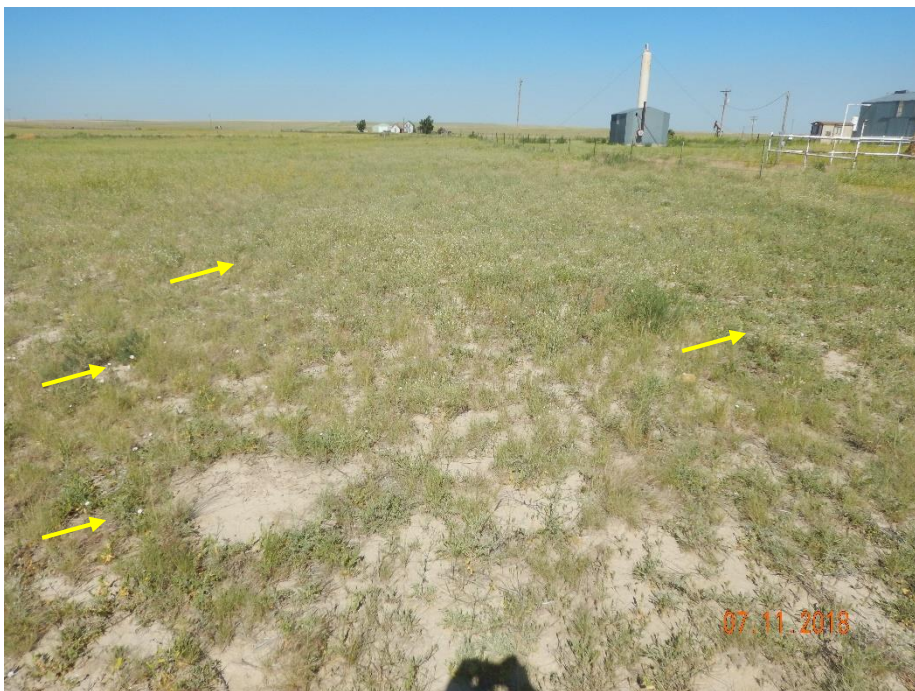
**Photo 13:** Photo taken from the adjacent lands south of the location, facing west. See comments under photo 11.

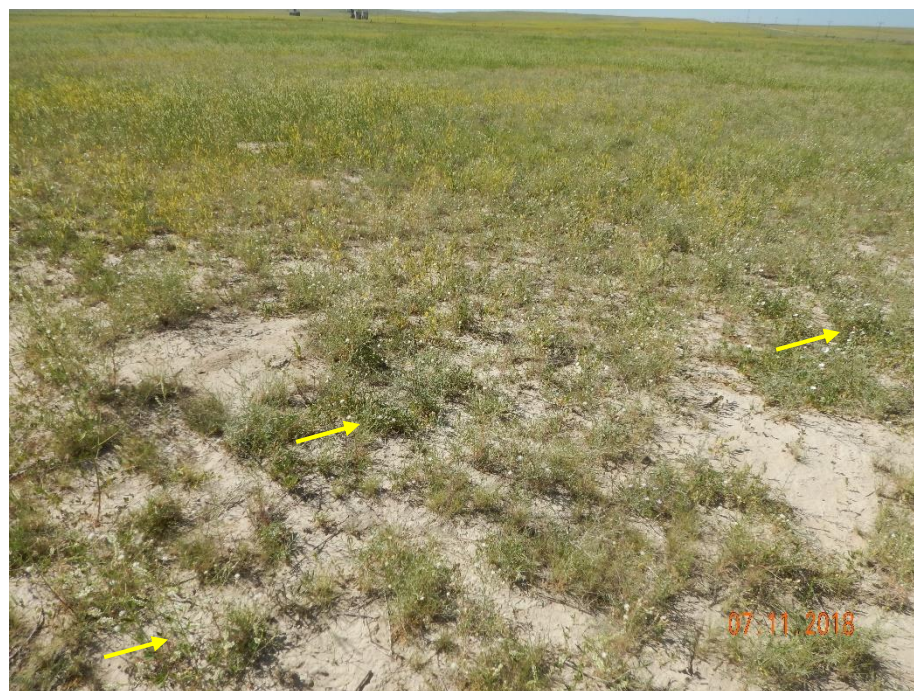
**Photo 14:** Photo taken from the adjacent lands south of the location, facing south. See comments under photo 11.

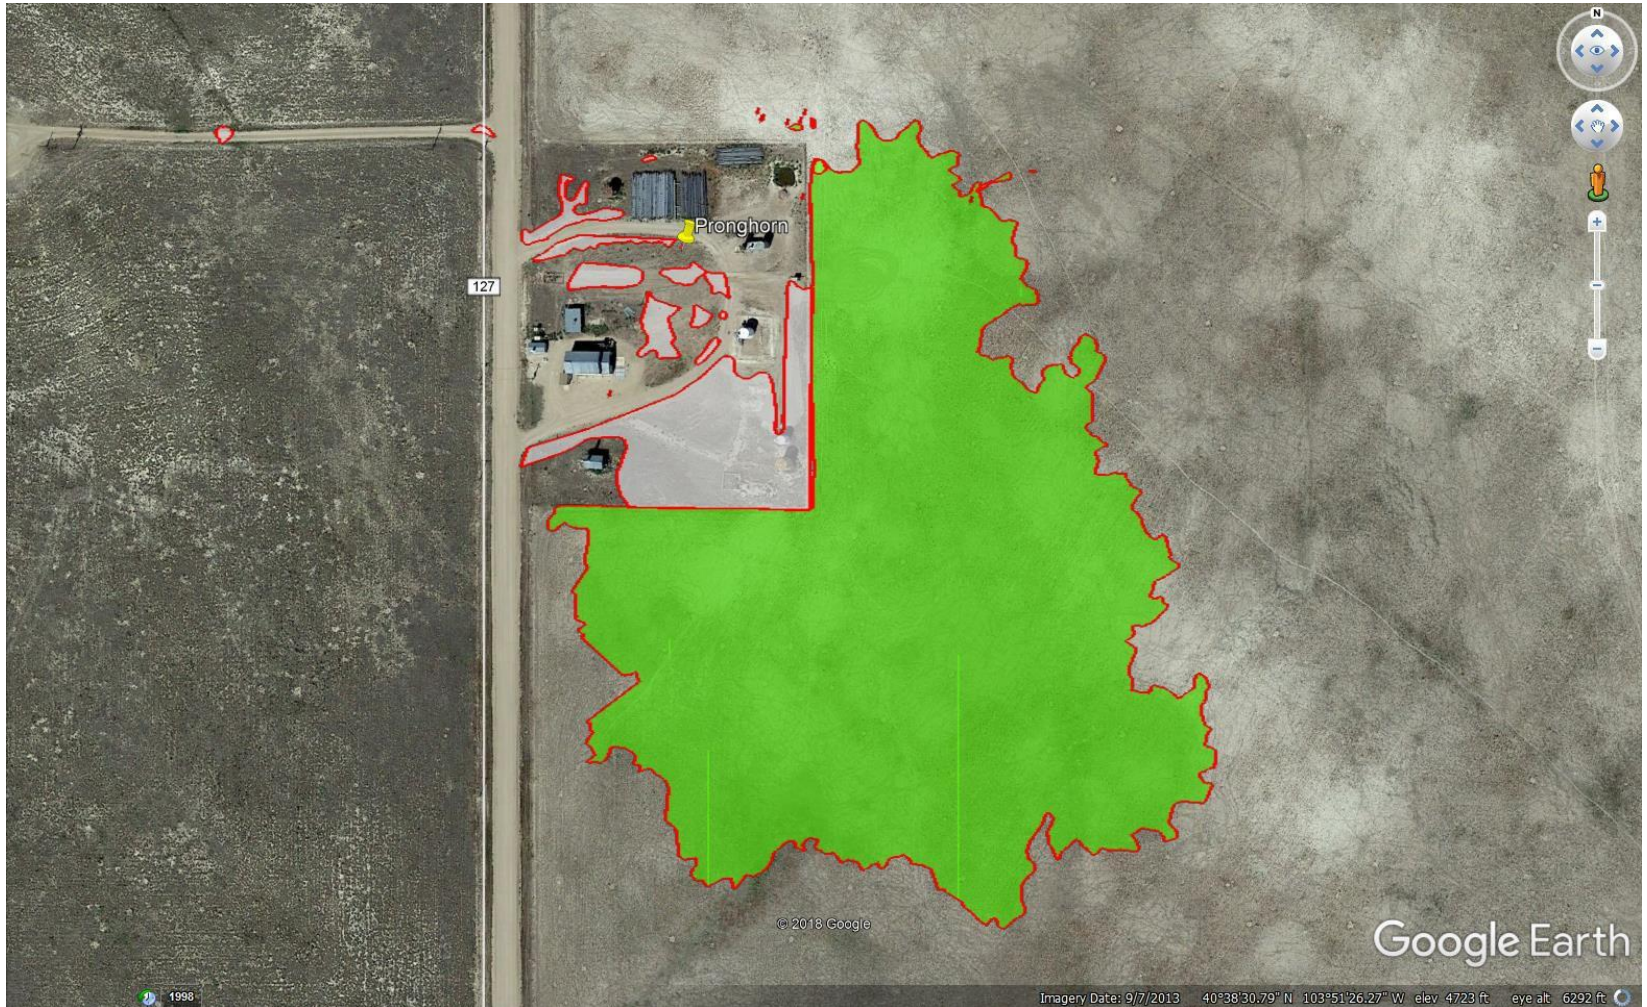
**Photo 15:** 2013 Aerial imagery. Photo shows areas (red polygon) where Noxious weeds were mapped using a GPS by the Reclamation Specialist. White Polygons represent areas of the location where Diffuse Knapweed were observed. Polygon in green area areas where Diffuse Knapweed has spread from the location onto the adjacent lands. It is noted that Knapweed patches observed on reference areas were not as dense as patches observed on location.
