Inspection Photos  
Location Name: Pinnacle Unit 12-30  
API: 05-103-05906

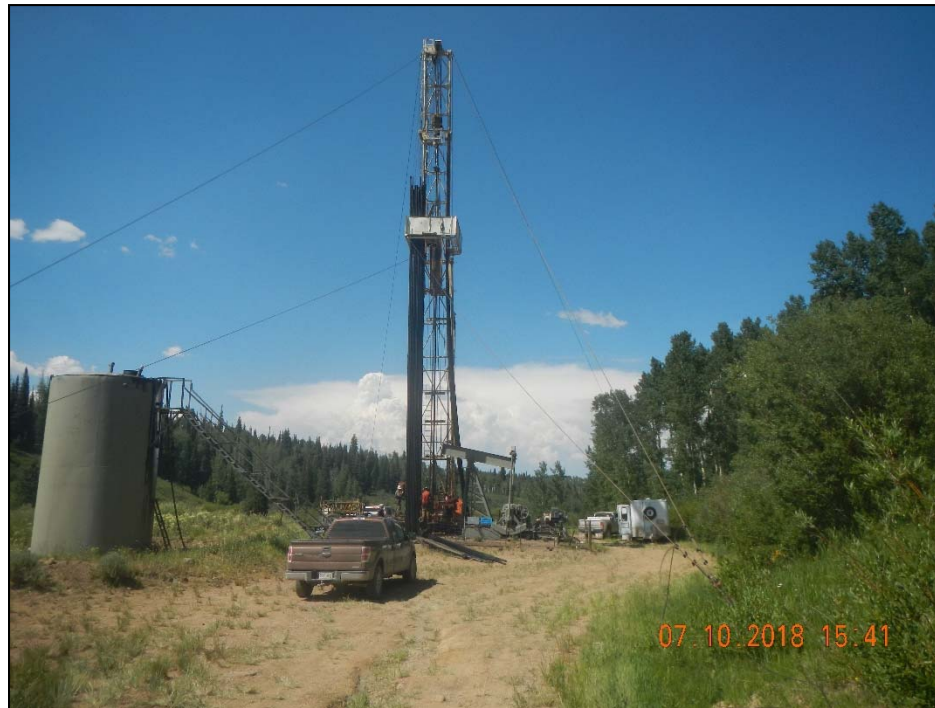
**Photo 1. Overview of location taken at entrance facing south.**
