Inspection Photos
Location Name: Carpenter 2-32
API: 05-081-05363

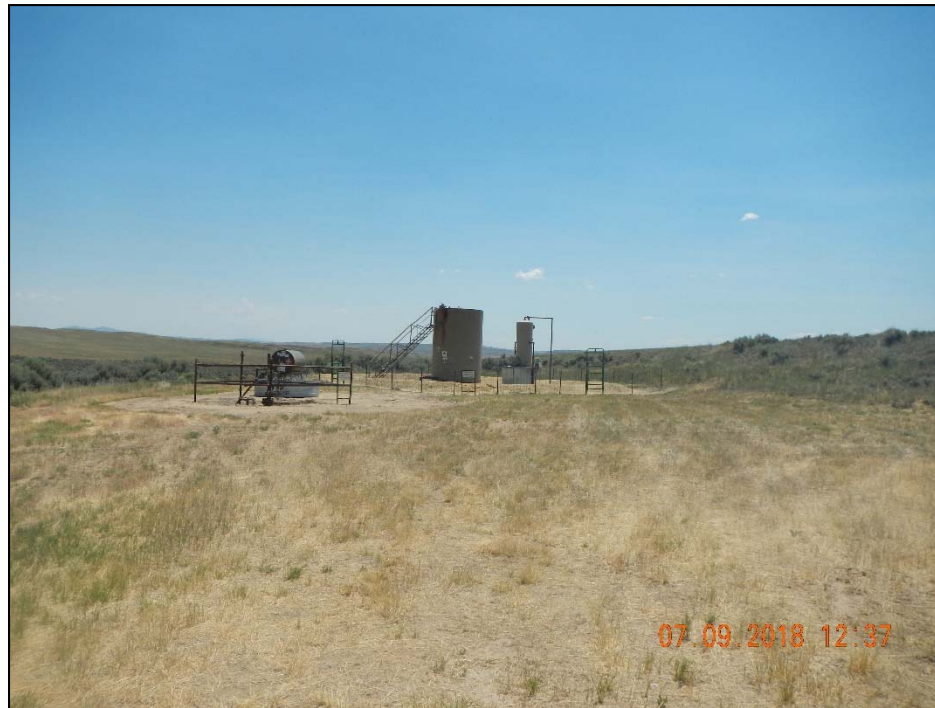
Photo 1. Overview of location taken at entrance facing southeast.
