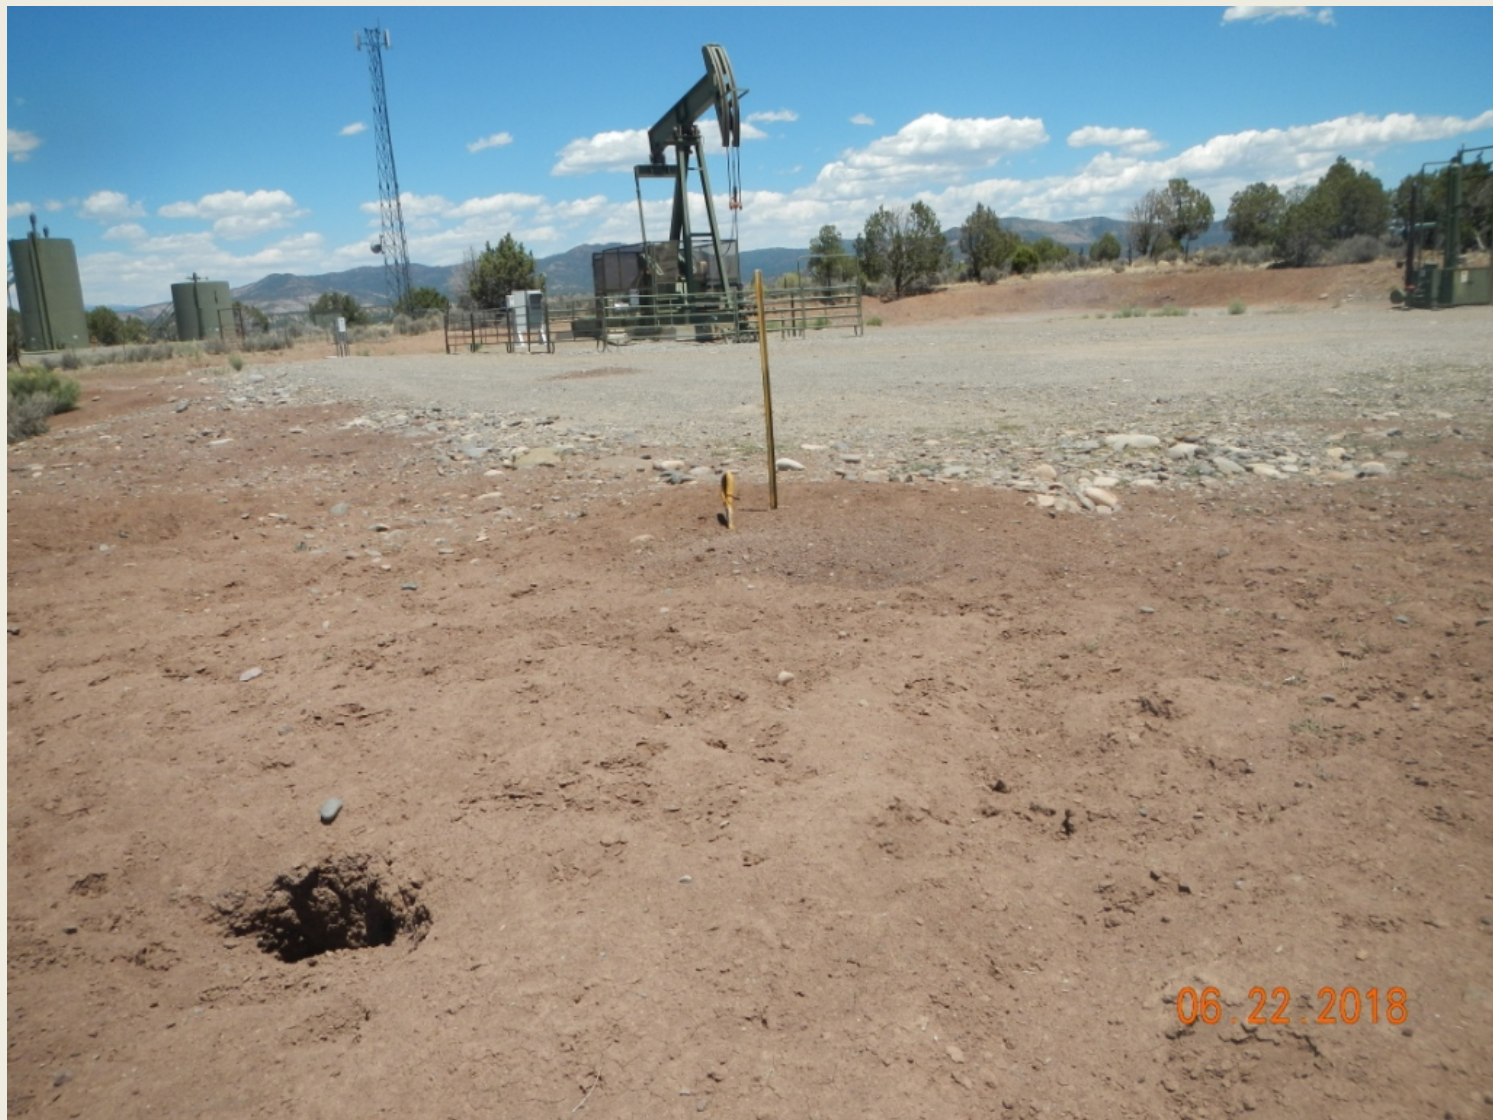
Photo 1. View of the project area from the southwestern corner facing center.

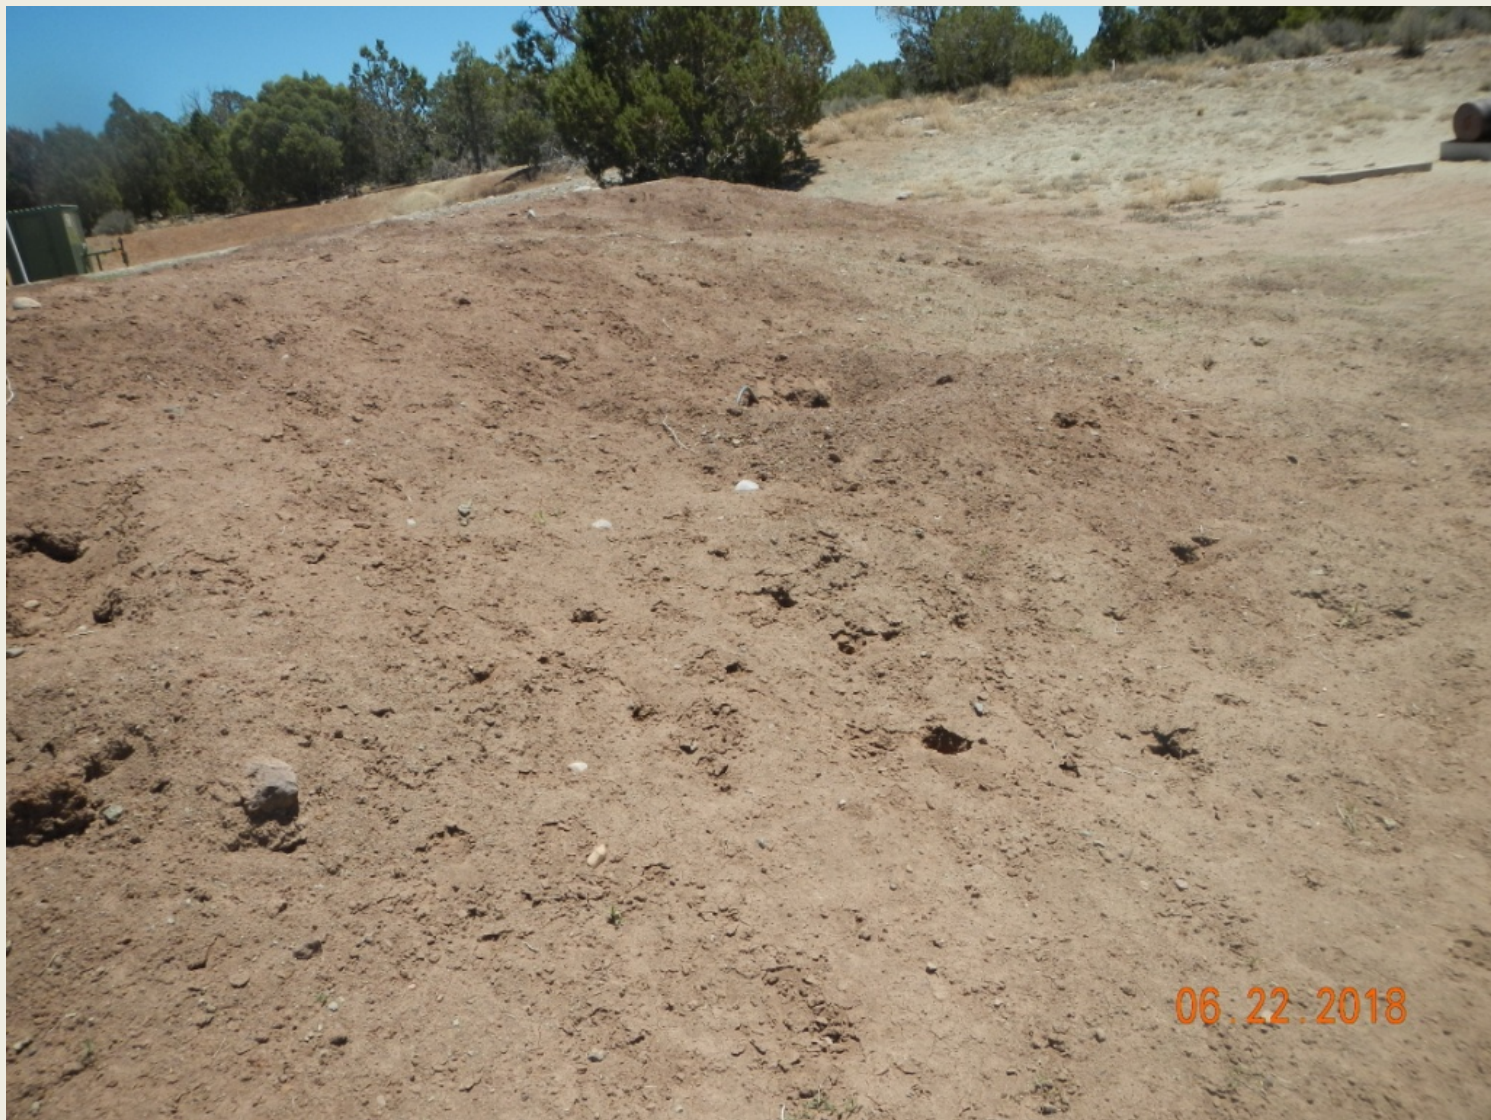
Photo 2. View of the southern portion of the project area from the southwestern corner facing eastward. Very little vegetative cover observed here.

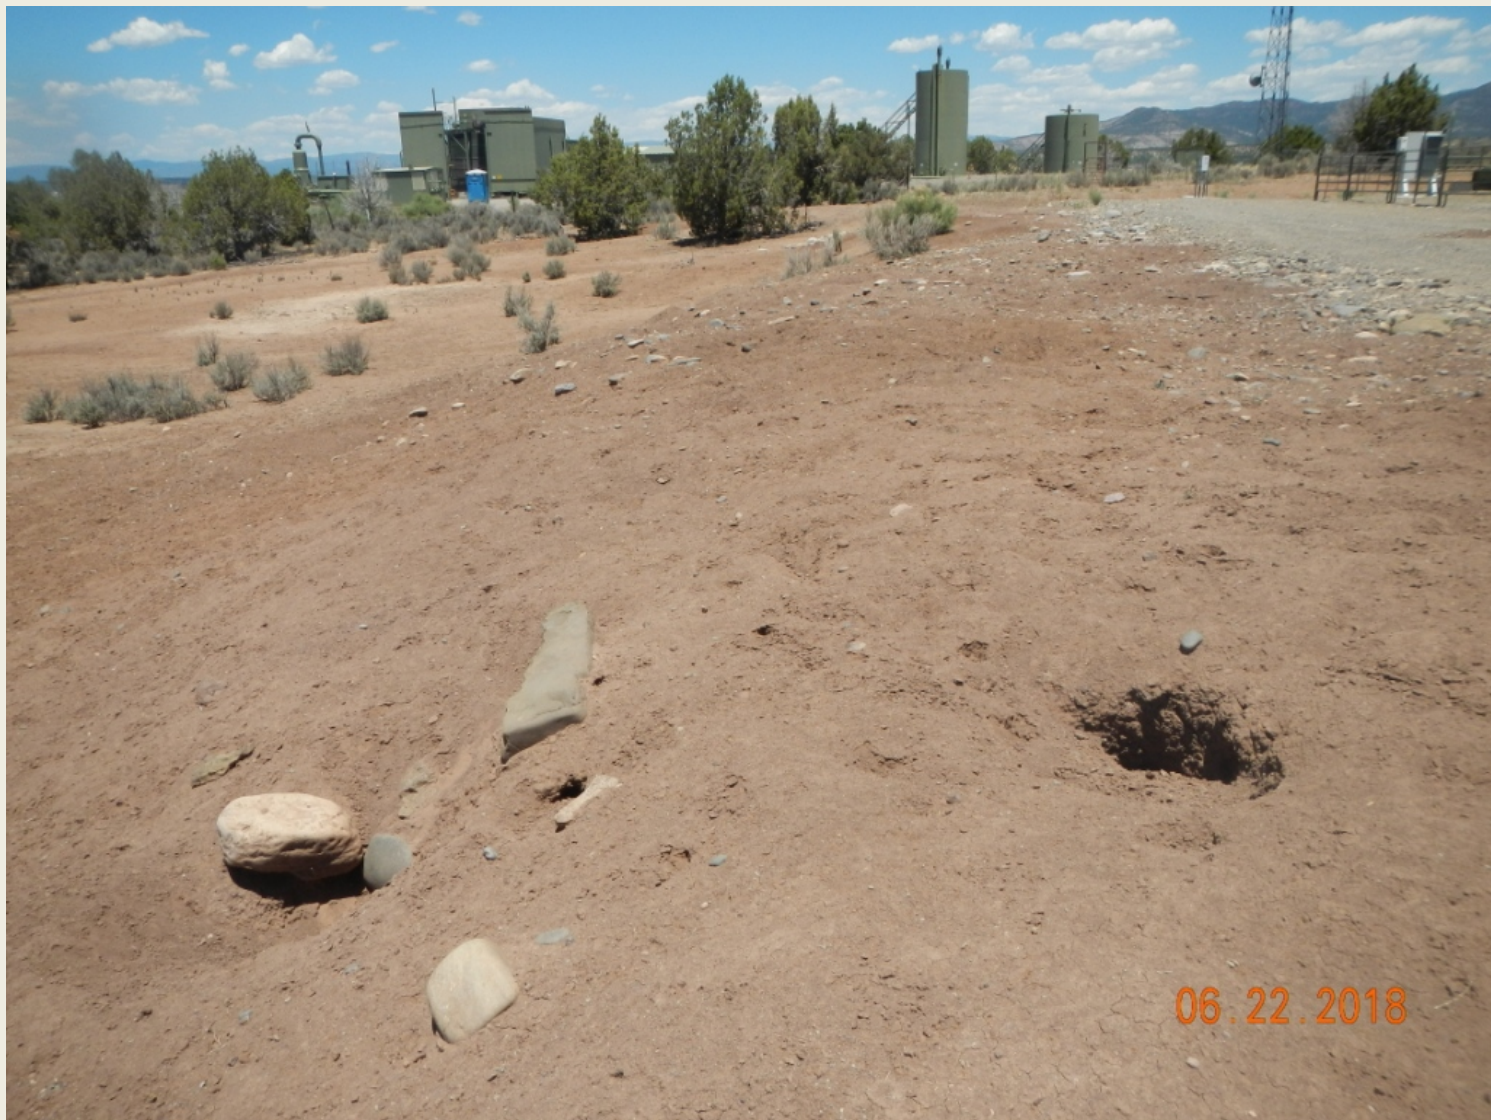
Photo 3. View of the western portion of the project area from the southwestern corner facing northward.

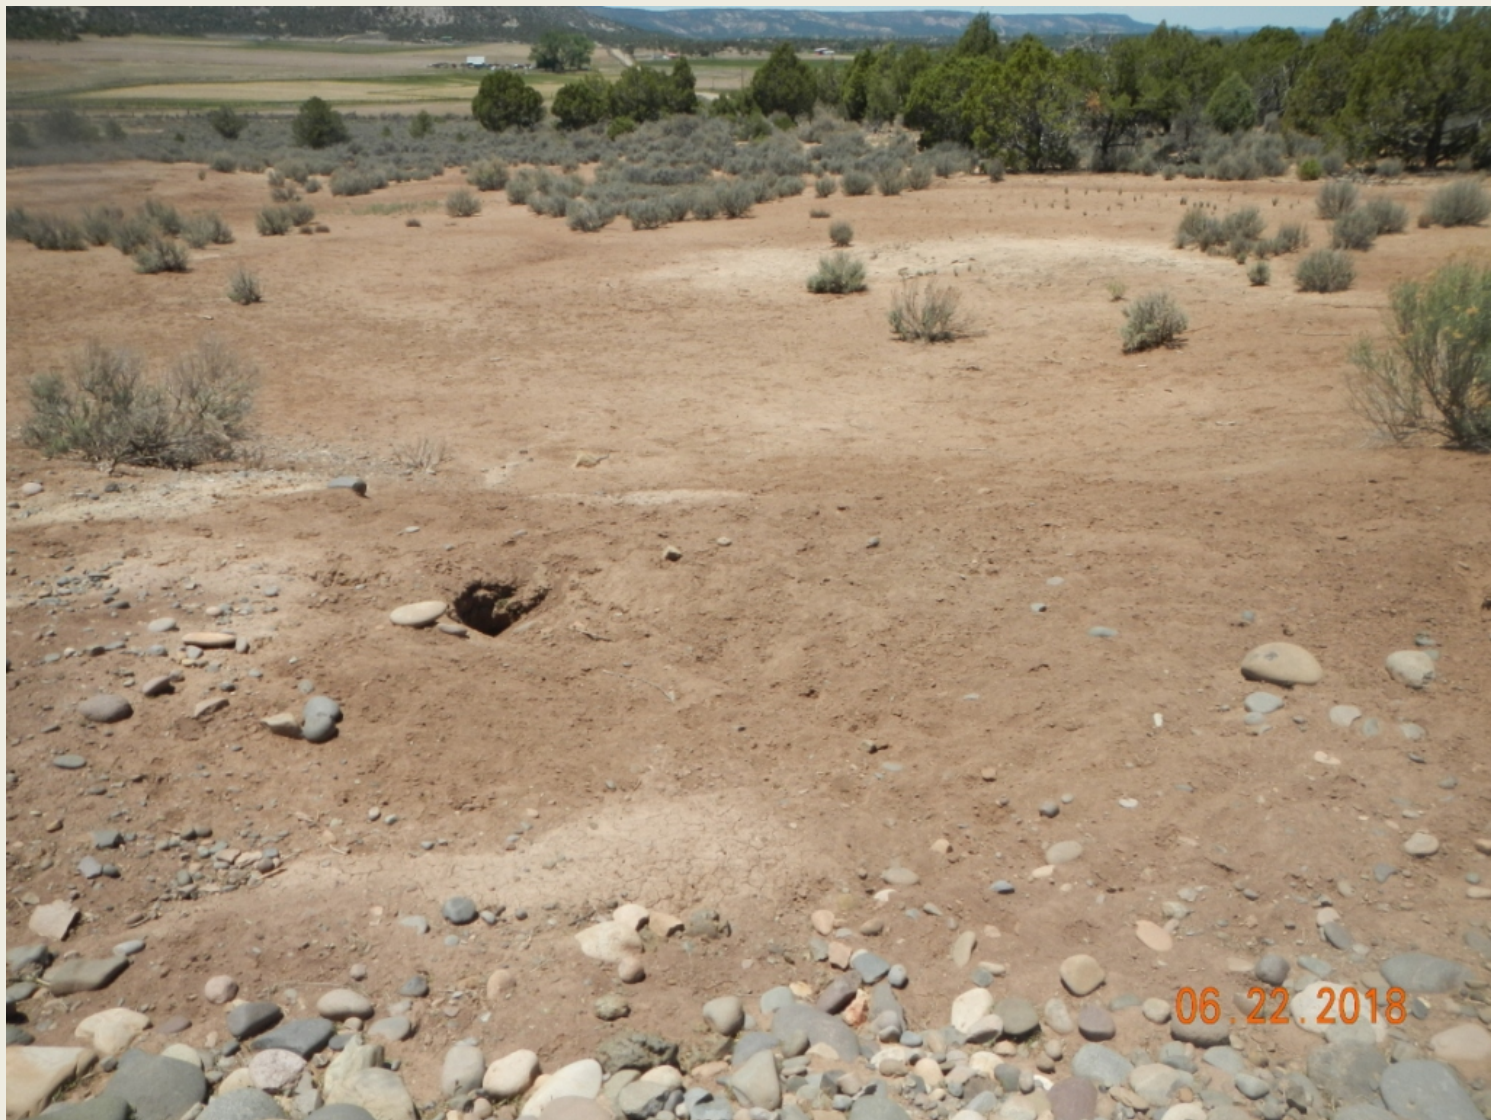
Photo 4. View of erosional channels in the western project area.

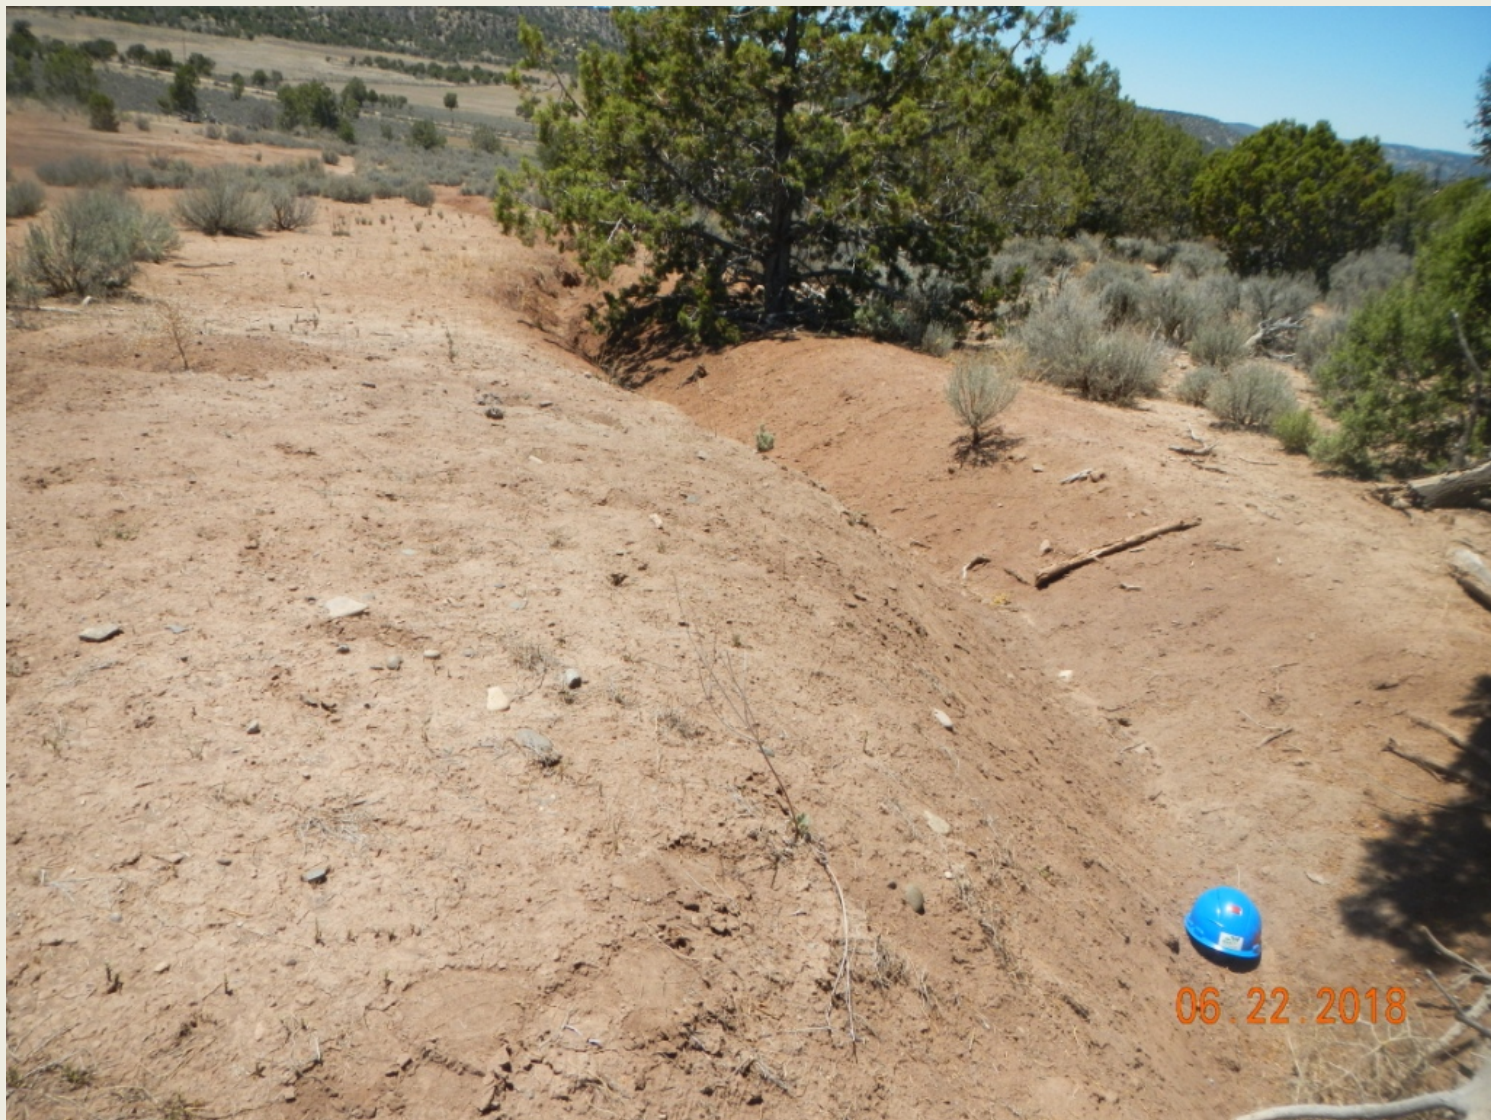
Photo 5. View of diversion in the northwestern project area needing stormwater controls to de-energize stormwater flows exiting the project area.
