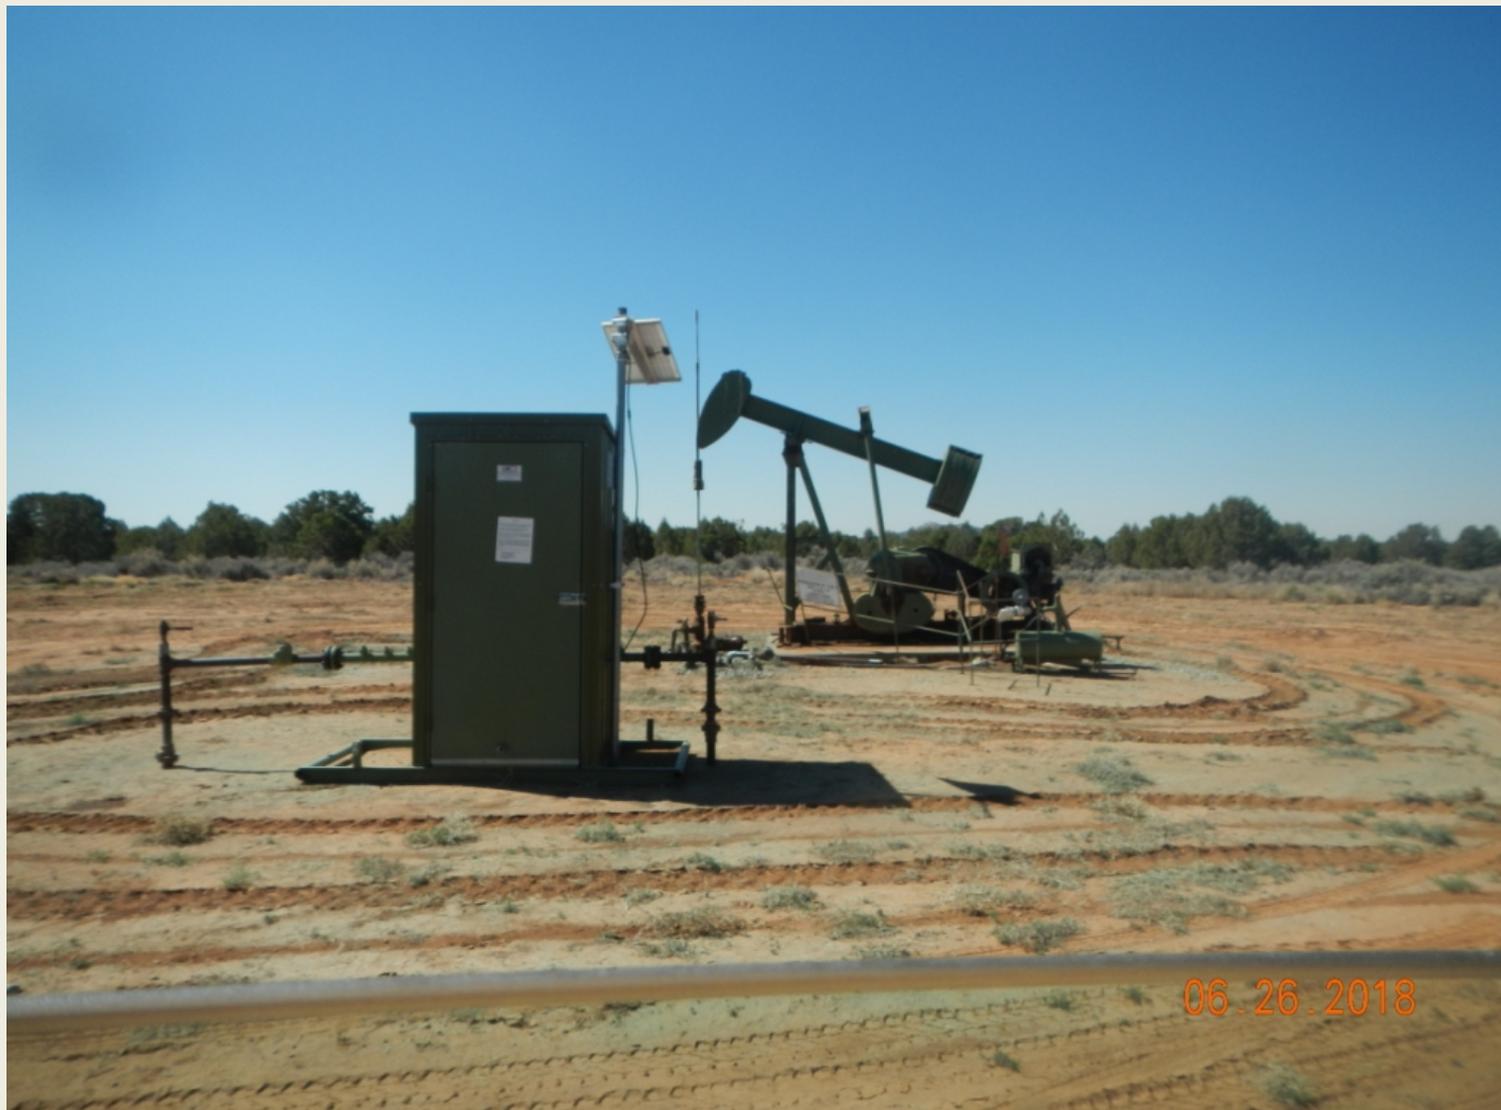
Photo 1. View of the project area from the well pad entrance facing center. Area is mowed and herbicide applied around facilities.

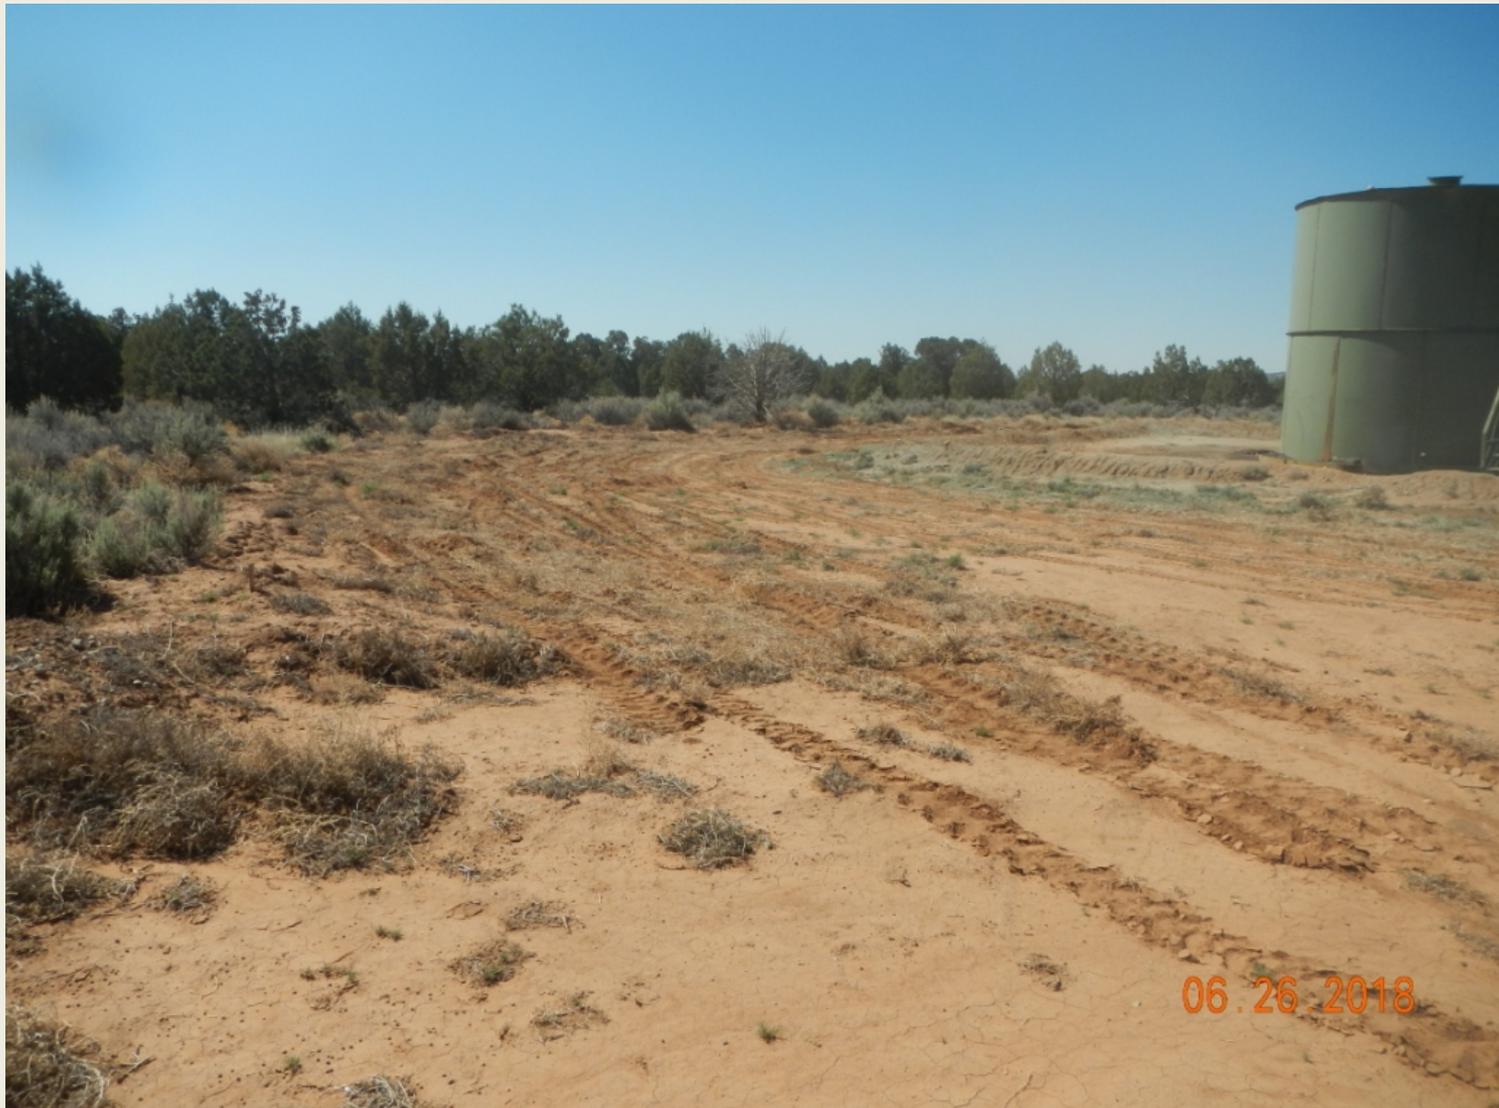
Photo 2. View of the southeastern portion of the project area from the entrance to the well pad facing southward.

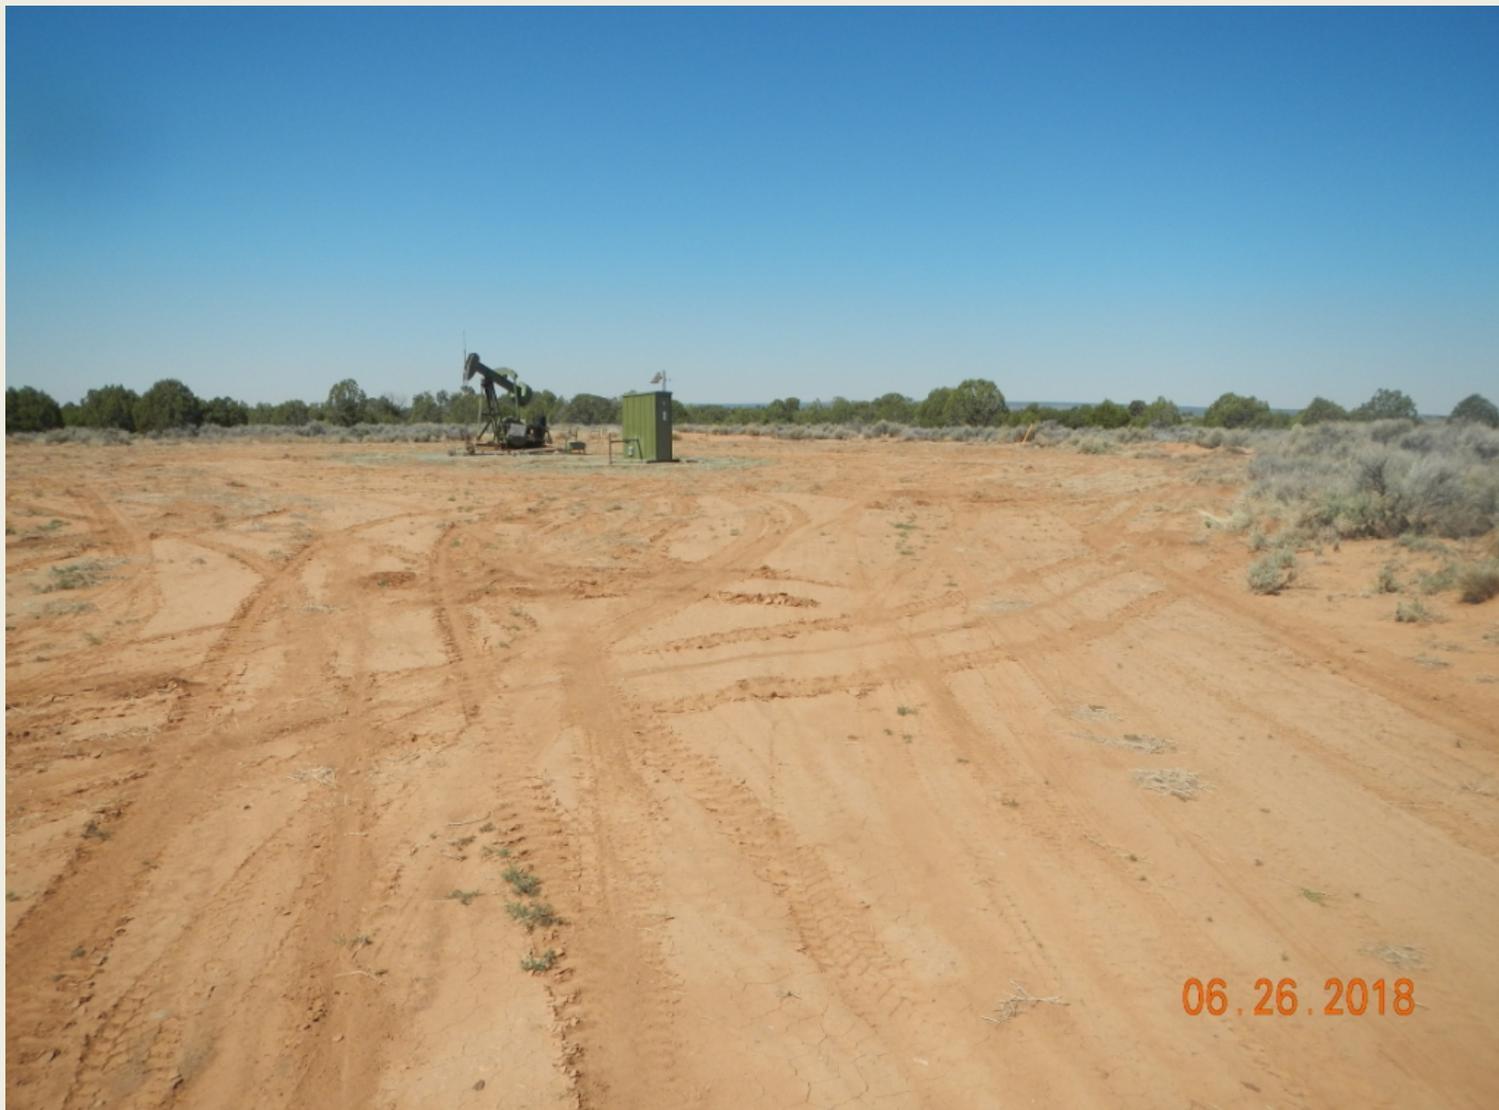
Photo 3. View of the northern portion of the project area from the well pad entrance facing westward.
