DOE PM 2-31
Api# 05-045-07036
Inspection # 689701621

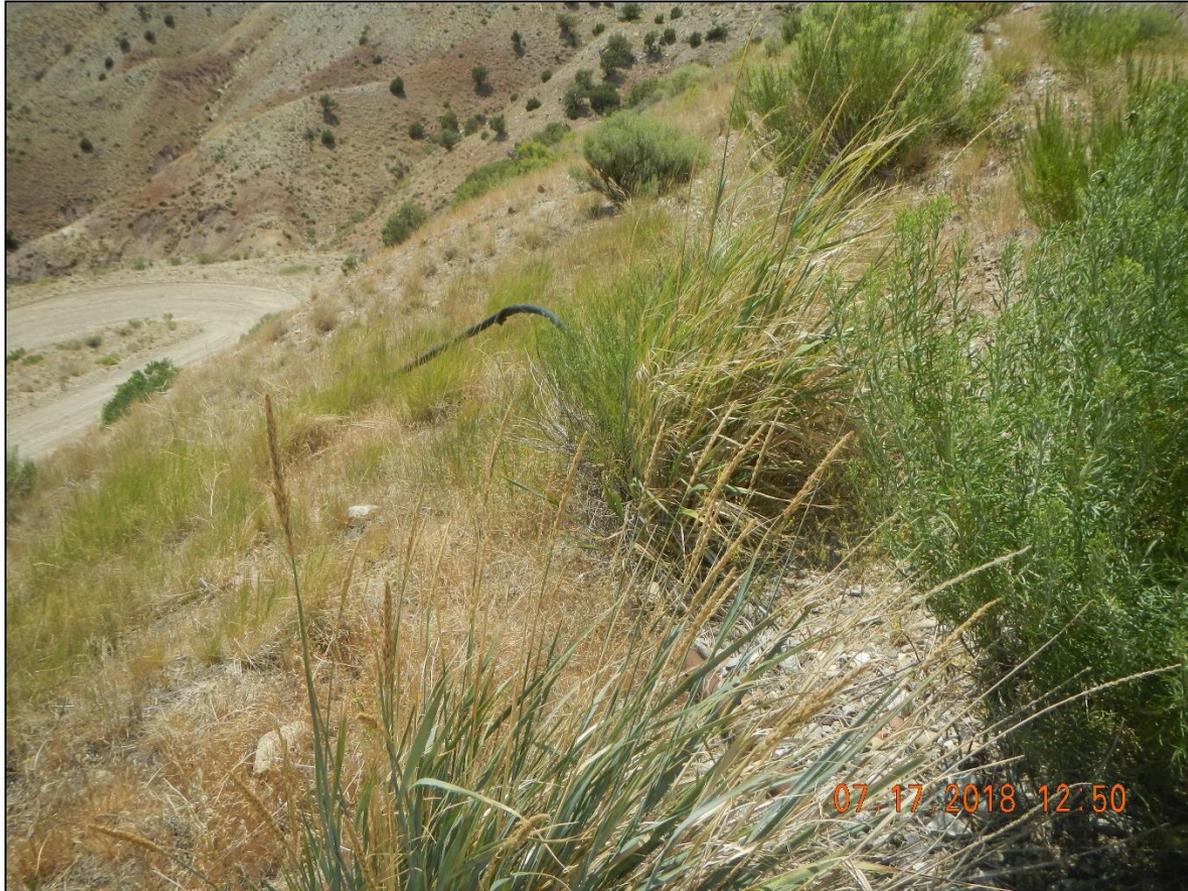
Tubing off the edge of location. 39.48637 -108.04253

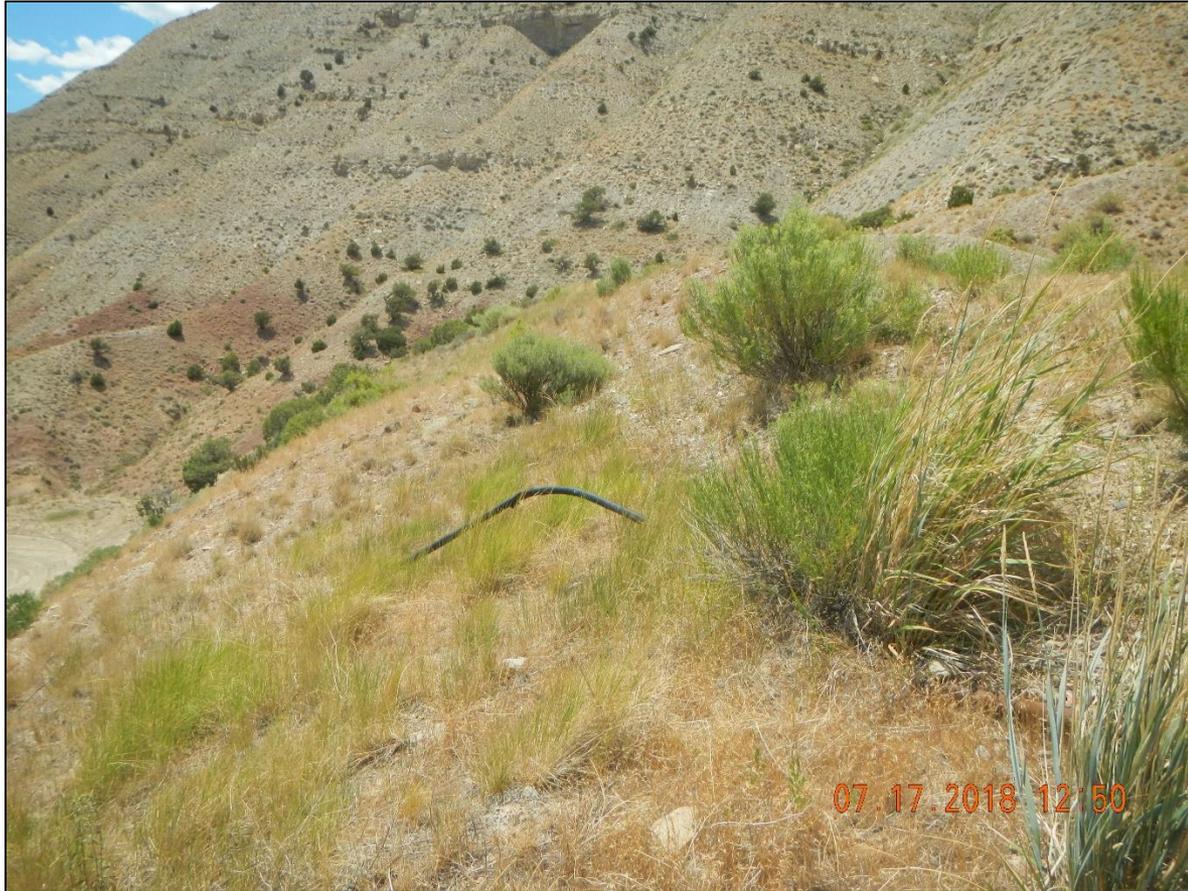
Tubing off the edge of location. 39.48637 -108.04253

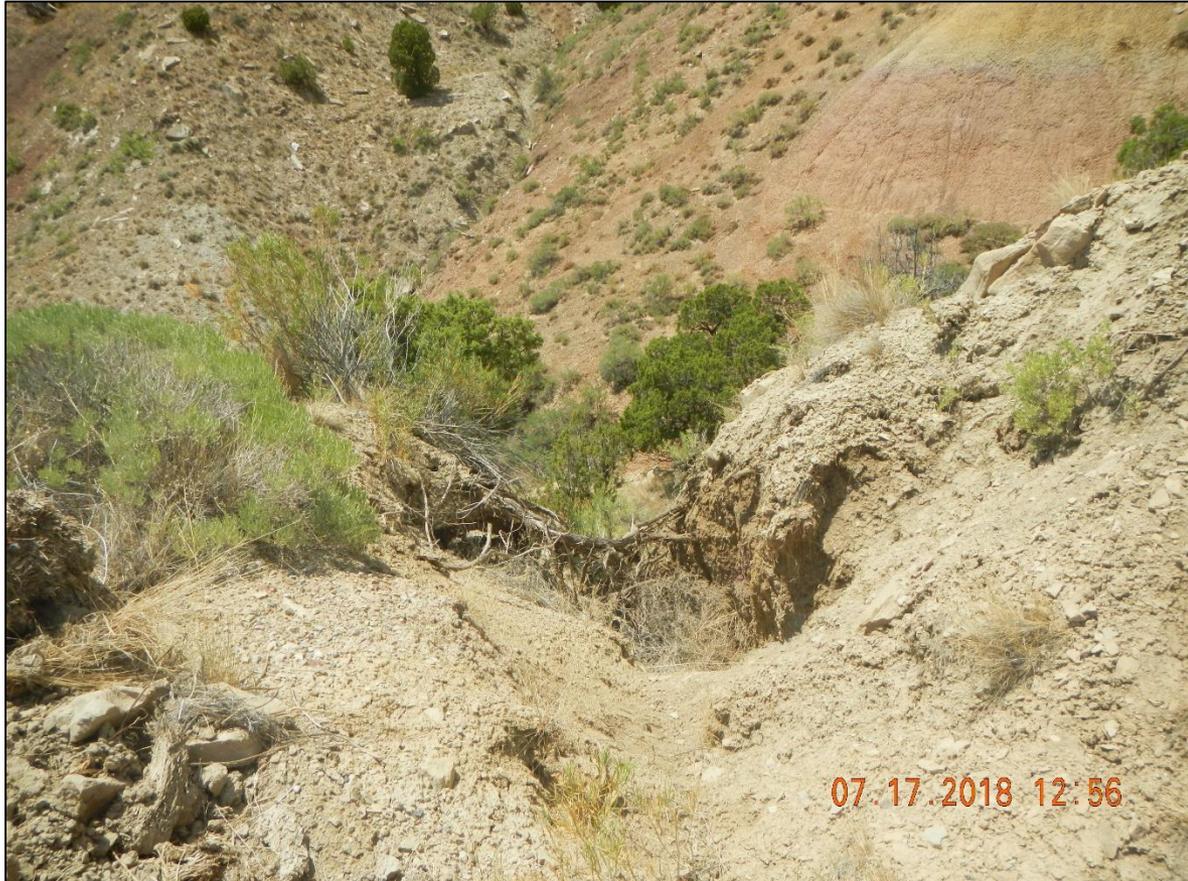
Erosion of hillside from ditch run off at top switch back. (39.48567 108.04314)

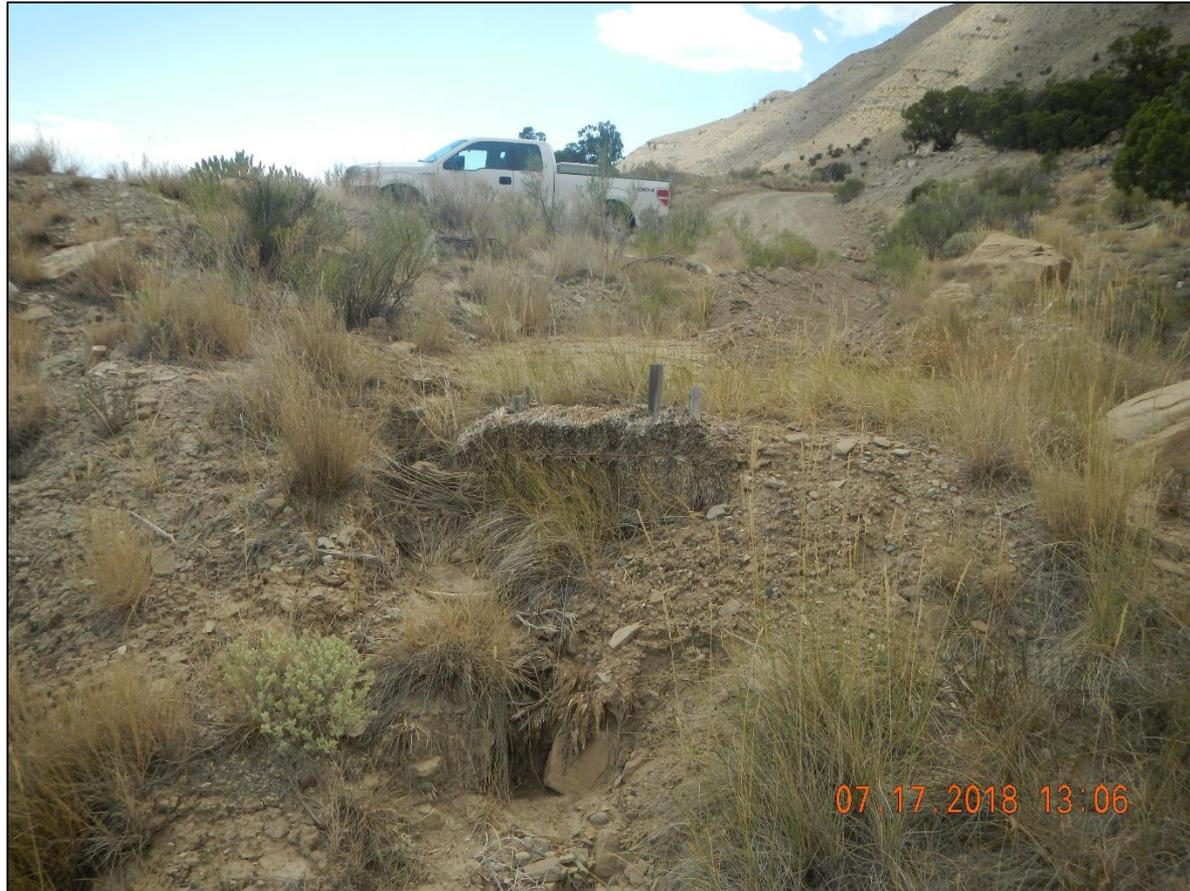
**Sediment build up over straw bales used for check dams @ Switch back
(39.48597 108.04075)**

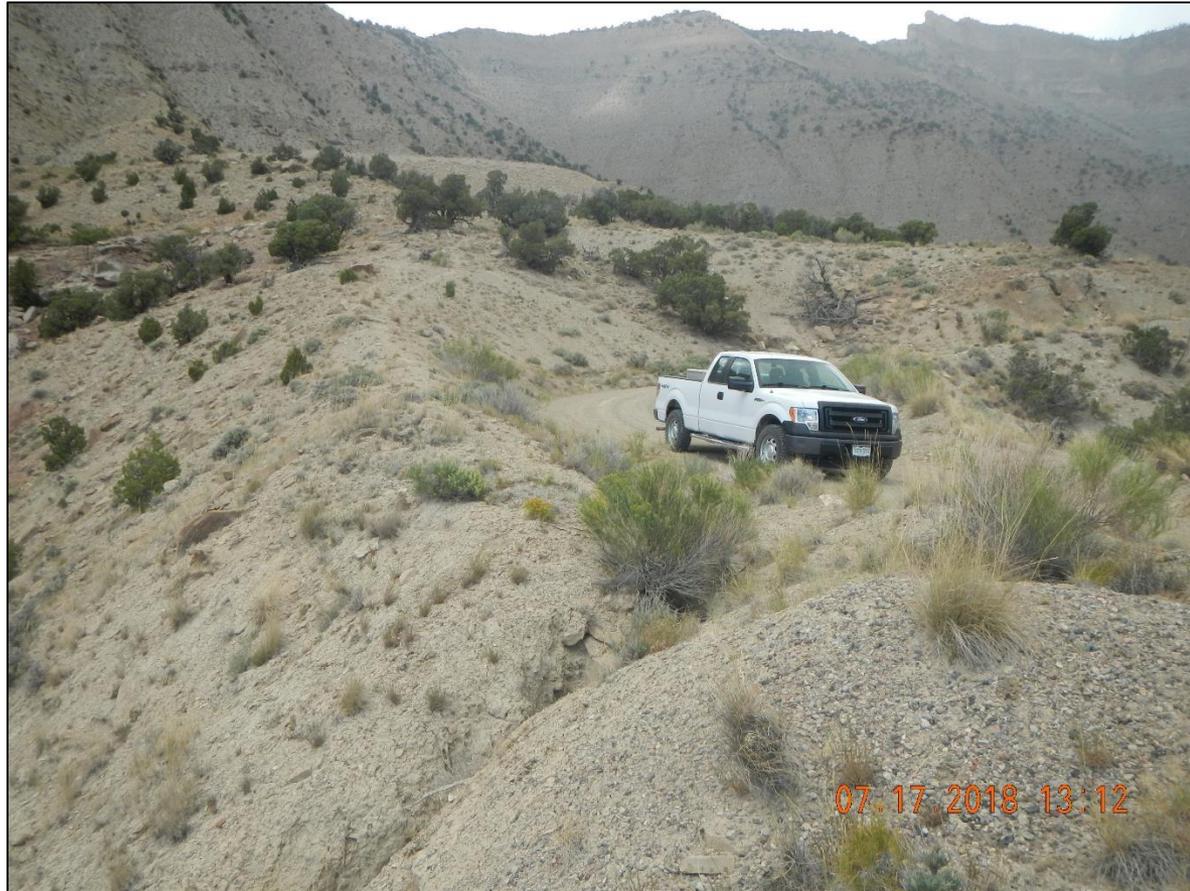
**Erosion of hillside from ditch run off and rilling of roadside @ (39.48523
108.04113)**

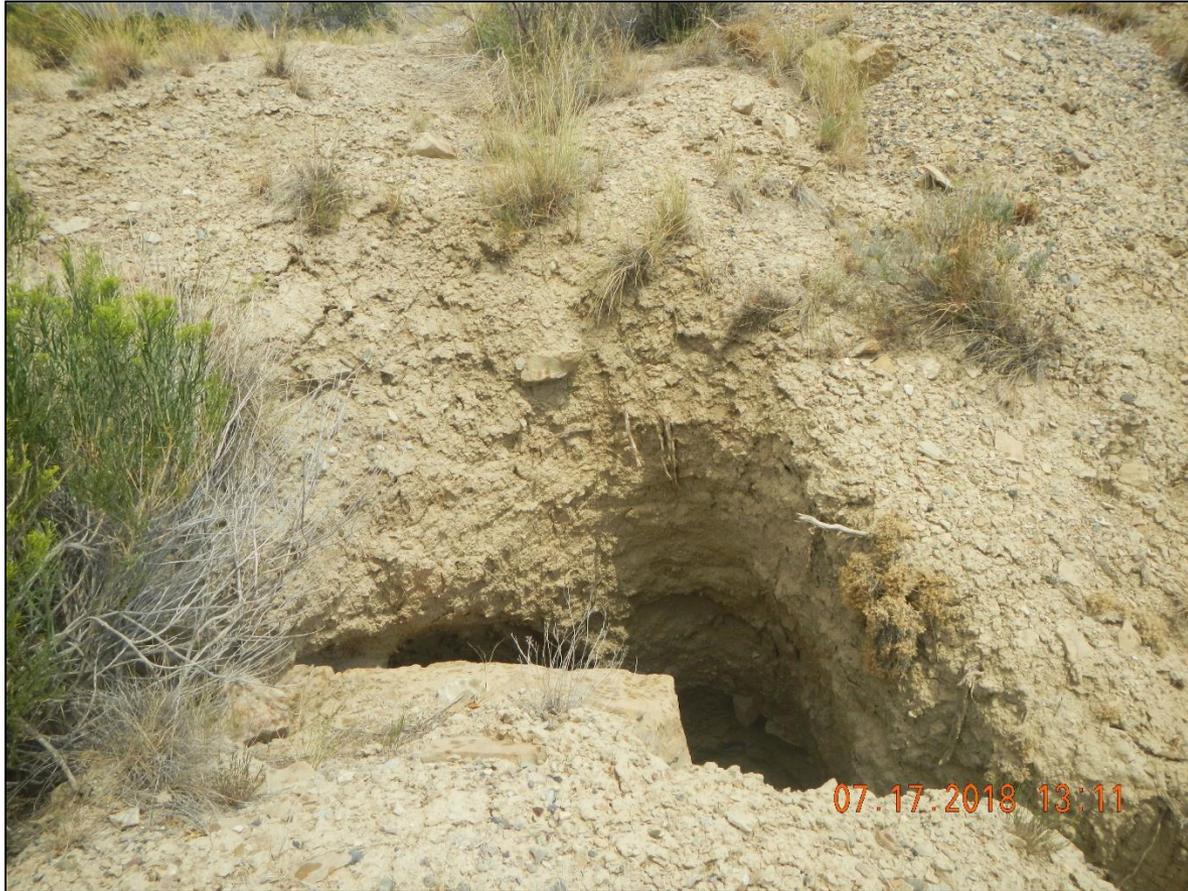
**Erosion of hillside from ditch run off and rilling of roadside @ (39.48523
108.04113)**

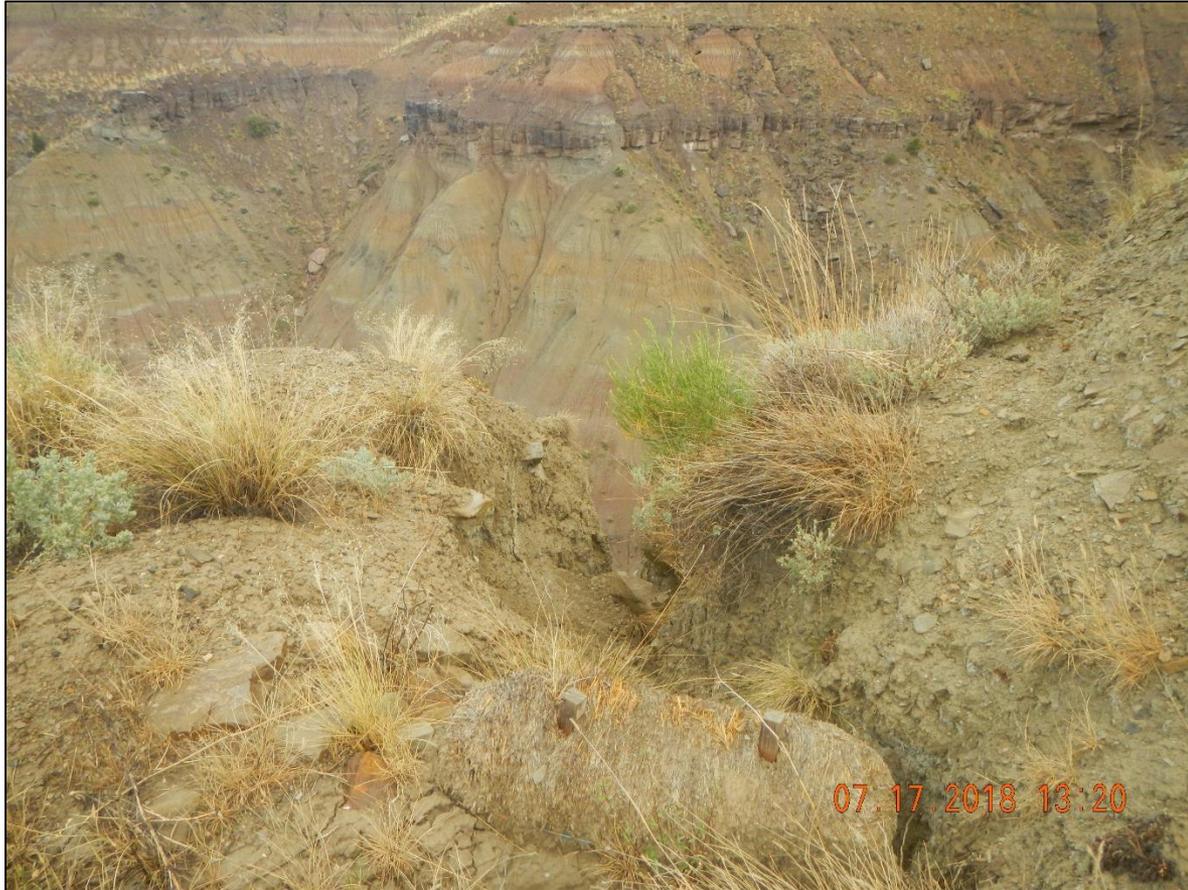
Erosion of hillside from ditch run off @ (39.48382 108.04018)
