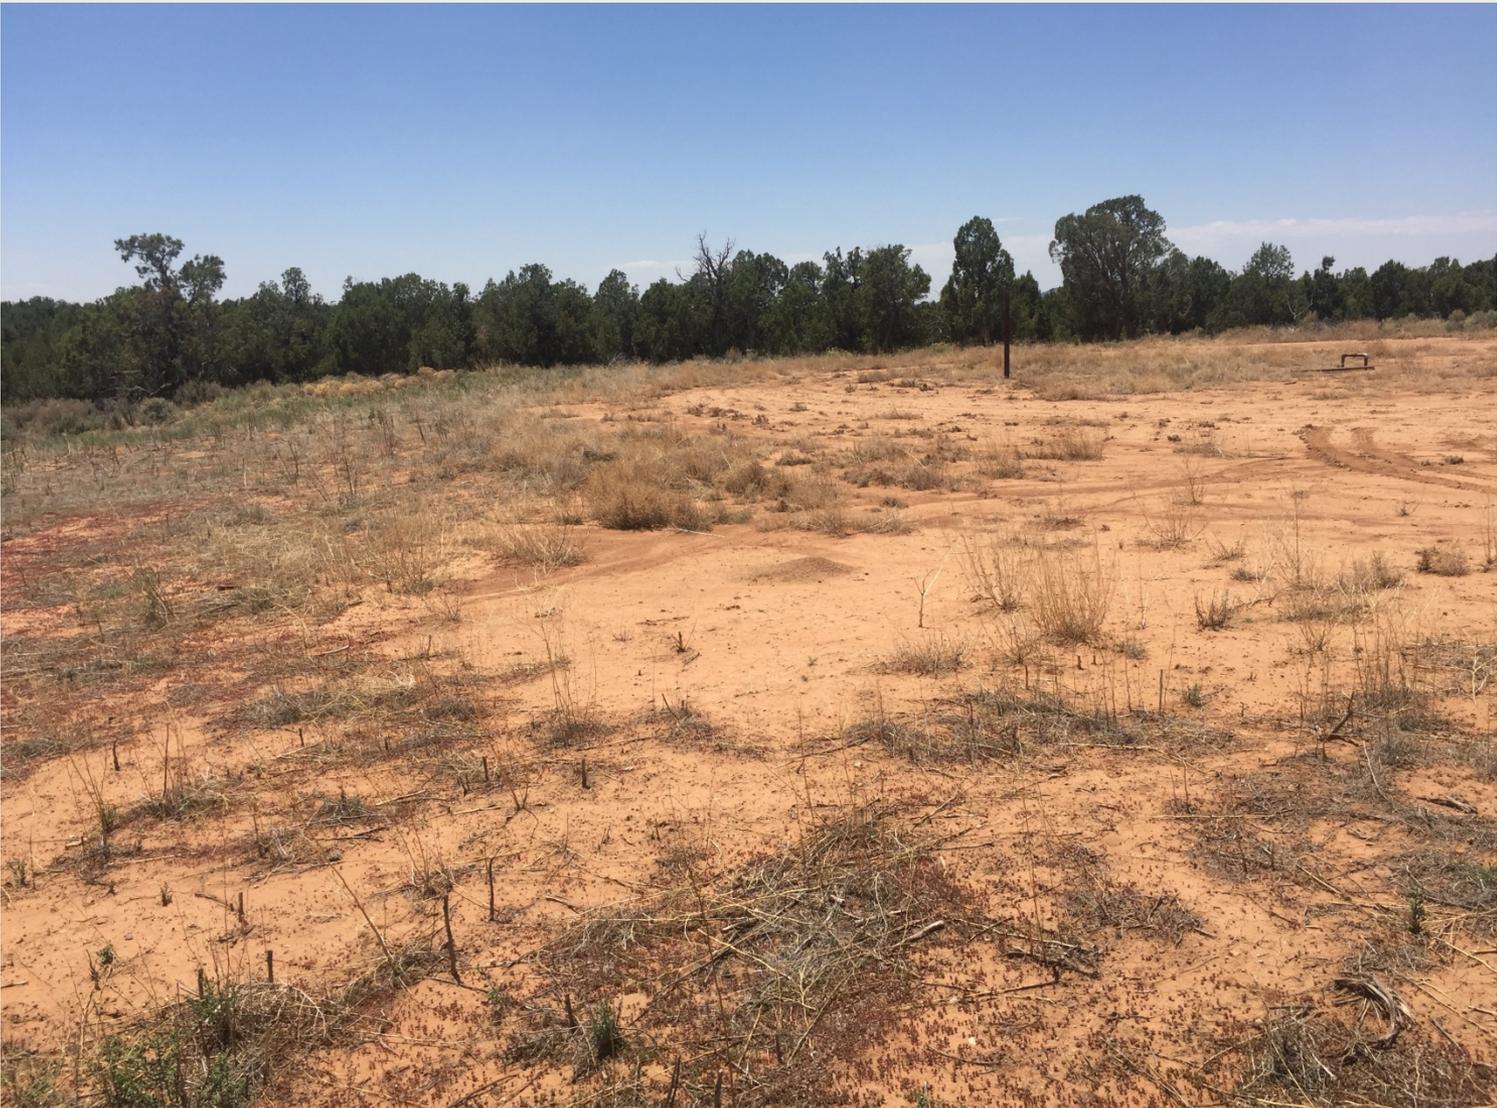
Photo 1. View of the project area from the northern edge facing enter. Photos taken before mowing herbicide weed treatments.

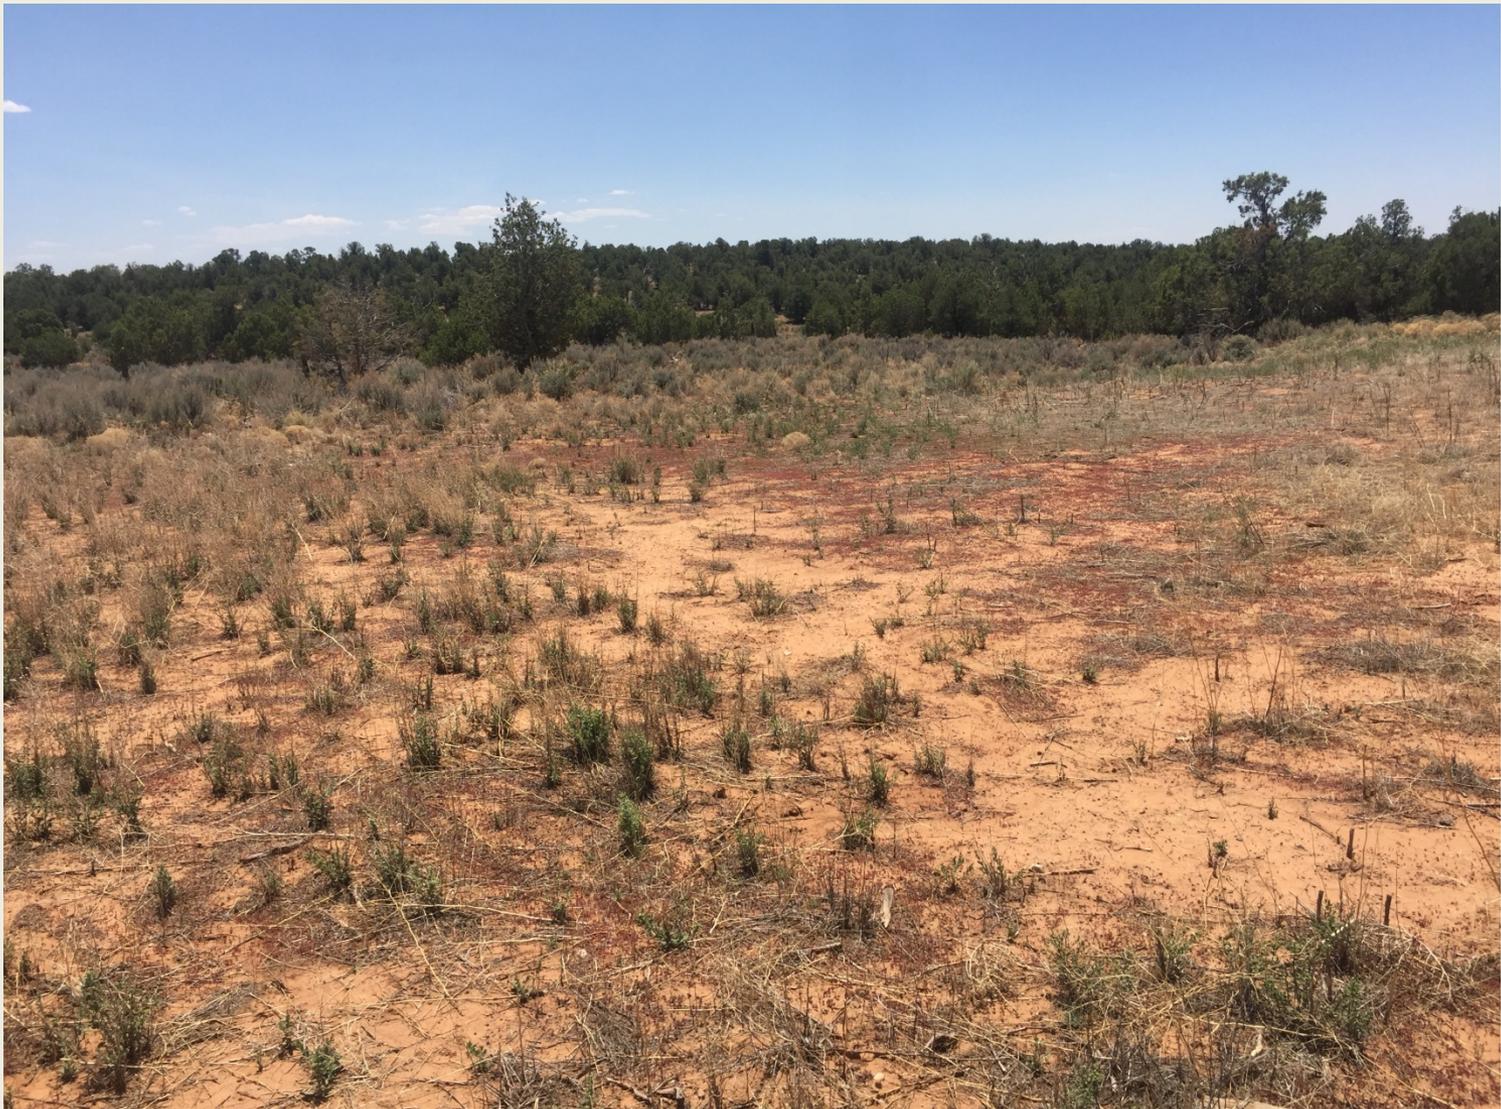
Photo 2. View of the eastern portion of the project area from the northern edge facing southward. Green vegetation is largely Russian knapweed (*Rhaponticum repens*).

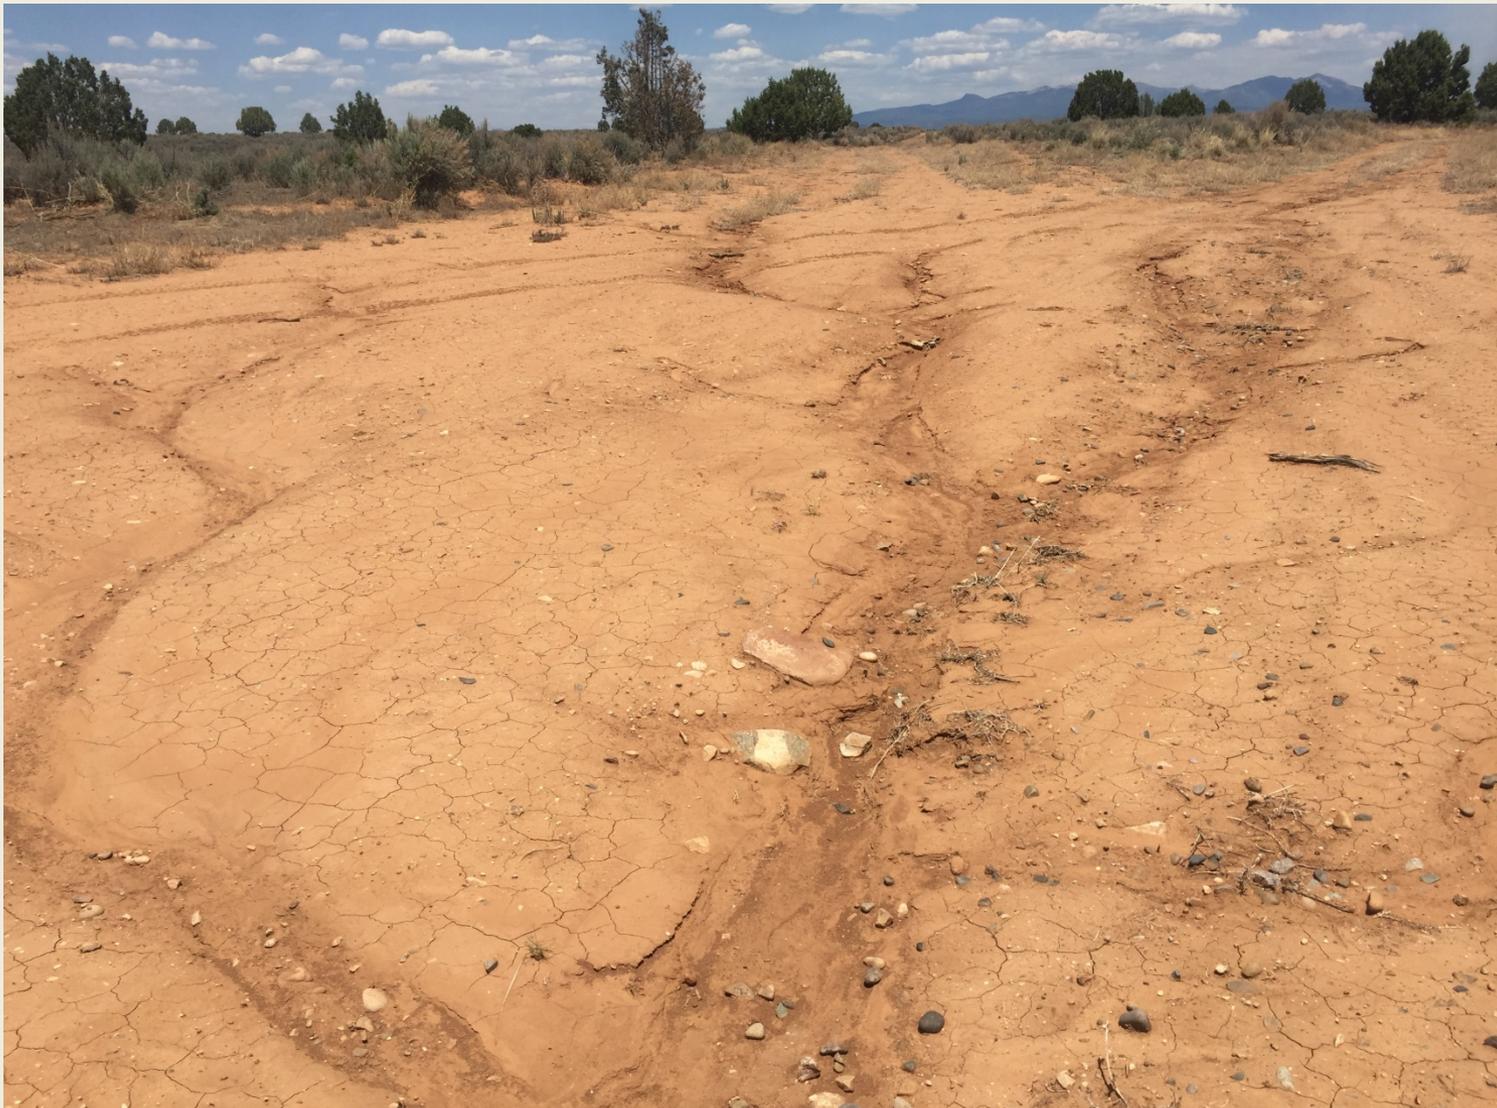
Photo 3. View of erosional channels forming within the northern portion of the project area where stormwater flows from the access road run onto the well pad.
