Inspection Photos

Operator: MALLARD EXPLORATION LLC # 10670

Location ID: 454592

Inspection Doc. Number: 682503625

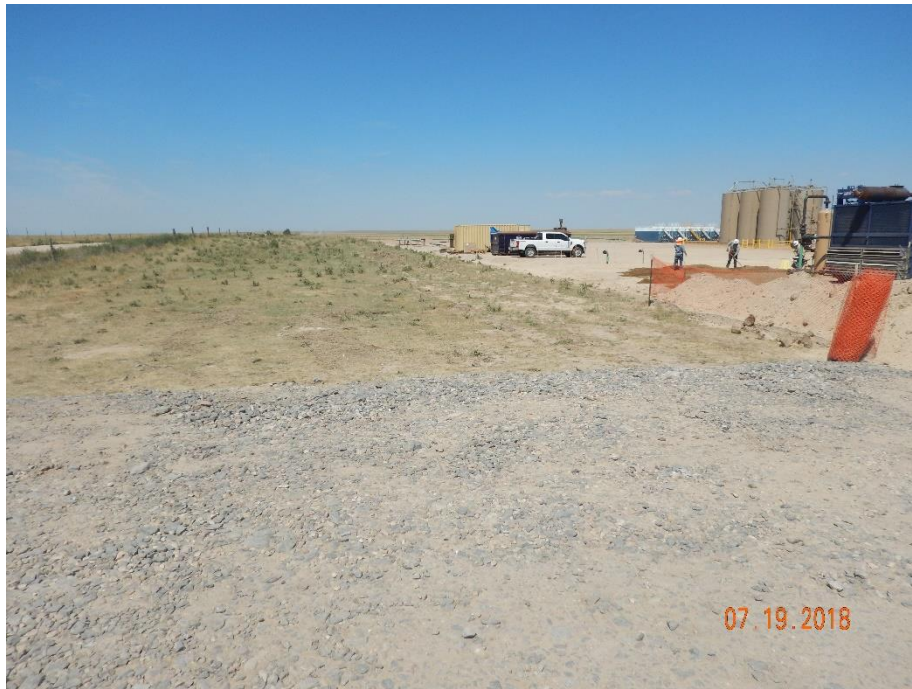
Photo 1: Photo taken from the south end of the location, facing west. Photos 1-4 provide overview of location from west, northwest, northeast to east.

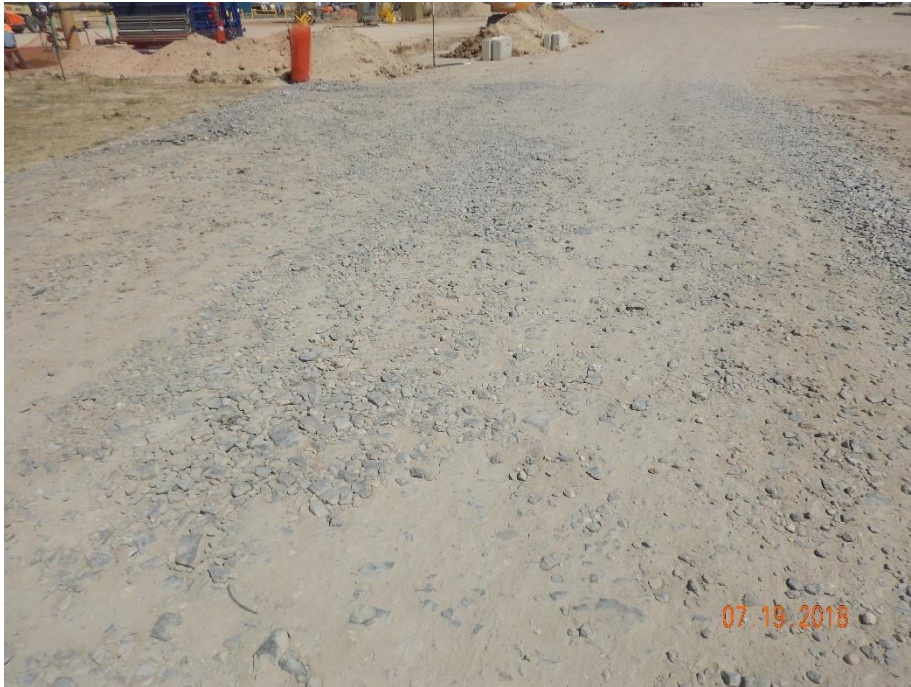
Photo 5: Photo taken from the access road. Photo shows tracking pad.

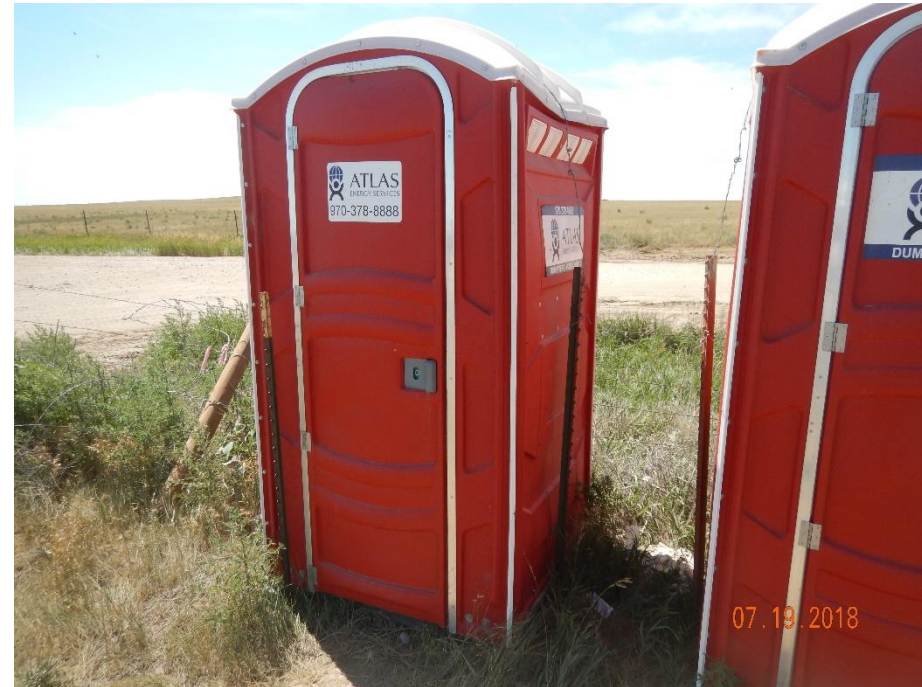
Photo 6: Photo taken from the south end of the location. Photo shows porta-johns are secured down.

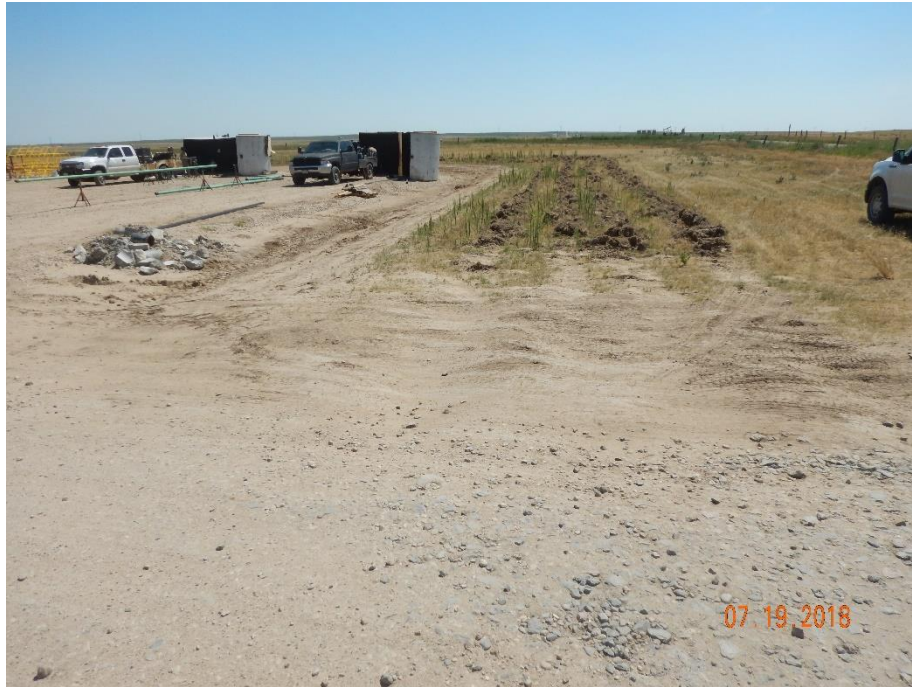
Photo 7: Photo taken from the south end of the location, facing east. Photo shows surface roughening used in conjunction with ditch along the perimeter of the location.

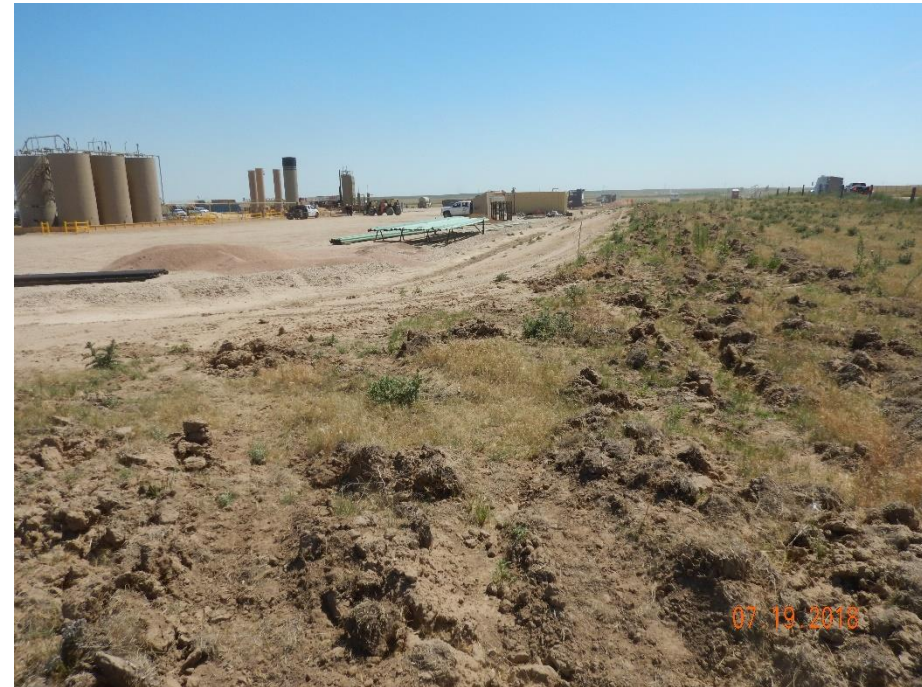
Photo 8: Photo taken from the southwest corner of the location, facing east. See comments under photo 7

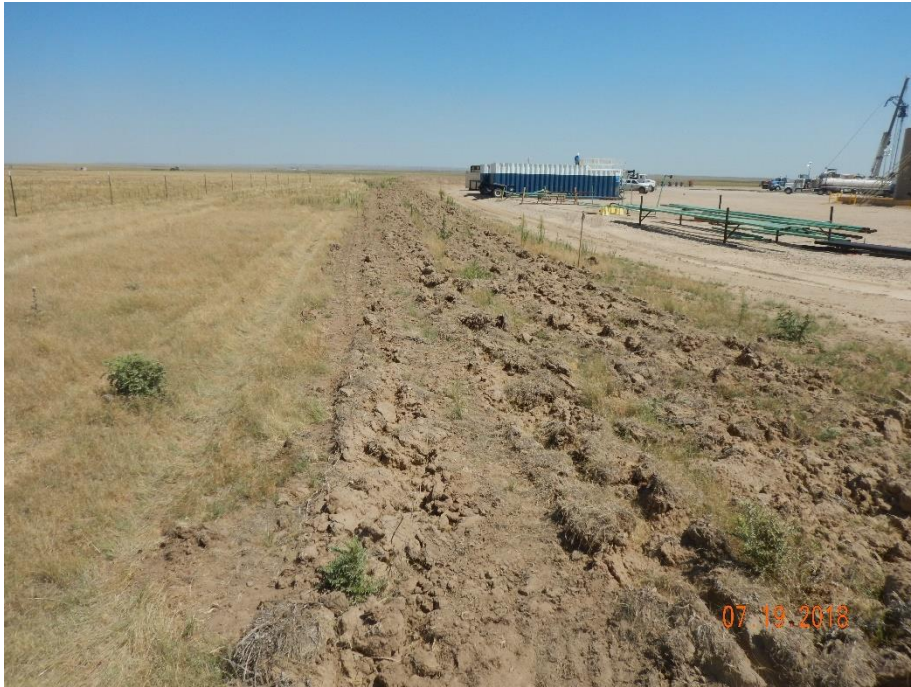
Photo 9: Photo taken from the southwest corner of the location, facing north. See comments under photo 7

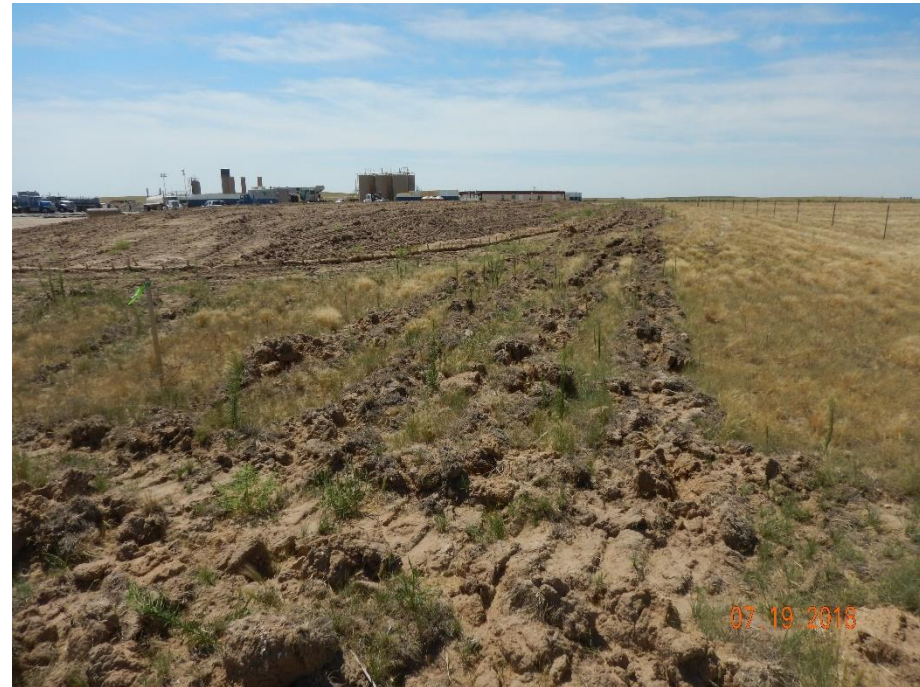
Photo 10: Photo taken from the northwest corner of the location, facing south. See comments under photo 7.

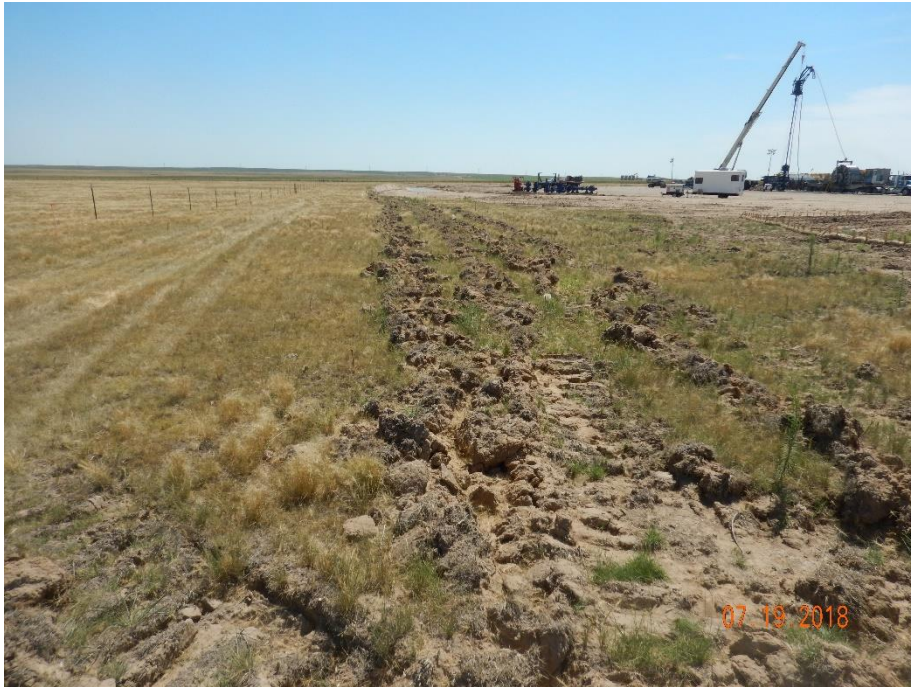
Photo 11: Photo taken from the northwest corner of the location, facing east. See comments under photo 7

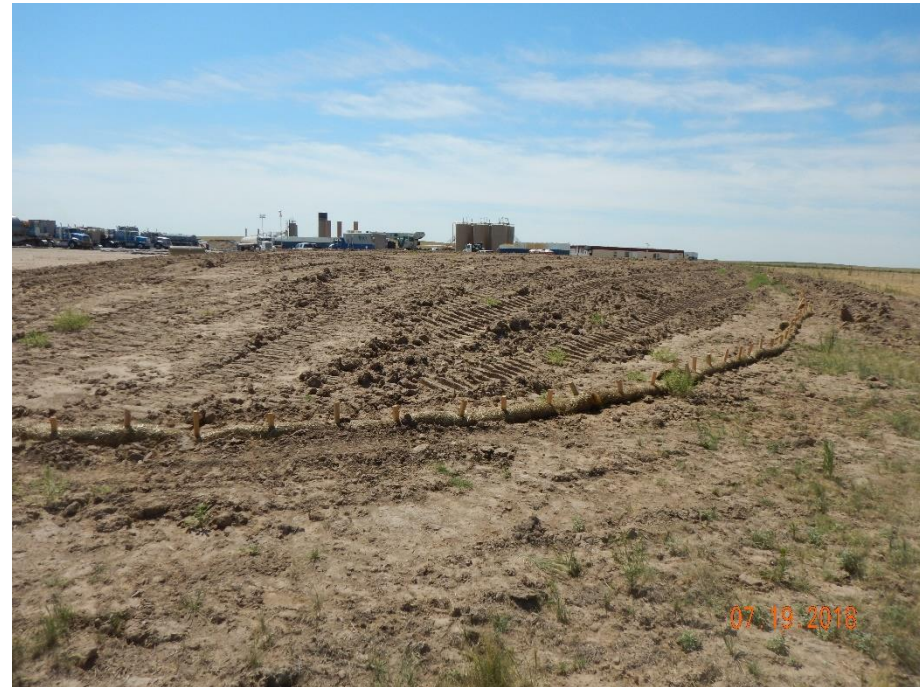
Photo 12: Photo taken from the northwest corner of the location, facing south. Photo of topsoil stockpile.

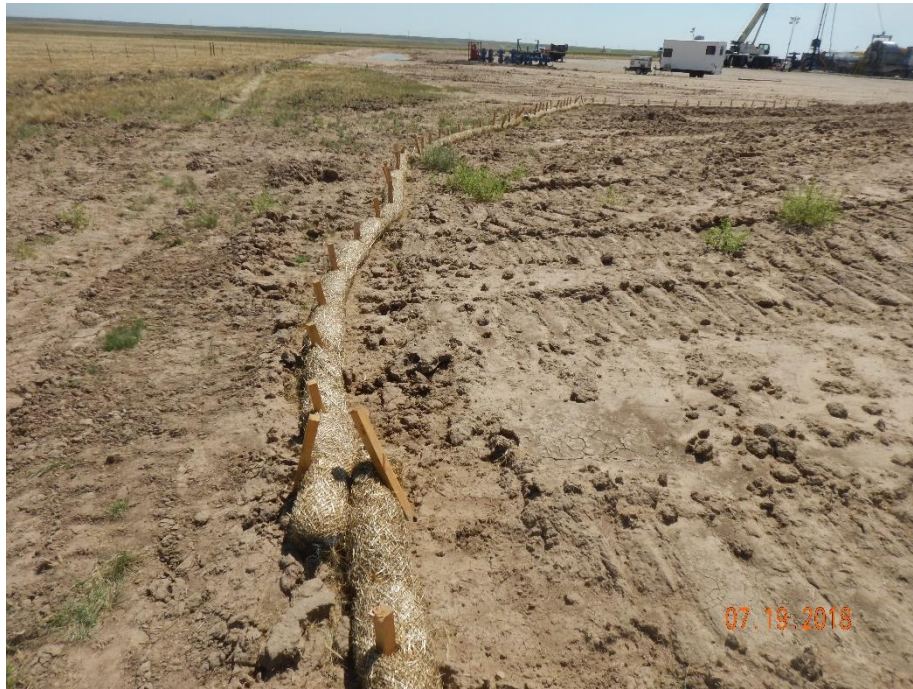
Photo 13: Photo taken from the north end of the topsoil stockpile. Photo shows straw wattle stormwater and sediment control along perimeter of the berm. Note that control has not been installed in accordance to good engineering practices; Wattles are required to be trenched and backfilled to be in proper functioning condition. Also note, the perimeter ditch runs partially on the southeast end of the berm, then travels to the northeast. Wattles appear to be the only control on the eastern/northeastern area of the stockpile. Unless appropriate measures are taken to ensure wattles are in proper functioning condition, the eastern/northeastern areas of the soil stockpile are at risk to sediment runoff and degradation.

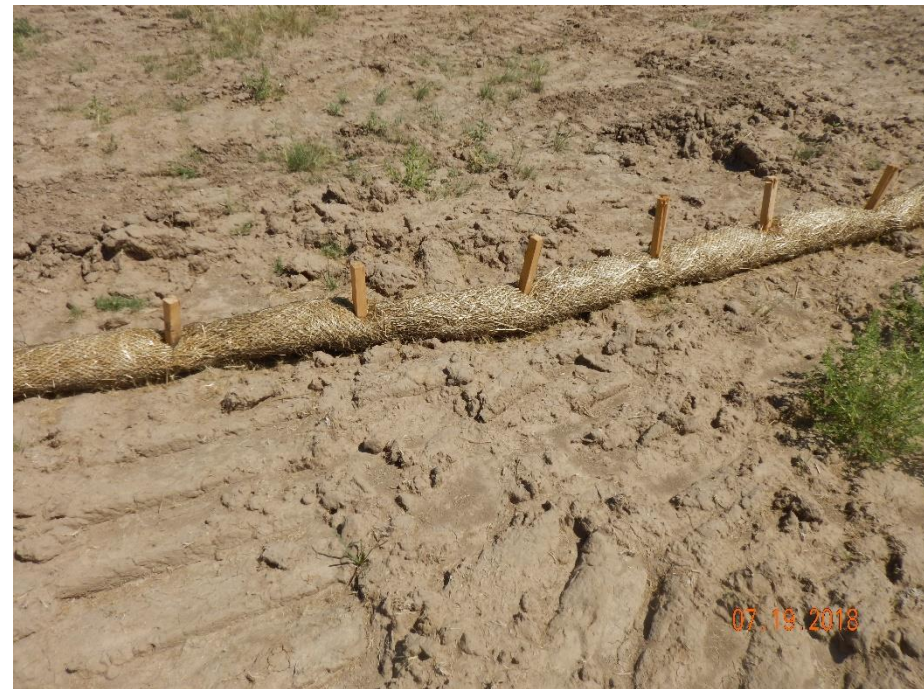
Photo 14: See comments under photo 13.

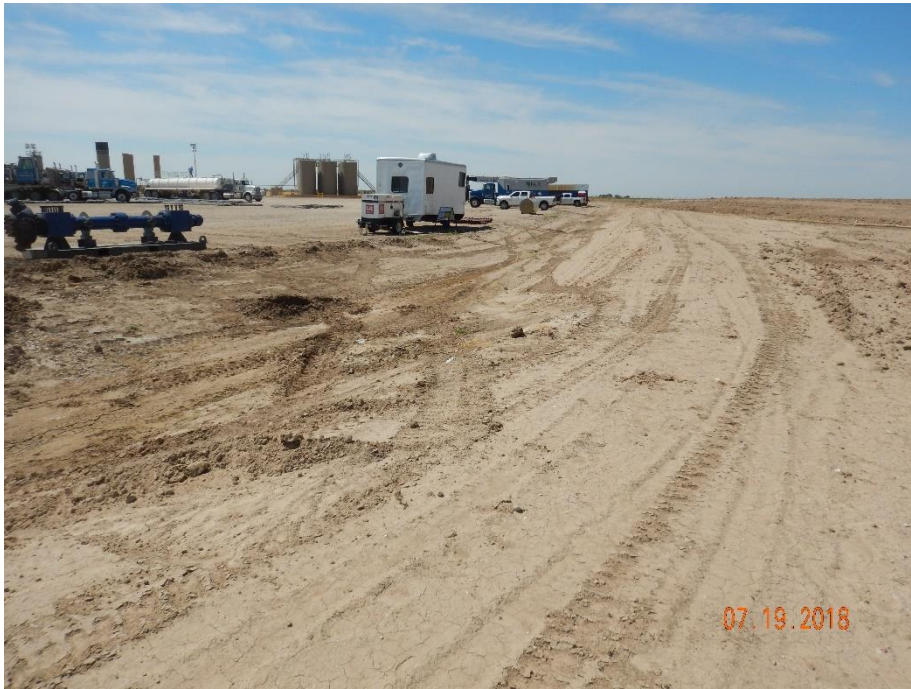
Photo 15: Photo taken from the North end of the location, facing south. Photo of perimeter stormwater ditch.

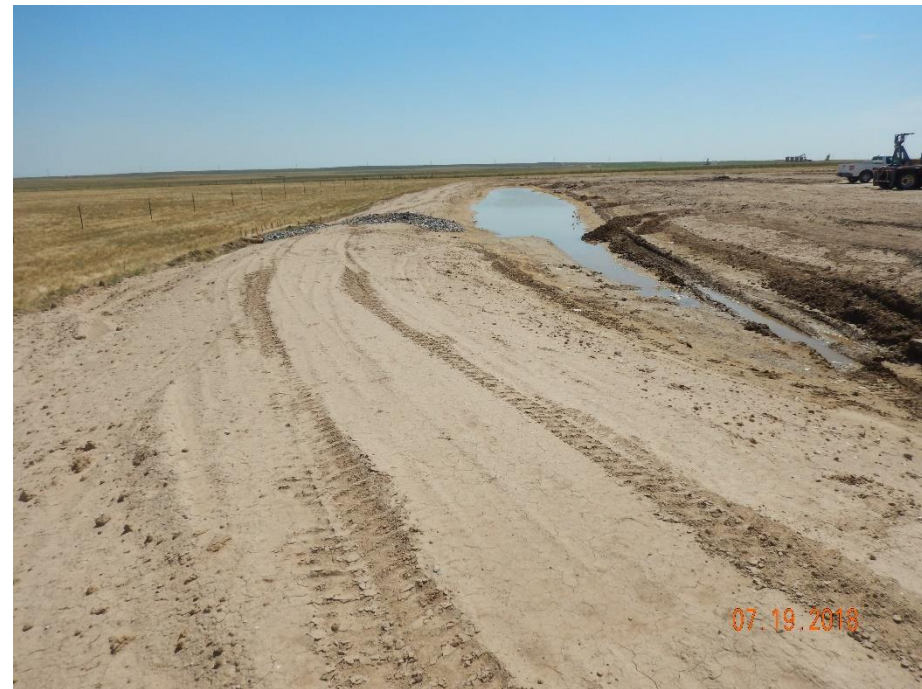
Photo 16: Photo taken from the North end of the location, facing south. Photo of sediment pond connected to the perimeter stormwater ditch.

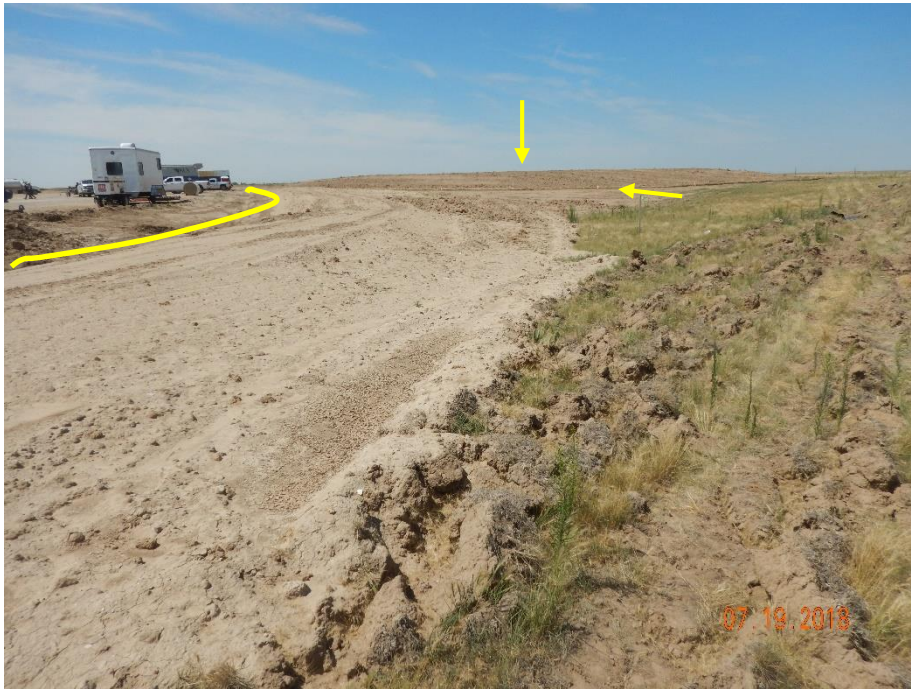
Photo 17: Photo taken from the north end of the locaiton, facing southwest photo shows perimeter stormwater ditch, soil stockpile and wattle BMPs. See comments under photo 13.

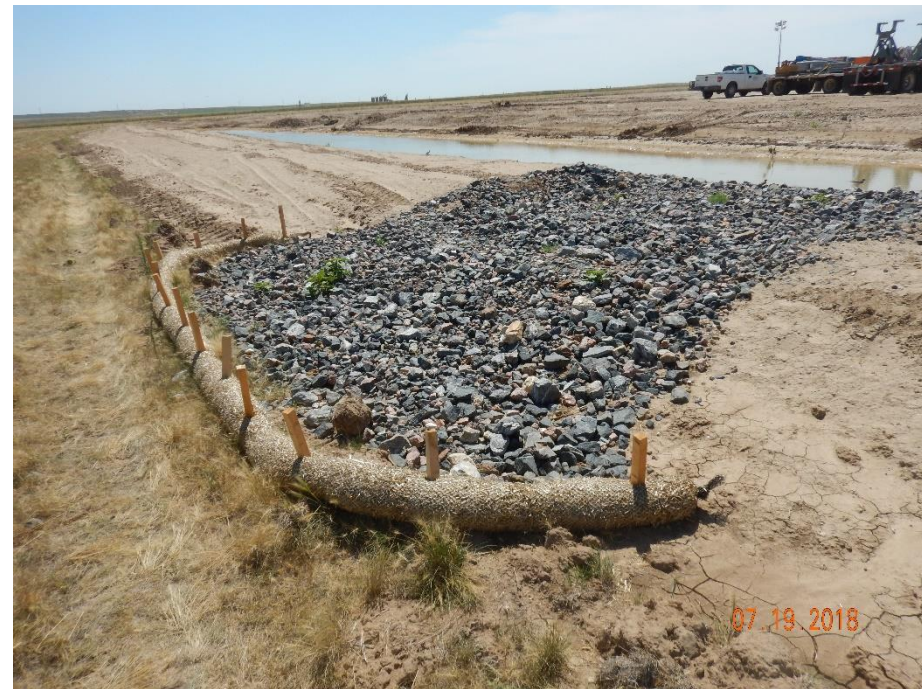
Photo 18: Photo taken from the south end of the sediment pond, facing east. Photo shows outlet appears to have sufficient outlet protections/armoring.

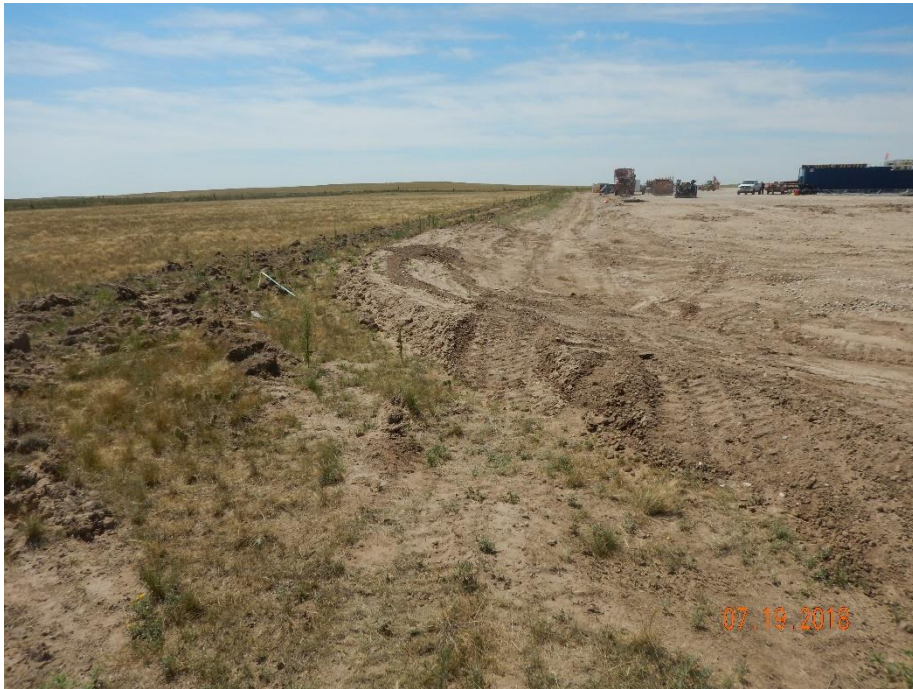
Photo 19: Photo taken from the northeast end of the location, facing south. See comments under photo 7

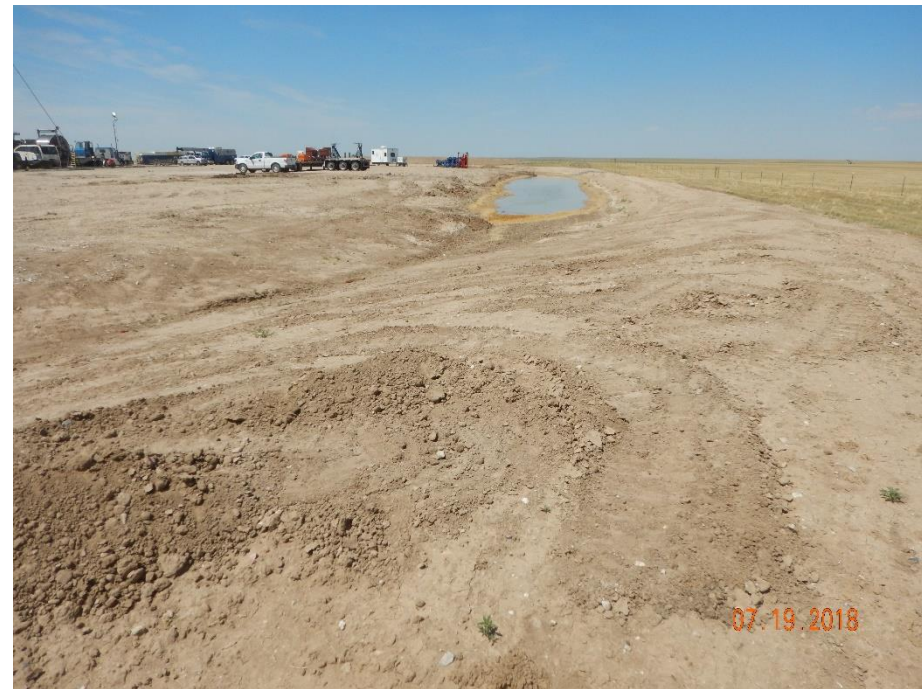
Photo 20: Photo taken from the northeast end of the location, facing west. See comments under photo 7

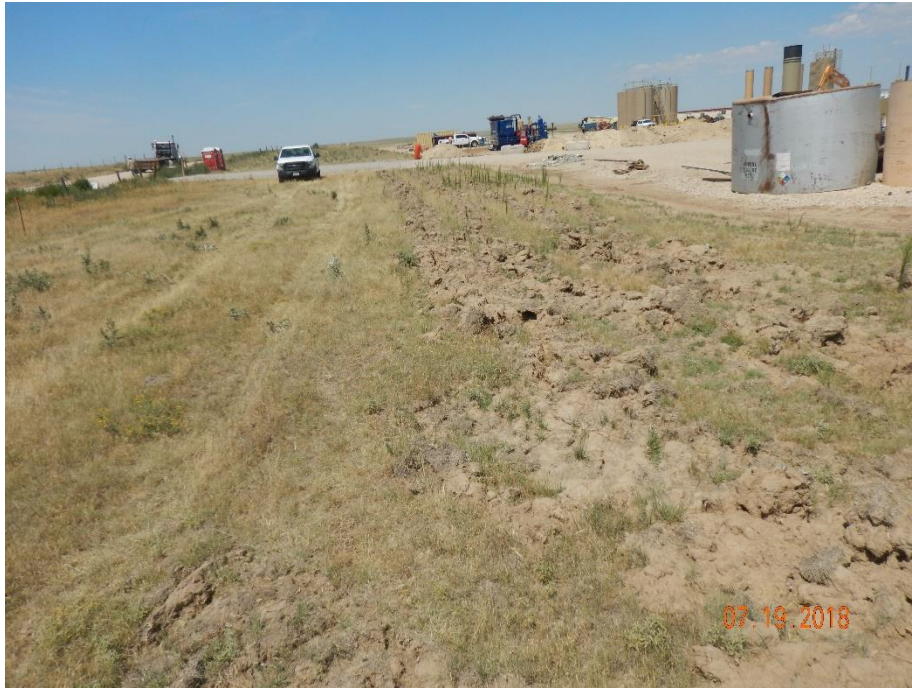
Photo 21: Photo taken from the southeast end of the location, facing west. See comments under photo 7

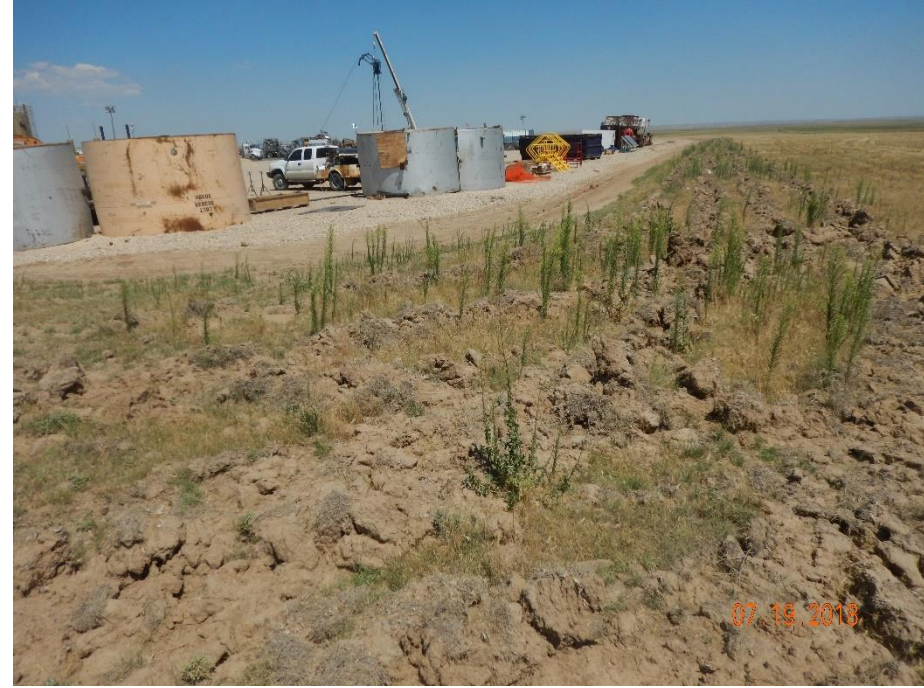
Photo 22: Photo taken from the southeast end of the location, facing North. See comments under photo 7
