Inspection Photos

Operator: RED HAWK PETROLEUM LLC - 10503

Location ID: 438327

Inspection Doc. Number: 682503634

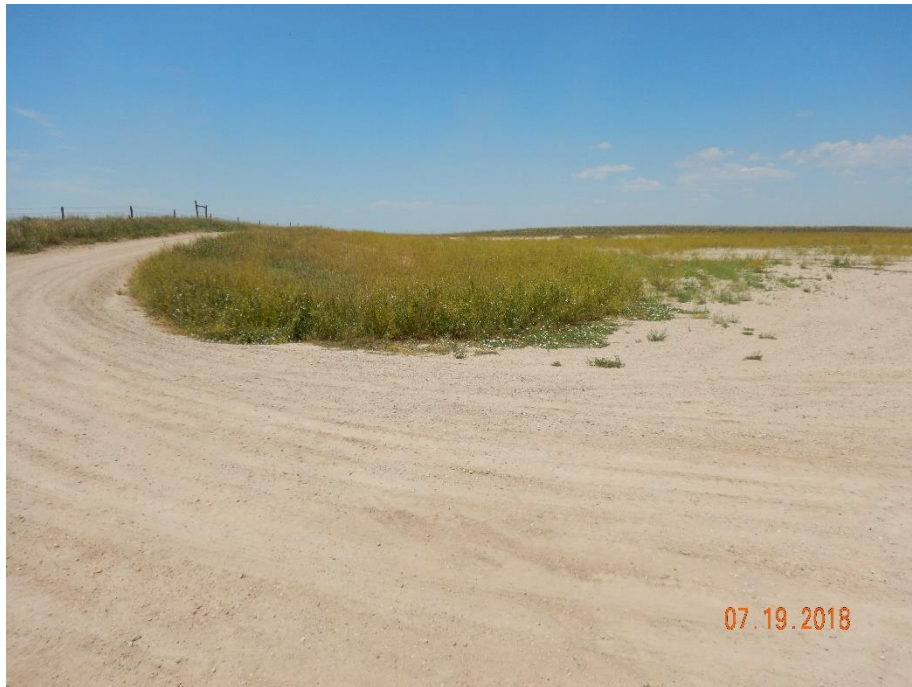
Photo 1: Photo taken from the access road, on the south end of the location, facing west. Photos 1-4 provide an overview of the location from west, northwest, northeast, to east.

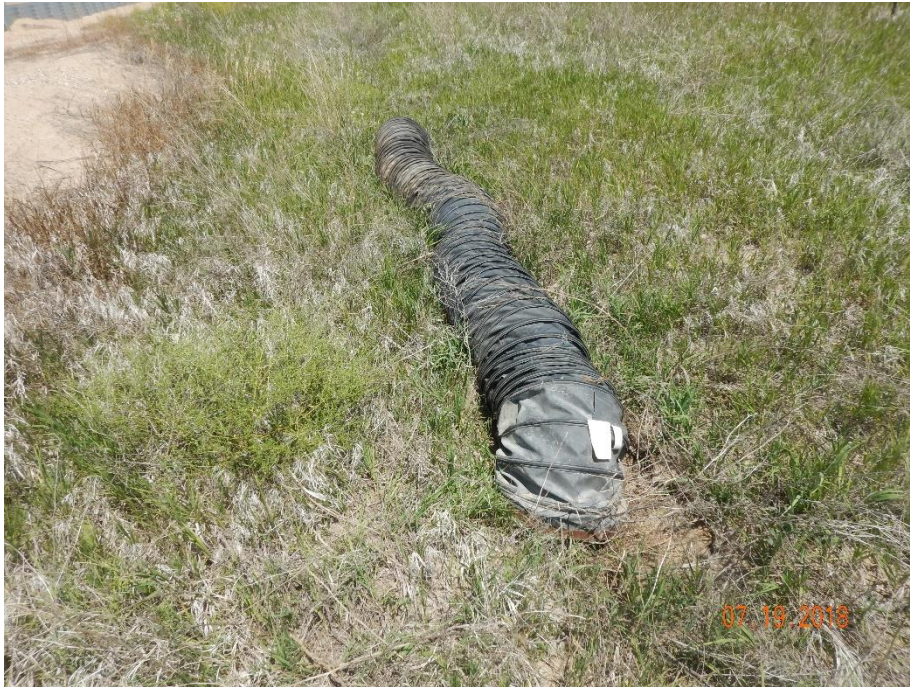
Photo 5: Photo taken from the ditch on the east end of the location. Photo of equipment/trash debris that needs to be removed and properly stored or disposed.

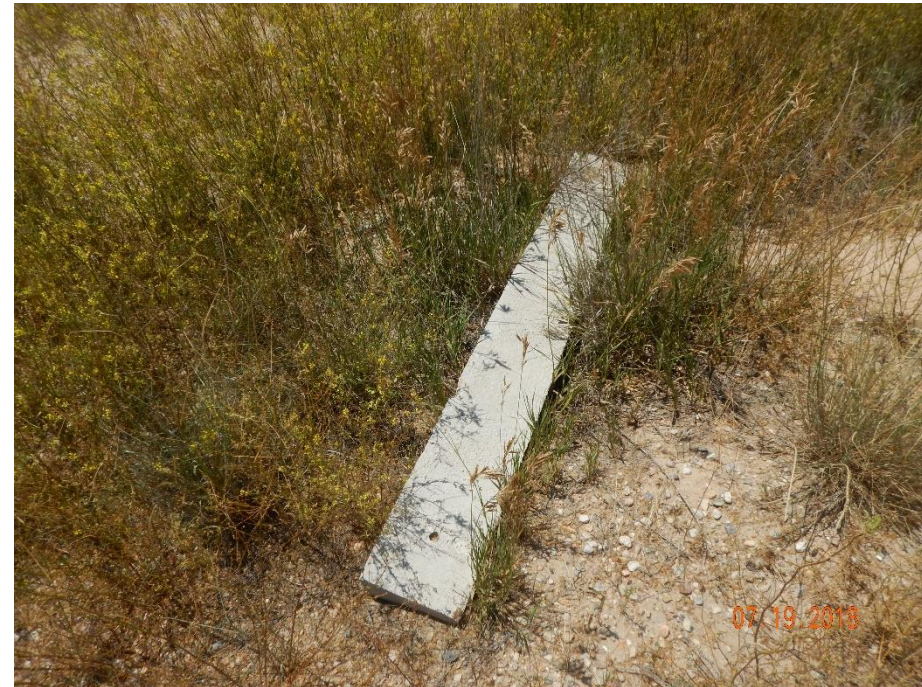
Photo 6: Photo taken from the south end of the location. Photo of equipment/trash debris that needs to be removed and properly stored or disposed.

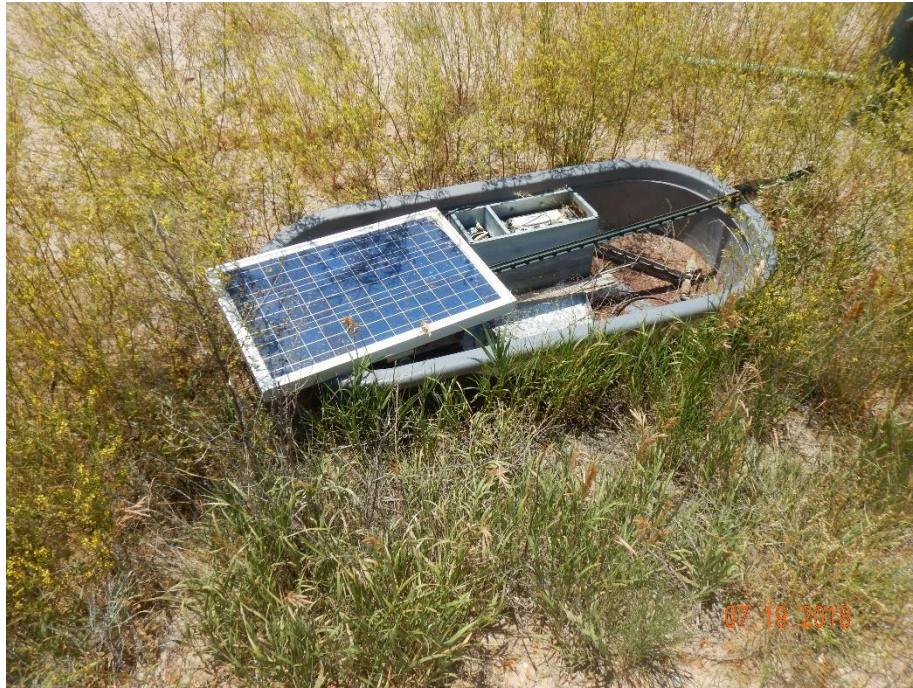
Photo 7: Photo taken from the south end of the location. Photo of equipment/trash debris that needs to be removed and properly stored or disposed.

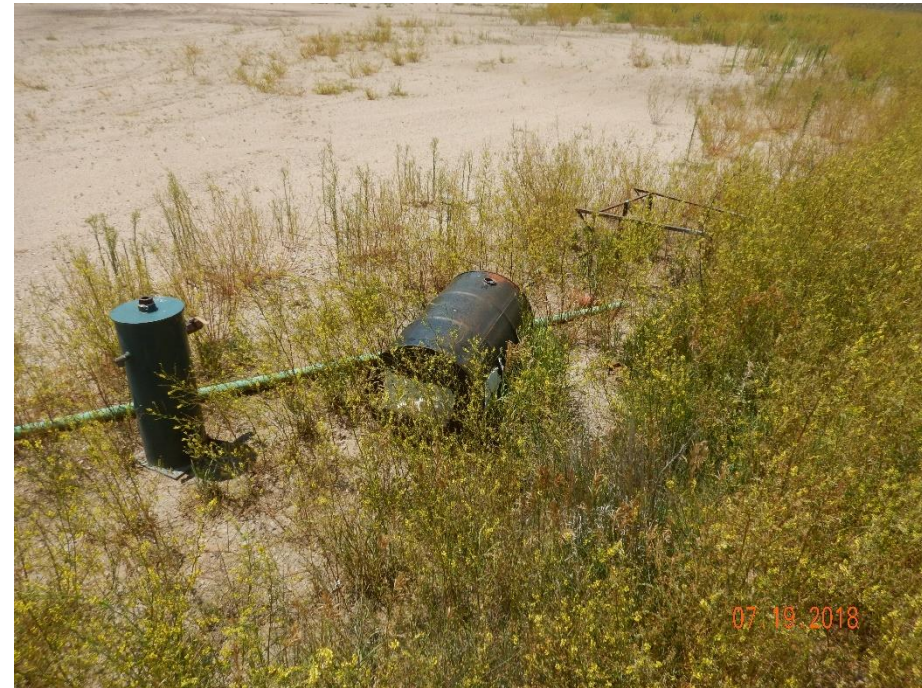
Photo 8: Photo taken from the south end of the location. Photo of equipment/trash debris that needs to be removed and properly stored or disposed.

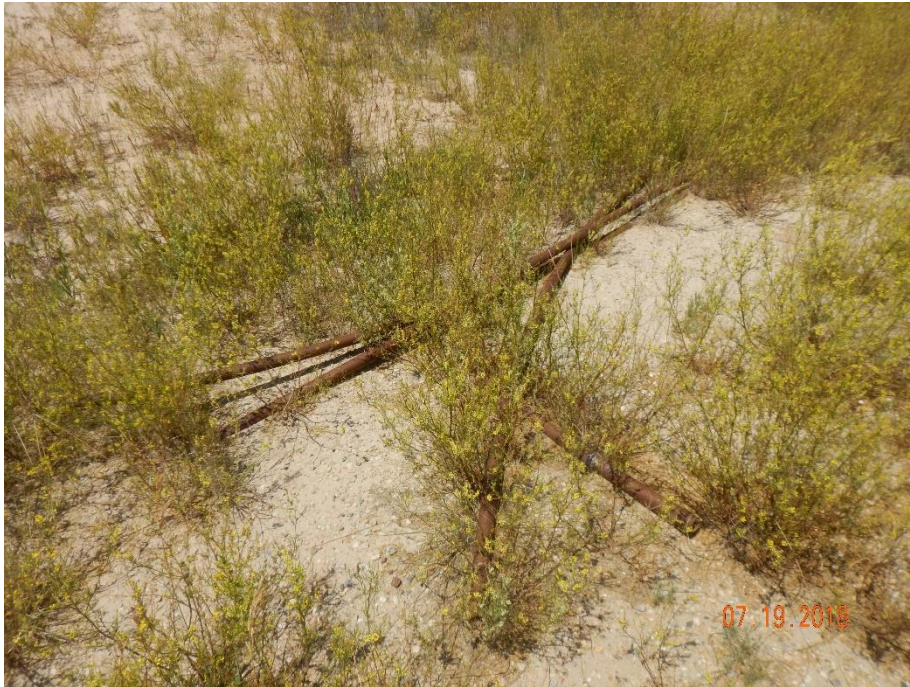
Photo 9: Photo taken from the west end of the location. Photo of equipment/trash debris that needs to be removed and properly stored or disposed.

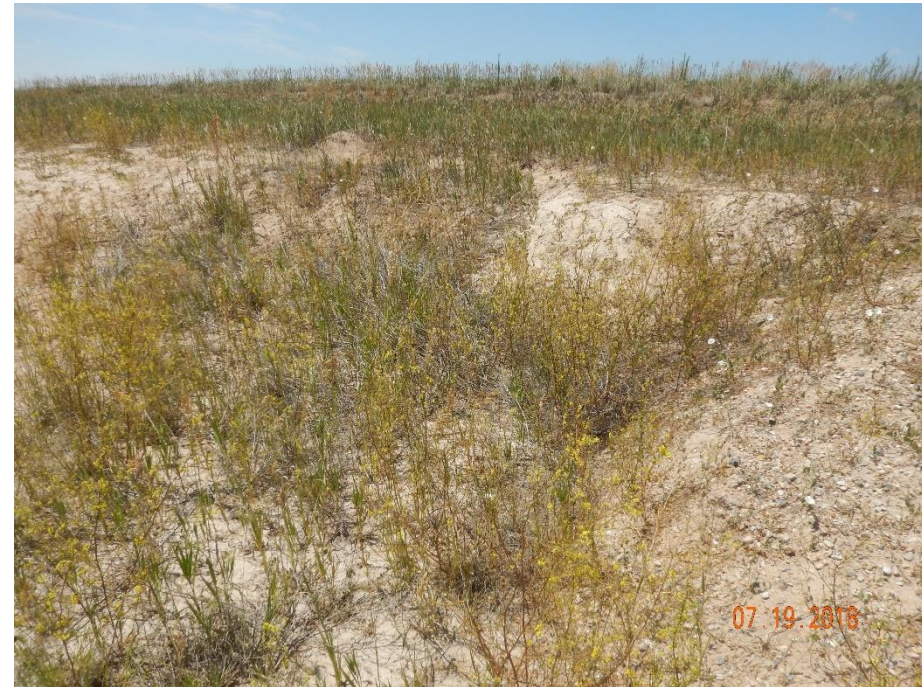
Photo 10: Photo taken from the west end of the location. Photo shows erosion degradation on the slopes. These concerns will be mitigated during interim reclamation.

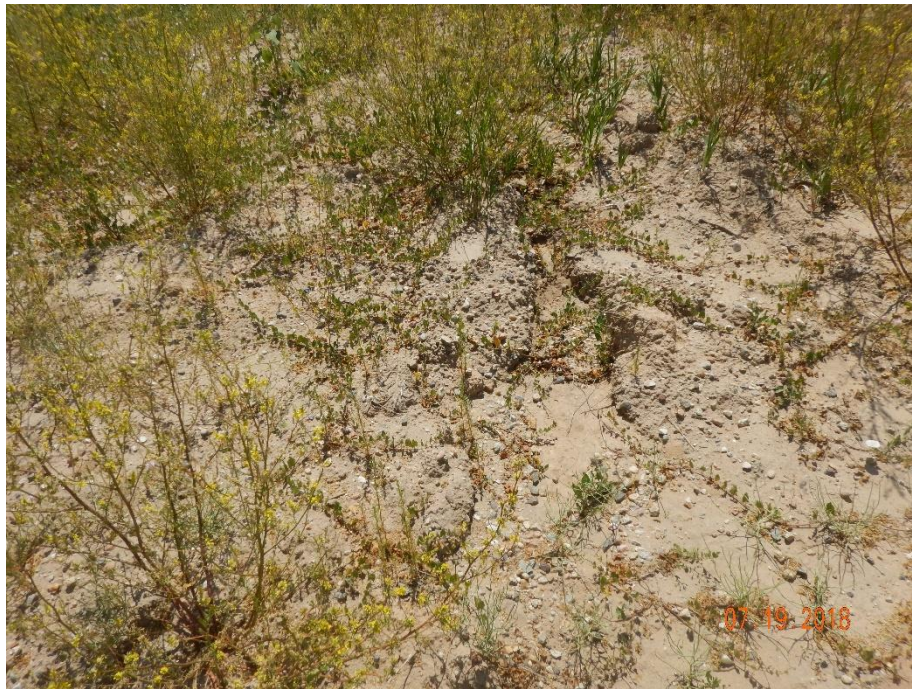
Photo 11: Photo taken from the south end of the location. Photo shows erosion degradation on the slopes. These concerns will be mitigated during interim reclamation.

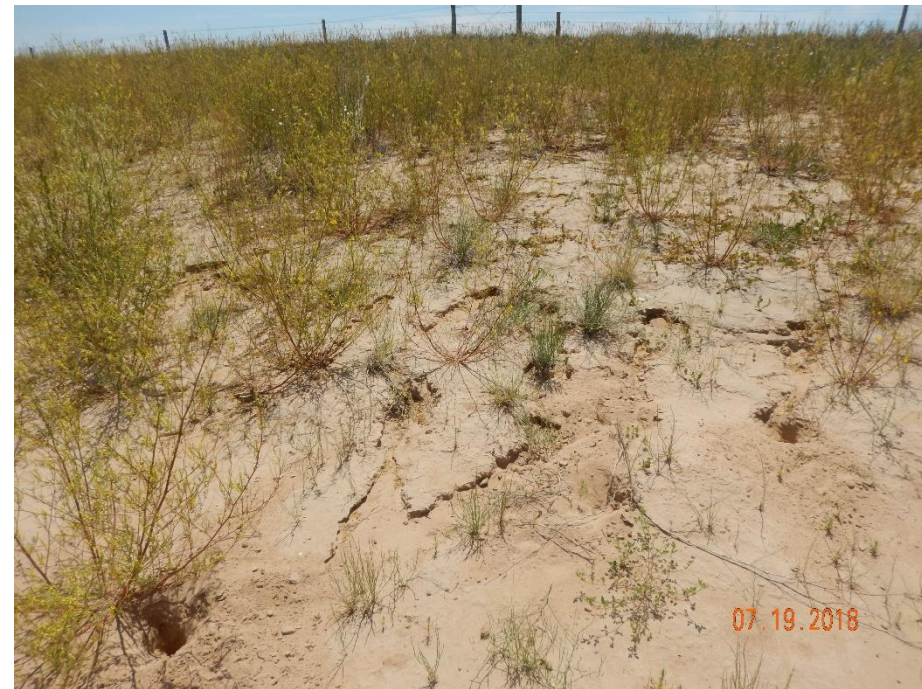
Photo 12: Photo taken from the south end of the location. Photo shows erosion degradation on the slopes. These concerns will be mitigated during interim reclamation.

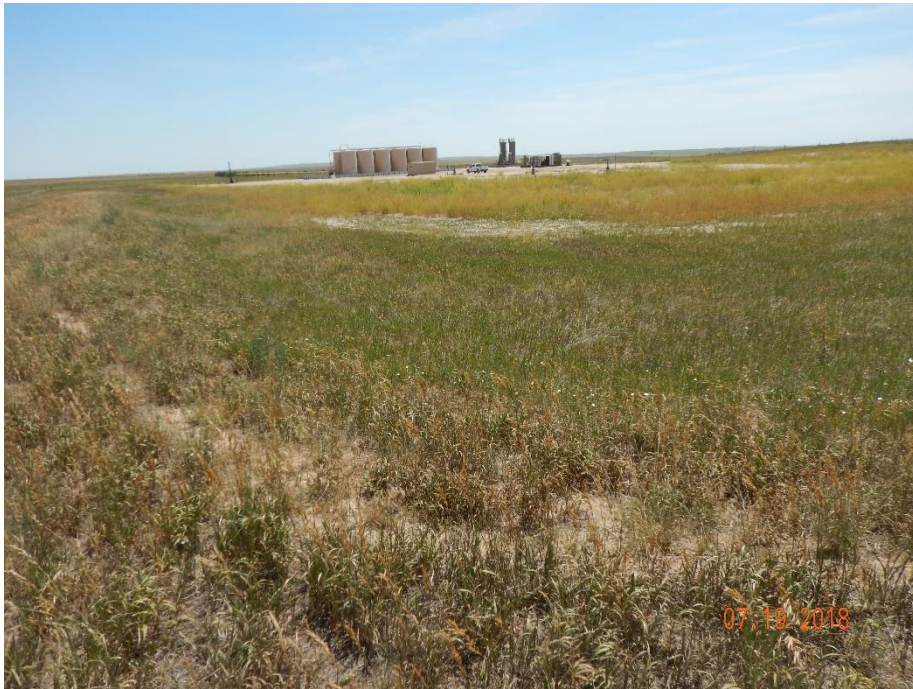
Photo 13: Photo taken from the topsoil berm on the northwest corner of the location, facing southeast. Photo shows areas on the west end of the location that do not appear to be necessary for production operations. These areas need to be reclaimed in accordance to COGCC 1003 interim reclamation requirements.

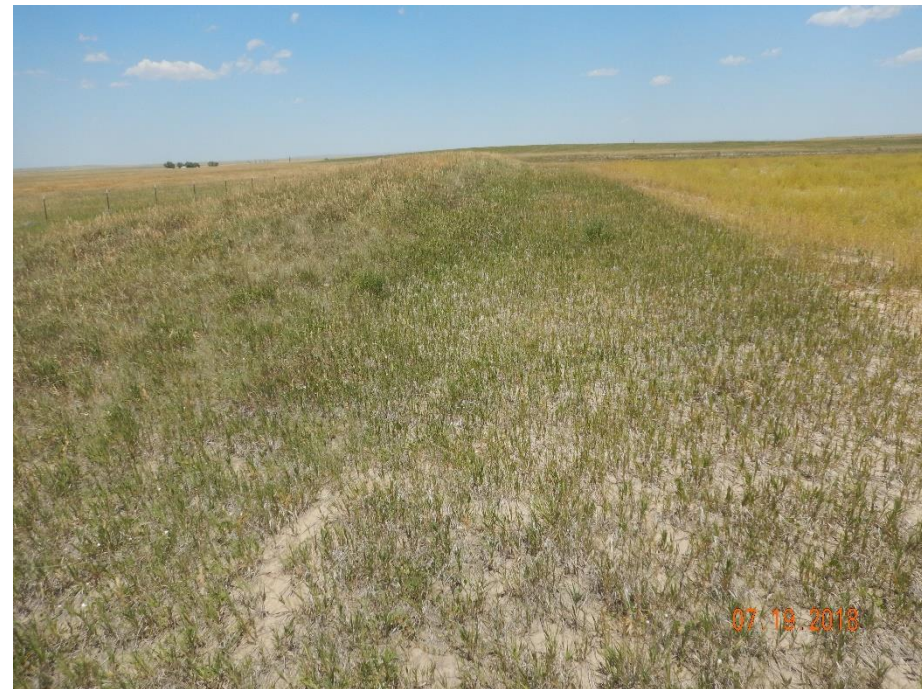
Photo 14: Photo taken from the topsoil berm on the southwest corner of the location, facing north. Photo of topsoil berm. Photo also shows areas on the west end of the location that do not appear to be necessary for production operations.

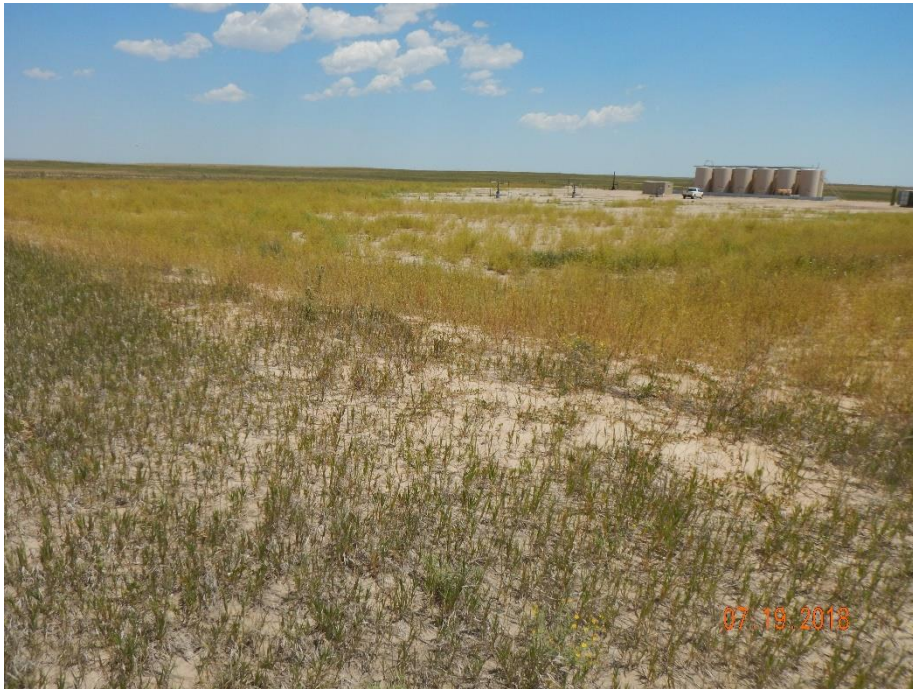
Photo 15: Photo taken from the topsoil berm on the southwest corner of the location, facing northeast. Photo shows areas on the west end of the location that do not appear to be necessary for production operations. These areas need to be reclaimed in accordance to COGCC 1003 interim reclamation requirements.

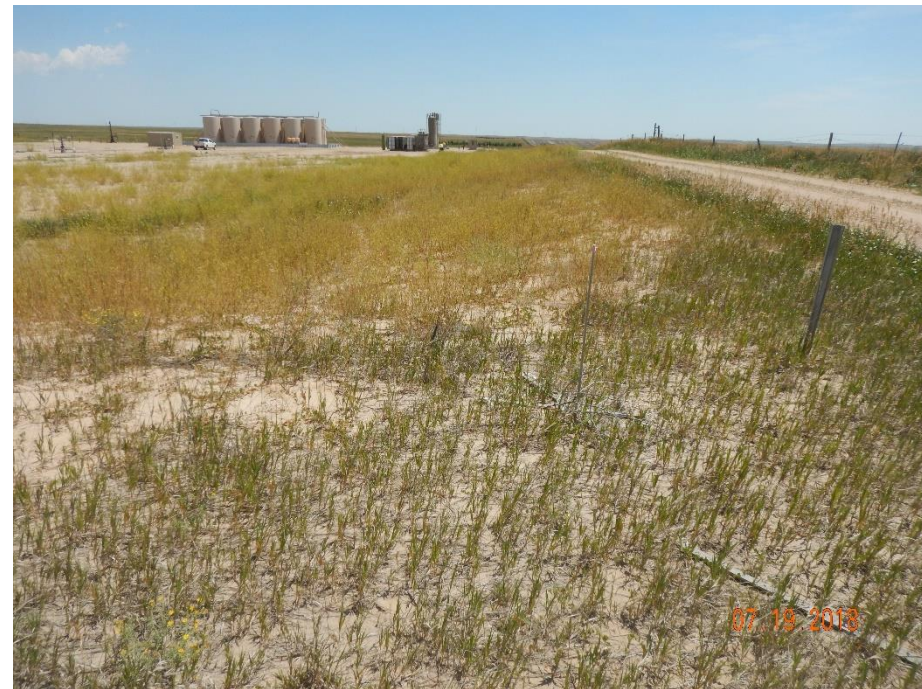
Photo 16: Photo taken from the topsoil berm on the southwest corner of the location, facing east. Photo shows areas on the west end of the location that do not appear to be necessary for production operations. These areas need to be reclaimed in accordance to COGCC 1003 interim reclamation requirements.

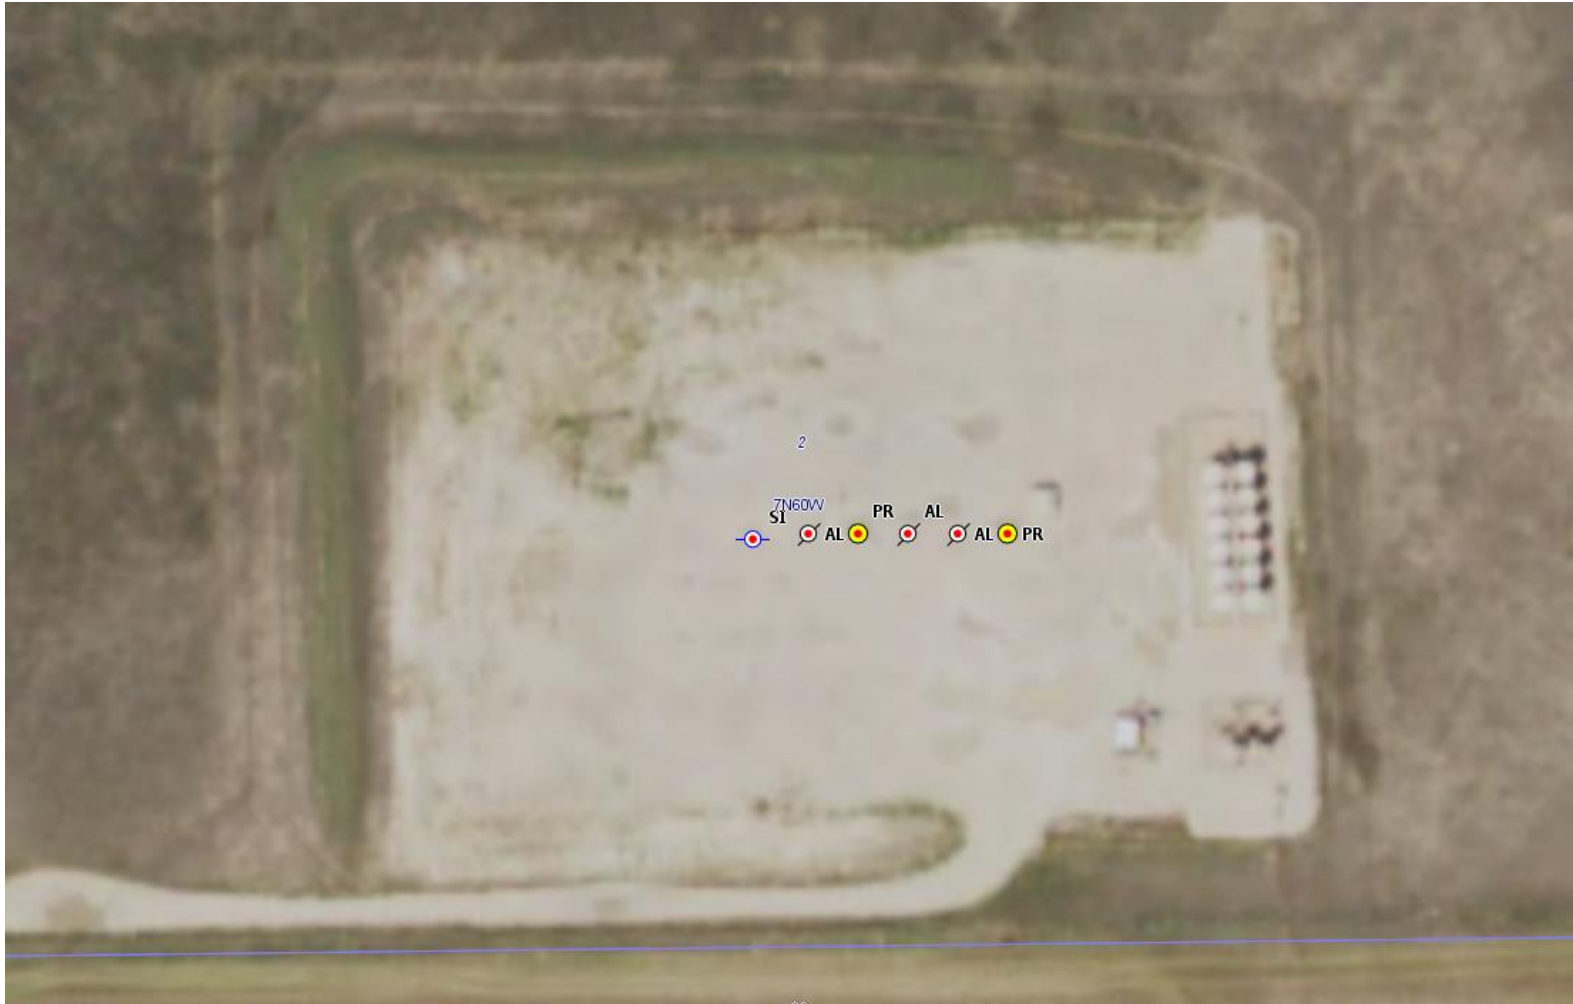
Photo 17: 2017 COGIS aerial imagery. Photo shows areas on the west end of the location that do not appear to be necessary for production operations. These areas need to be reclaimed in accordance to COGCC 1003 interim reclamation requirements.
