Inspection Photos  
Location Name: UPRR 43 PAN AM I 29  
Facility ID: 242097

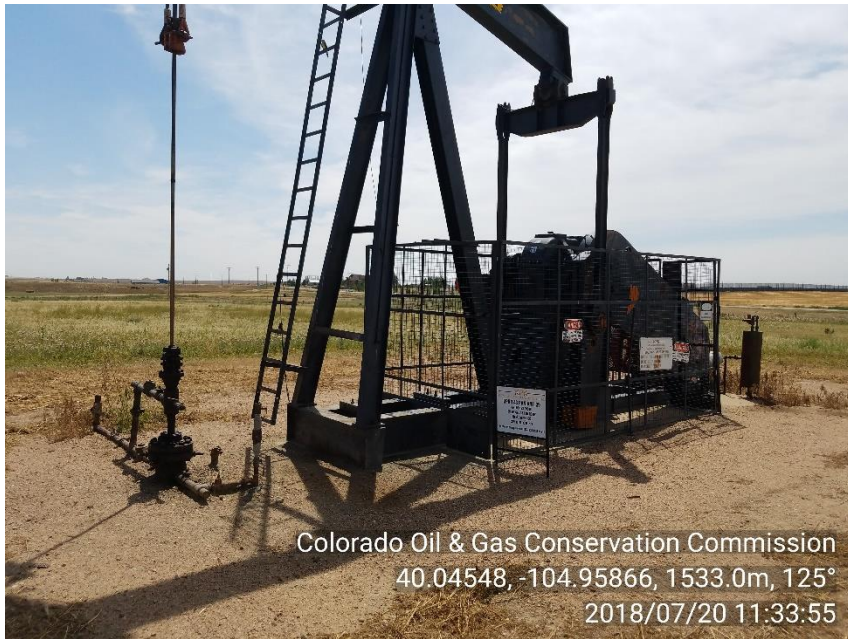
Photo 1. Wellhead

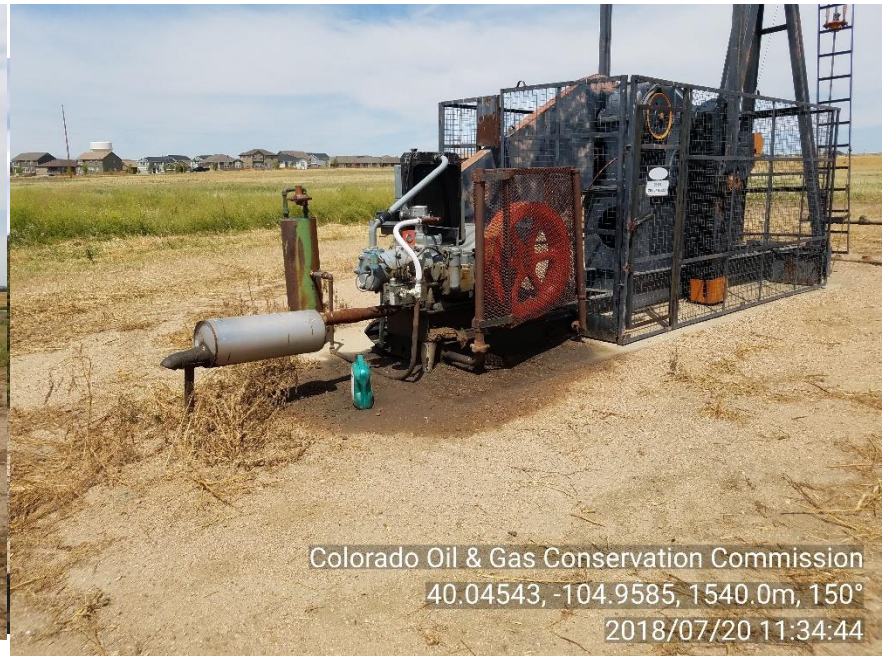
Photo 2. Stained soil near pump jack prime mover
