**Inspection Photos**  
**Location Name: Joker / 36-9-62**  
**Location #: 417683**

Joker 36-9-62 (API # 05-123-31719) wellhead

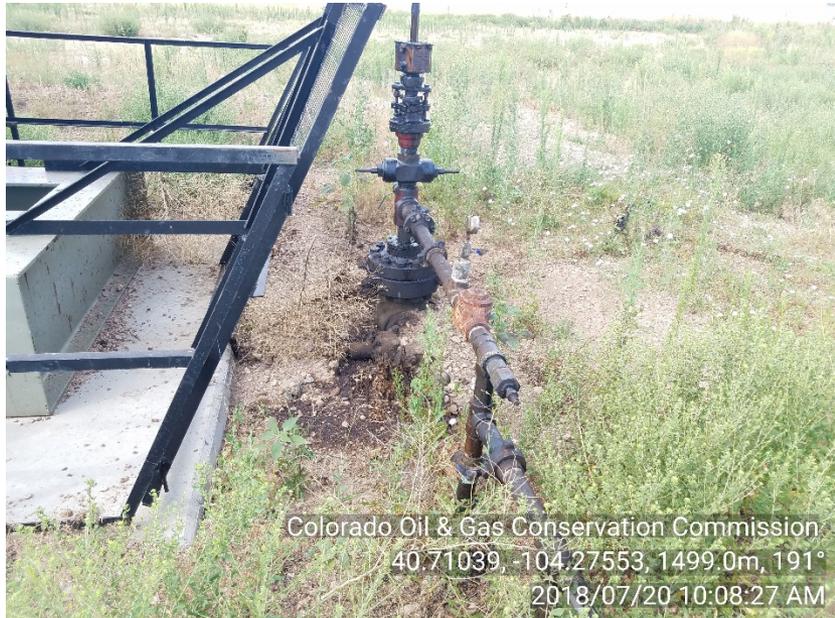
**Photo #1**

**Stained soil, weeds**

**Bradenhead not plumbed to surface**

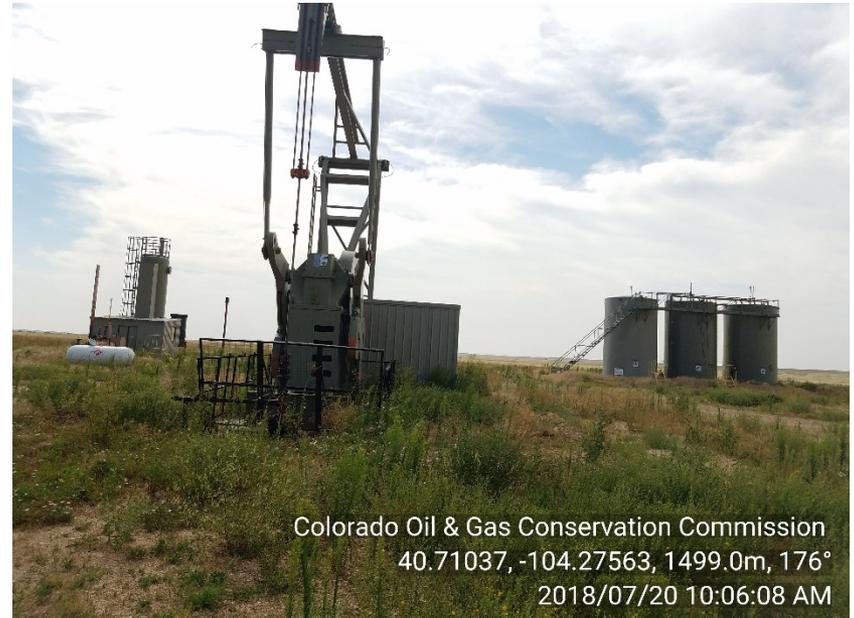
**Photo #2**

Joker 36-9-62 (API # 05-123-31719) Battery & Well

**Weeds**

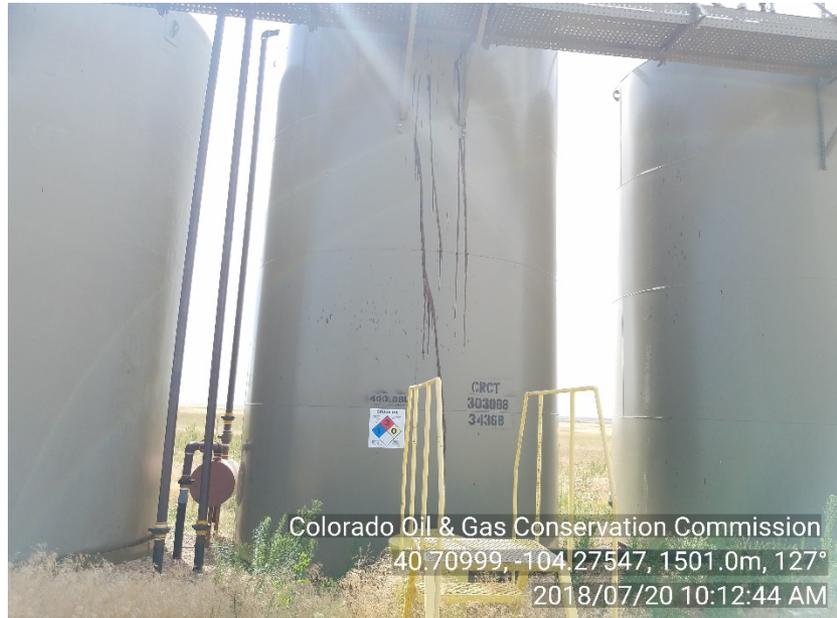
**Photo #3**

Joker 36-9-62 (API # 05-123-31719) Oil & H2O tanks

**Stain on middle tank**

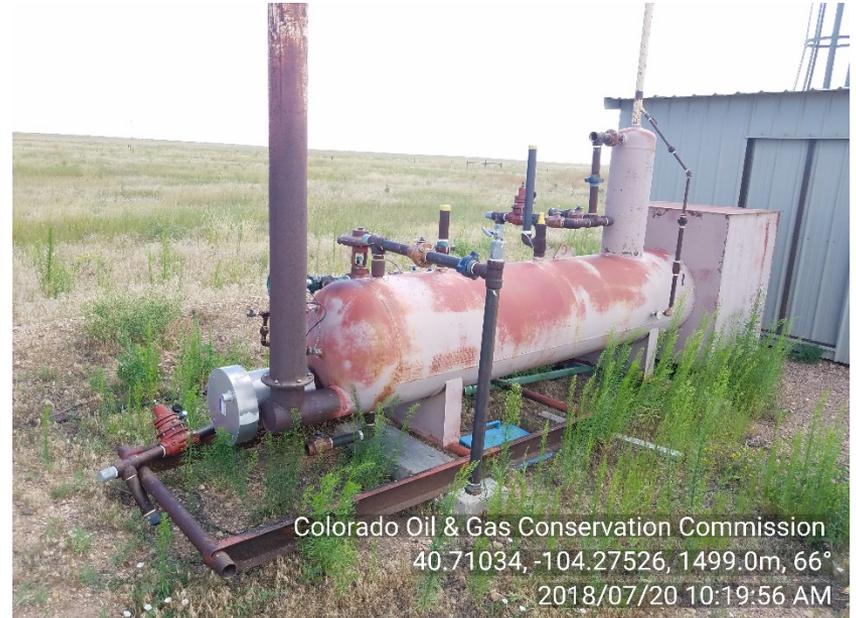
**Photo #4**

**Unused equipment, weeds**

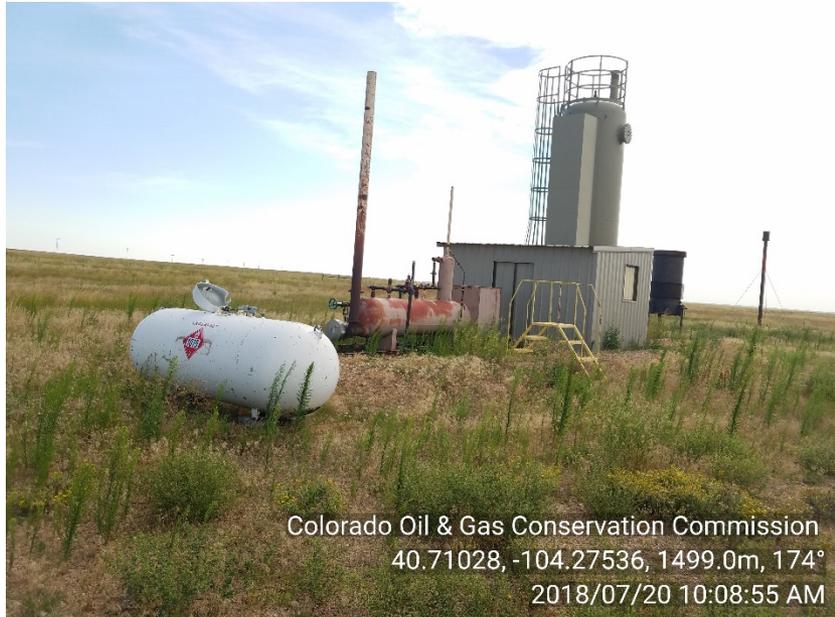
**Photo #5**

Joker 36-9-62 (API # 05-123-31719) Propane tank,  
Treater & Separator

**Weeds**

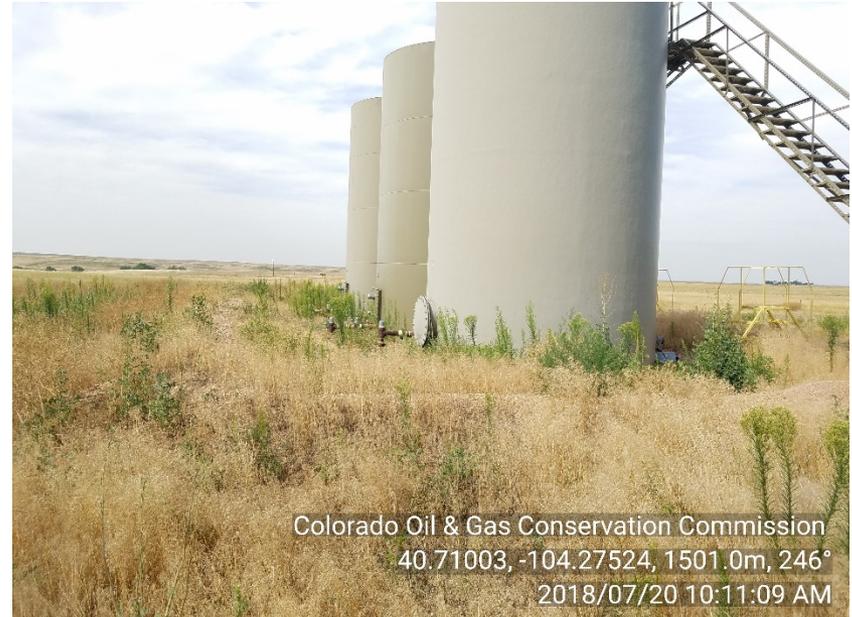
**Photo #6**

Joker 36-9-62 (API # 05-123-31719) Oil & H2O tanks

**Weeds**

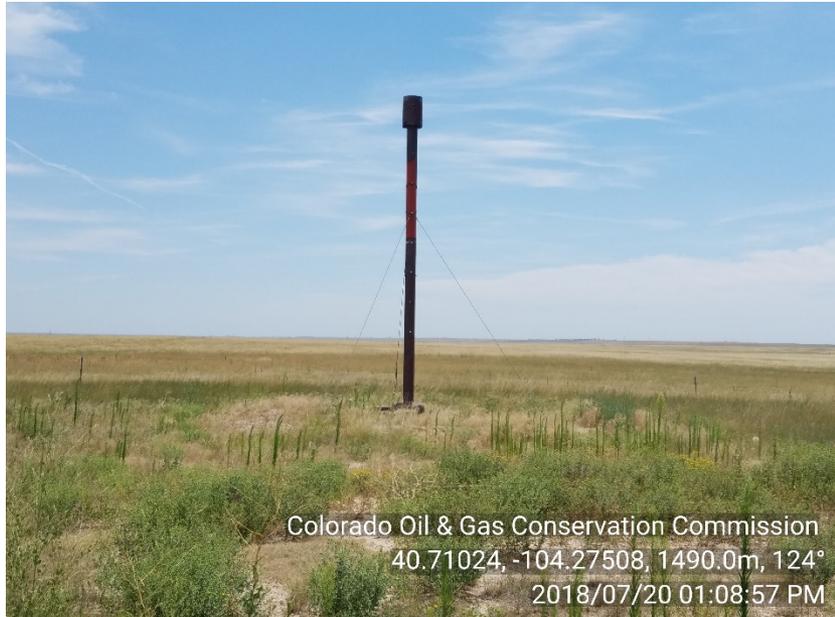
**Photo #7**

Joker 36-9-62 (API # 05-123-31719)  
Candlestick Flare

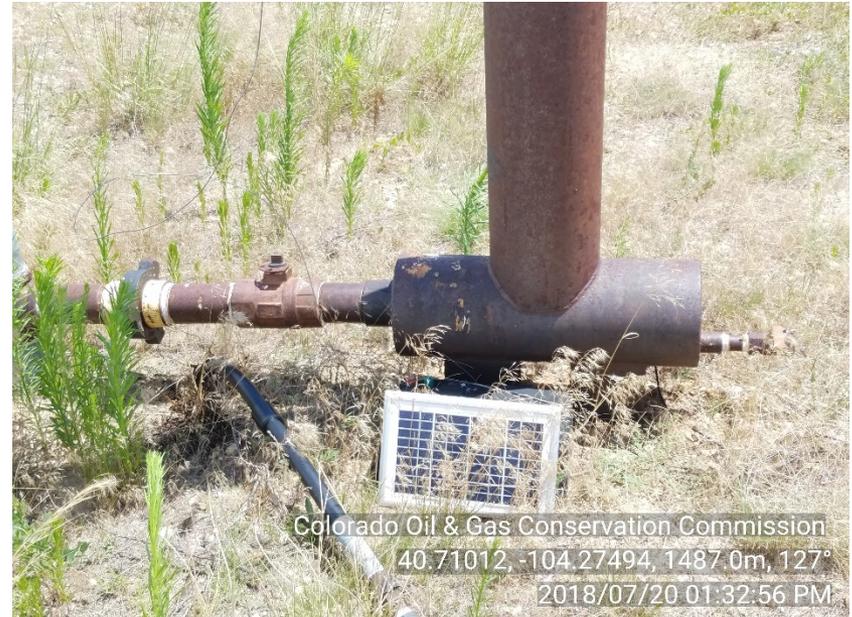
**Photo #8**

Joker 36-9-62 (API # 05-123-31719)  
Candlestick Flare battery

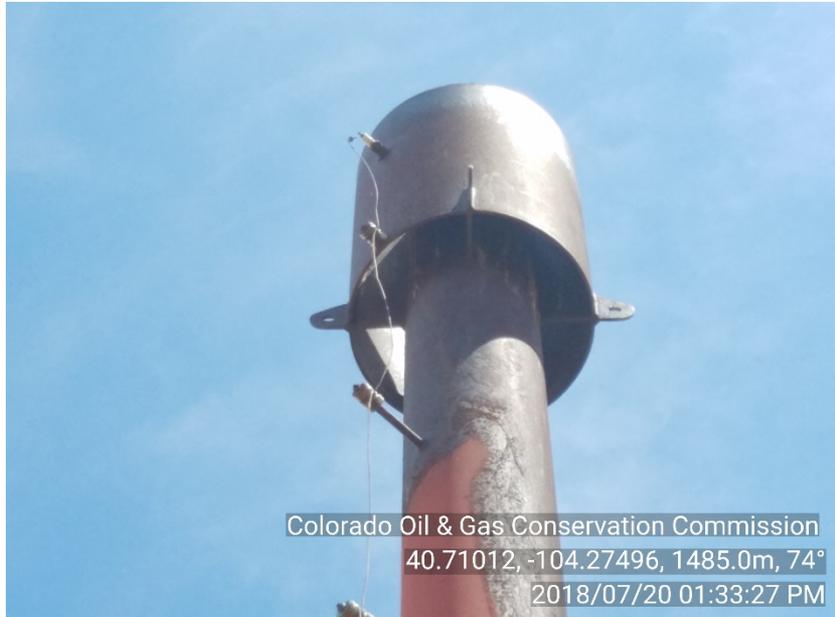
**Photo #9**

Candlestick Flare

**Unhooked spark plug**

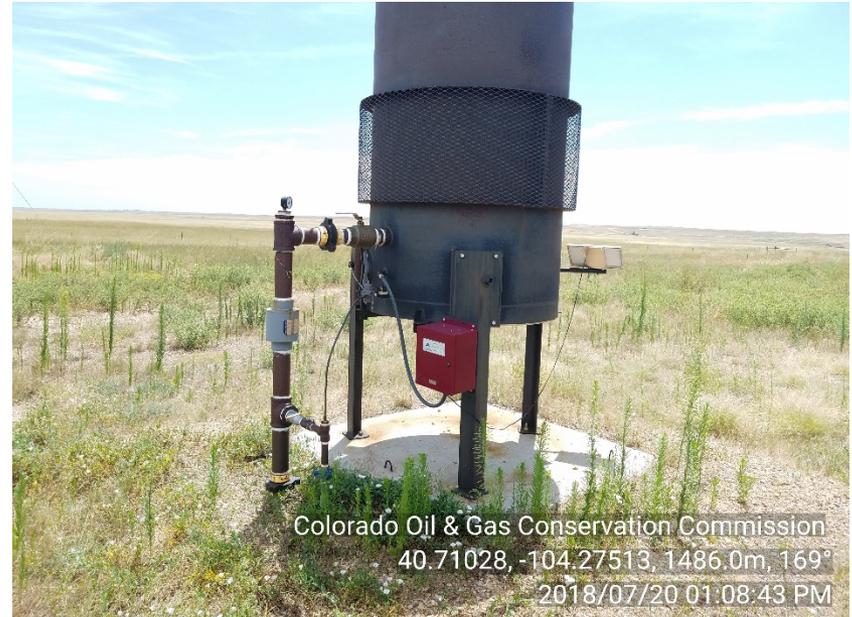
**Photo #10**

Joker 36-9-62 (API # 05-123-31719) ECD

**Inlet valve is shut. Not in operation**

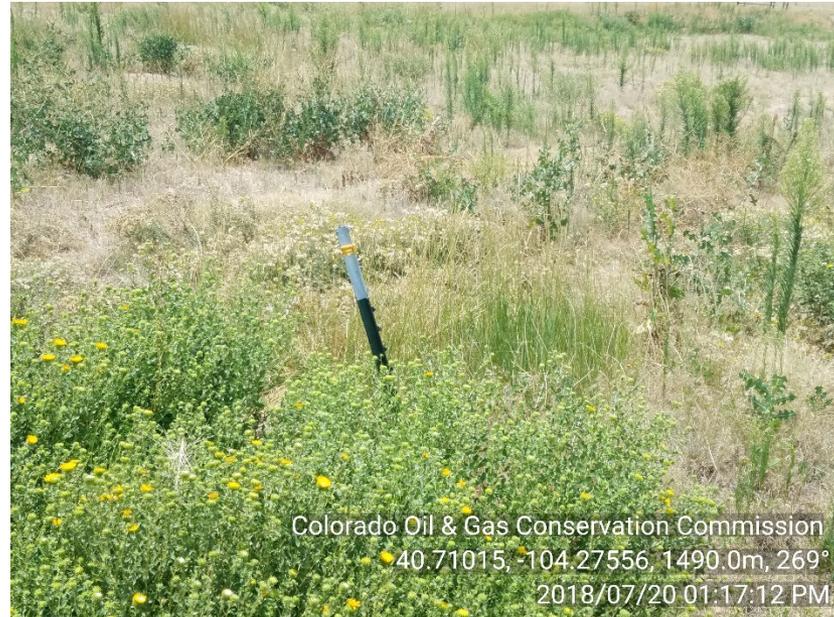
**Photo #11**  
Joker 36-9-62 (API # 05-123-31719)  
**Anchors / Markers - Visibility**
