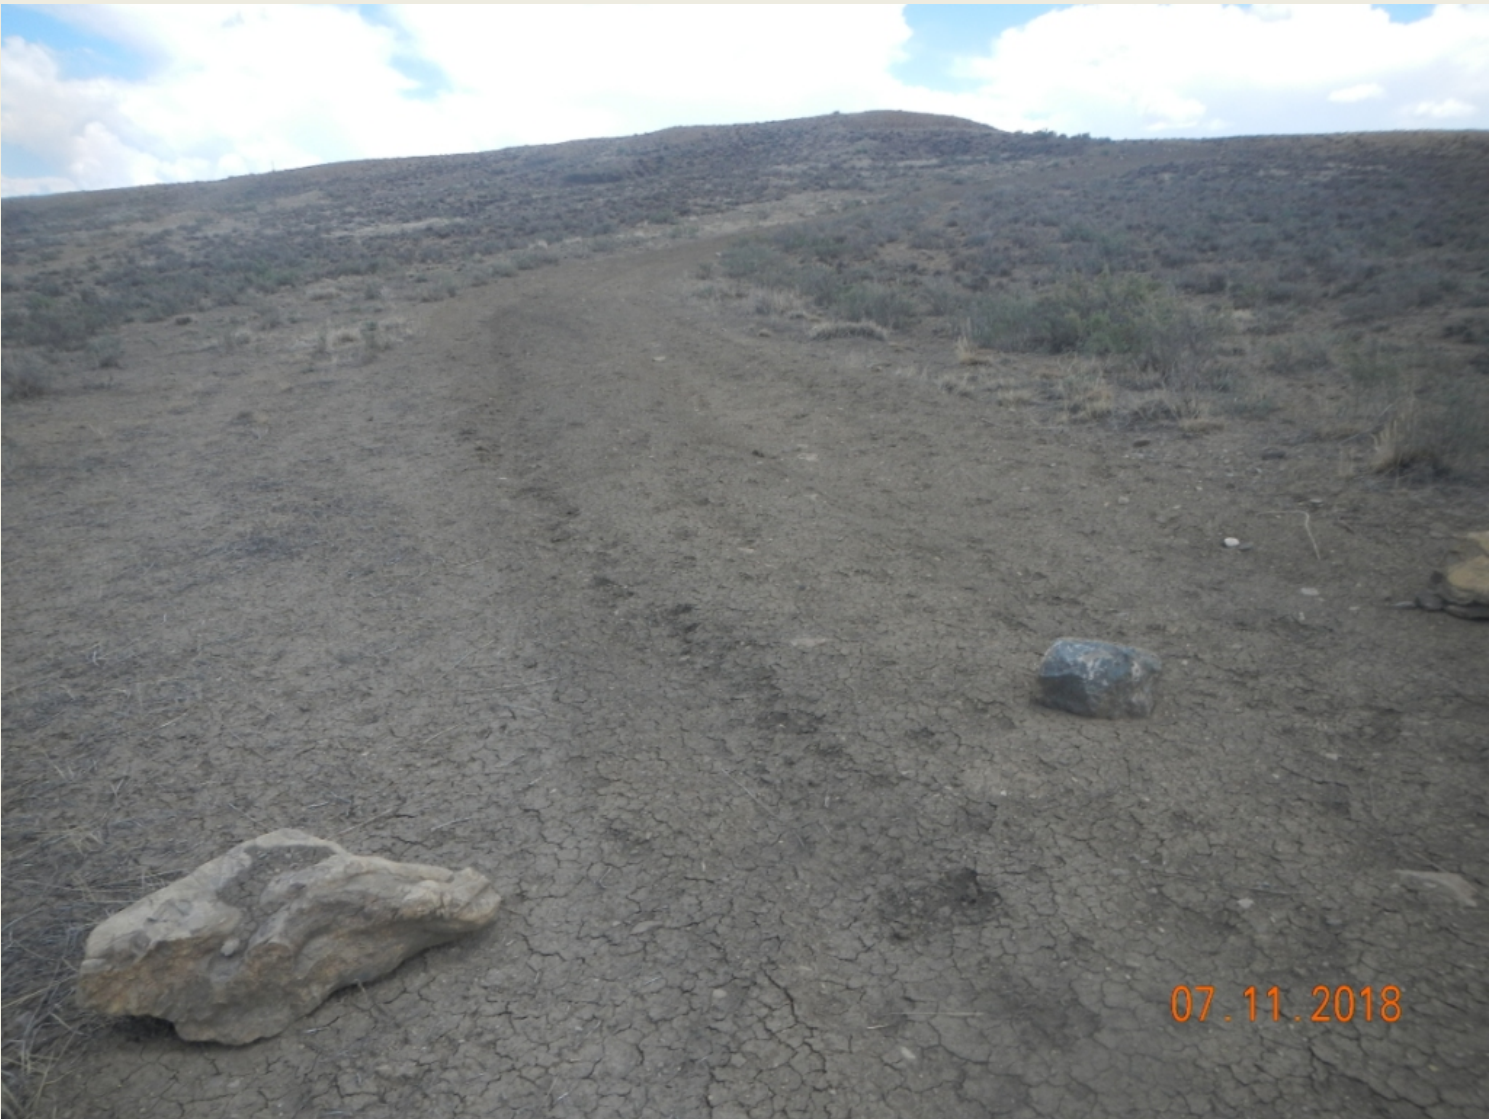
**Photo 1. View of the beginning of reclaimed access facing northward.**

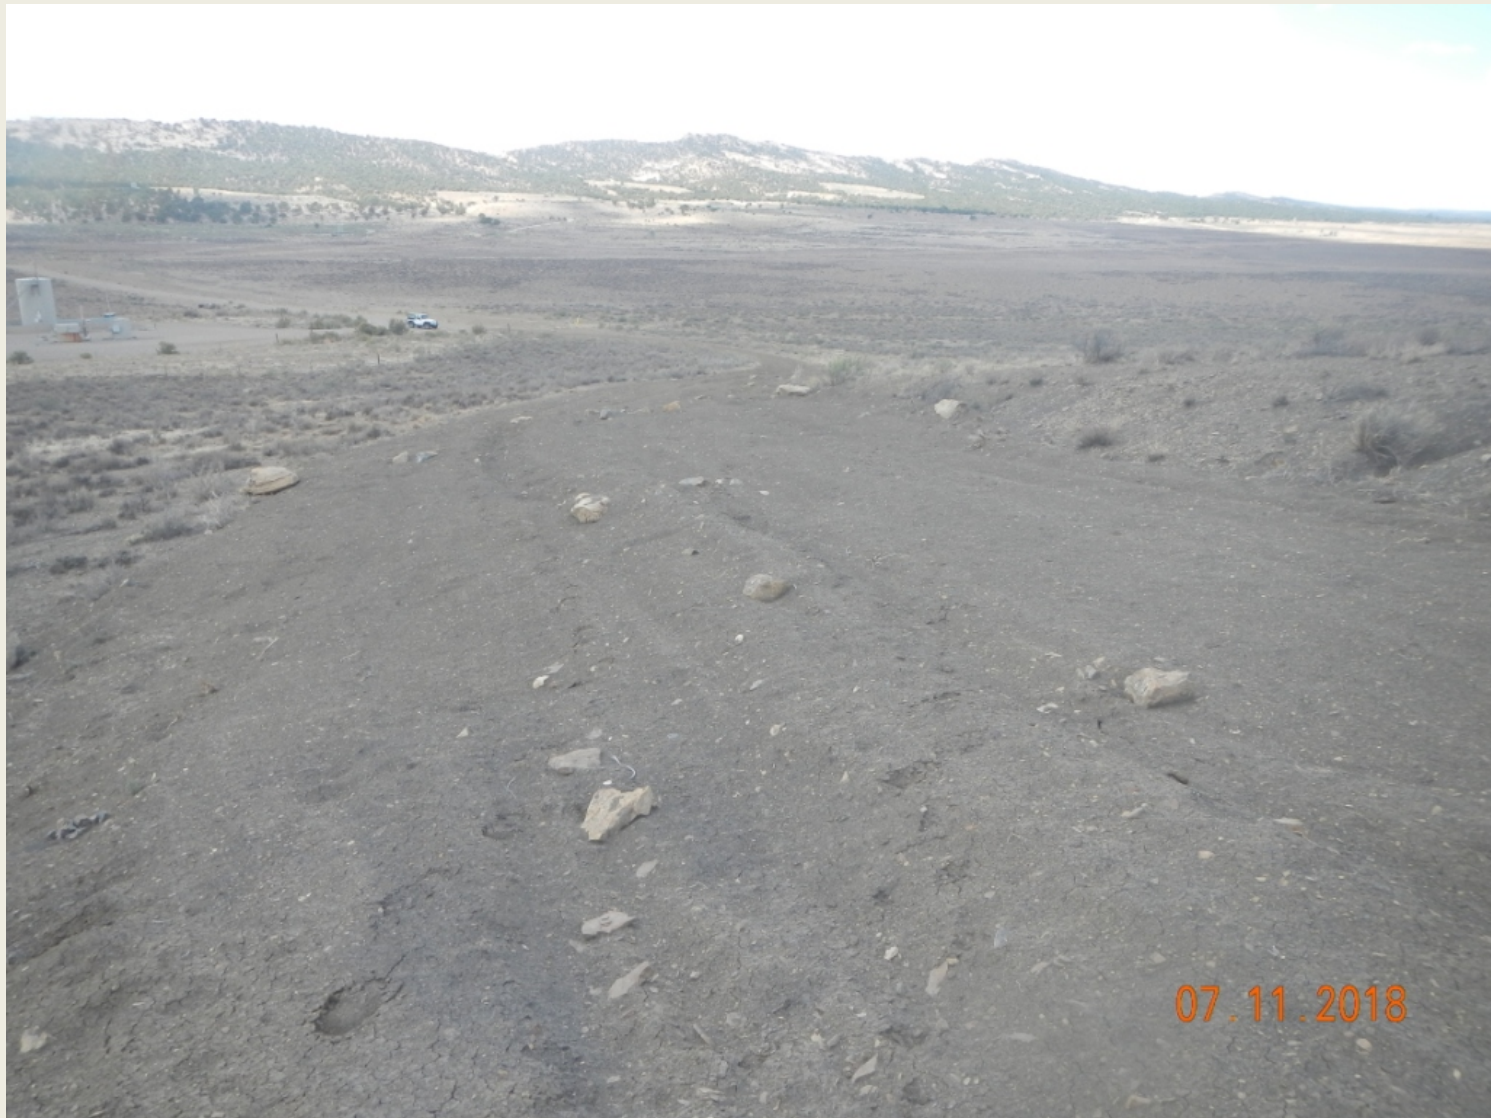
**Photo 2. View of a portion of the reclaimed access facing southwestward. Reclamation activities appear to have been conducted. Little germination observed.**

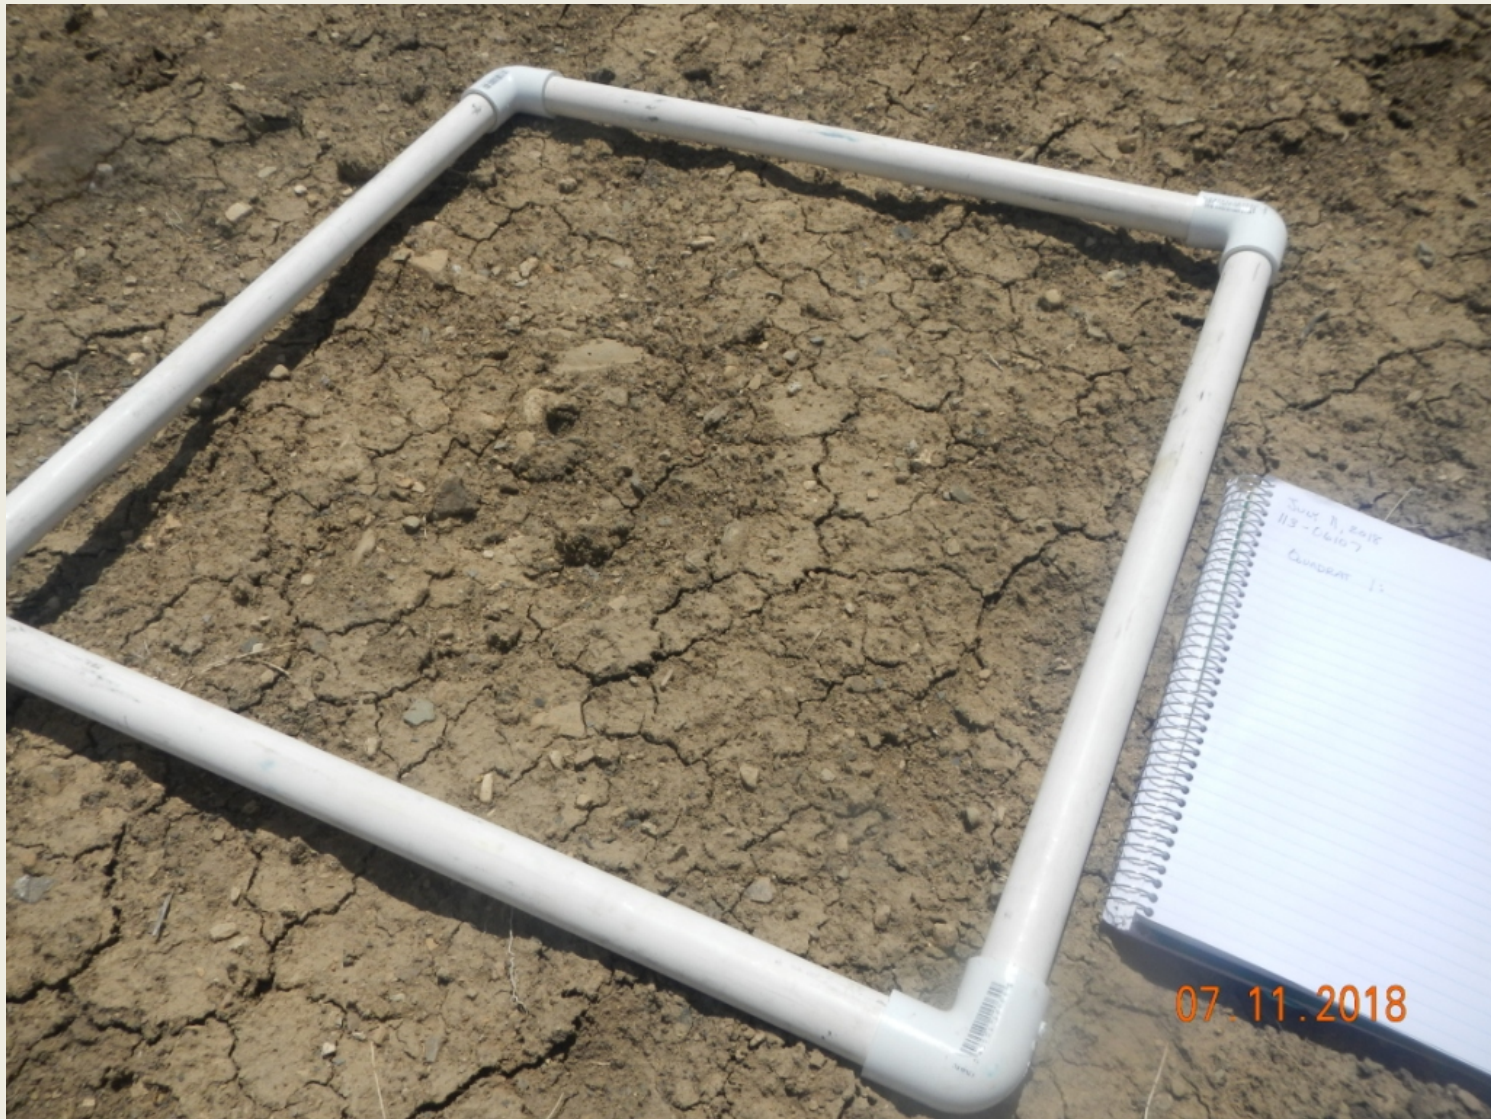
**Photo 3. View of sample quadrat 1. No germination observed within the sample quadrats.**
