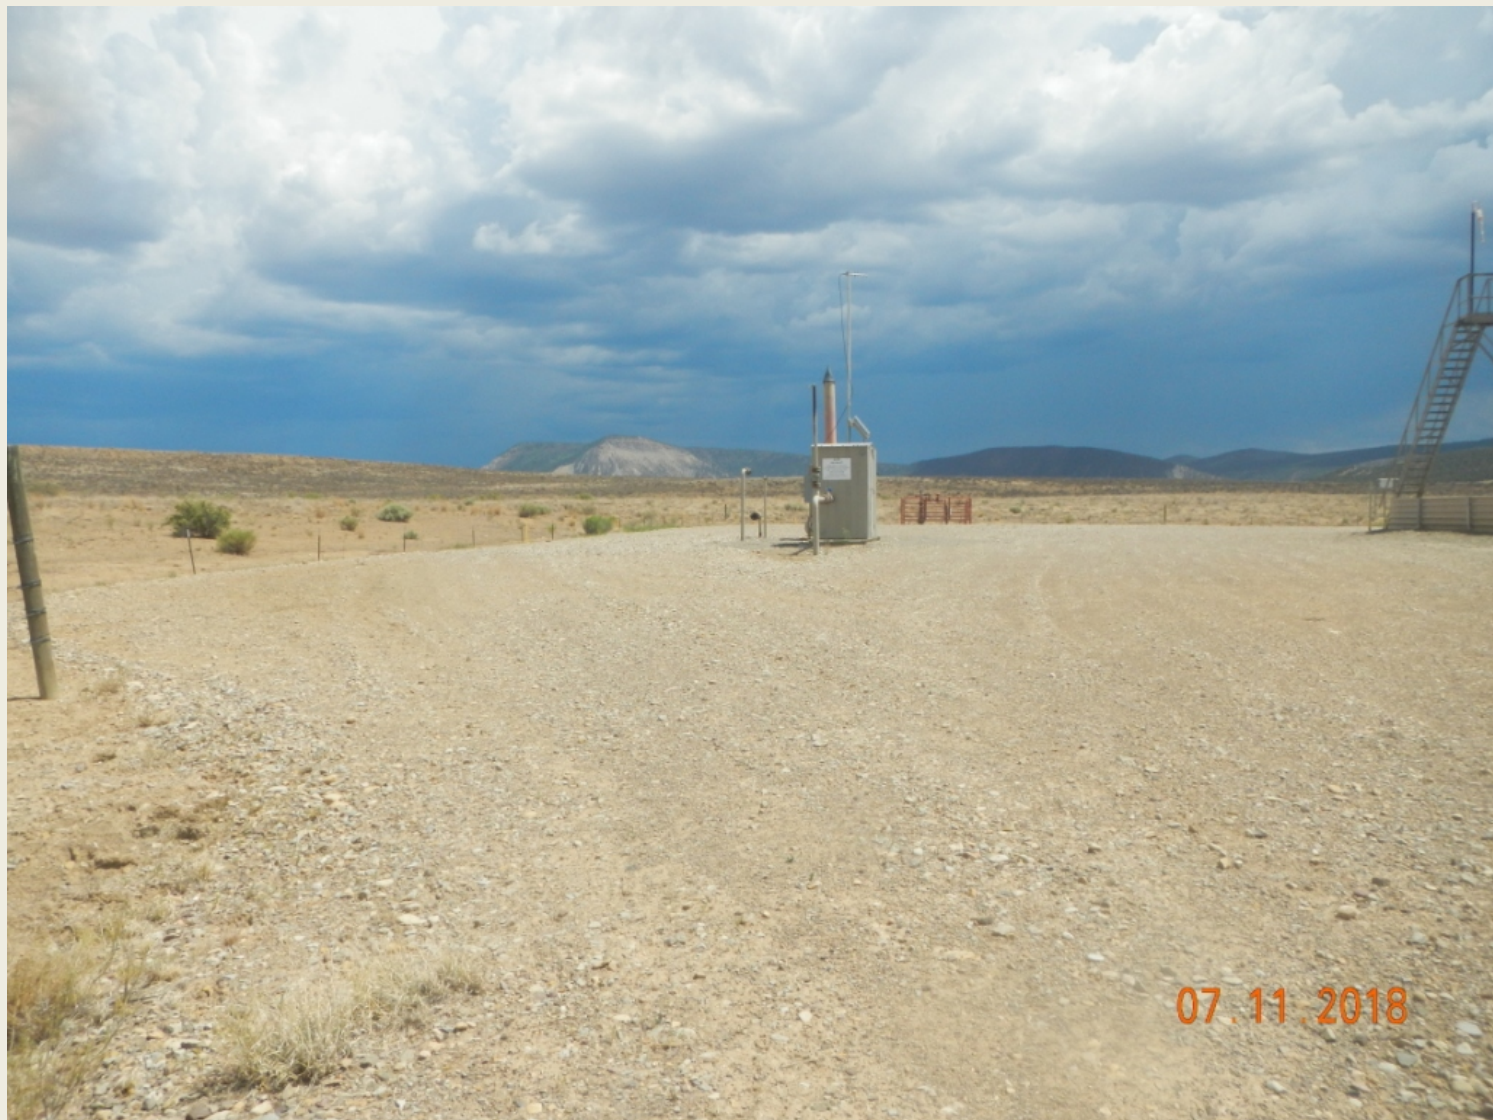
Photo 1. View of the project area from the well pad entrance facing center.

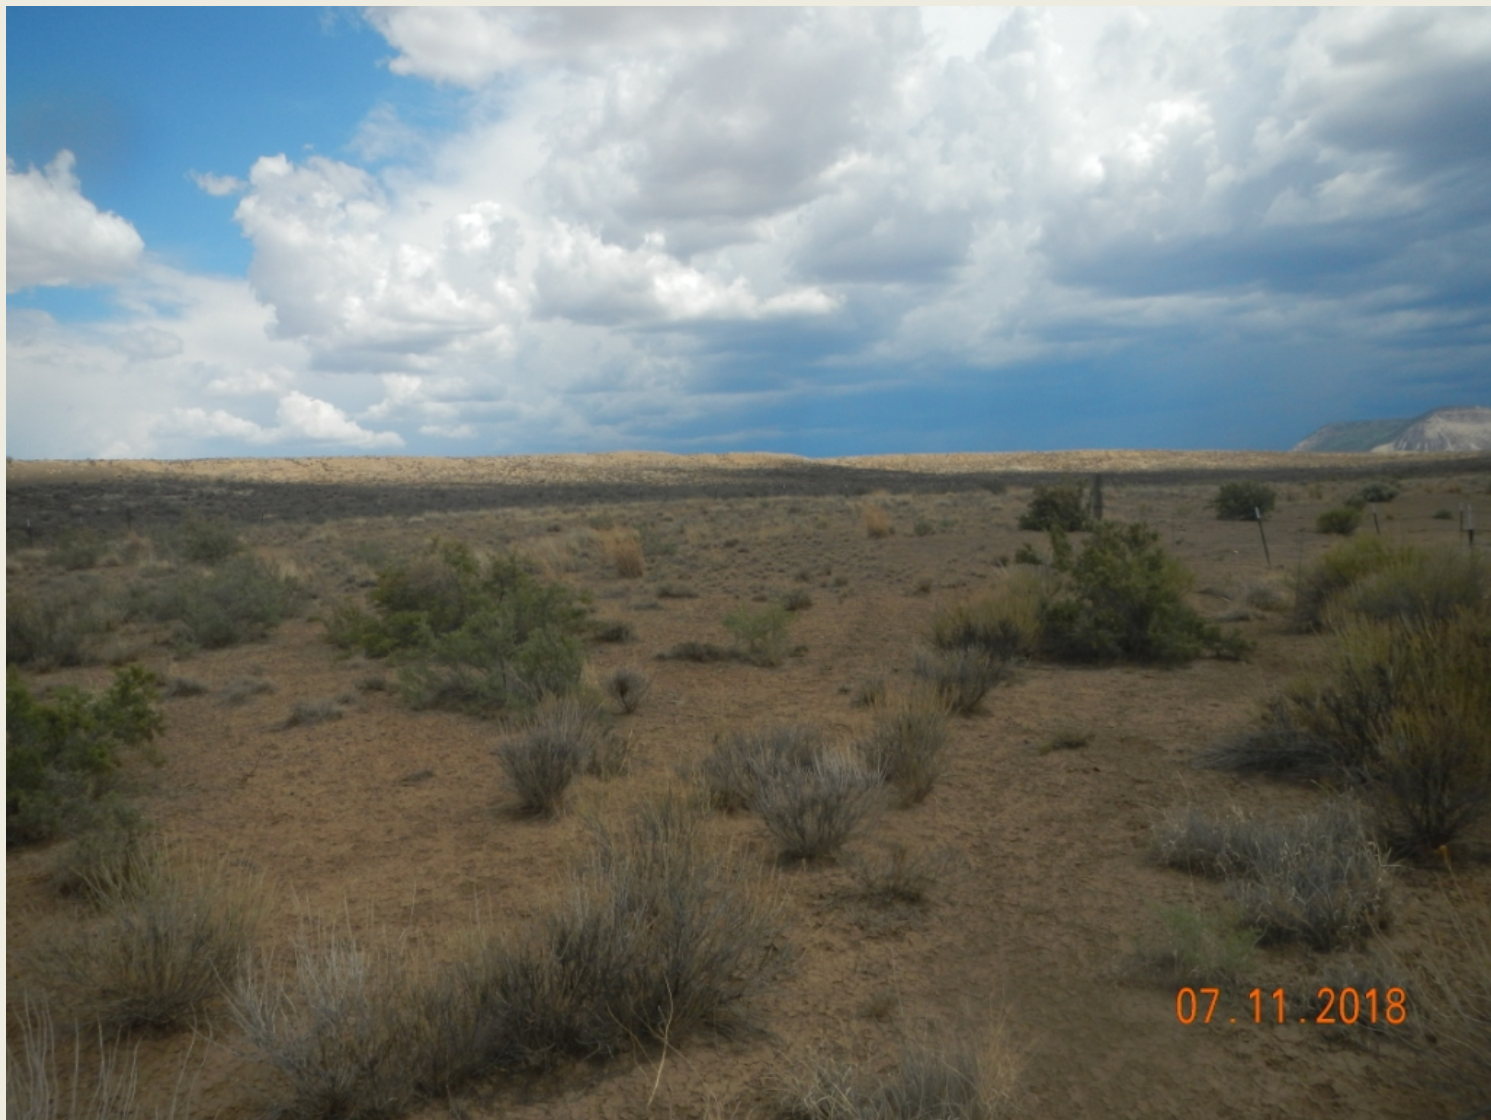
Photo 2. View of the northern interim reclamation area from the northwestern corner facing eastward. Vegetation is dry, but appears to be progressing.

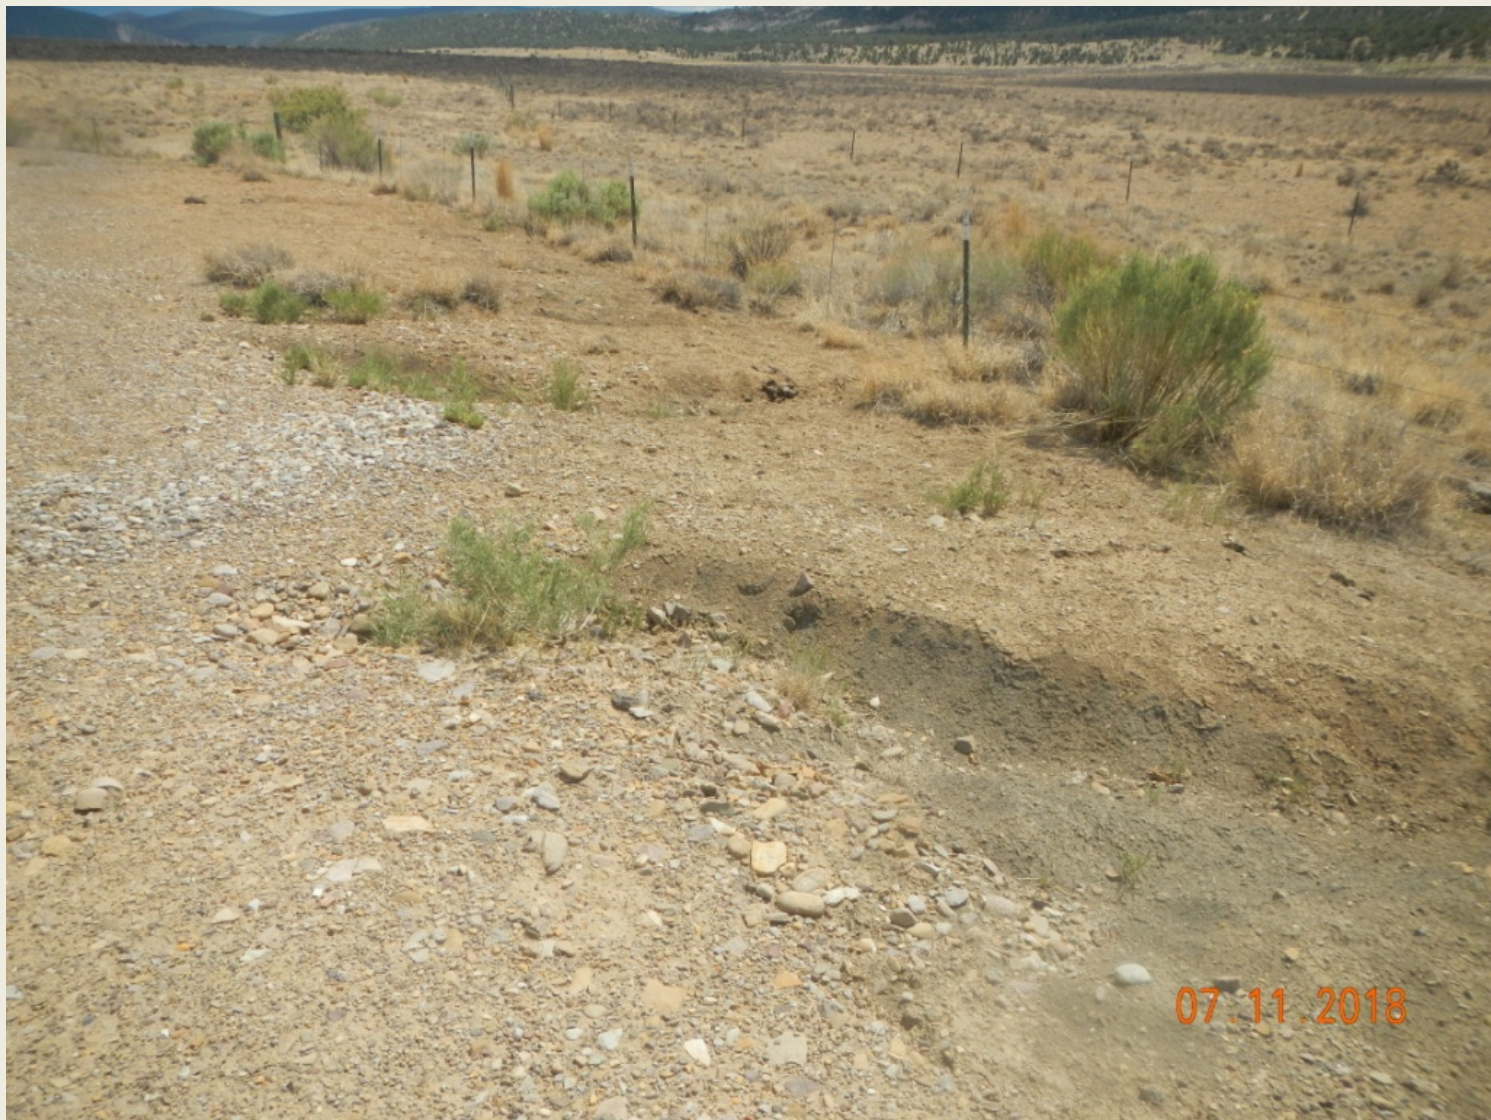
Photo 3. View of erosional channels forming within the southern project area. This needs to be monitored and stormwater controls installed if erosion worsens.
