## Inspection Photos

**Location Name:** Federal Osprey- 68N60W / 35NENW

**Location #:** 331181

**Federal Osprey 35-3** (API # 05-123-20272) wellhead

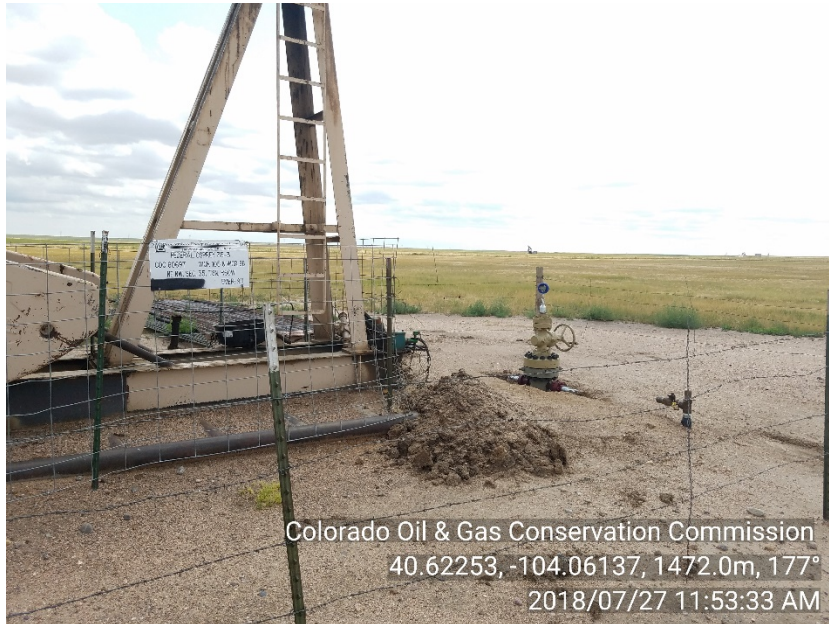
**Photo #1**

**Bradenhead not plumbed to surface**

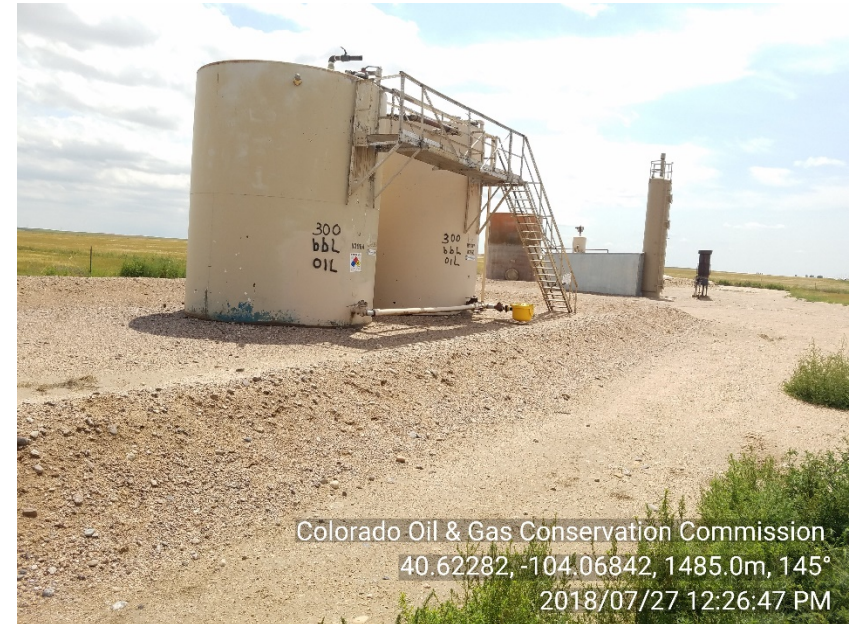
**Photo #2**

**Federal Osprey 35-3** (API # 05-123-20272) Battery

View 1

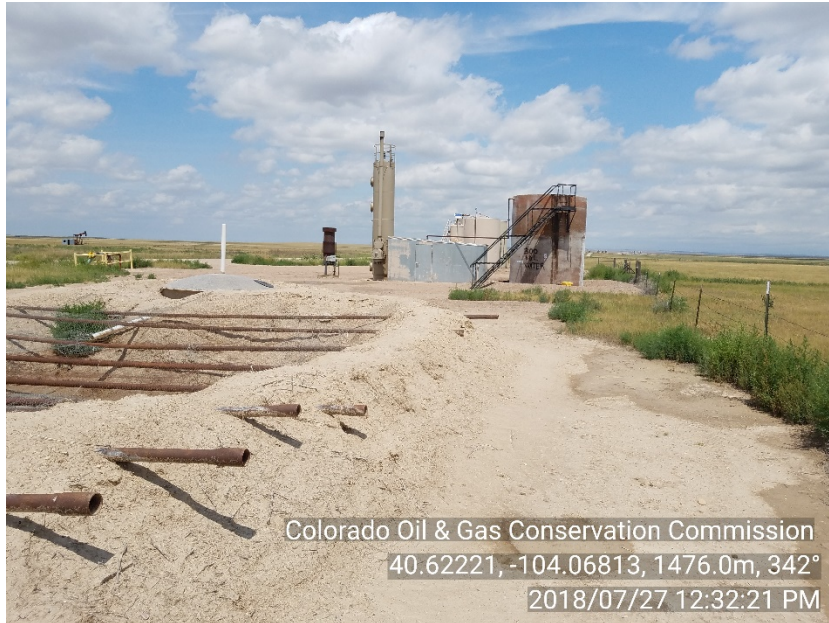
**Photo #3**

***Federal Osprey 35-3*** (API # 05-123-20272) Battery

View 2

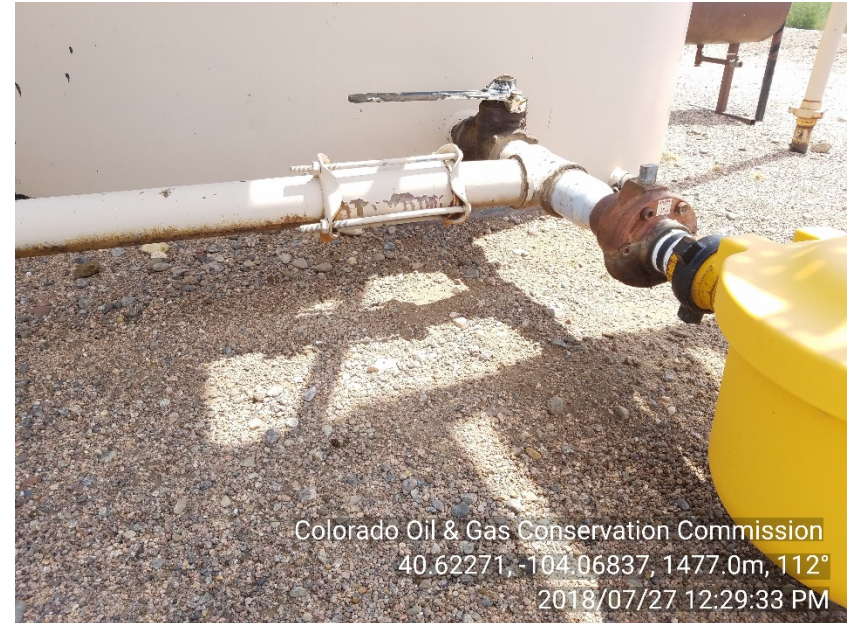
**Photo #4**

***Federal Osprey 35-3*** (API # 05-123-20272) oil tanks  
load-out

**Stain on ground from previous FIR  
Appears to have cleared**

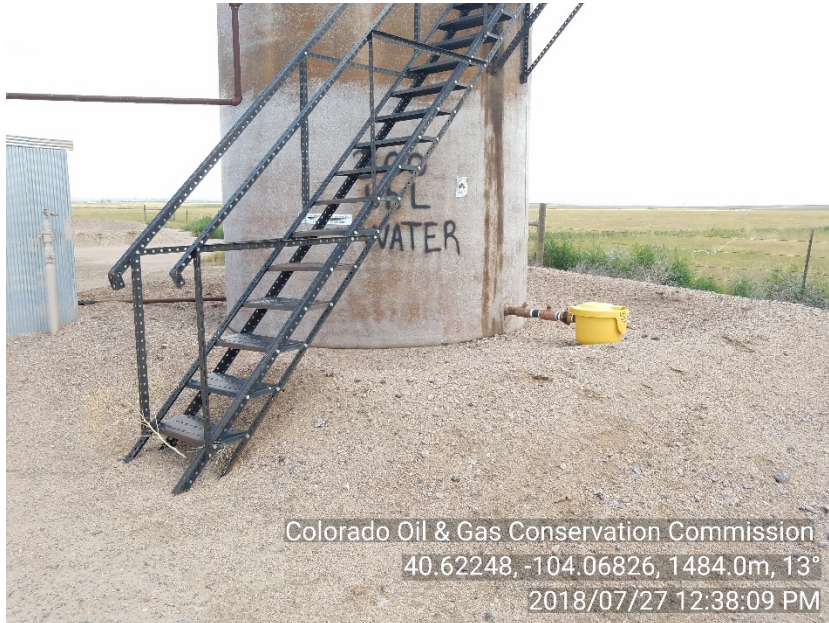
**Photo #5**

**Federal Osprey 35-3 (API # 05-123-20272) H2O tank**

**Berms dimensions appear inadequate for containment of vessel contents as referenced in previous FIR.**

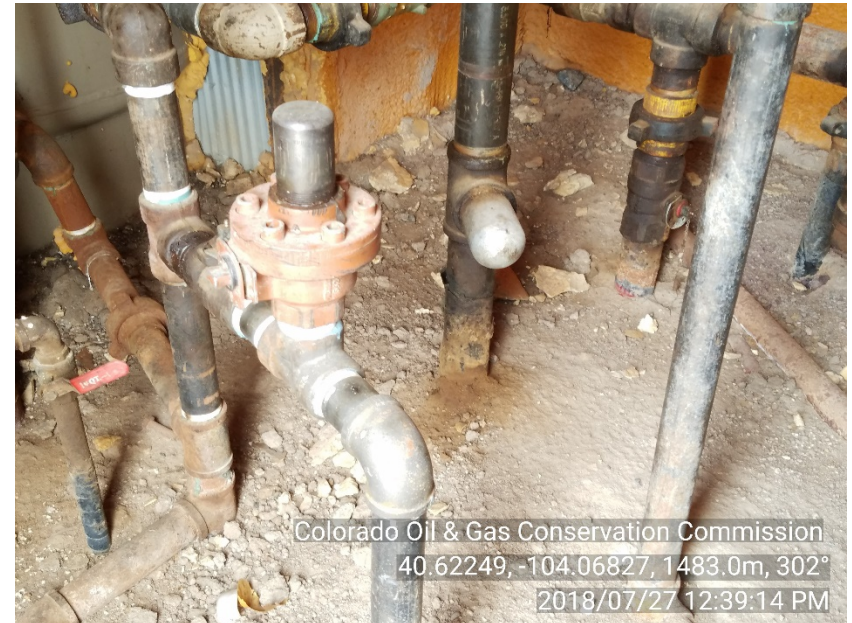
**Photo #6**

**Federal Osprey 35-3 (API # 05-123-20272) Oil treater**

**Stain on ground from previous FIR remains apparent**

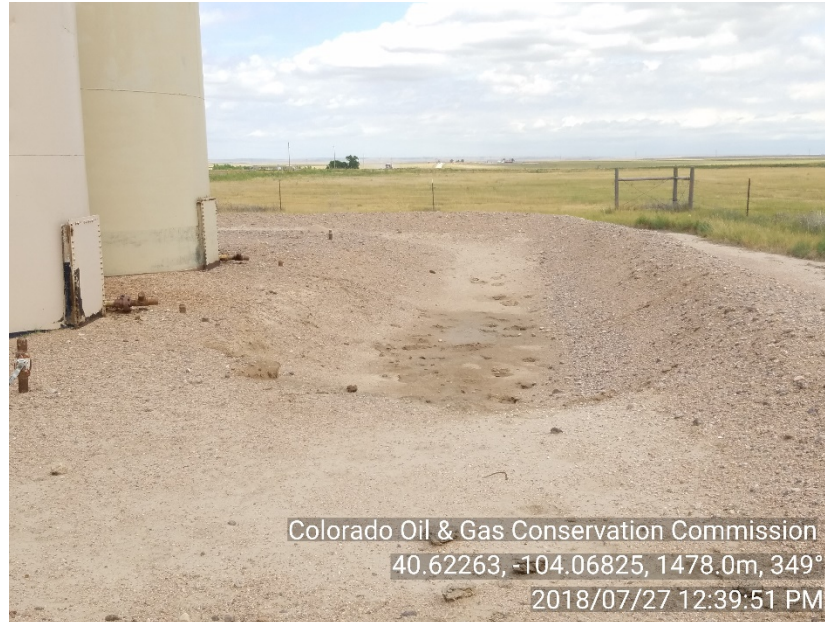
**Photo #7**

***Federal Osprey 35-3*** (API # 05-123-20272) oil tanks

**Un-permitted pit referenced from previous FIR  
Remains apparent**

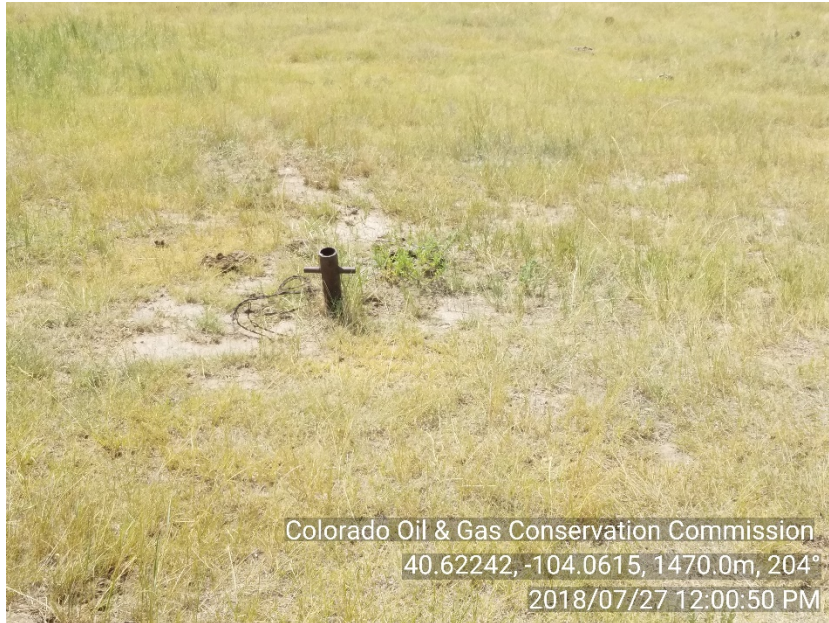
**Photo #8**

**Federal Osprey 35-3** (API # 05-123-20272) well anchors

**1 - Un-marked anchor referenced from previous FIR  
Remains apparent**

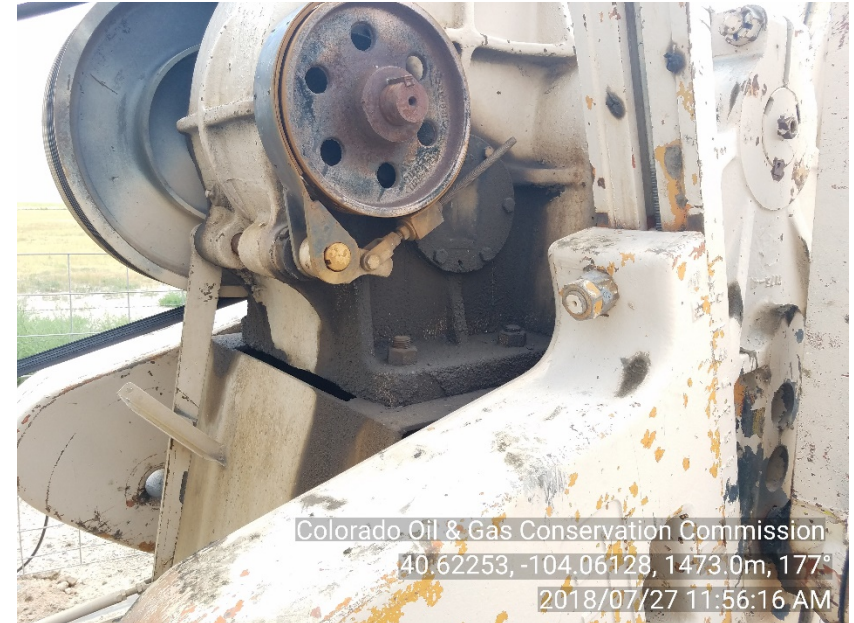
**Photo #9**

**Federal Osprey 35-3** (API # 05-123-20272)

Pumping Unit

**Stain on gearbox from previous FIR  
remains apparent**

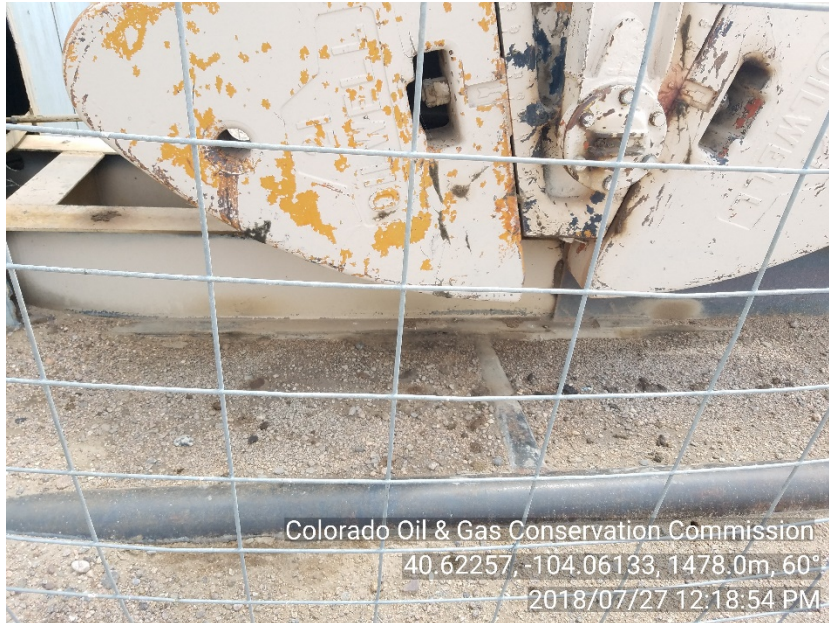
**Photo #10**

**Federal Osprey 35-3** (API # 05-123-20272)

Pumping Unit

**Stain on ground near skid referenced from previous FIR  
Remains apparent**

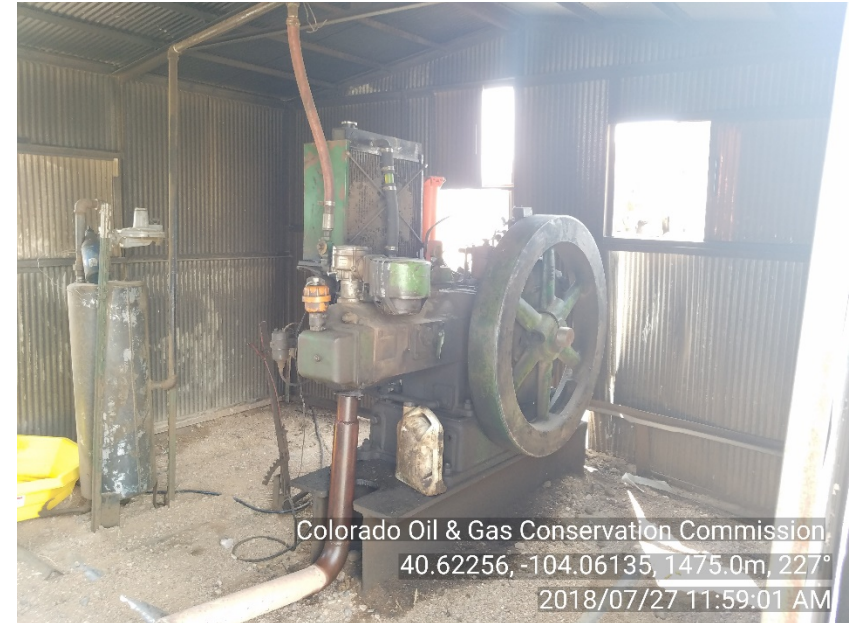
**Photo #11**

**Federal Osprey 35-3** (API # 05-123-20272)

Gas Engine – Prime Mover

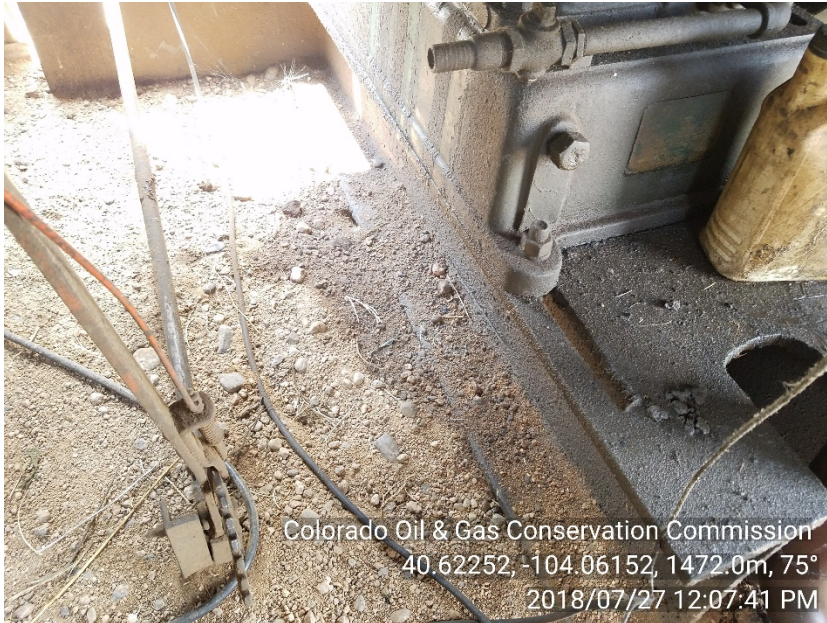
**Photo #12**

**Federal Osprey 35-3** (API # 05-123-20272)

Gas Engine – Prime Mover

**Stain on ground near skid  
referenced from previous FIR  
Remains apparent**

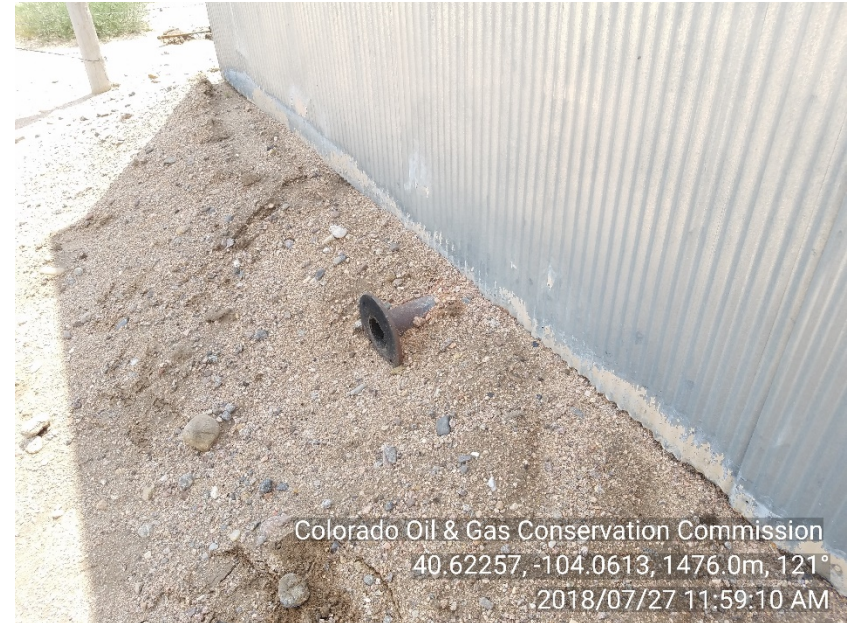
**Photo #13**

**Federal Osprey 35-3** (API # 05-123-20272)

Gas Engine – Prime Mover

**No engine muffler  
referenced from previous FIR  
Remains apparent**

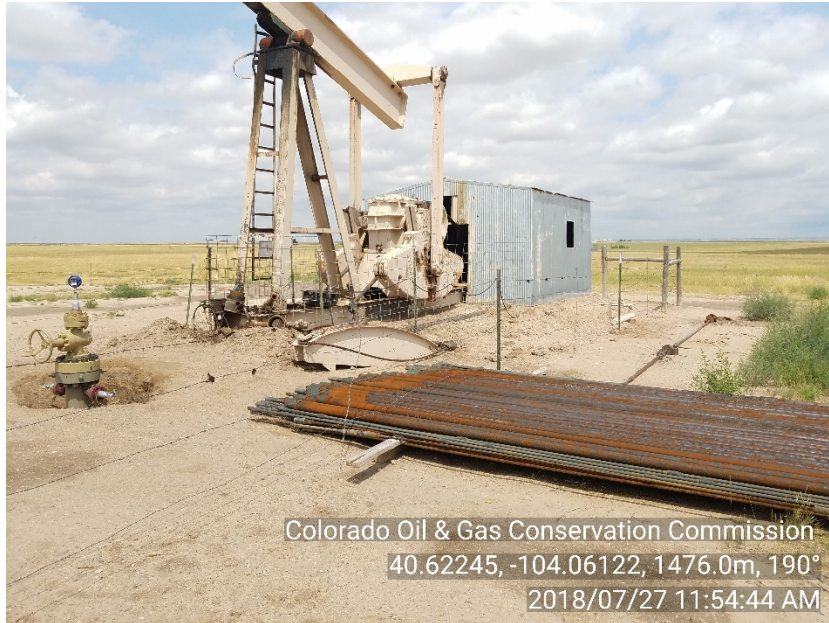
**Photo #14**

**Federal Osprey 35-3** (API # 05-123-20272) wellhead

**Ground oil stains near wellhead**

**referenced from previous FIR**

**Appear to have cleared**

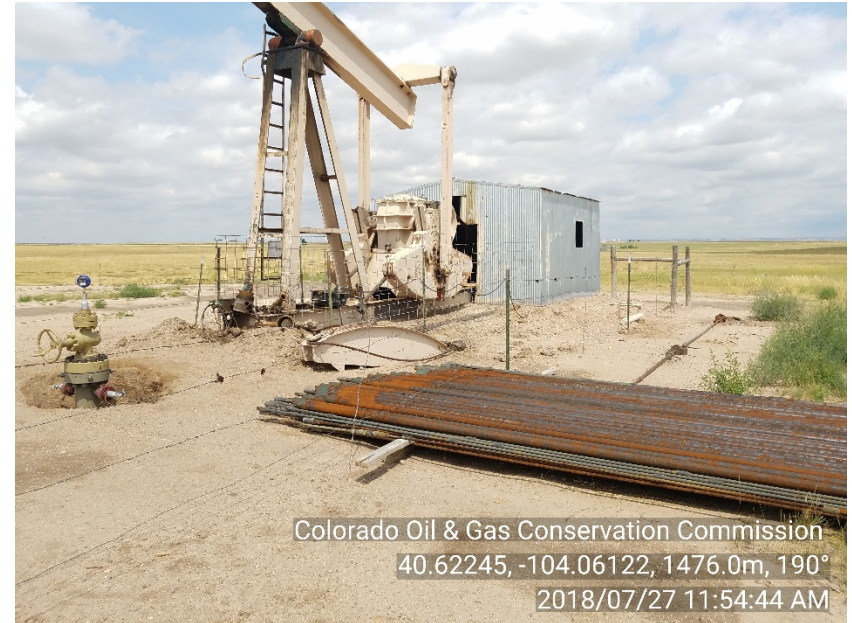
**Photo #15**

**Federal Osprey 35-3** (API # 05-123-20272) wellhead

**Tubing & Rods have been pulled from well**

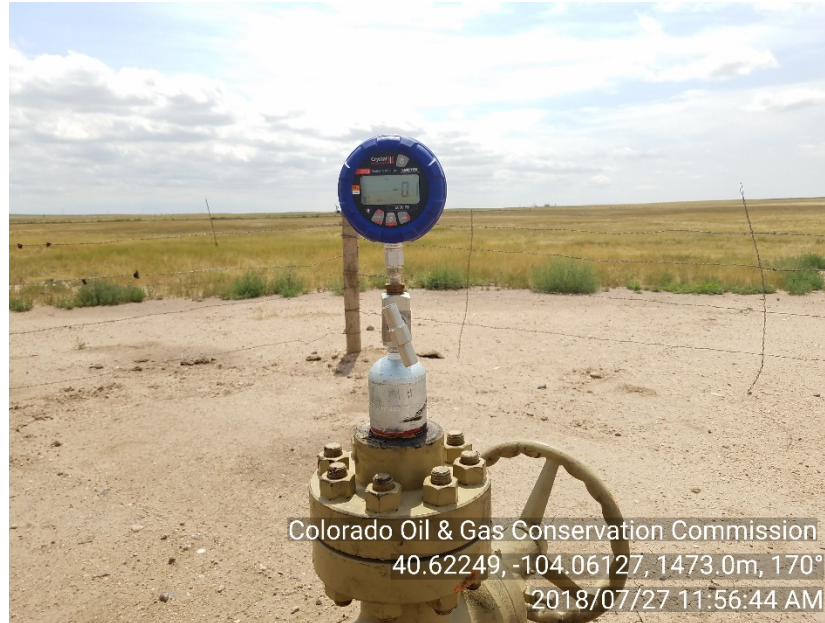
**Photo #16**

***Federal Osprey 35-3*** (API # 05-123-20272) wellhead

**Observed Crystal brand digital gauge on wellhead**
