Well Name : Jacques 9

API # : 067-10021

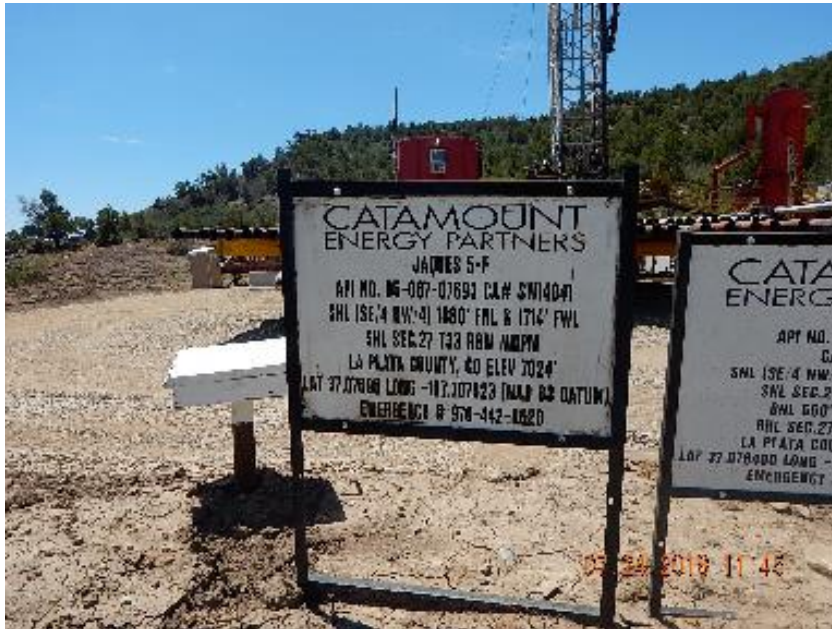
Photo 1: Wellhead sign.

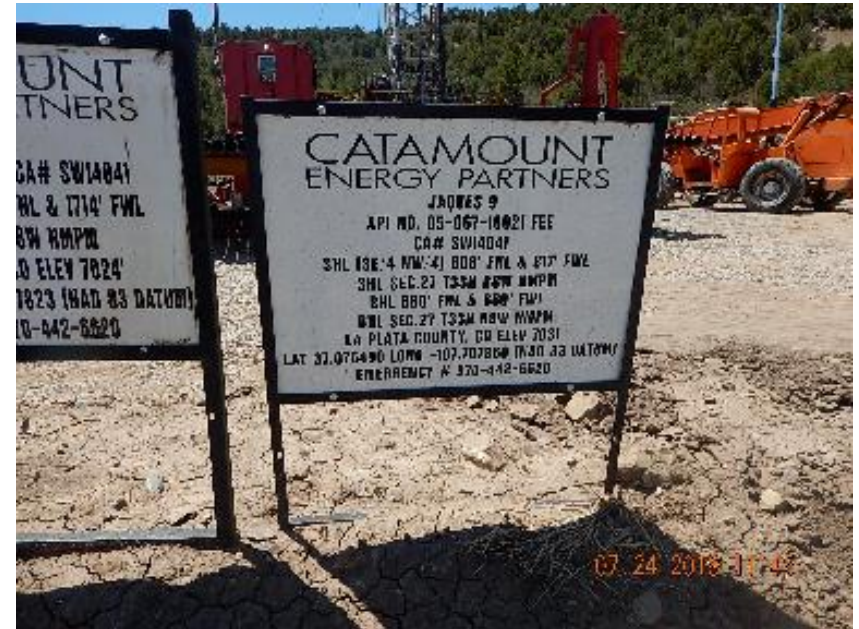
Photo 2: Wellhead sign.

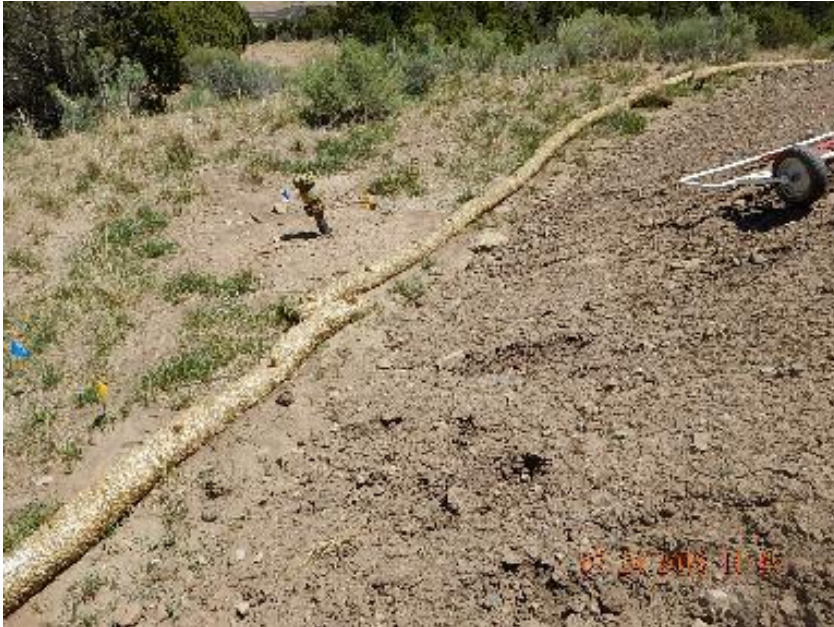
Photo 3: Waddle not trenched in.

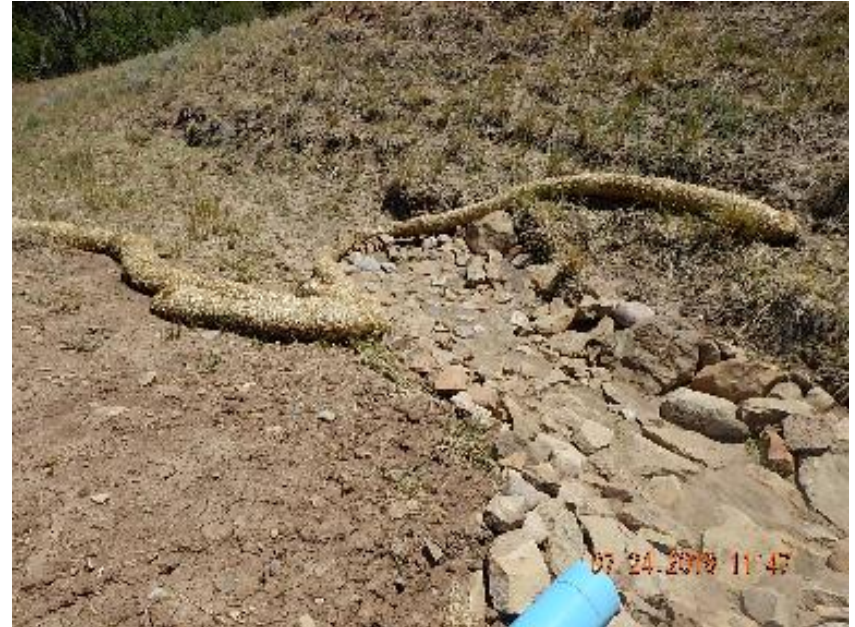
Photo 4: Waddle with stormwater flow under cutting waddle.

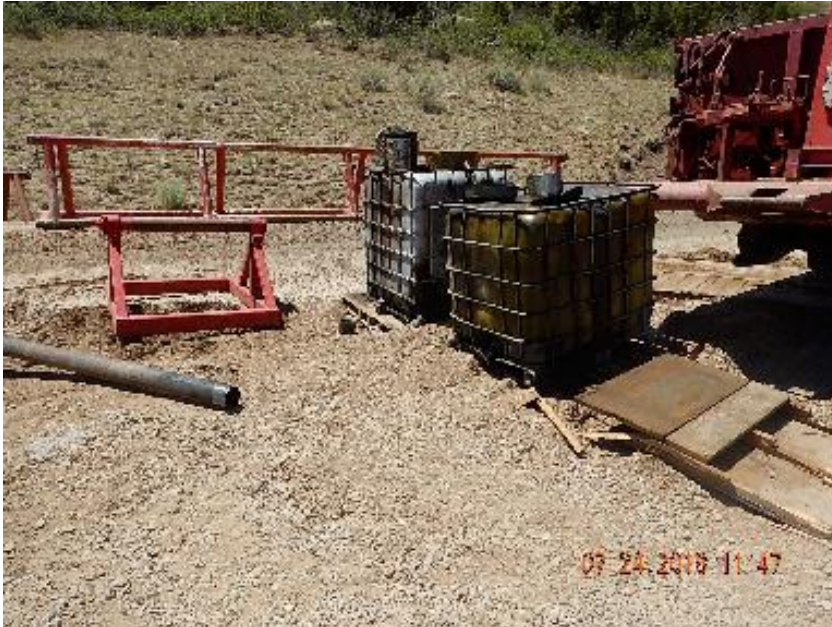
Photo 5: Oil totes with no spill prevention.

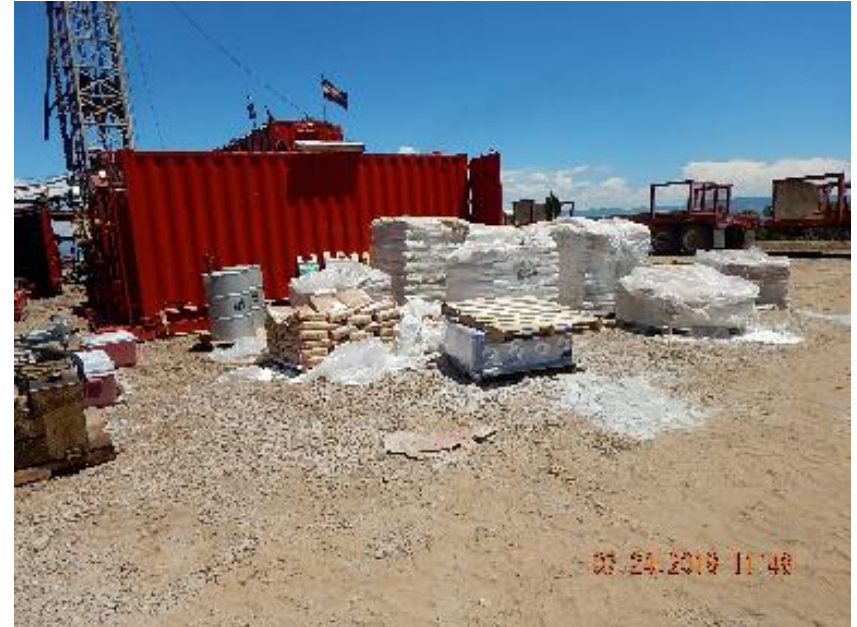
Photo 6: Spilled dry drilling materials and 55 gallon drums with no spill prevention.

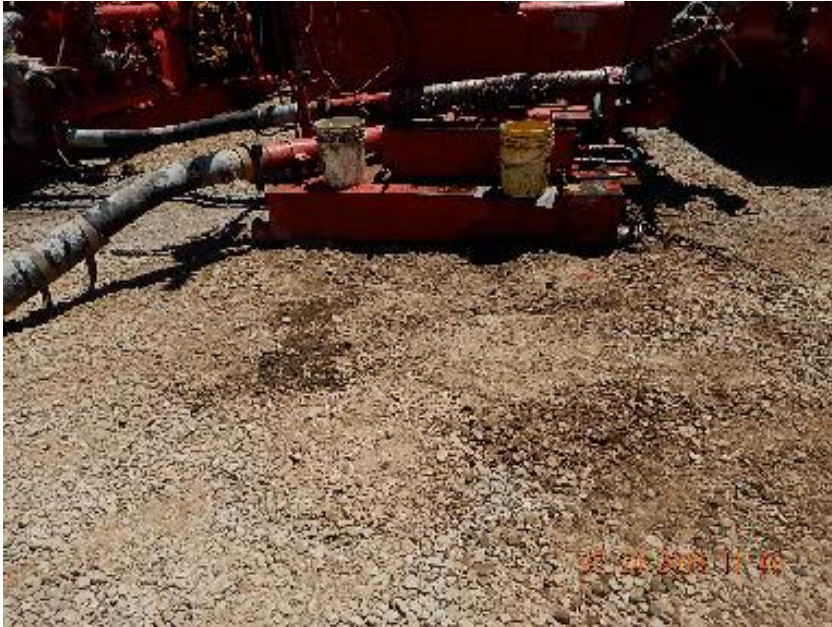
Photo 7: Impacted soil and gravel around drilling equipment.

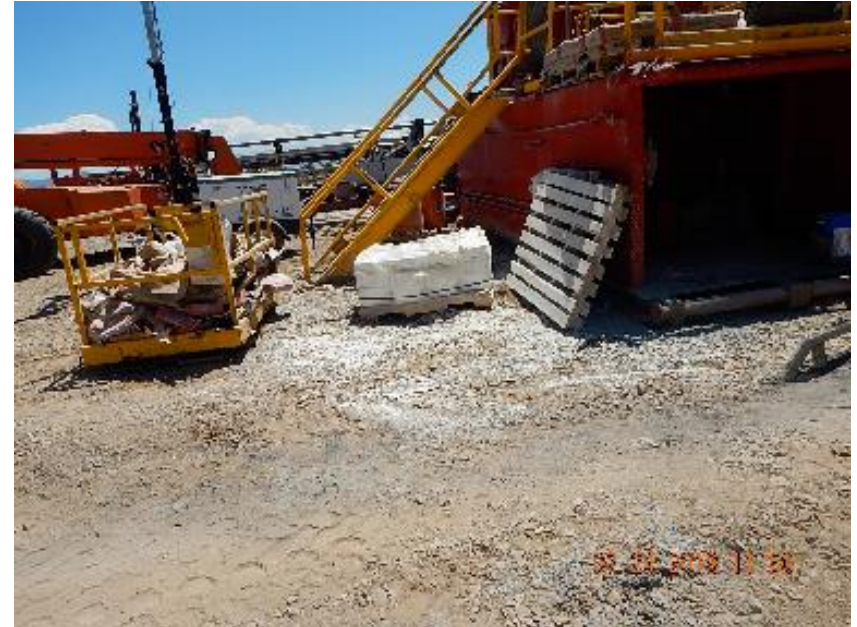
Photo 8: Spilled dry materials in working area.

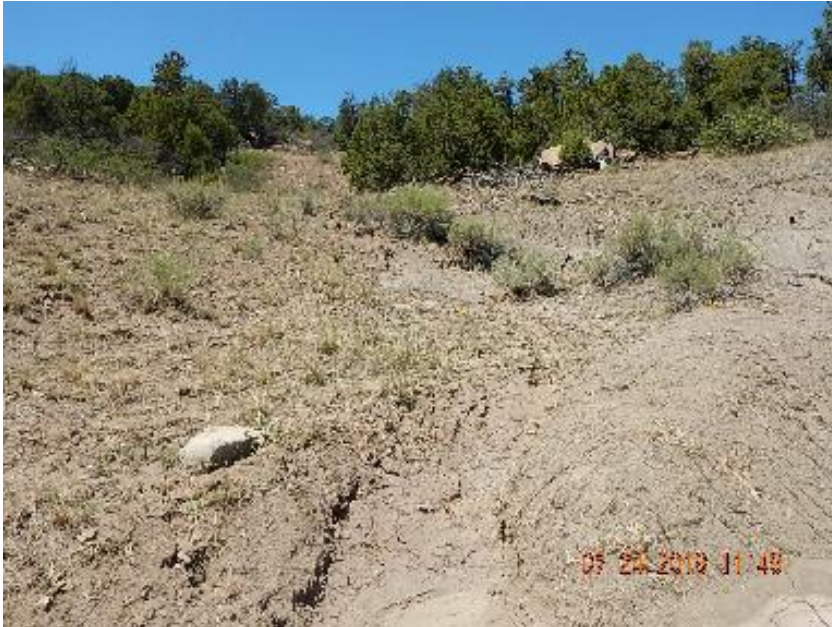
Photo 9: Breach in ditch and berm allowing stormwater and sediment to flow out of diversion ditch.

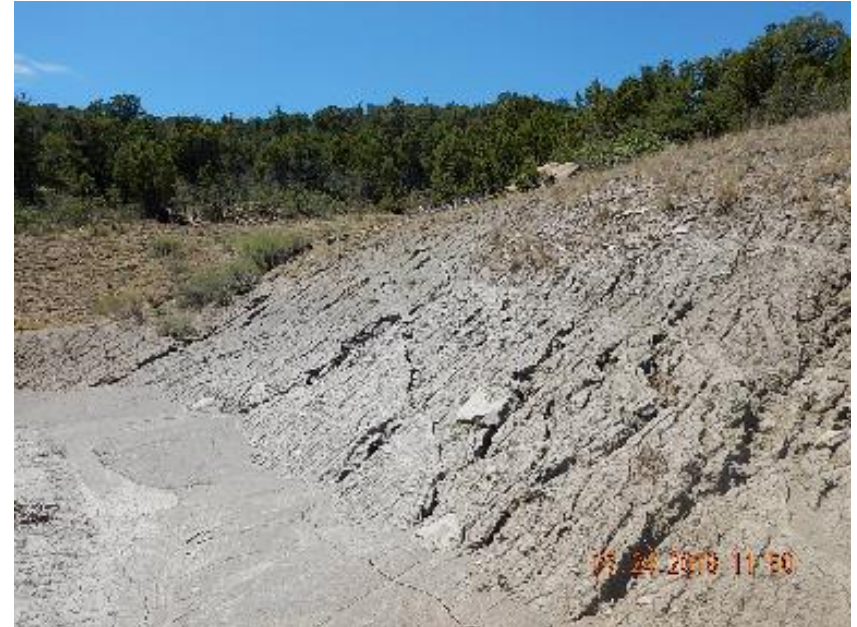
Photo 10: Rilling on cut slope with ditch at base of slope more than 75% full of sediment.

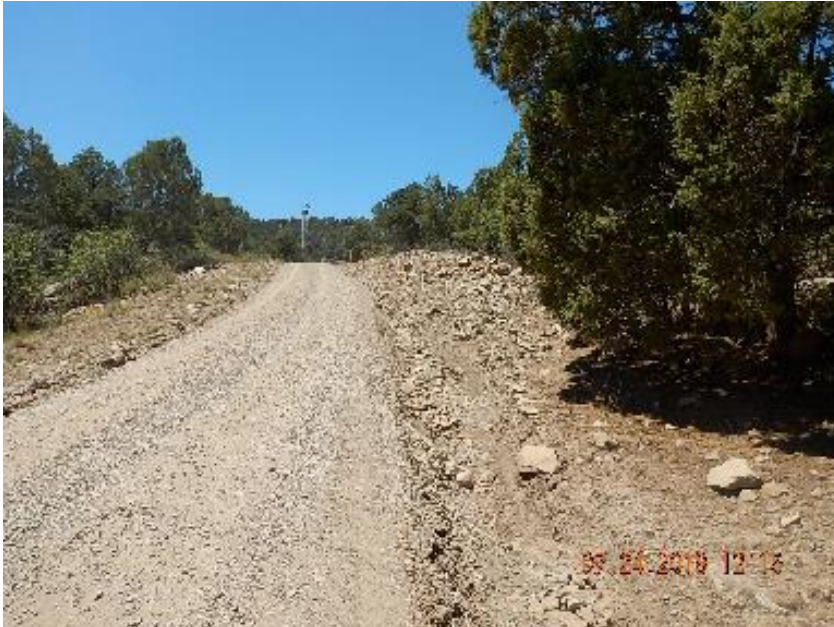
Photo 11: Access road with no stormwater velocity controls.

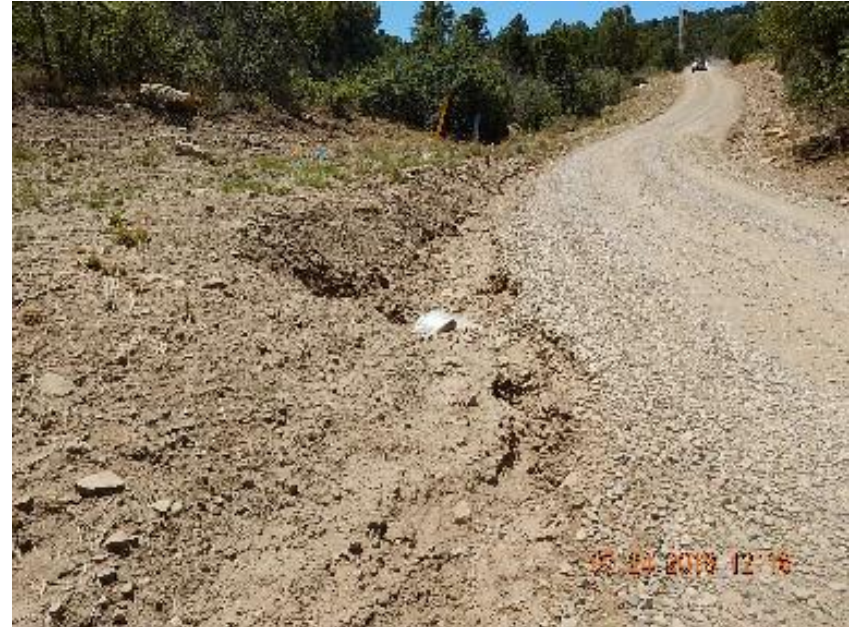
Photo 12: Stormwater flow over culvert along access road.

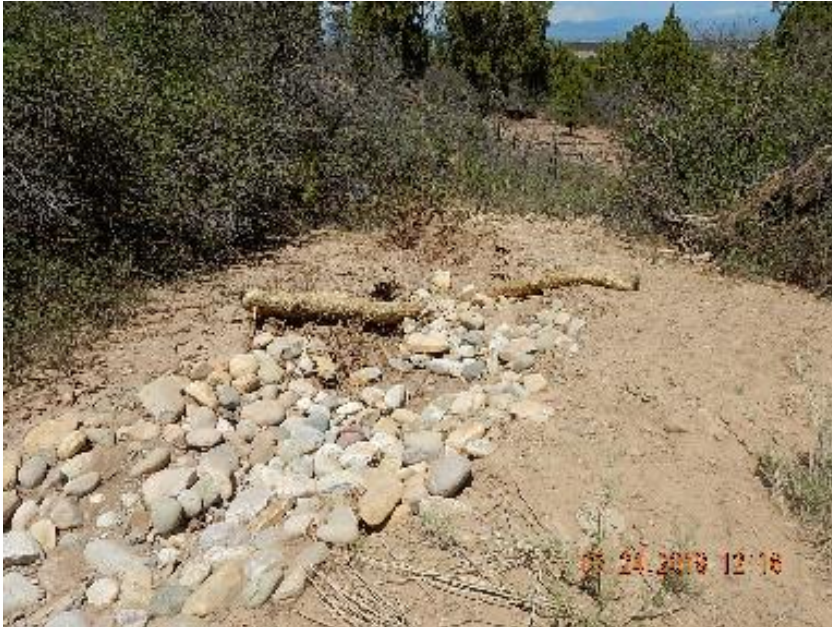
Photo 13: Blown out sediment trap.

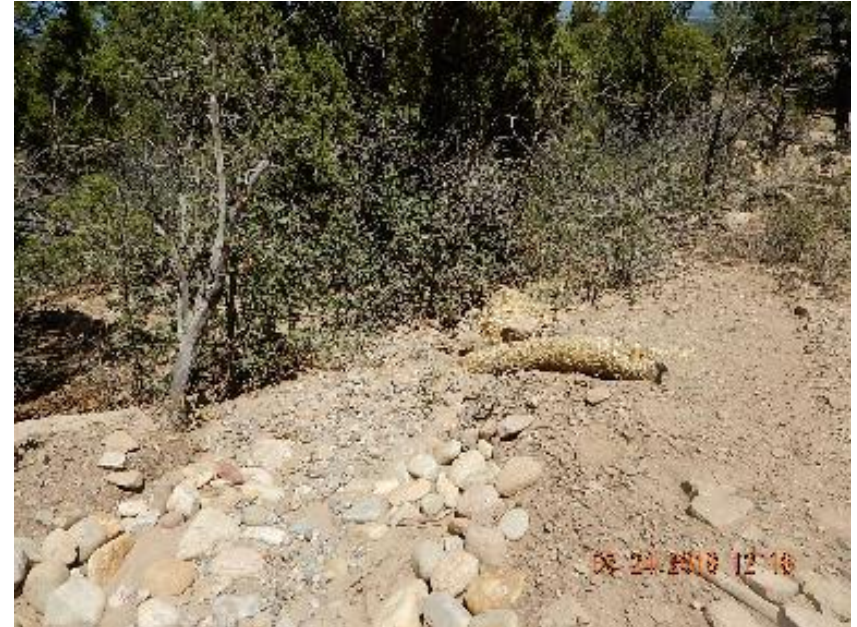
Photo 14: Blown out sediment trap, armor, and waddle.

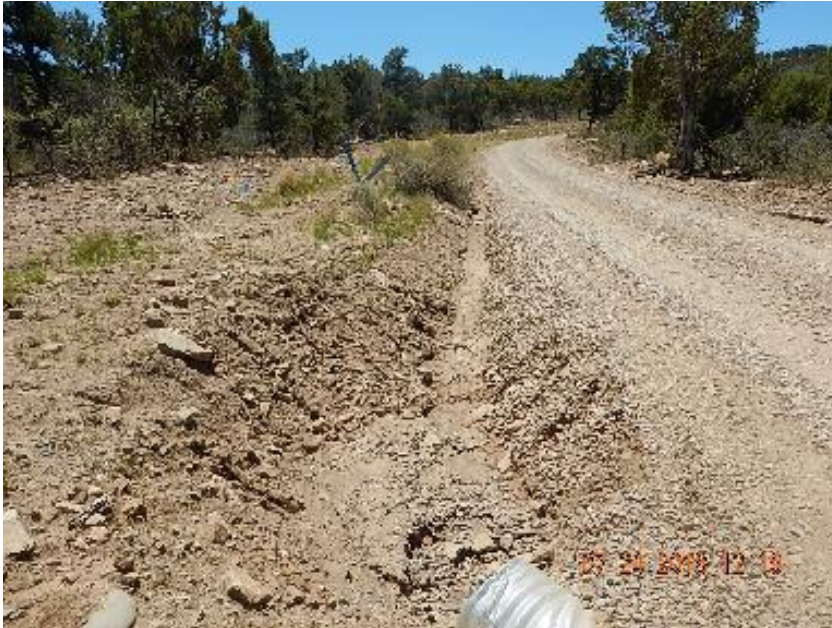
Photo 15: Ditch along access road with no storm water velocity controls.

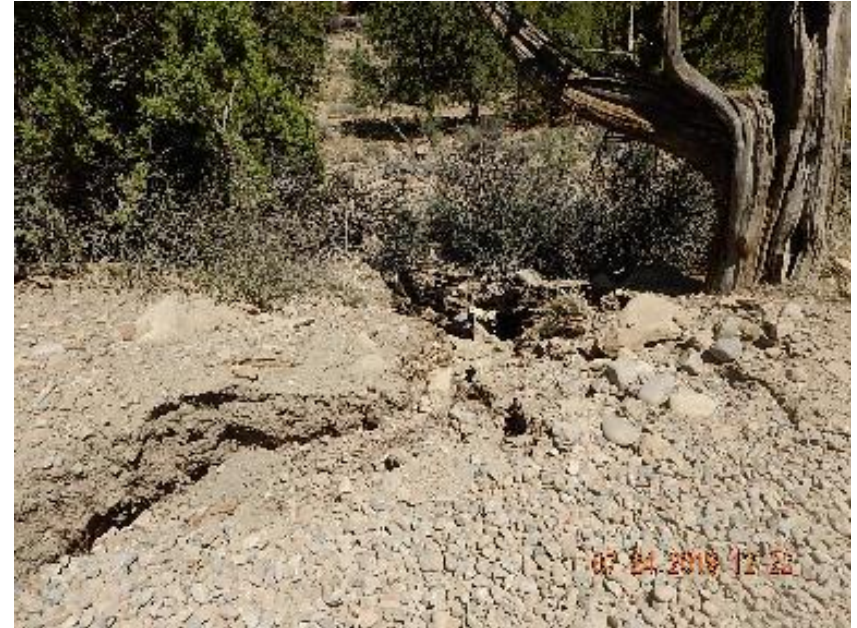
Photo 16: Stormwater flow crossing the road resulting in erosion on down slope edge of roadway.
