Inspection Photos  
Location Name: Kowach 1-9  
API: 05-081-06185

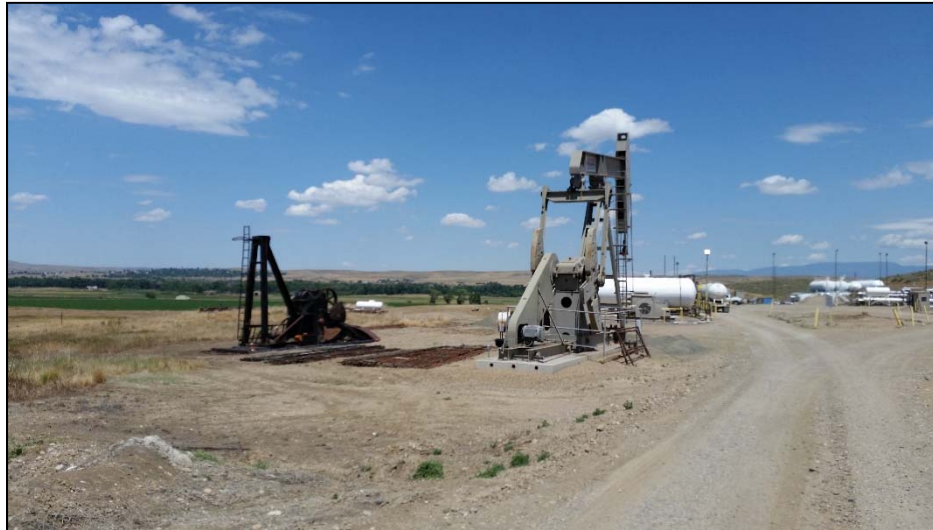
**Photo 1. Overview of location taken at entrance facing northwest.**

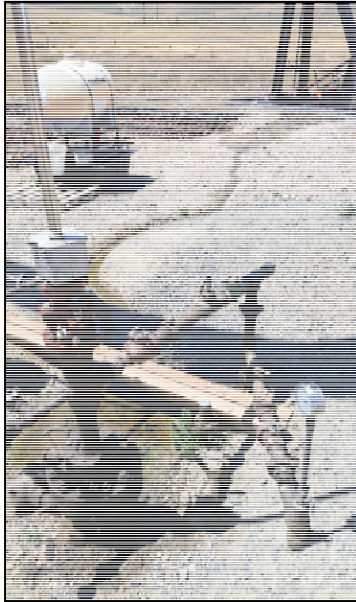
**Photo 2. Fluid in cellar being drained out.**

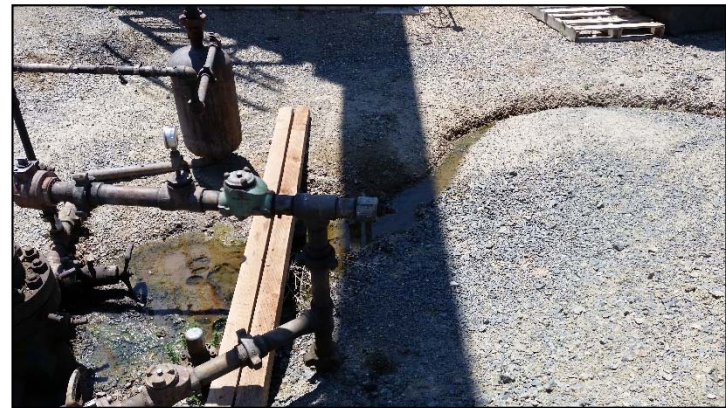
**Photo 3. Drain pathway out of cellar.**

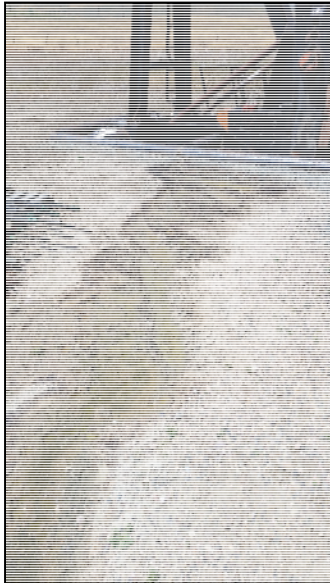
**Photo 4. Fluid draining out of cellar toward pumpjack stored on location.**

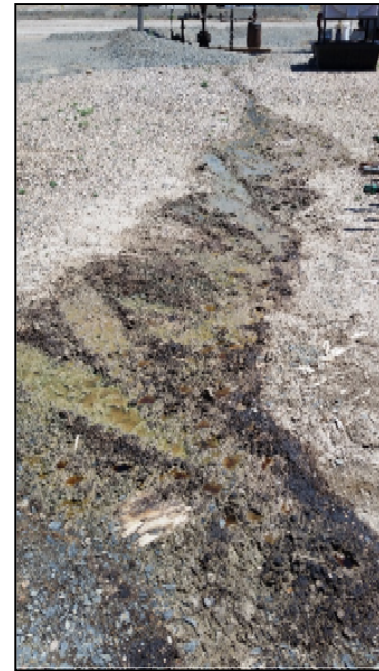
**Photo 5. Drain pathway out of cellar, stained soil where fluid has evaporated.**
